Inspection Exercise

Bridge – John Doe over John Doe River

- Overview: built in 1950, 3 span steel stringer bridge over water

Bridge – Willoughby Road over the Sycamore Creek

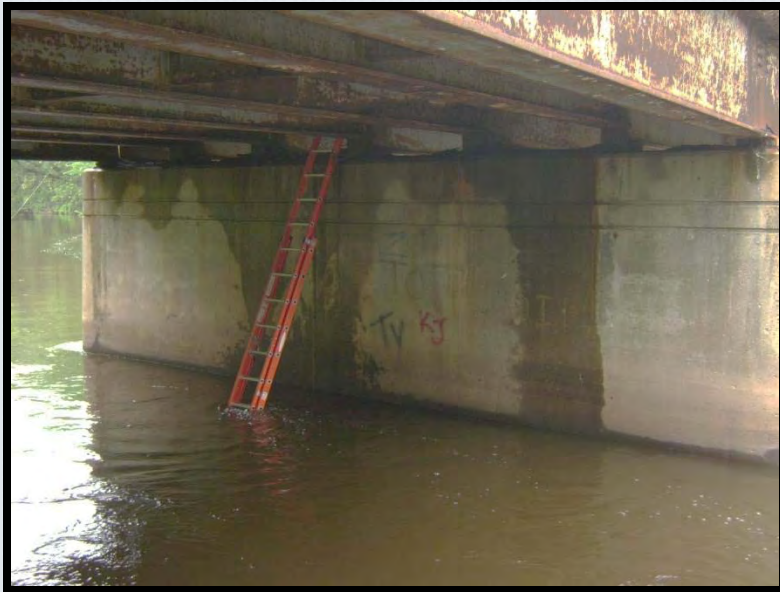
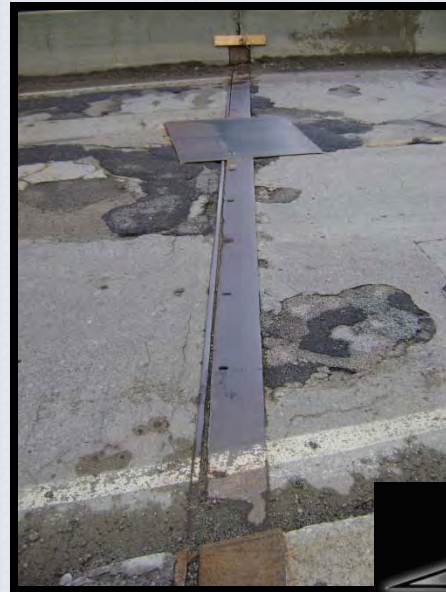
- Upon inspection noted full depth hole in deck at expansion joint and heavy scale at steel beam ends – limited access to beam ends due to water
- Requested a detailed inspection via phone with bridge owner followed up with an email request
- Authorized by the bridge owner to perform D.I.

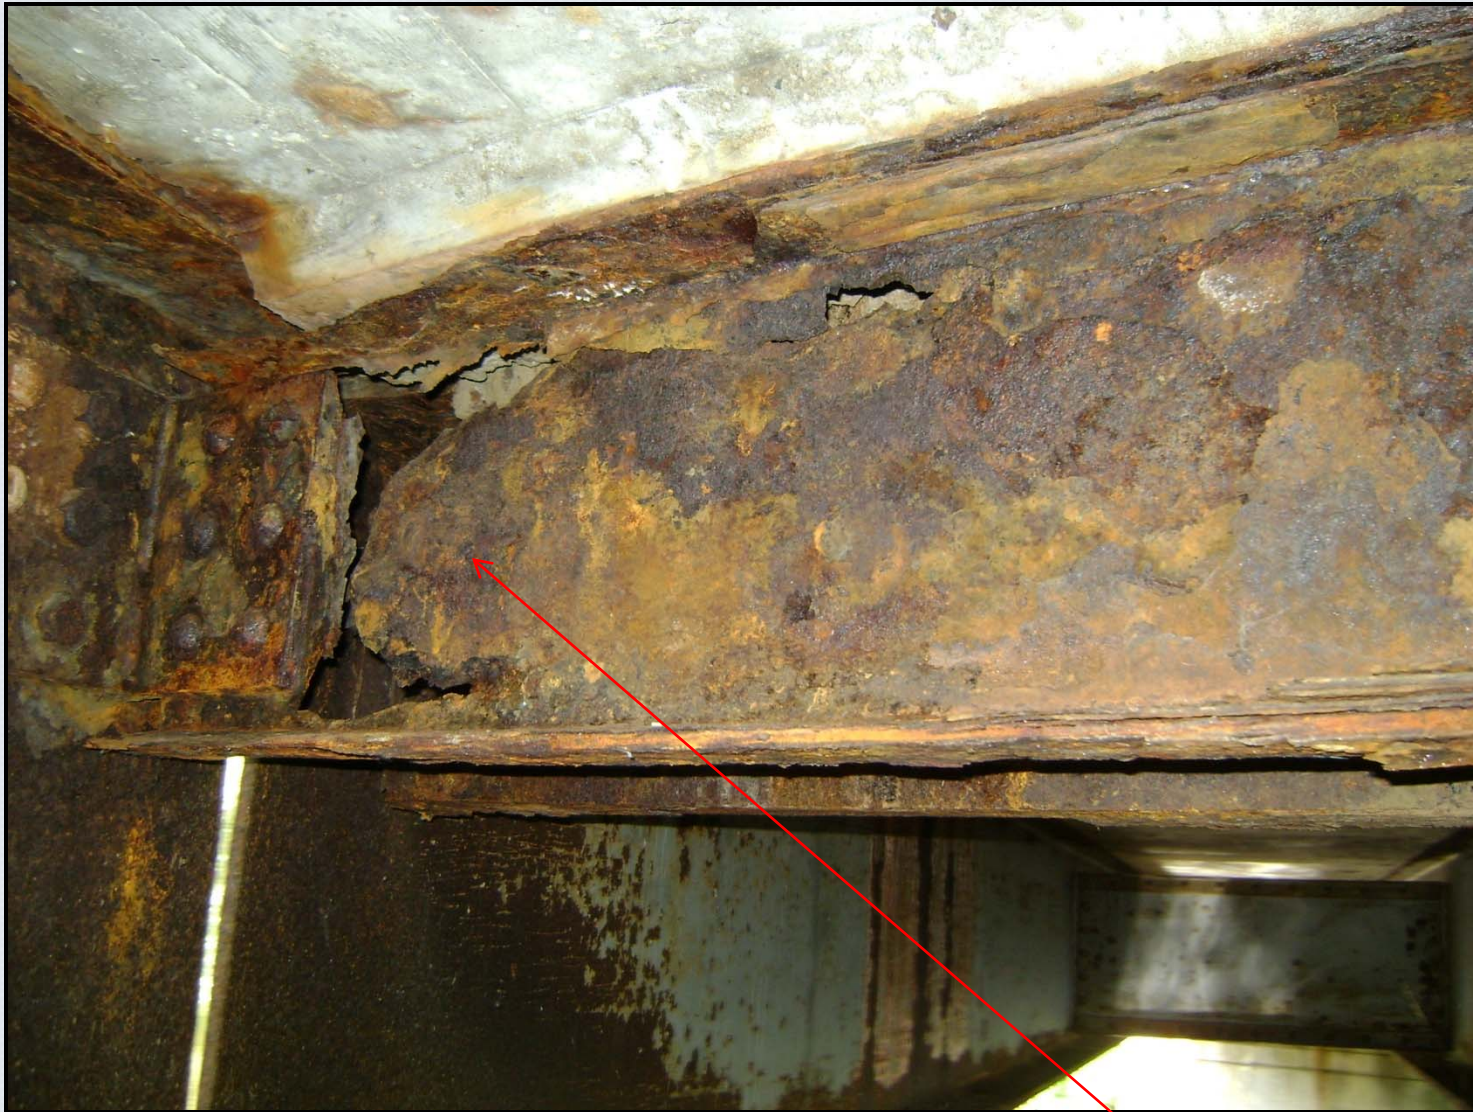
- Detailed Inspection Findings – Holes in end diaphragms at piers

- Observed corrosion and loss of section at beam ends in the webs and bottom flanges; Holes in the web of beam ends
- Documented holes at the end diaphragms at the piers. End diaphragm at bay 3s rotted off completely, Holes in H-bearings
- Compiled an RFA to the bridge owner with findings from the detailed inspection and requested a load rating

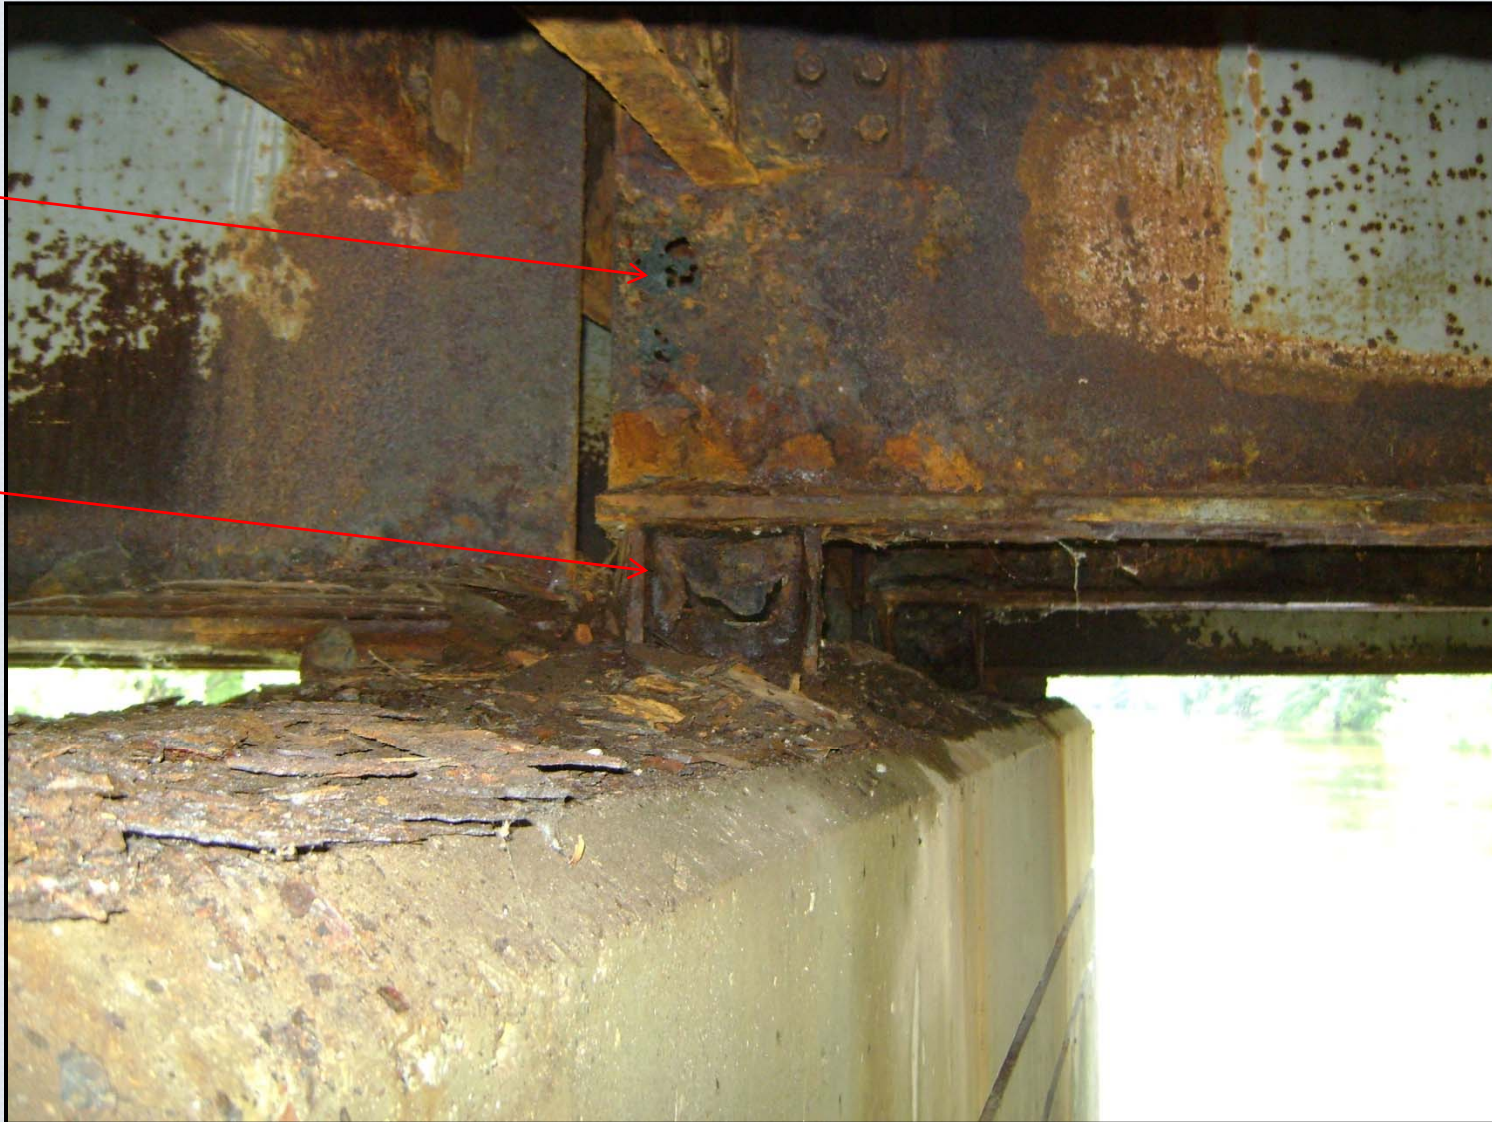
- Detailed Inspection Findings – After removing scale, holes in beam webs and H-bearings

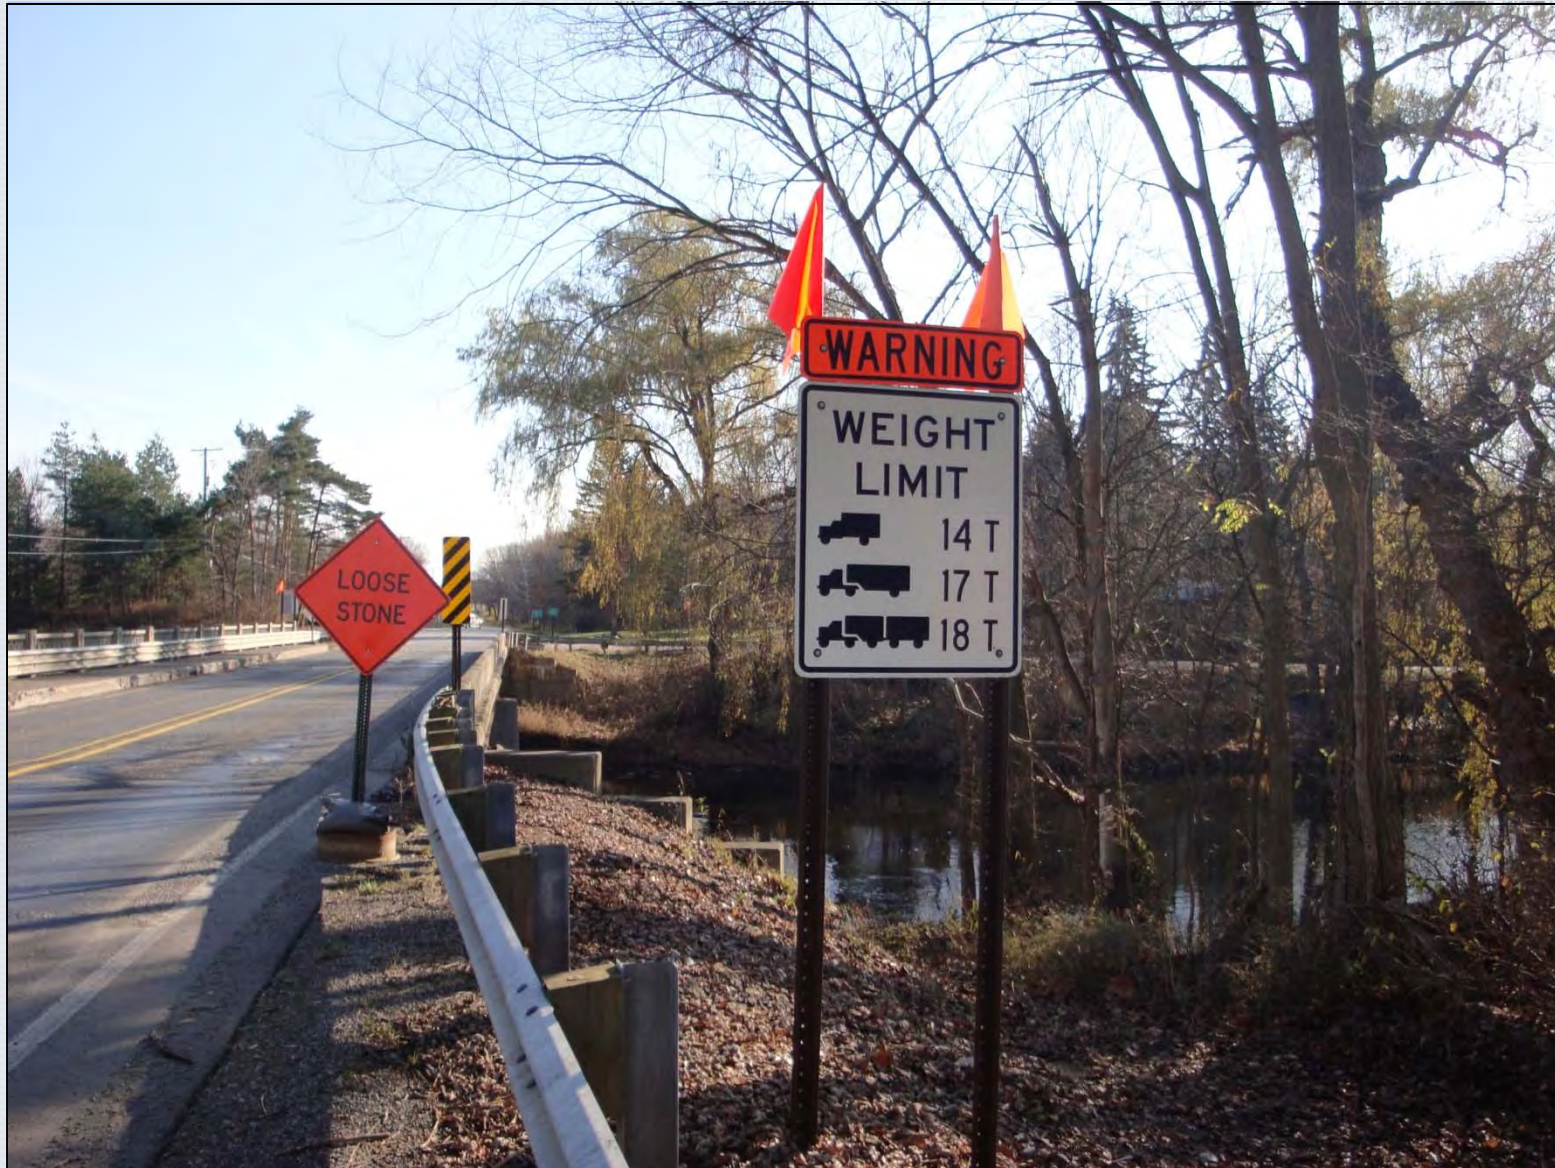
- Reduced Load Posting from 42T/67T/75T to 14T/17T/18T

- Load Rating Results –

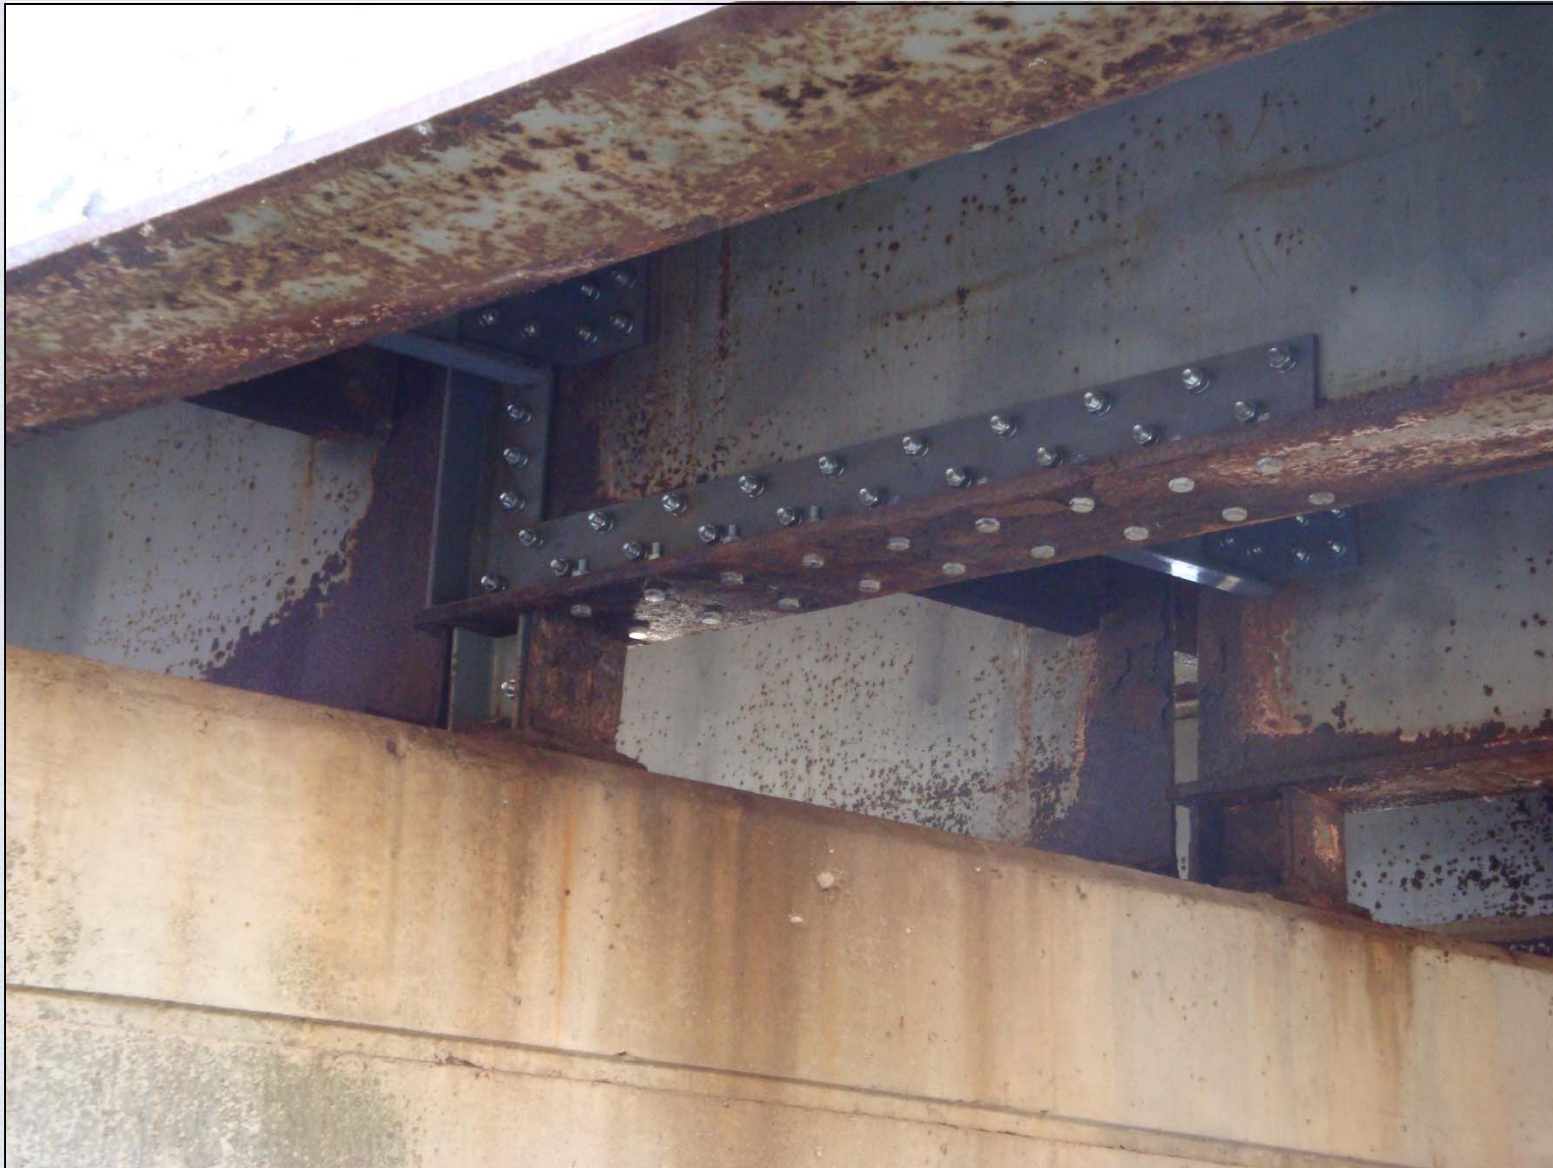
- Emergency Repairs –

- The bridge owner used an in house maintenance crew to install several beam end repairs, diaphragm replacements and h-bearing repairs

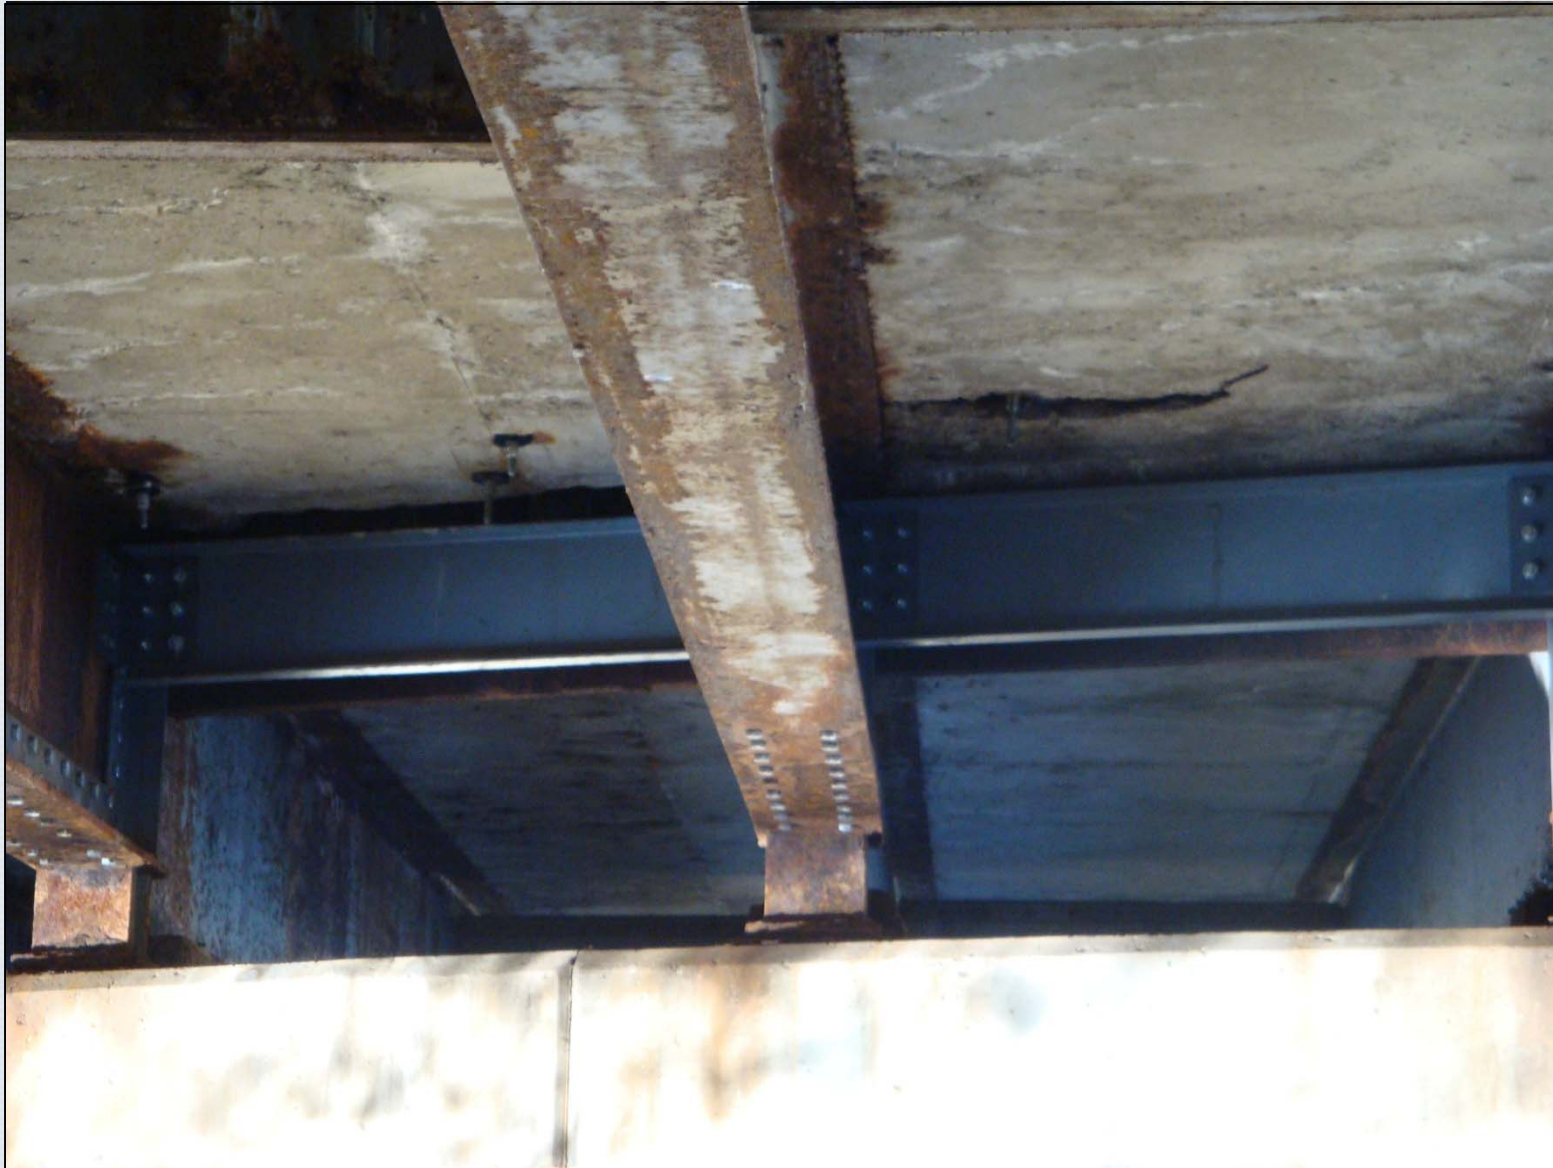
- Emergency Repairs –

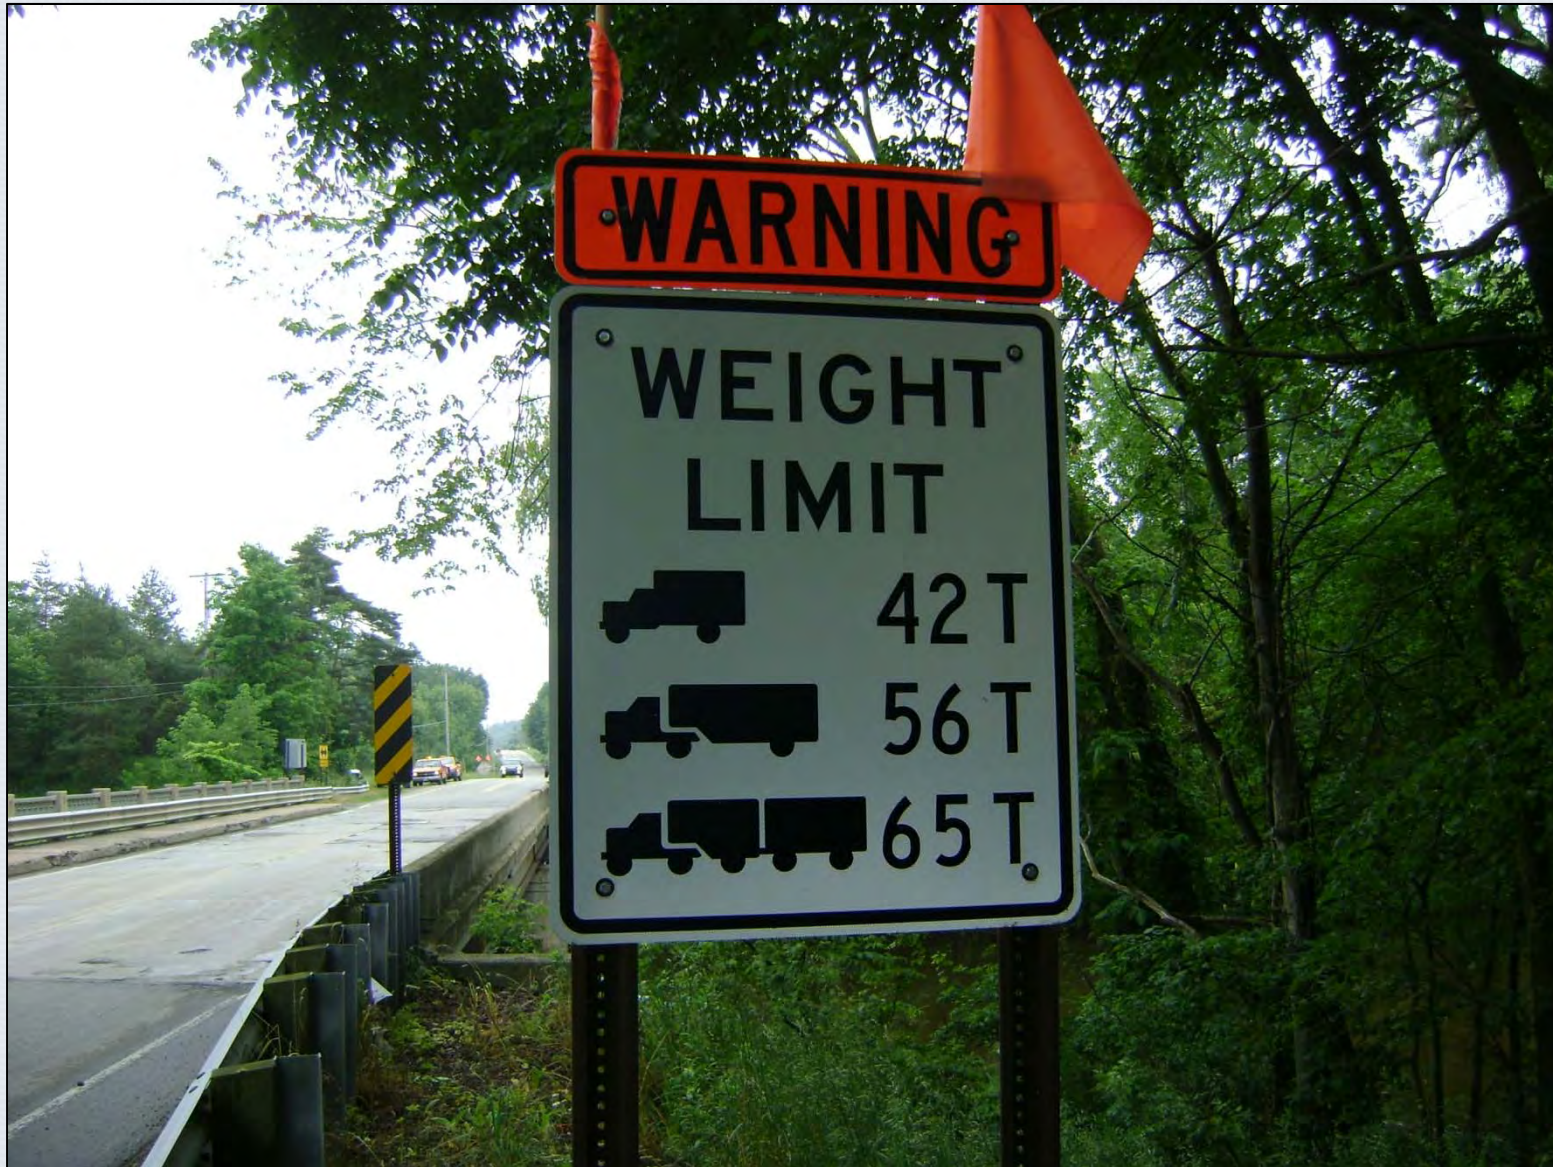
- Load Posting after Emergency Repairs were performed—

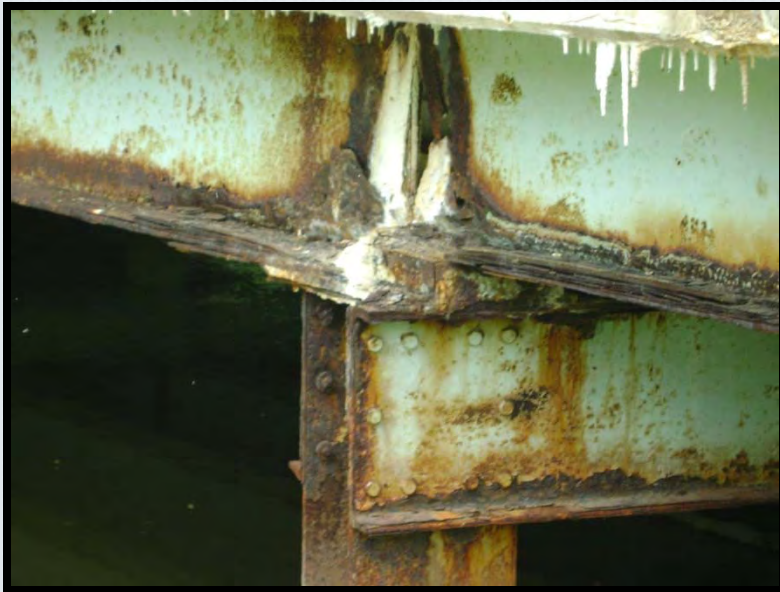
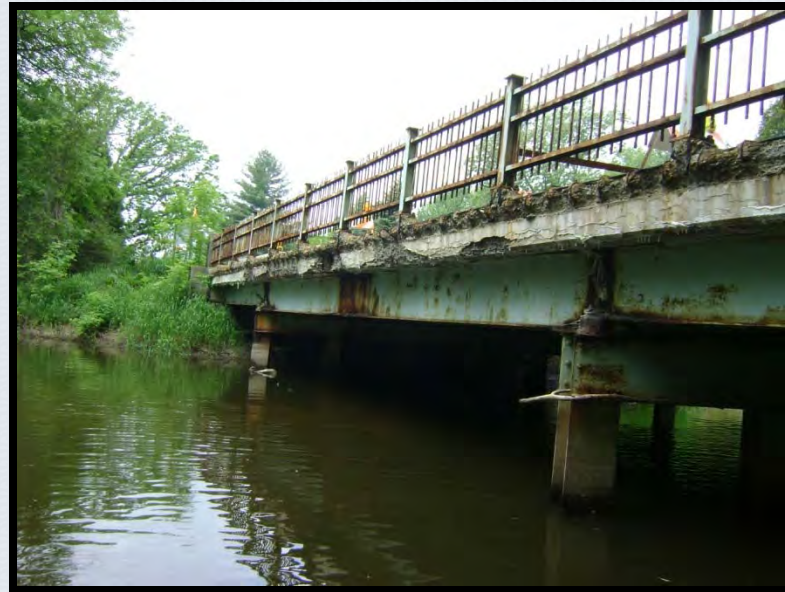
- Confirmed heavy scale at steel beam ends
- Due to high water levels there was limited access and limited visibility of the steel pier pile bents
- Completed the inspection with a comment that we would return in July to inspect the pier units at lower water levels

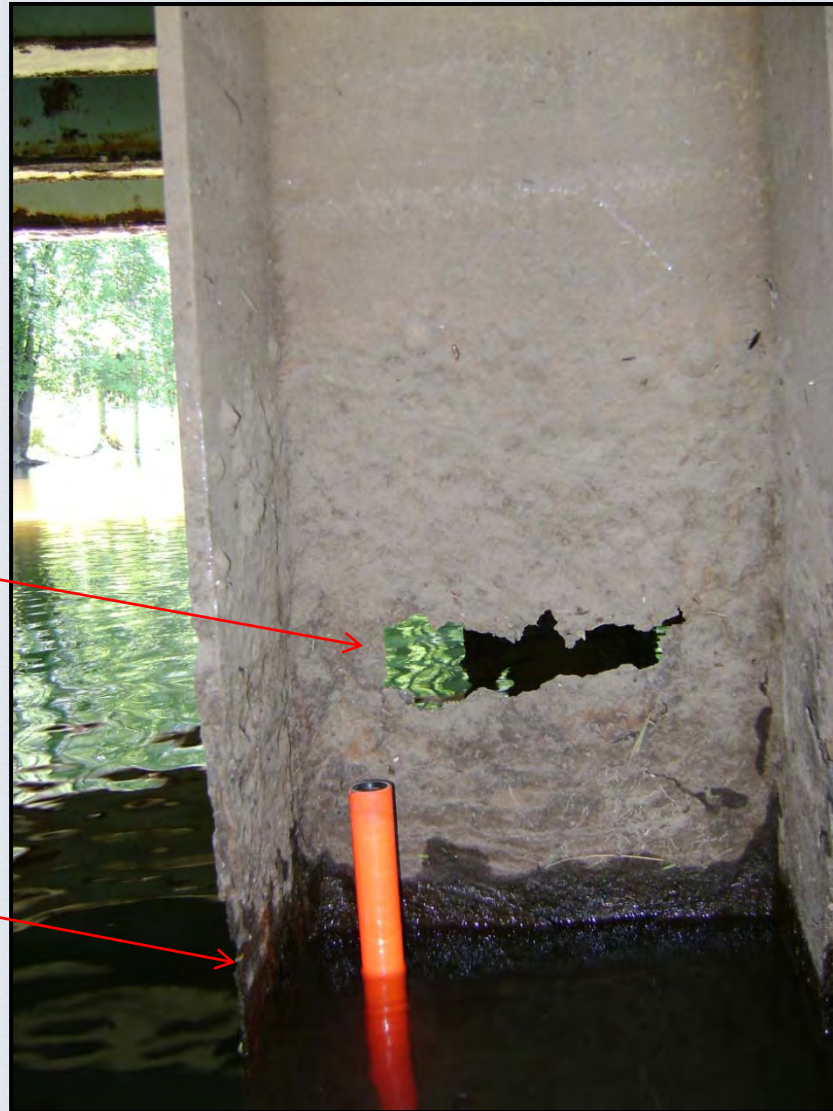
Holes and section loss in web

Paper thin flanges

- Discovered extensive holes in the webs and flanges of several pier pile bents at both piers
- Called bridge owner from site to recommend immediate closure of the bridge

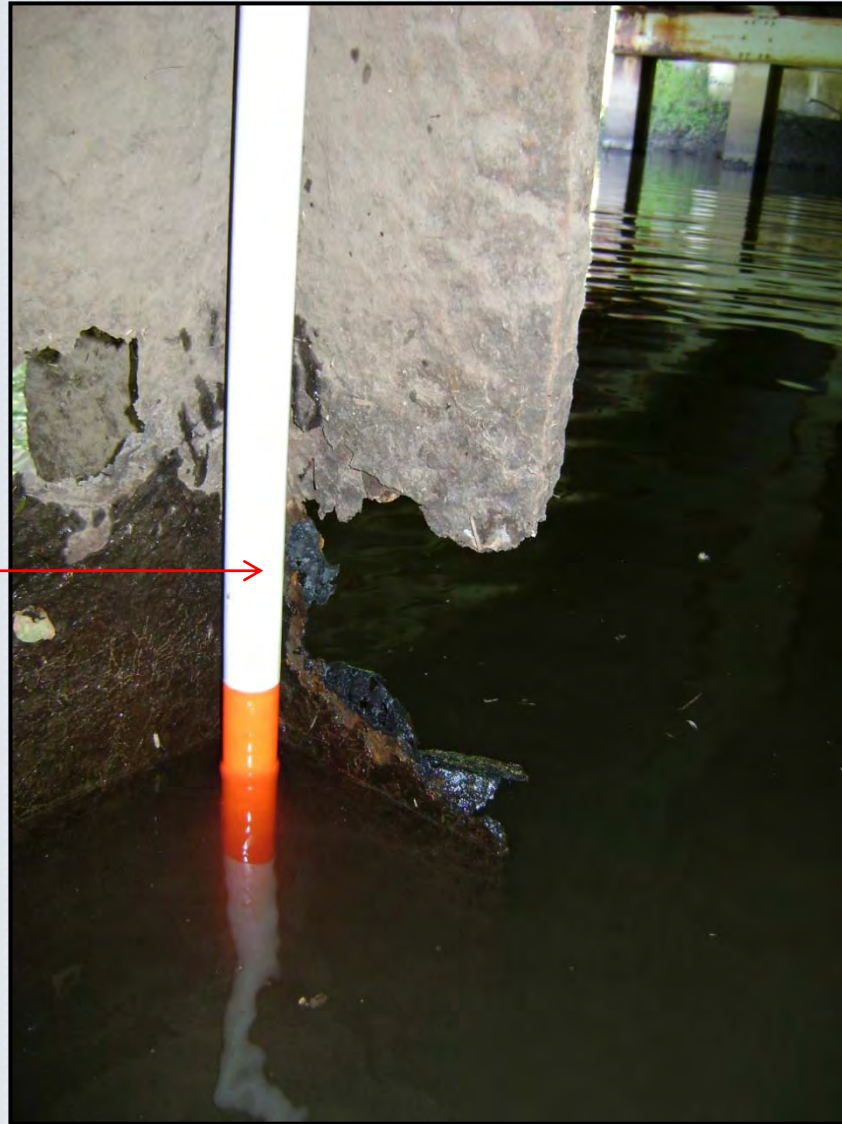
- Detailed Inspection Findings – at another location.....more of the same

Holes in web

Holes in the flange

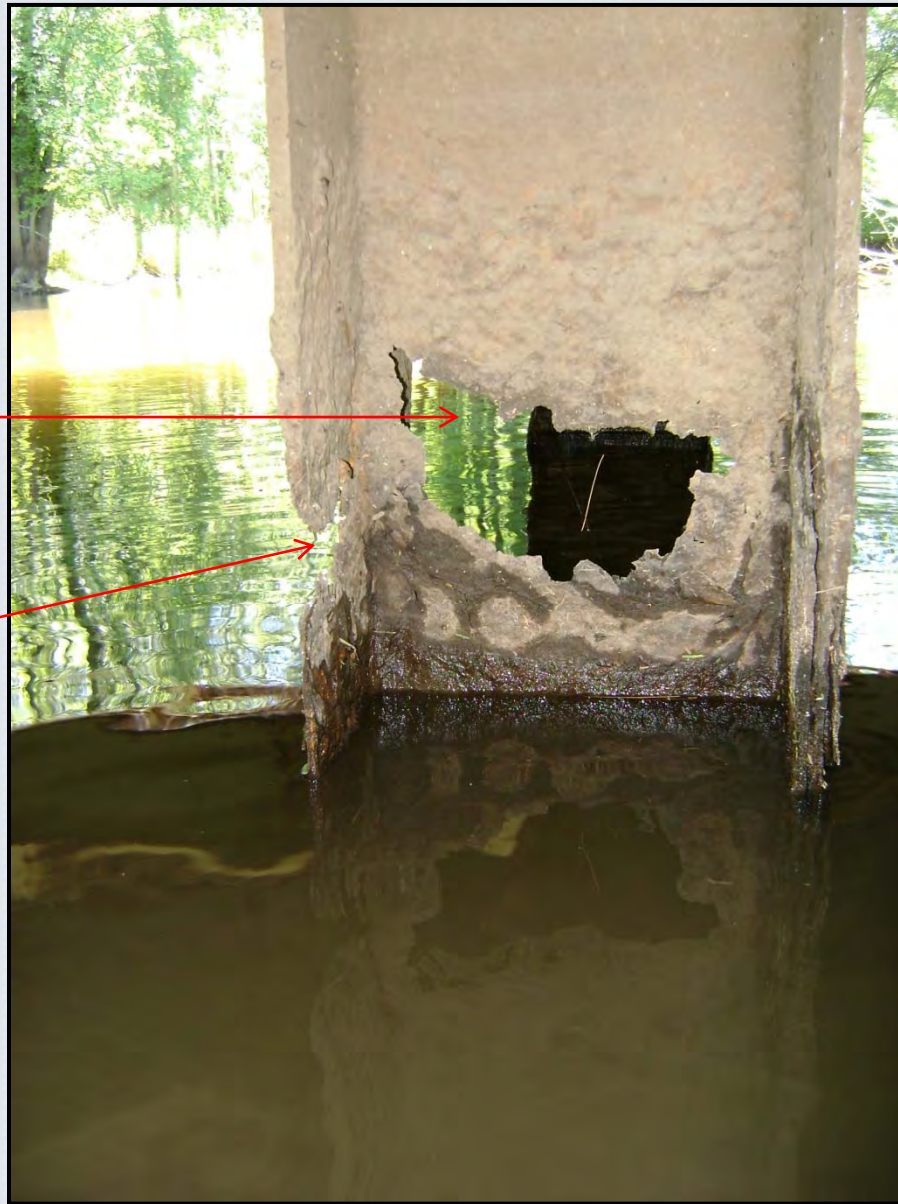
- Detailed Inspection Findings – more of the same at yet another location

Holes in web

Holes in the flange

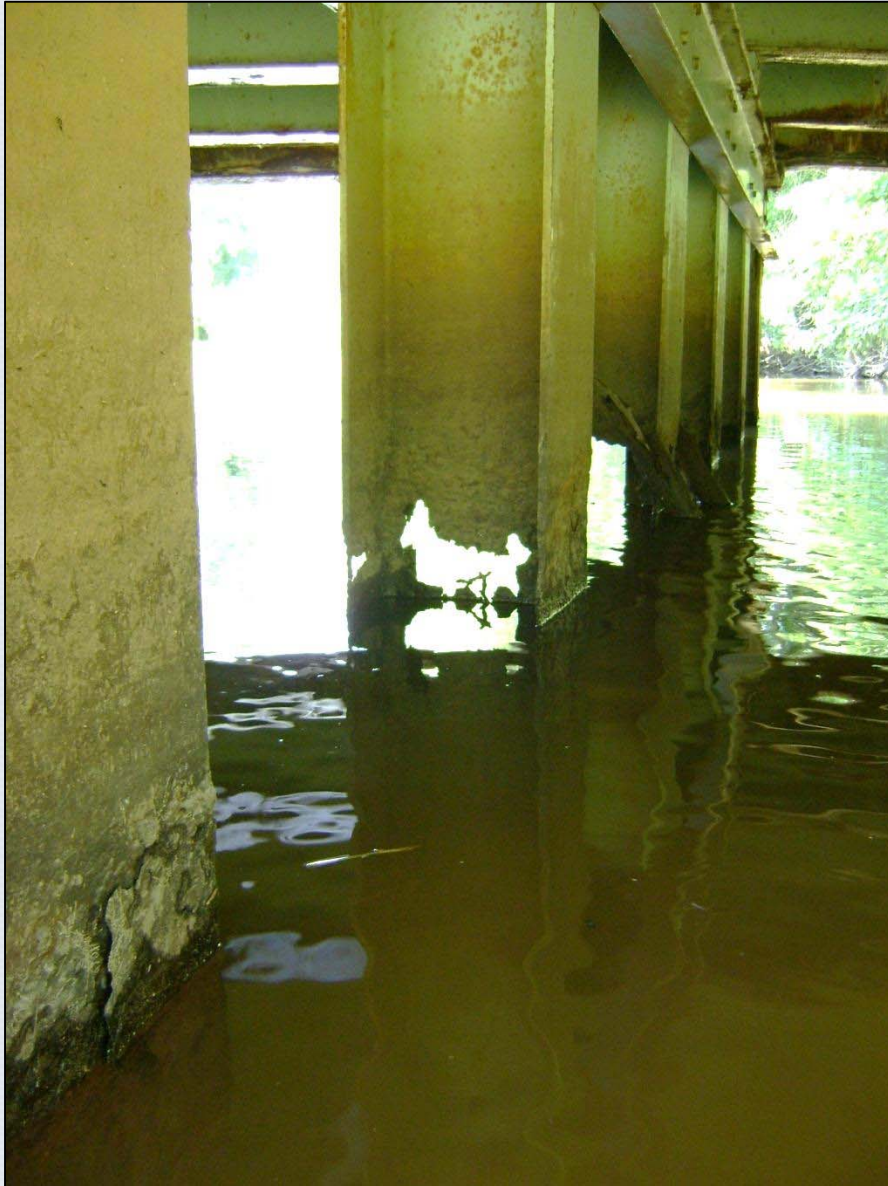
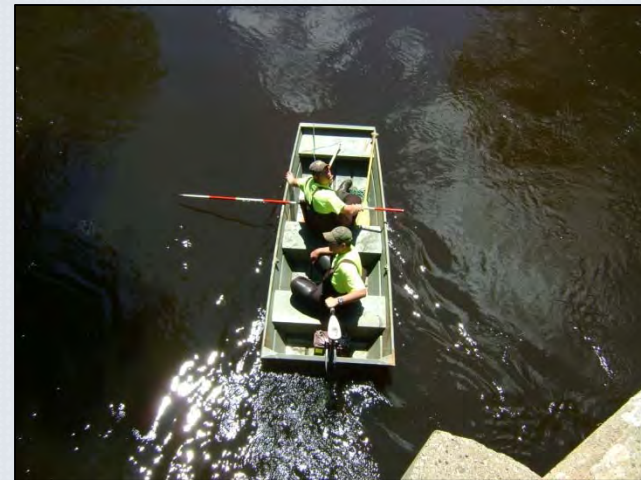
- Detailed Inspection Findings – Get the heck out of here, the bridge is going to fall!
