Michigan Bridge Conference

Use of NDT Tools in Preserving Pre-stressed and Reinforced Concrete Substructures

Siva Venugopalan

Siva Corrosion Services, Inc.

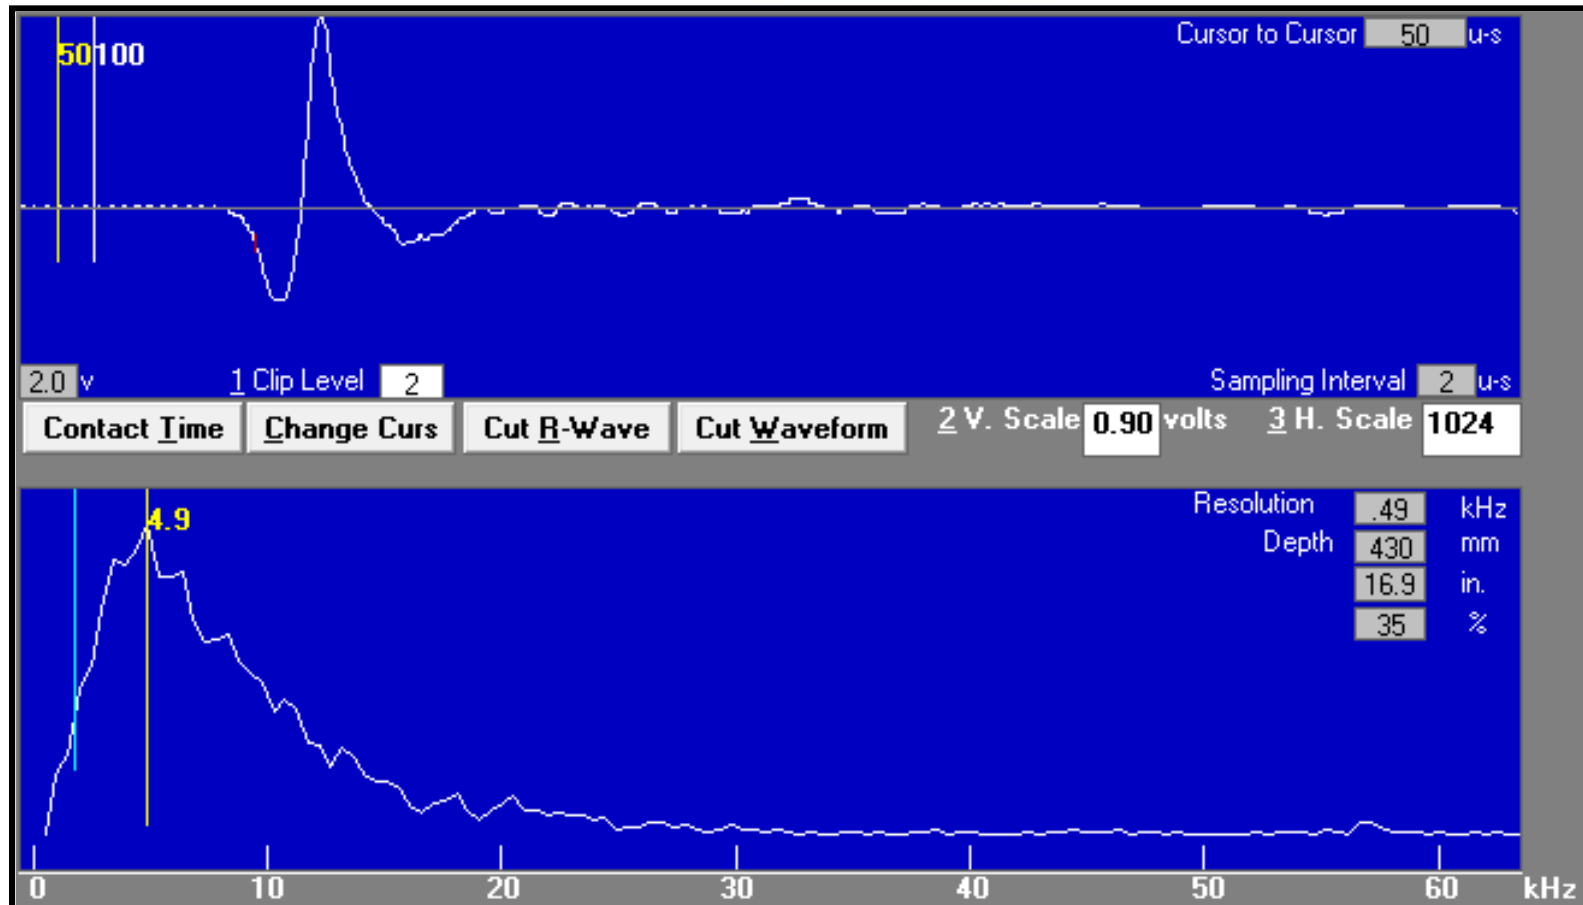
Impact-Echo (IE): NJ Pier Apron

- Concrete apron was cast-in-place around pier to protect against scour
- During pouring, the form was breached and cementitious material leaked out
- Owner was concerned that excessive voids may lead to lack of scour protection

- Utilized Impact-Echo (IE) acoustic technique to identify large voids within the apron
 - Ultrasonic waves are introduced into the concrete via impacts with steel ball bearings
 - Sound waves reflect off of discontinuities (i.e. voids, cracks, honeycombing), thus locating voids
- Tests were performed in a 2'x 13' grid along the apron

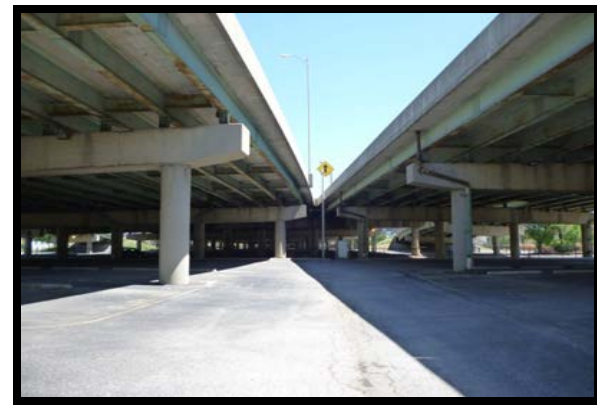
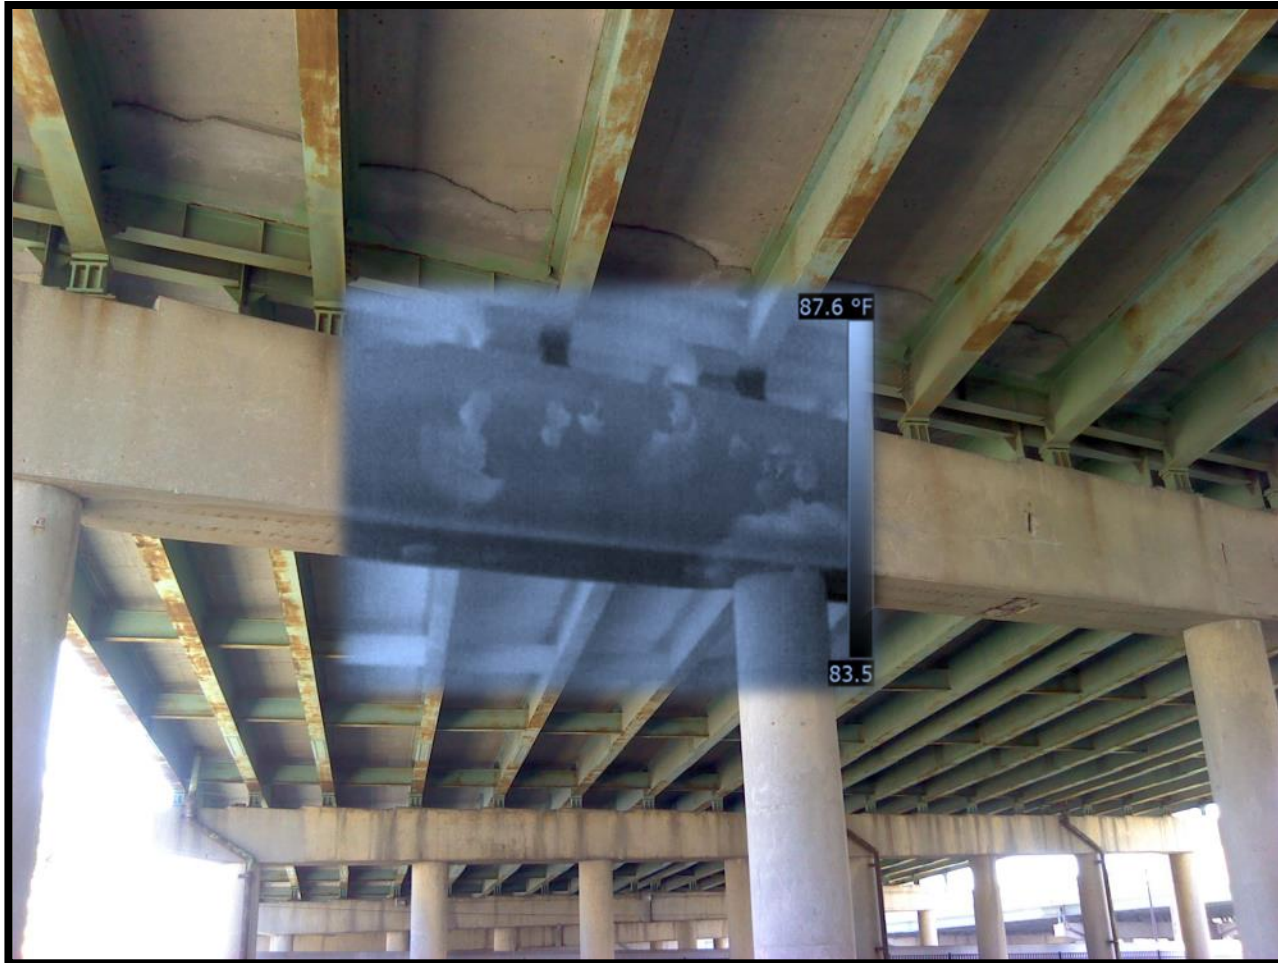
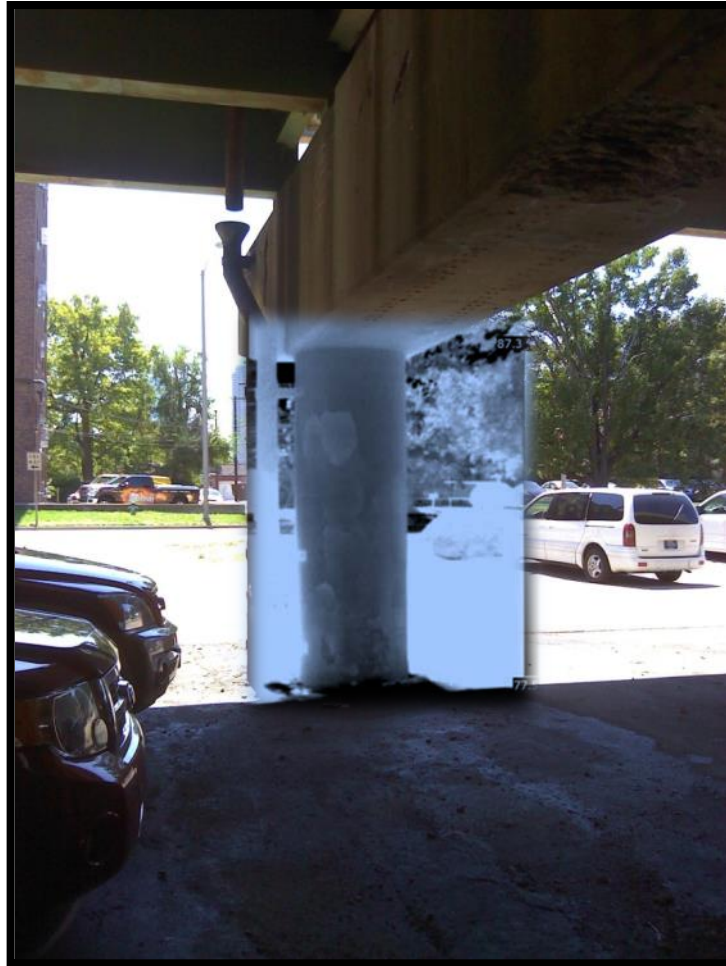
- Highway I-65 in Indianapolis, Indiana passes over seven city streets and was constructed in 1972 of reinforced concrete
- The substructure of its 45 spans showed significant corrosion-related damage
- SCS evaluated the deck and substructure components to determine whether corrosion mitigation methods may be used to extend the structure's life
- IR quickly and effectively identifies areas of delamination

- IR quickly and effectively identified areas of delamination
- Delamination was used in conjunction with other data (cover, chloride profiles, etc.) to estimate remaining service life & life cycle cost of various repair options
- Recommended installation of an ICCP system at expansion joint piers to extend the life of the substructure

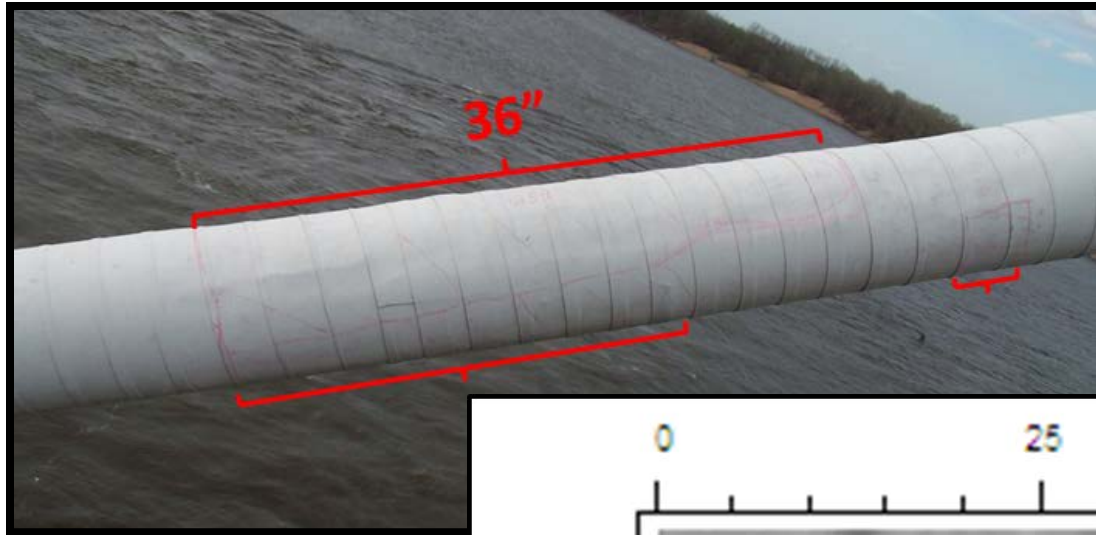
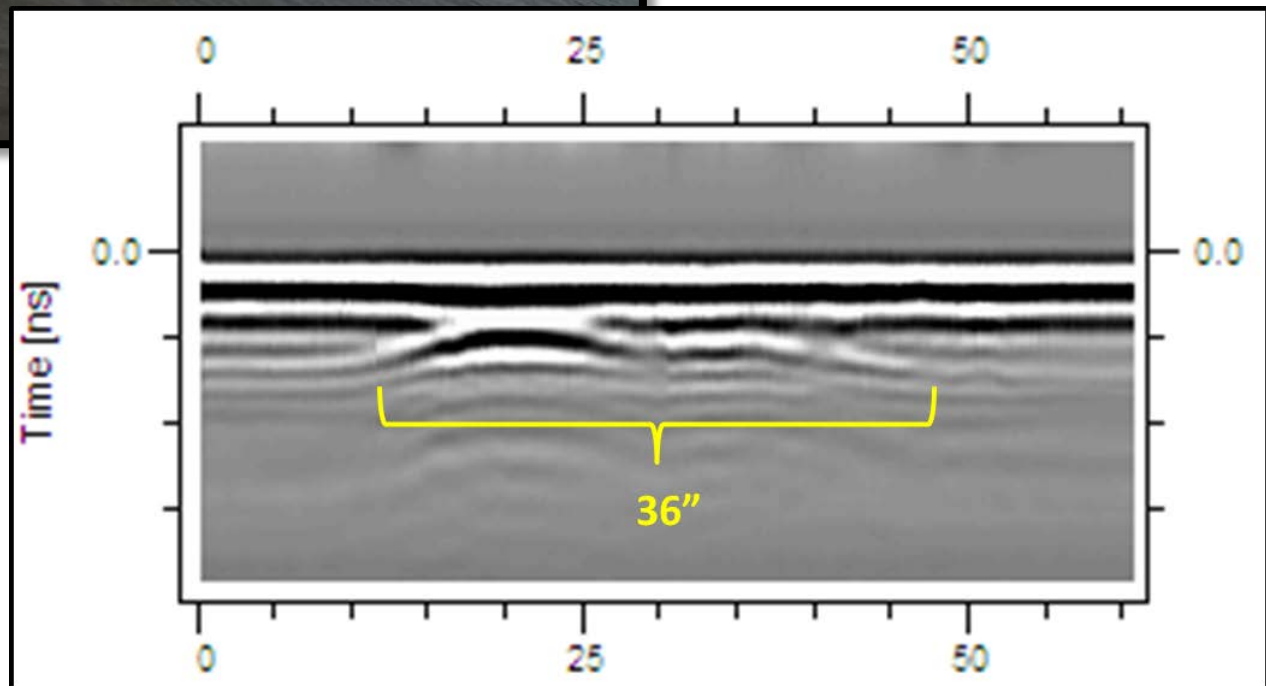
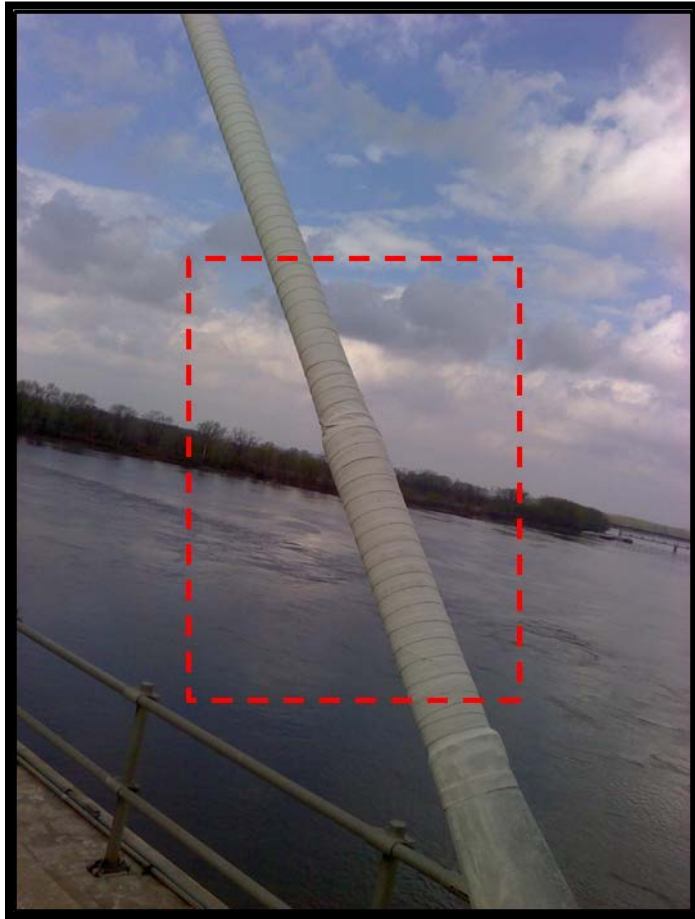
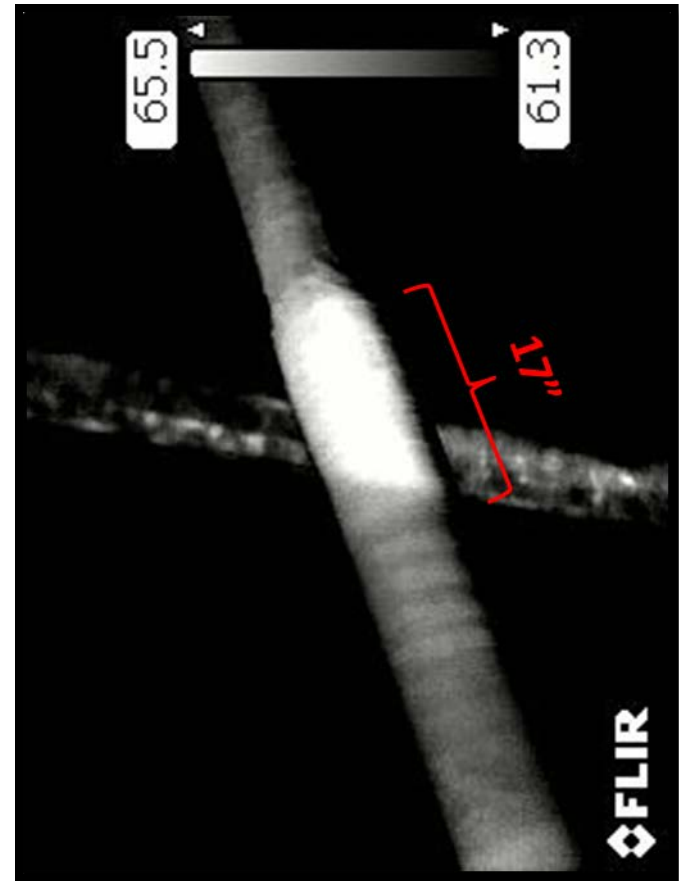
- During past inspections, cracks and voids were observed in the HDPE stay pipes
- Water was observed inside the tendon anchorages and neoprene boots
- Water or voids within grouted stay cables could lead to corrosion of the strands

- Identified over 100 voided locations using IR/GPR
- All voids were confirmed with IR, GPR, or Sounding
- Invasive testing (borescoping) was performed to determine if voids are problematic
- Additional cable openings at voids locations is planned to quantify the extent of damage

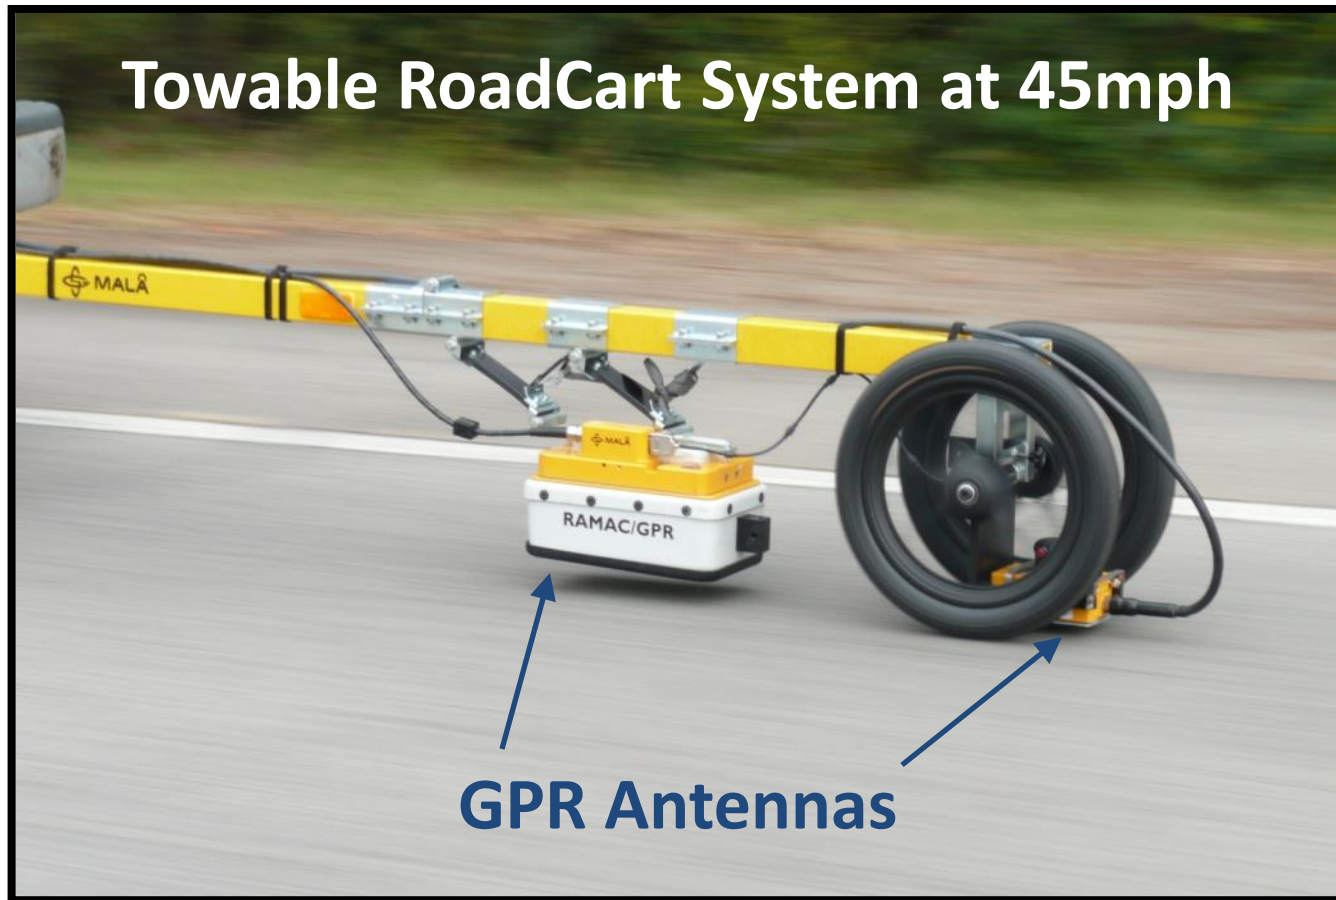
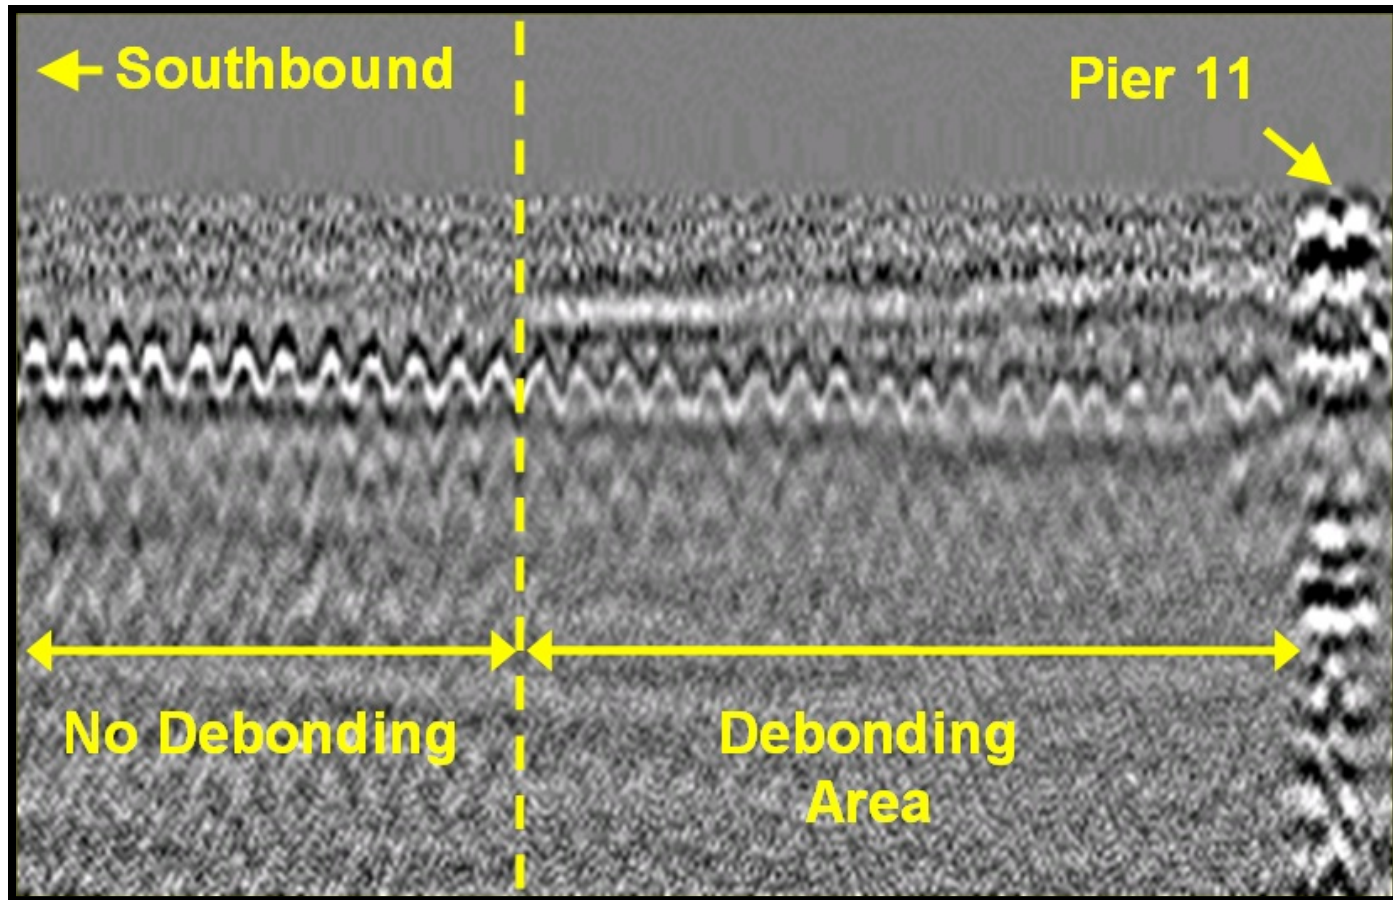
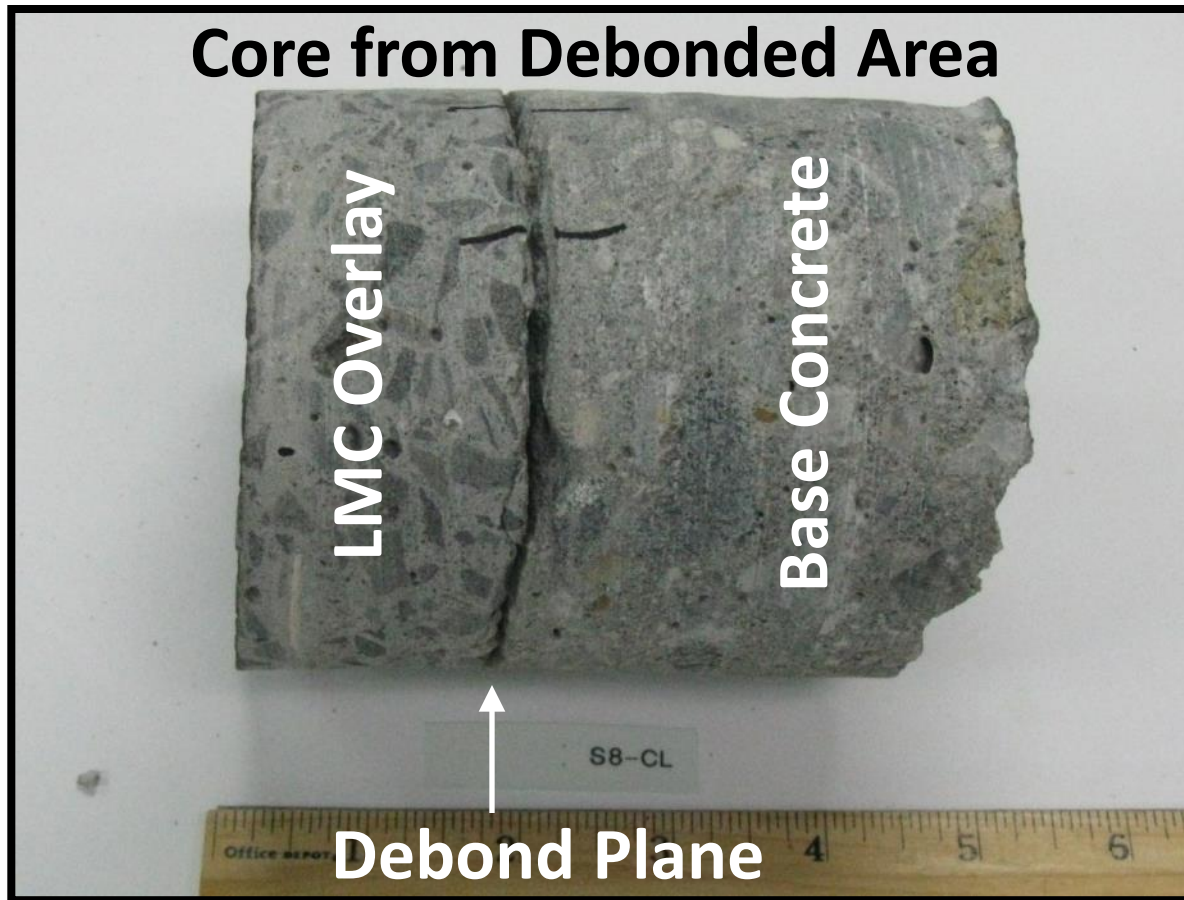
- The NJTA deck was over 100,000 sq. ft.
- The overlay placed in 1994 had current significant delamination and spall, cracks, and growth of spall
- Requested to determine the cause of delamination and quantify the extent of damage on the riding surface
- Use Ground Penetrating Radar (GPR) to identify deck delamination and confirm results via sounding and coring at select locations.
- Perform petrographic analysis and chloride content testing on cores

- Extent of delamination quantified
- Petrographic analysis revealed:
 - Cause of delamination was improper finishing of the base concrete leading to a weakened layer at the overlay-base interface
 - High chlorides at the rebar due to escalating delamination
- Replacement of overlay recommended

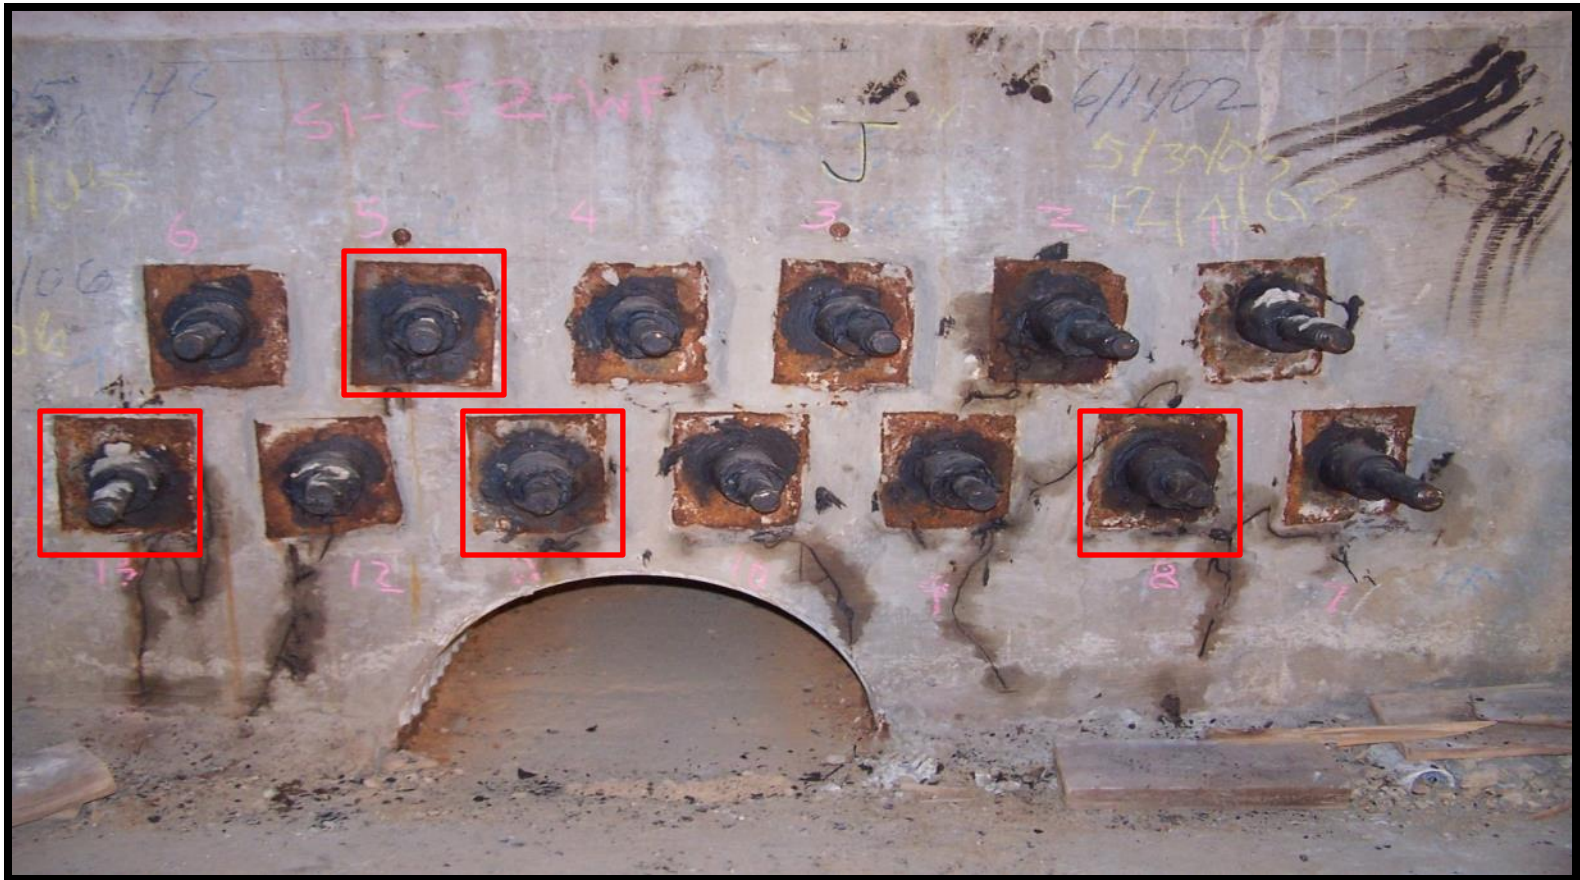
Problem Rods – Interior End

- Post-tensioned (PT) rods may be broken or deteriorated
- Remaining strength depends on the number of PT rods still in good condition
- Unlike regular reinforced concrete structures, any significant reduction in PT rod section can result in increased stress which then lead to sudden failure
- Test Wisconsin bridge PT rods in a unit that also had visible corrosion on the exterior of the boxes

- Remove and replace all rods identified as significantly corroded or already broken
- By identifying and replacing severely corroded PT rods, the Department can mitigate risks and extend the service life

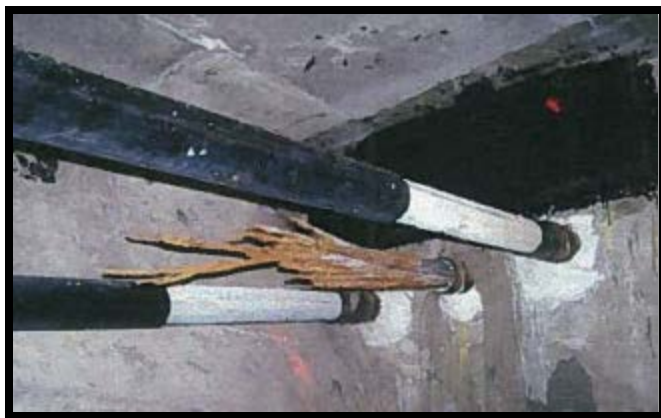
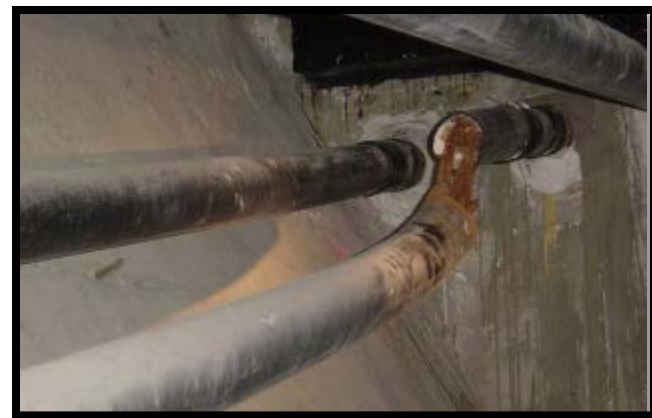
- During previous inspections, voids were identified in the tendons and PT bar ducts
- Some tendons had experienced significant corrosion (broken wires)

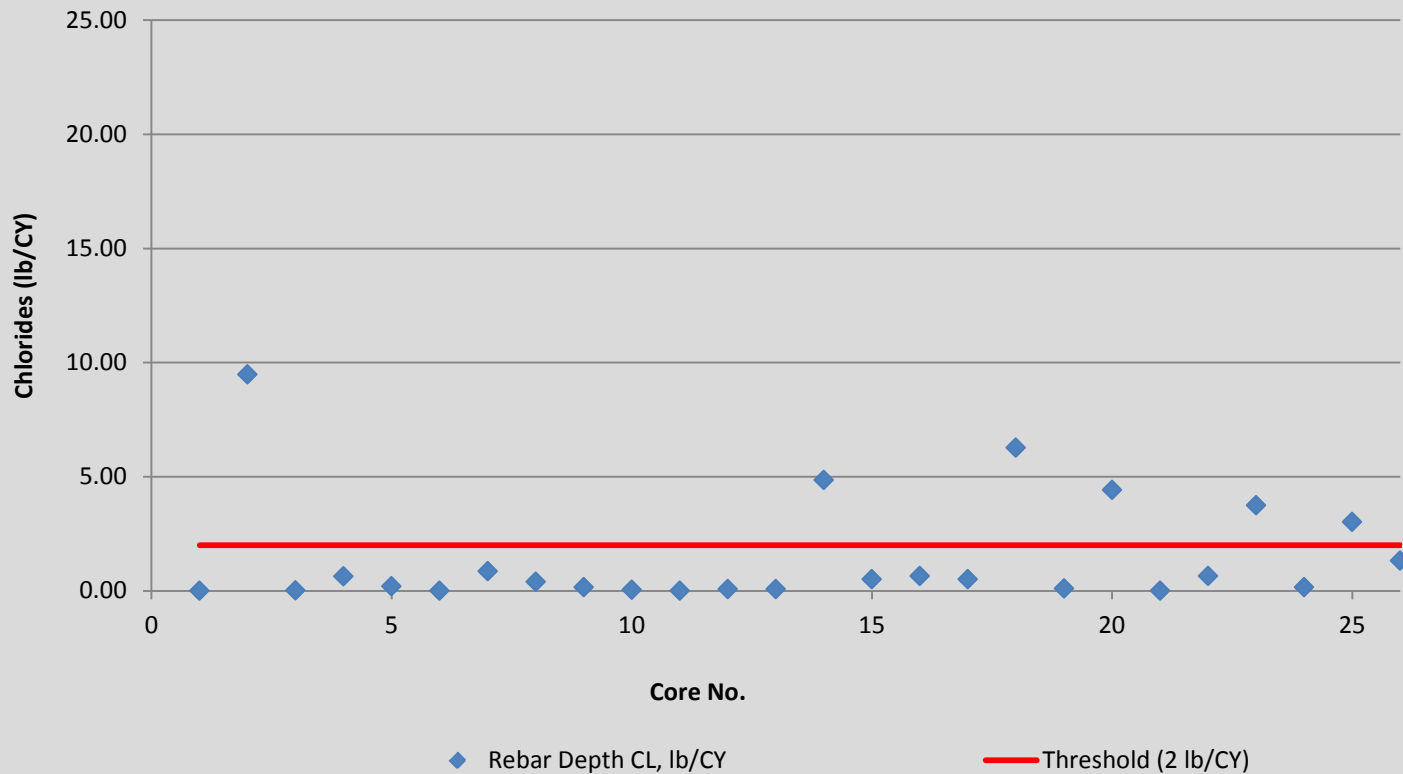
King St. Chlorides at Rebar Depth

- Using NCHRP 558 service life modeling, the deck is projected to experience 39% of concrete damage in about 50 years if nothing is done
- The deck has a total compromised area of 28% (5.28% delam + 23% chloride above threshold)
- The SR for this structure is 56.1
- The deck would not last another 50 years if nothing other than patching is done
