**Applications of Non-Destructive Evaluation (NDE)
for Detection, Ranking and Quantifications of Deterioration**
Prestressed Concrete Box Beams
Reinforced Concrete Bridge Decks

Elin Jensen, Lawrence Technological University

March 19, 2014

Michigan Department of Transportation

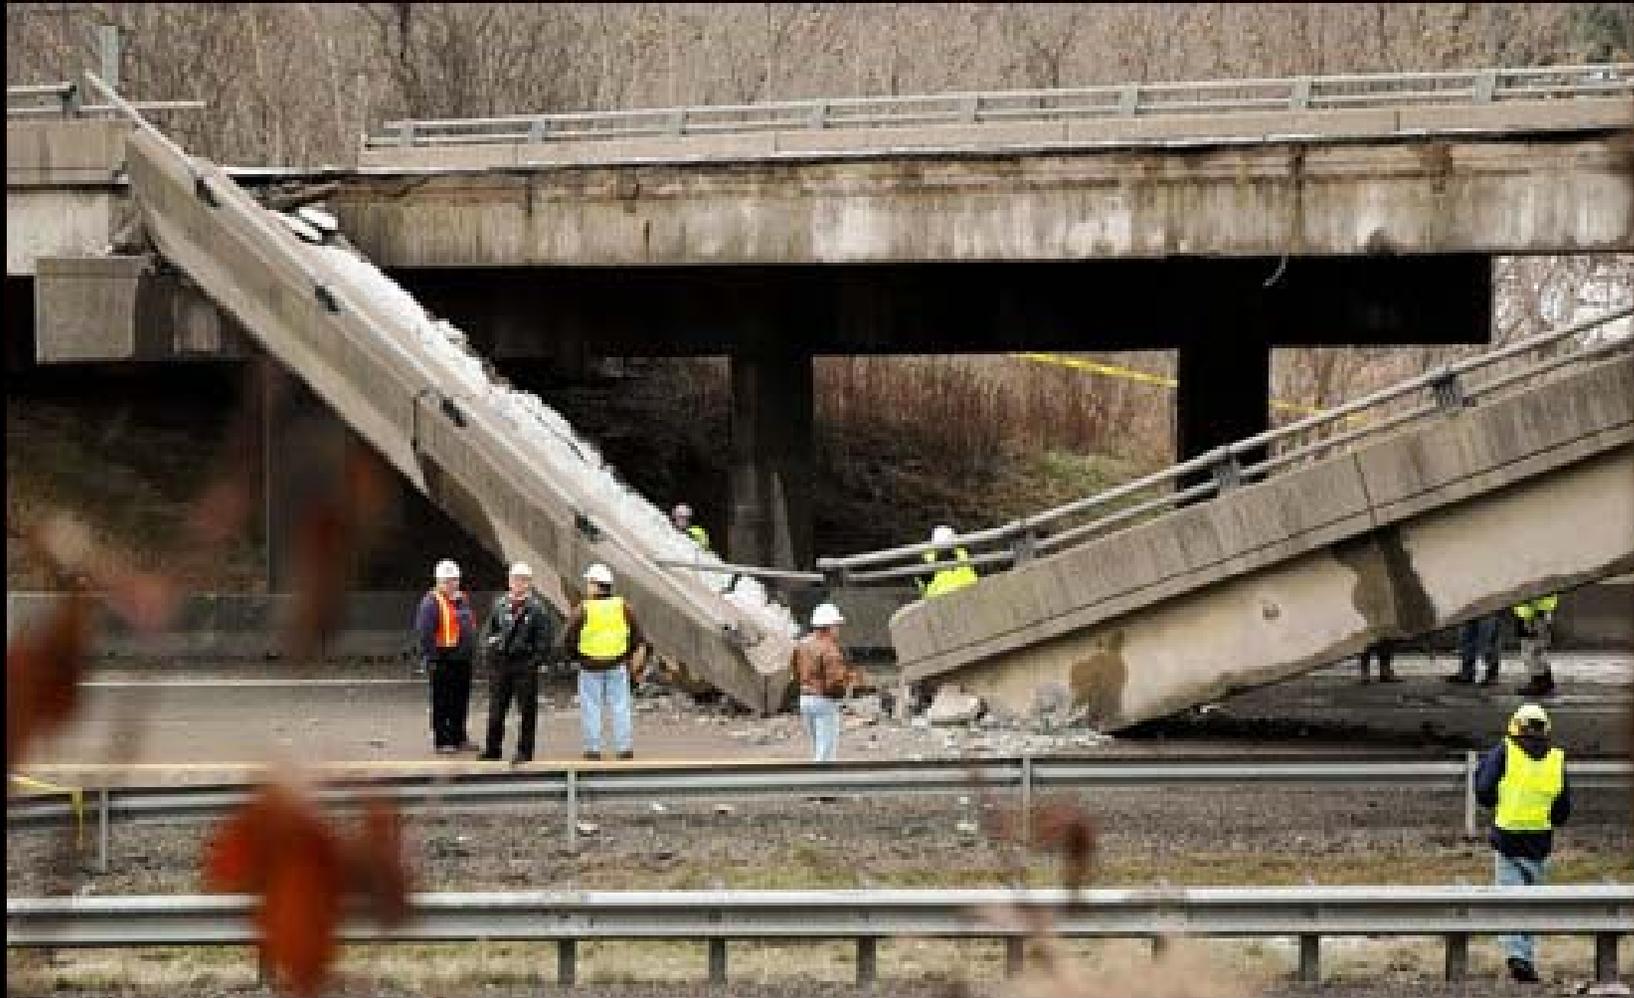
Lake View Drive Bridge failed under service loads

- Fabrication errors: inadequate bottom flange thickness, bottom concrete cover as well as wall thickness
- High chloride levels and carbonation.
- Clogged drain holes
- Strand exposures and ruptures due to collision and corrosion damage

- Longitudinal cracking near bottom strand
- Exposure, corrosion, and fracture of prestressing strands
- Spalling of bottom concrete cover
- Efflorescence as well as leakage of water between beams.

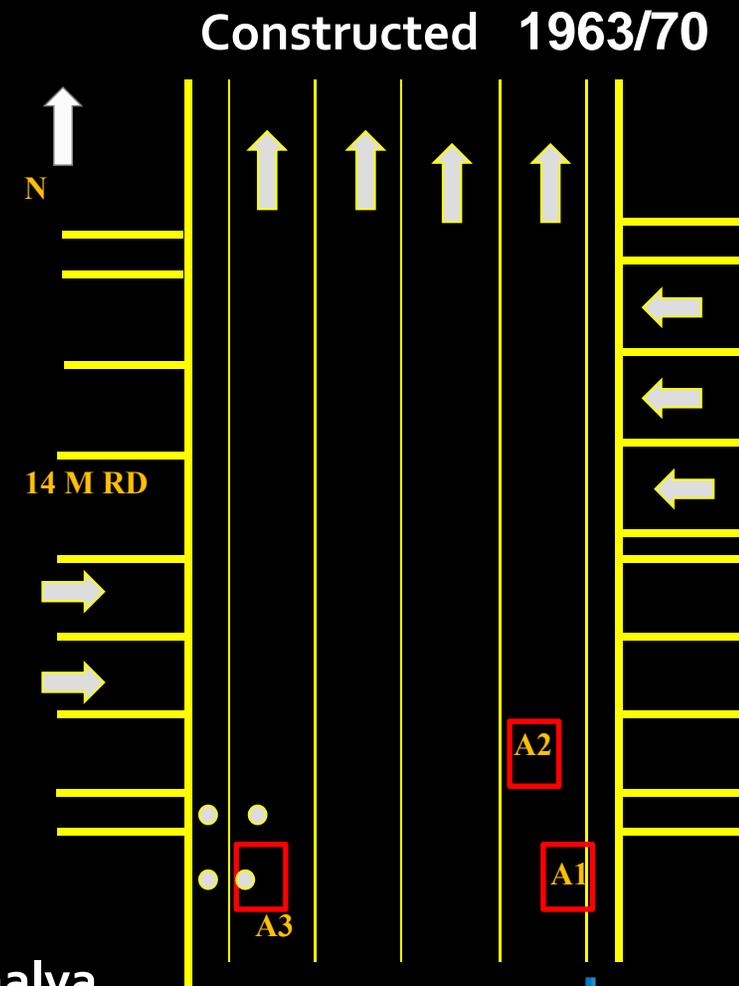
Chance of Corrosion of I-75 NB over 14 Mile Road

Location	A1	A2	A3
Average half-cell potential (mV)	-315	-220	-150
Corrosion rate ($\mu\text{m}/\text{year}$)	78	36	20
COV (%)	13.4	14.4	9.1
Chance of rebar corrosion	50%	50%	5%
# of data points	36	36	36

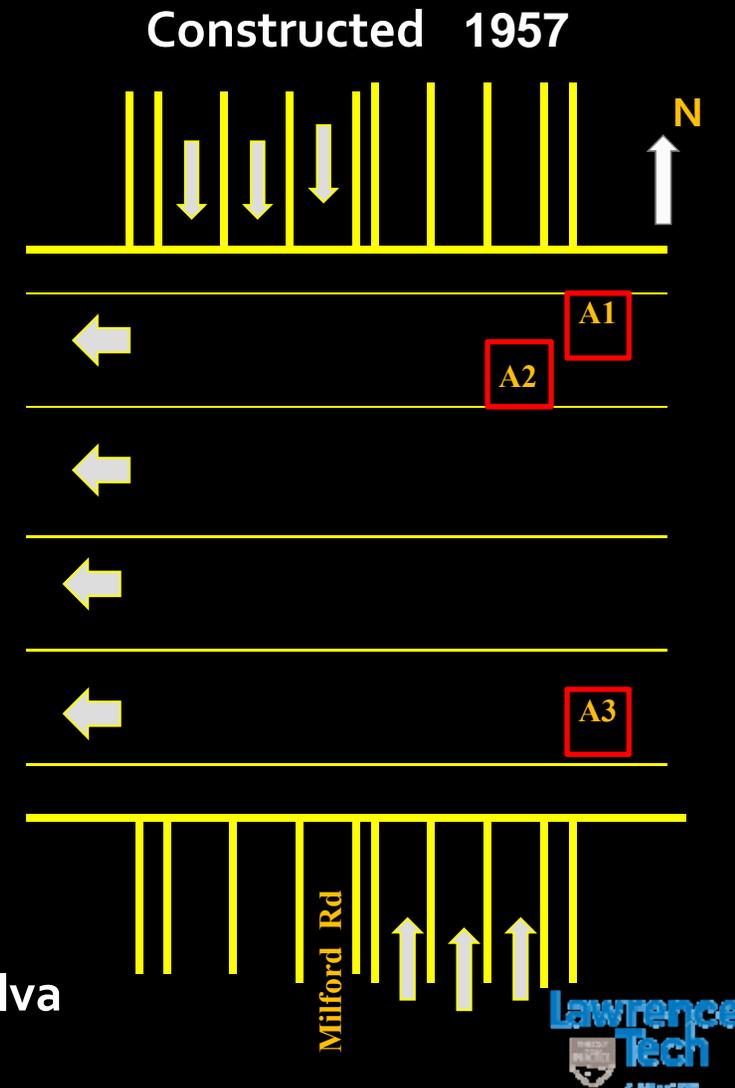
Chance of Corrosion of I-96 WB over Milford Rd

Location	A1	A2	A3
Average half-cell potential (mV)	-405	-400	-368
Corrosion rate ($\mu\text{m}/\text{year}$)	>120	>120	114
COV (%)	4.5	7.6	7.3
Chance of rebar corrosion	95%	95%	95%
# of data points	36	36	36

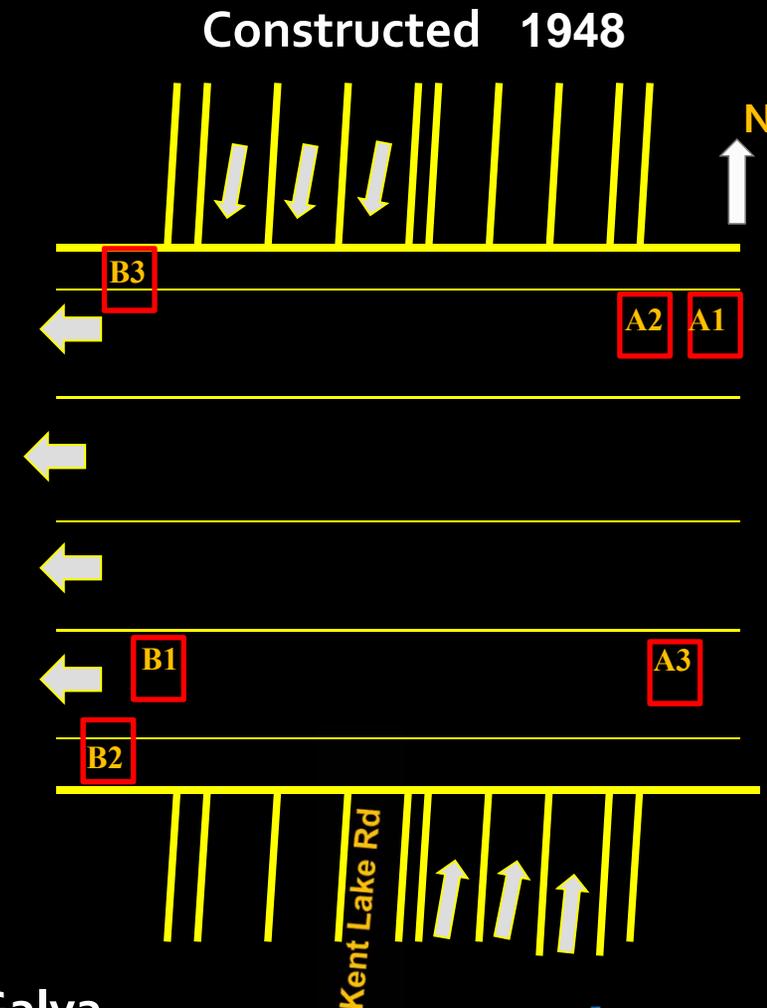
Chance of Corrosion of I-96 WB over Kent Lake Rd

Location	A1	A2	A3	B1	B2	B3
Average half-cell potential (mV)	-411	-406	-344	-207	-397	-547
Corrosion rate ($\mu\text{m}/\text{year}$)	>120	>120	97	42	110	>120
COV (%)	18.1	15.3	12.7	12	15.9	8.7
Chance of rebar corrosion	95%	95%	50%-95%	50%	95%	Visible evidence
# of data points	36	36	36	36	36	36

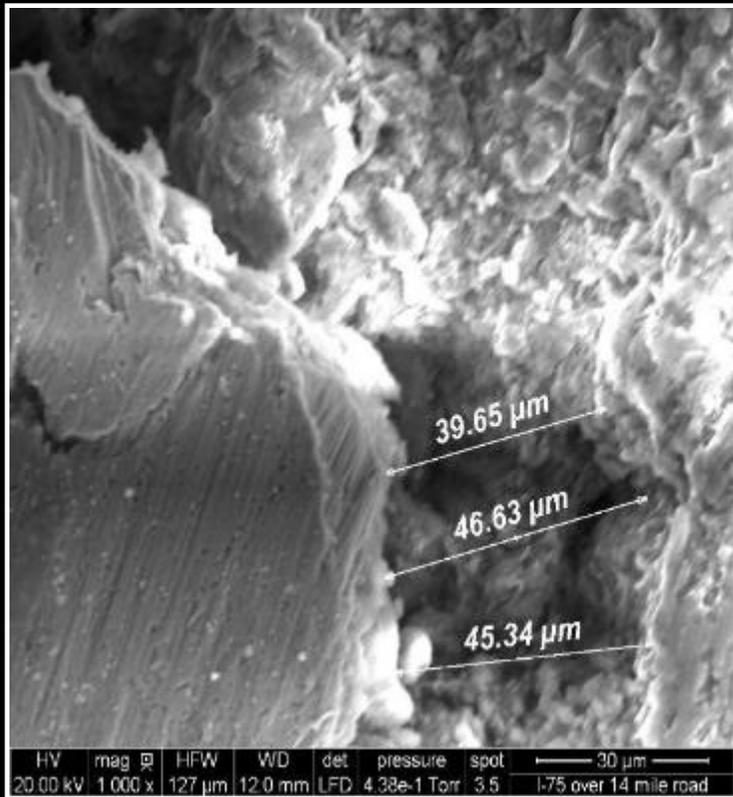
I-75 NB over 14 Mile Road
(43 μm)

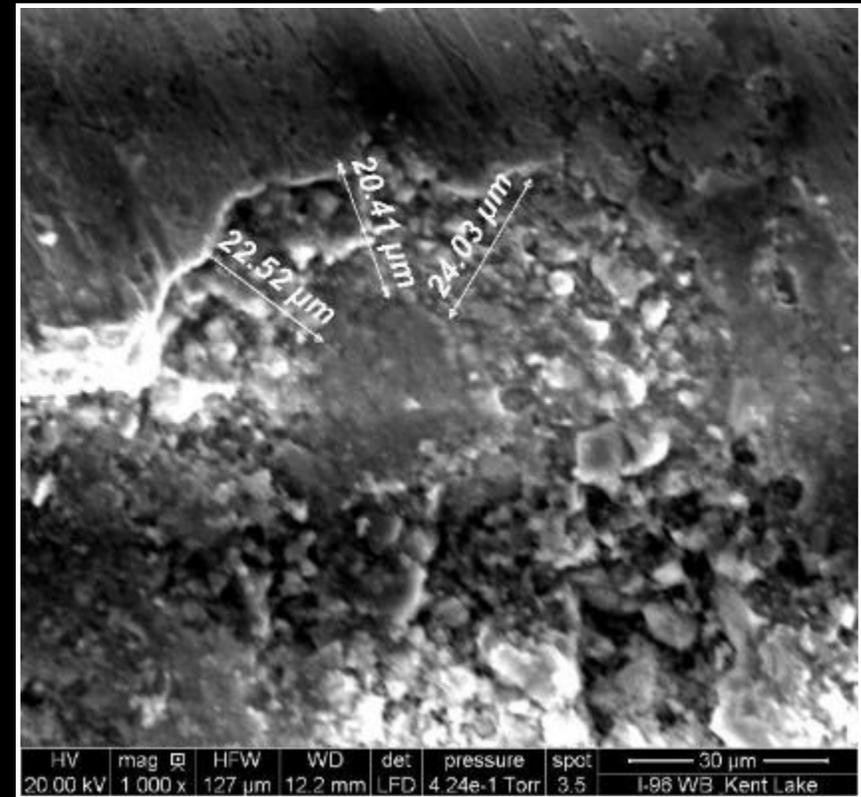
I-96 WB over Kent Lake Road
(22 μm)

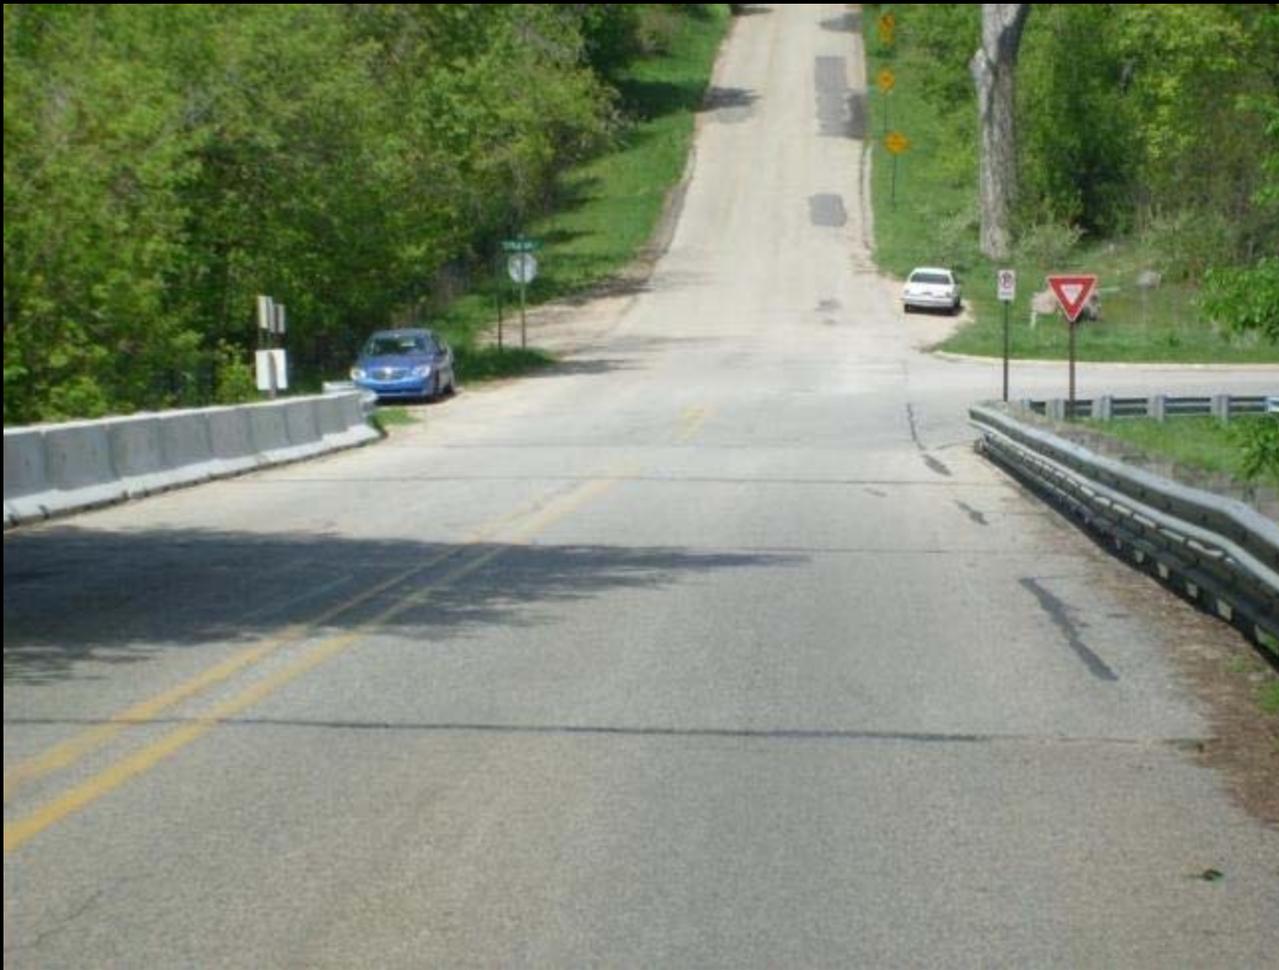
Plainfield Bridge #6 in Chidsdale Avenue before decommission. Wearing surface in Fair condition according to MDOT inspection rating.

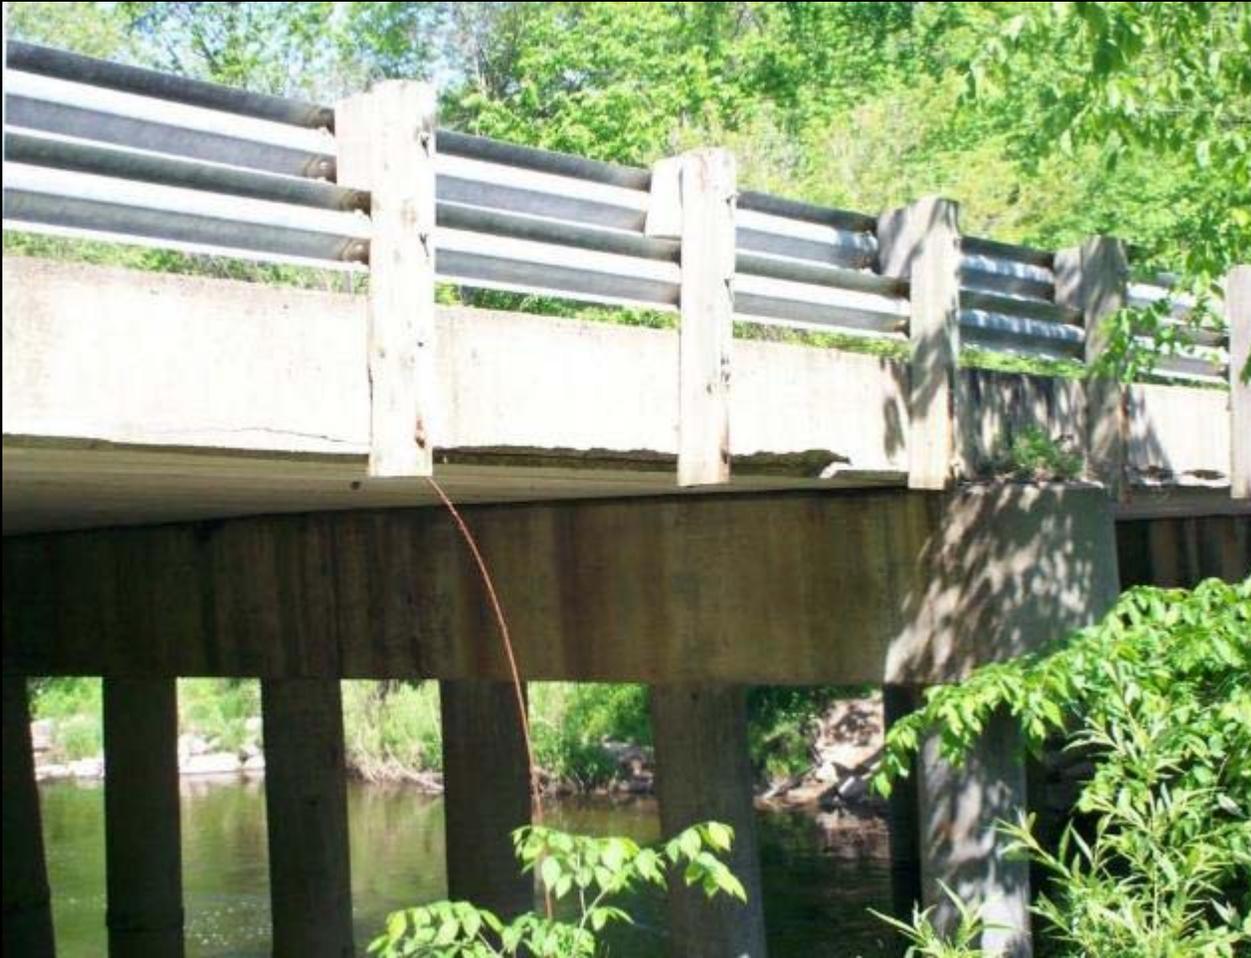
Box beams showing signs of deterioration. Exterior box beam showing spalling and exposed bottom strand.

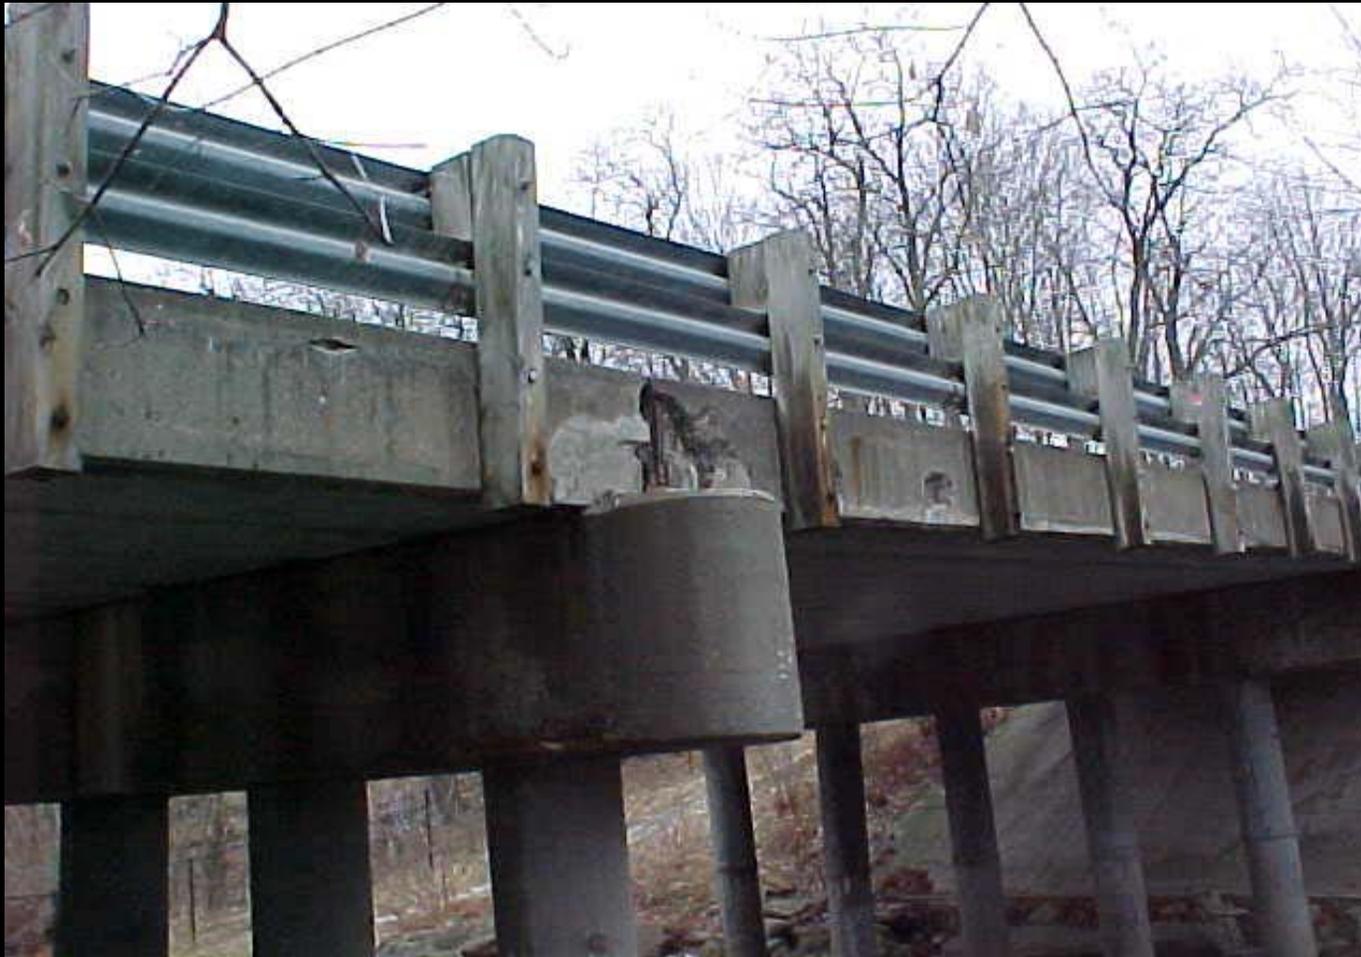
Exterior box
beam showing
spalling and
exposed
transverse
reinforcement.

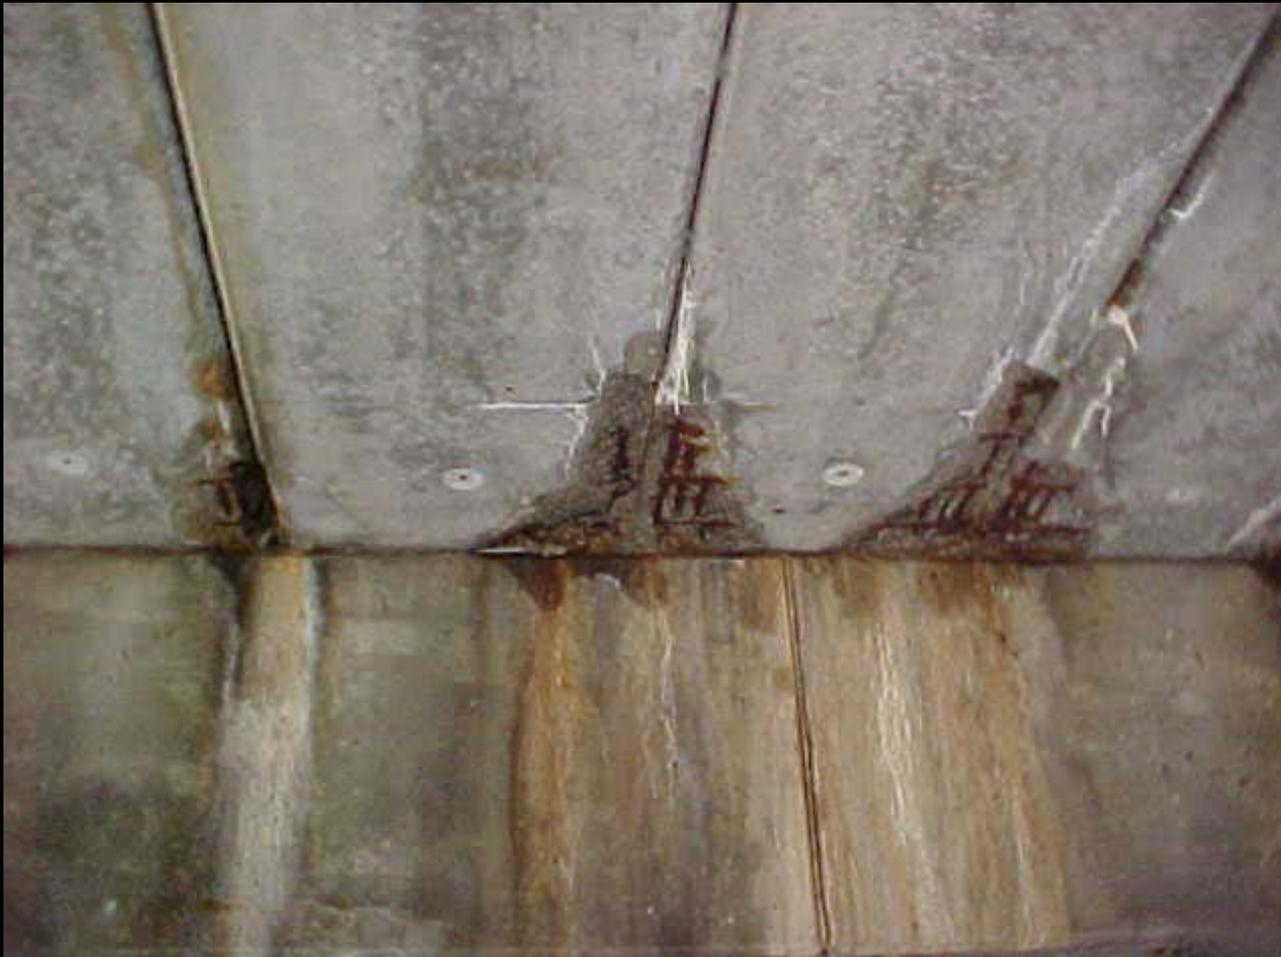
Underside of
box beams
showing spalling
and exposed
bottom strands
and transverse
reinforcement.

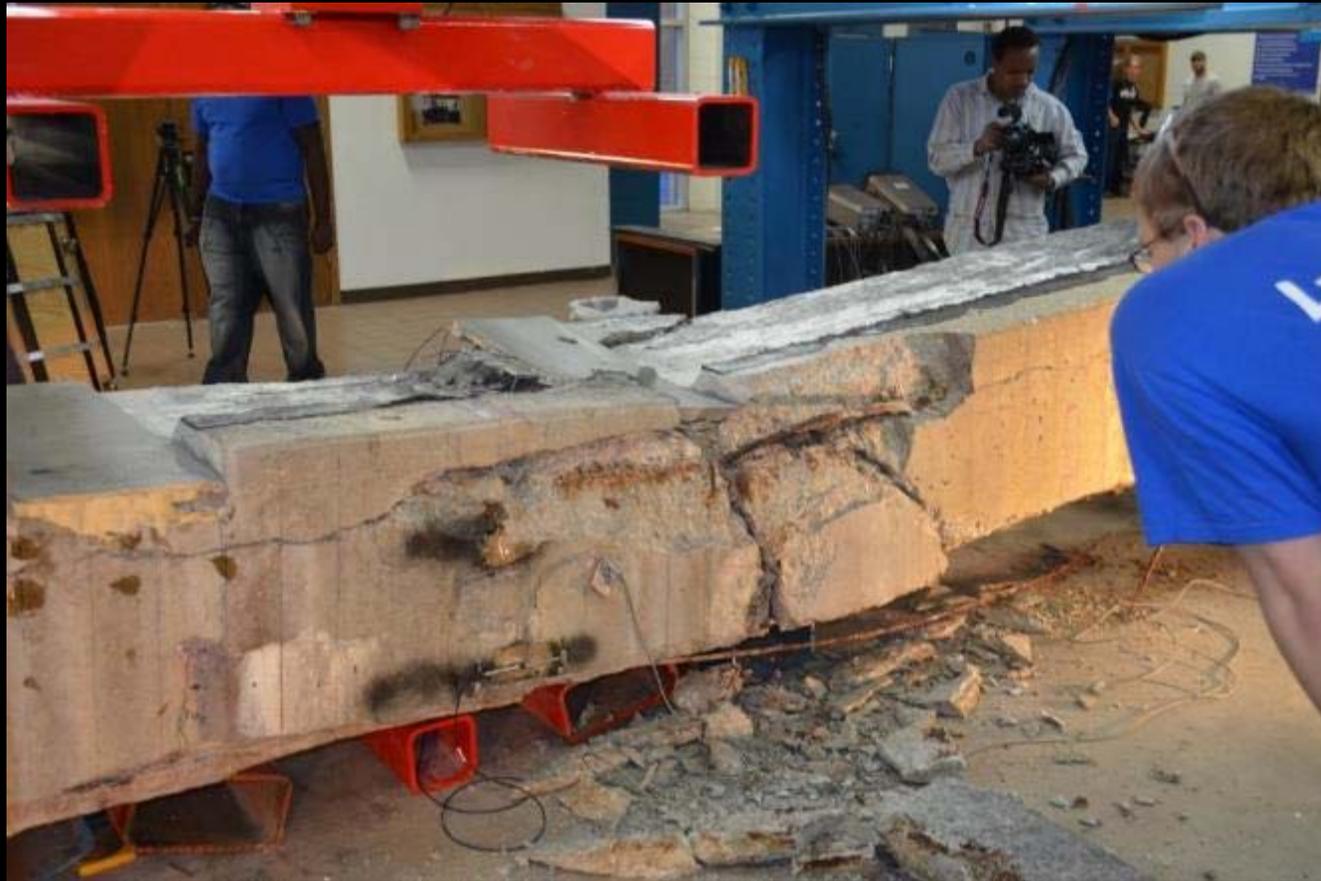
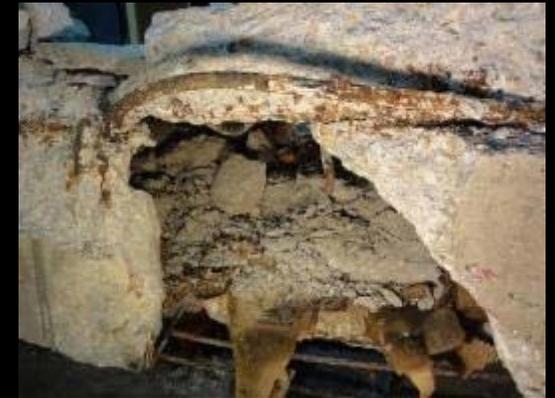
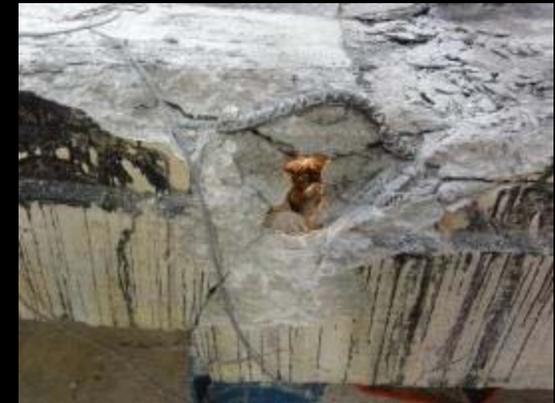
Failed MDOT Salvaged Beam

- The flexural beam failure progressed as expected with the assumption of 20 % average loss of cross section area and 2 of 10 strands broken.
 - The fracture was a brittle shear failure
- Analysis of MFL data as well as visual (microscope) quantification of loss of cross section of the strands will provide further calibration of the MFL method to detect and quantify corrosion
