Kent County
Road Commission

2015 Bridge Conference

Pine Island Drive Bridge Restoration

LTU Beam Testing Update

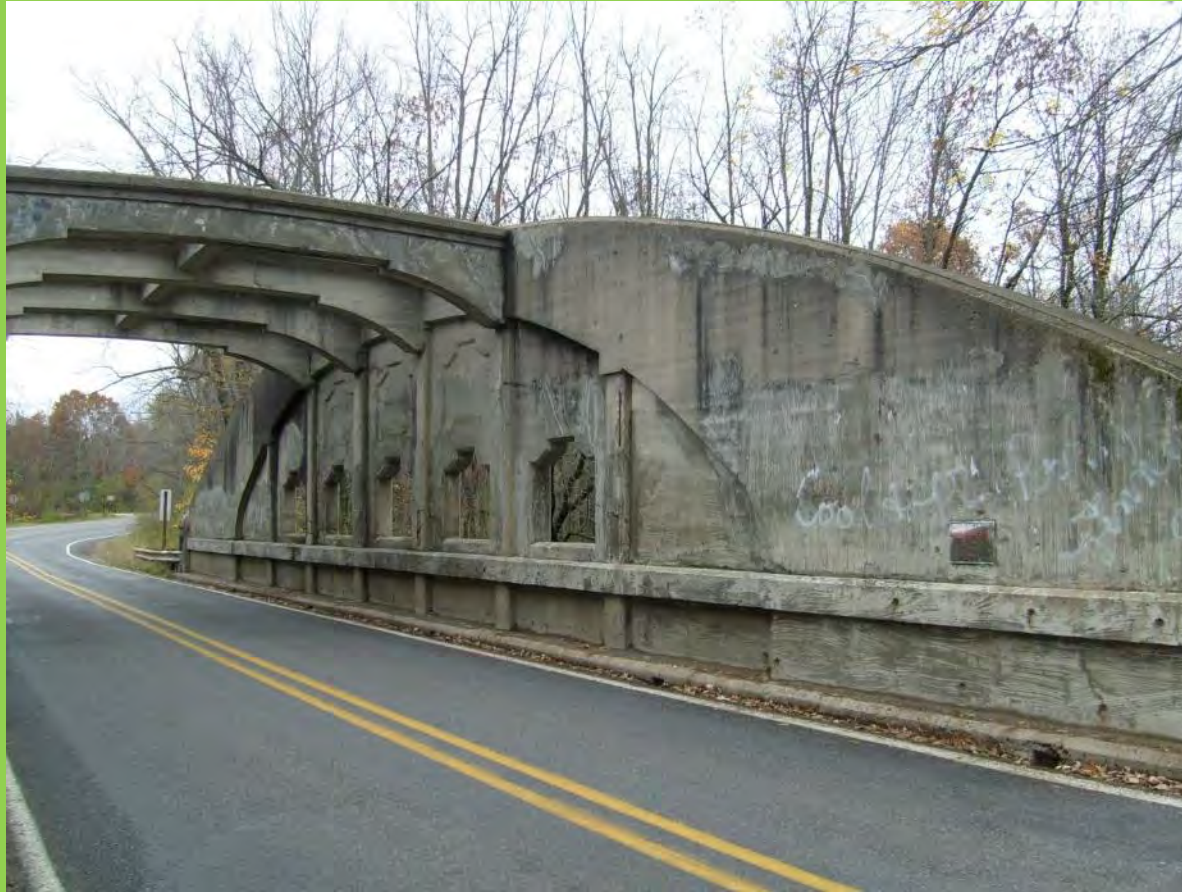
Modest Spalling, Graffiti, Mold, and Failed Past Repair Efforts All Contributed to Make the Bridge a Bit of an Eyesore

But For 90 Years Old – It could be
Worse

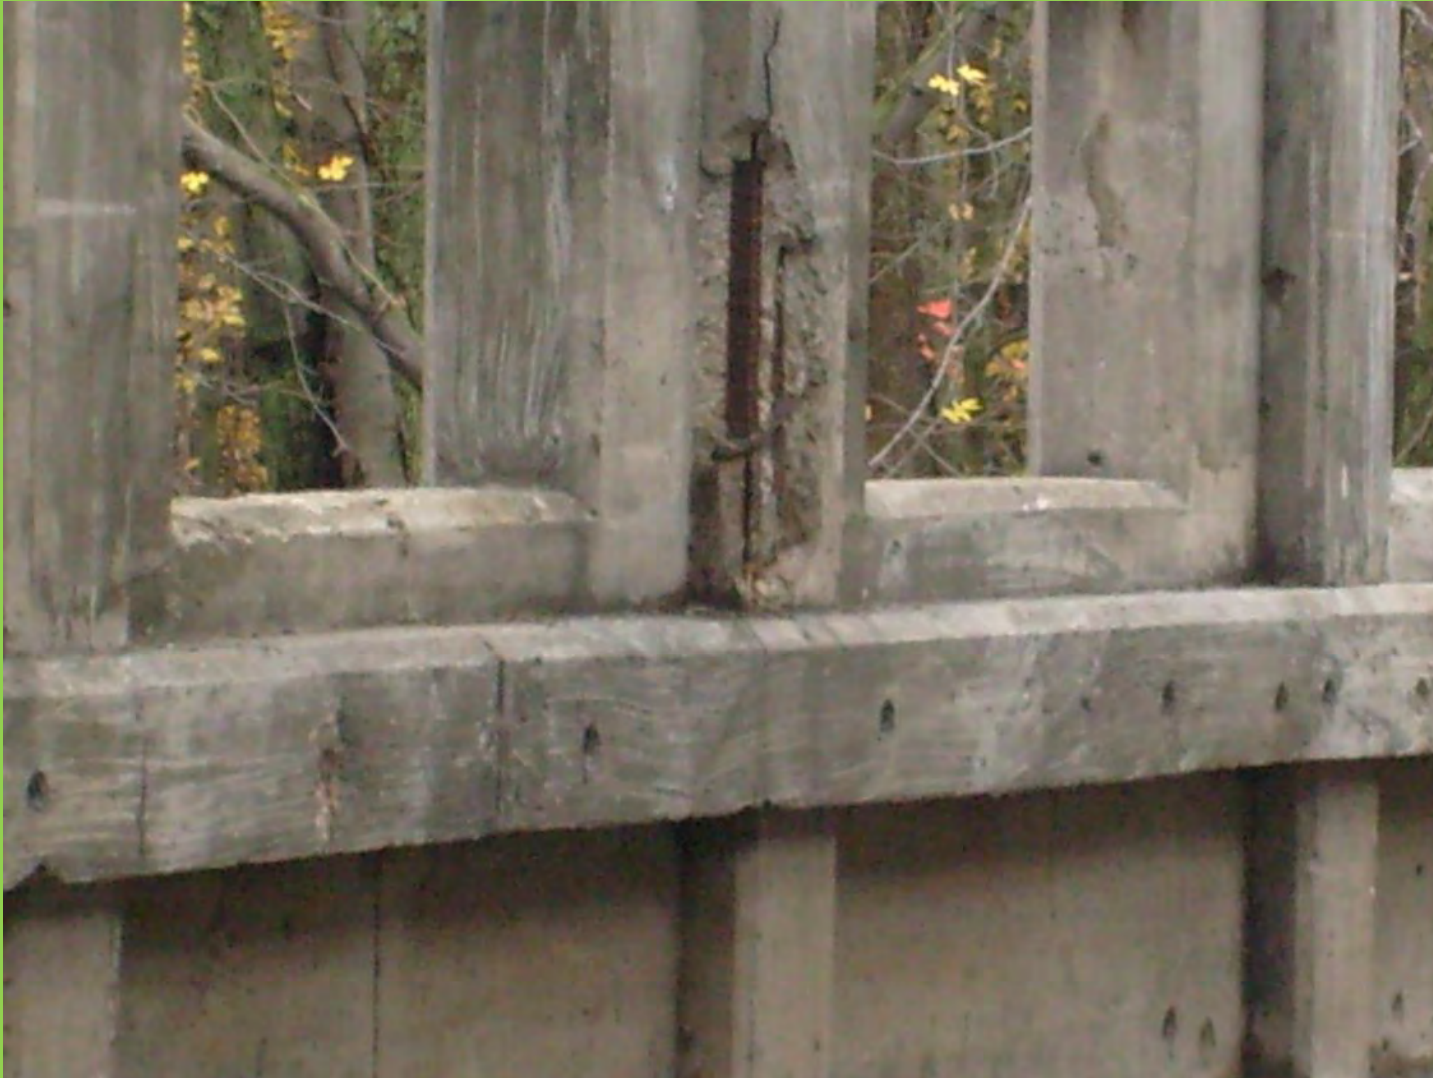
And In Some Places It Was Worse....

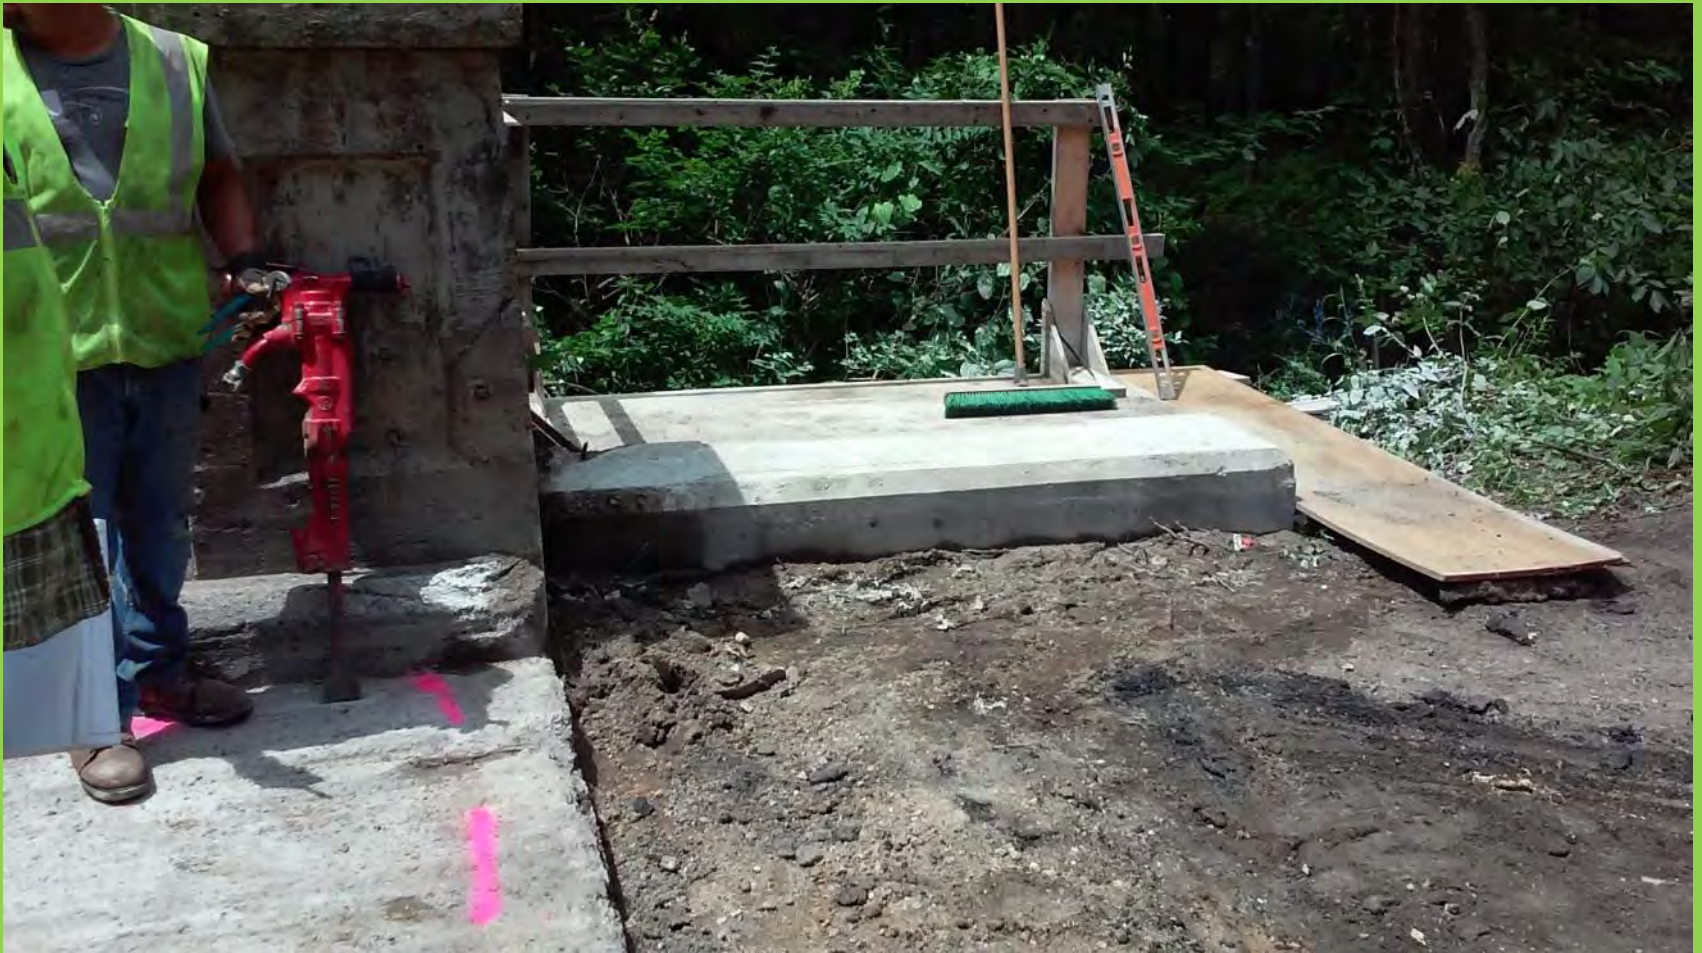
First Step – Milling. This is a lot like Christmas Morning – You Never Know What You'll Get....

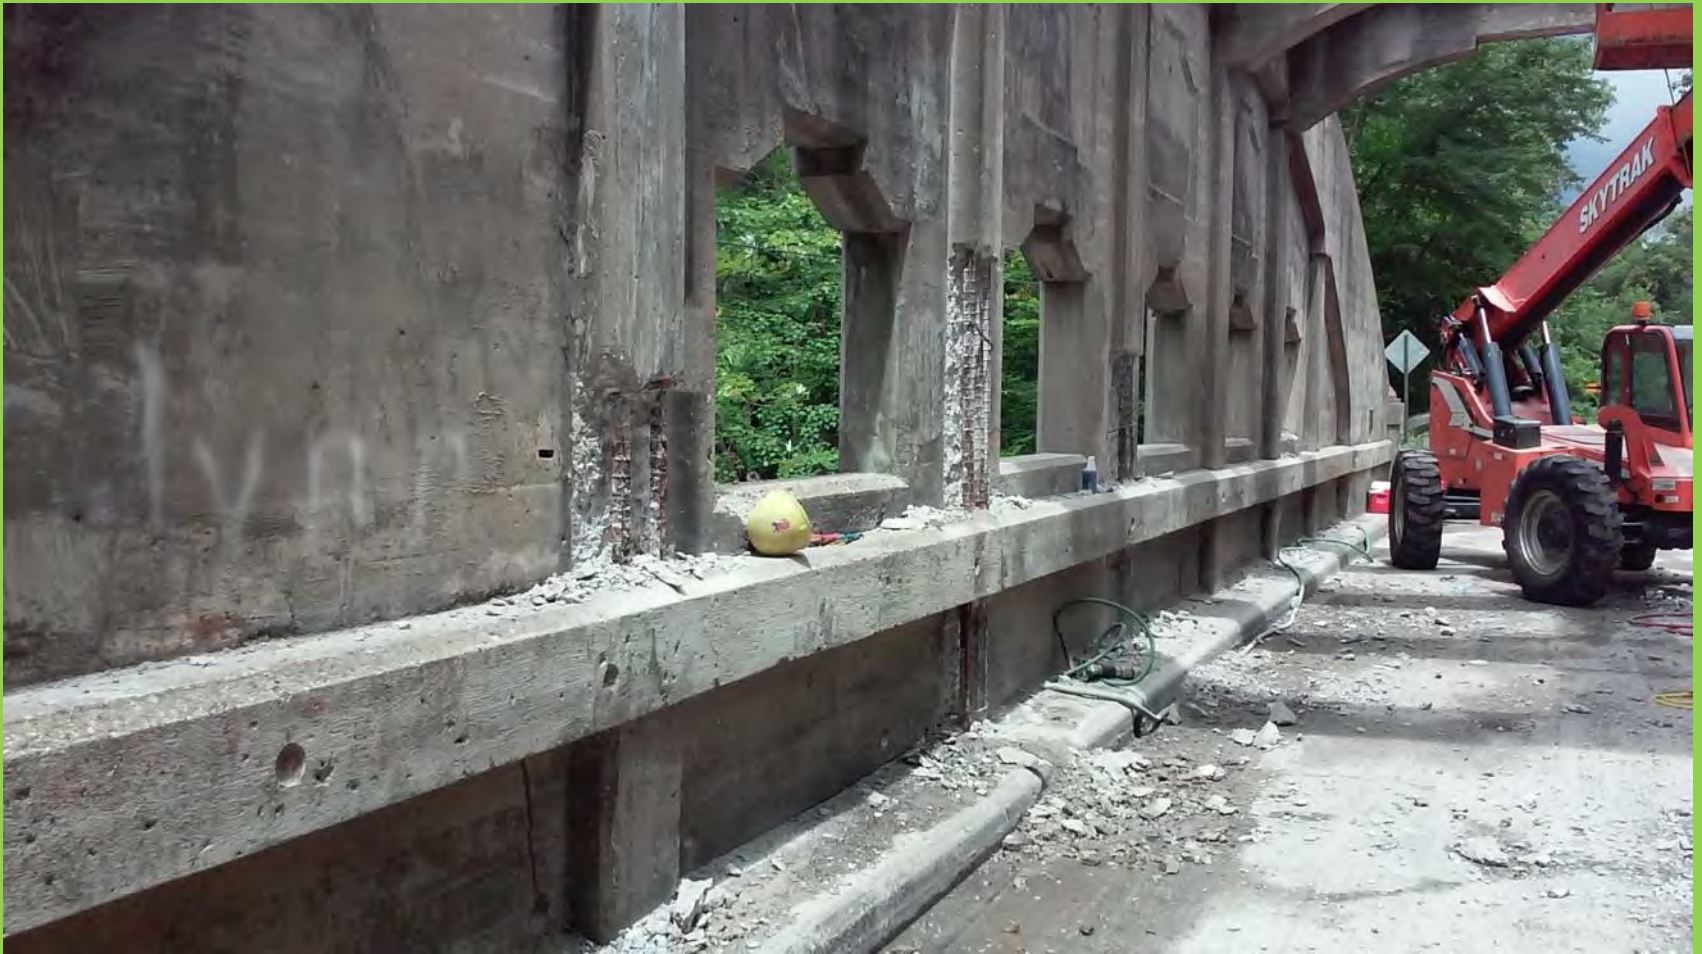
Only minor chipping was required on the inside faces of the “truss”

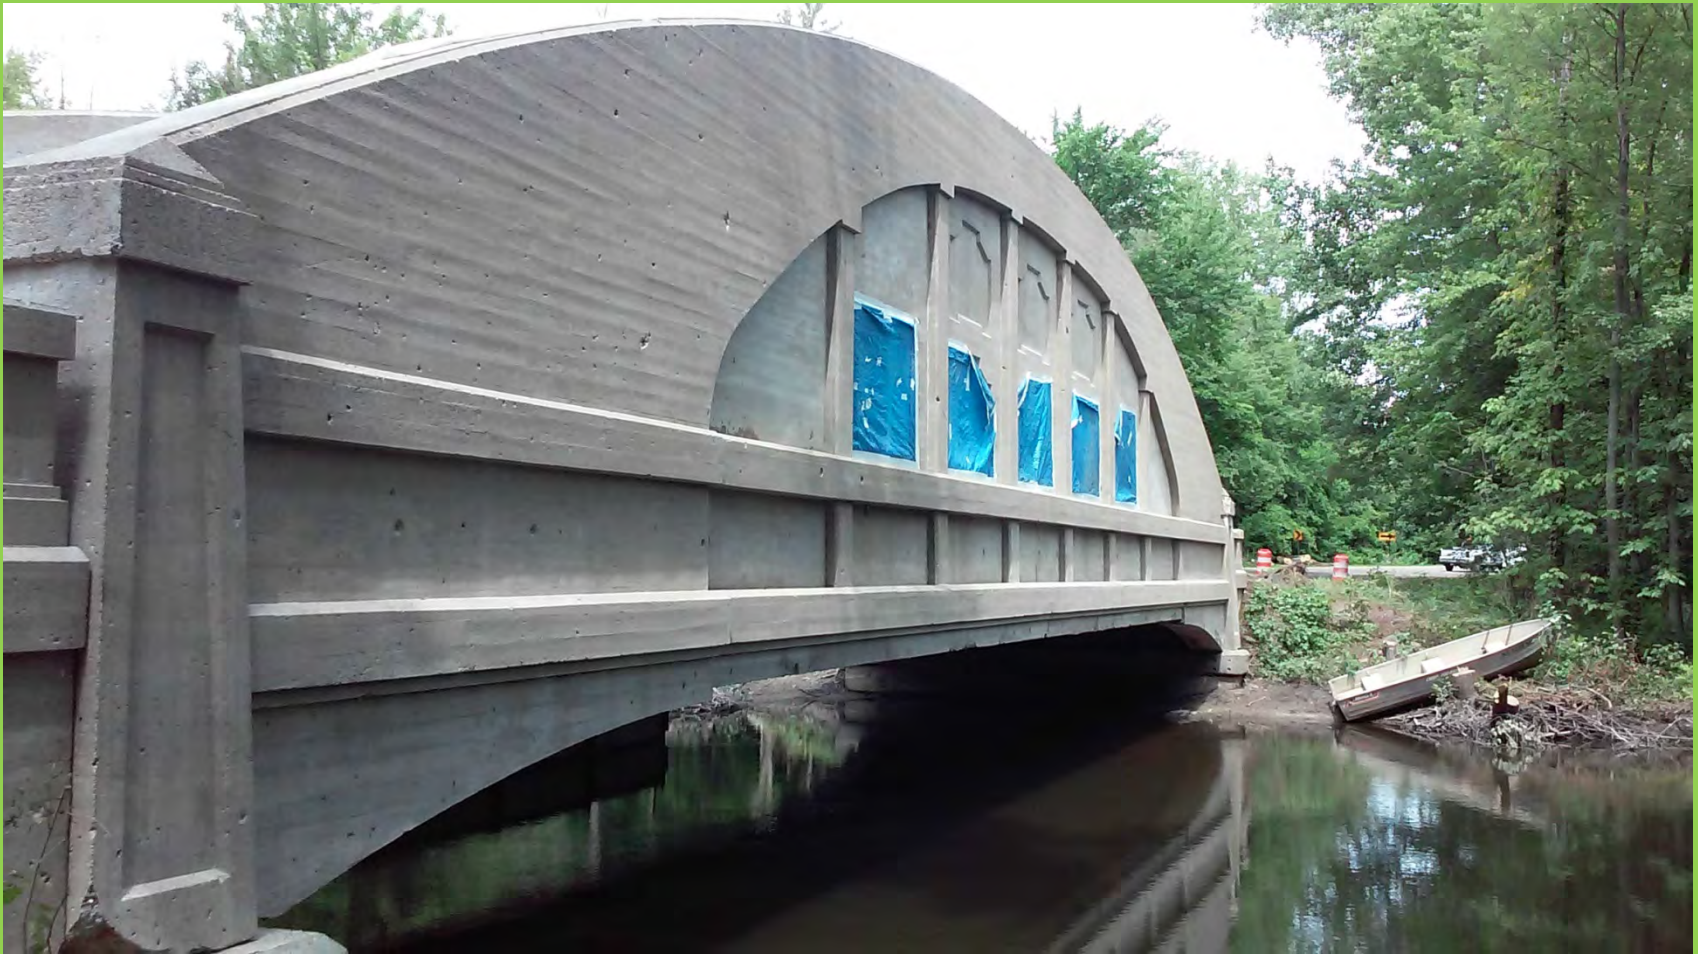
All areas have been soda blasted, the lower area had also been sand blasted. The lower area used to have epoxy over it

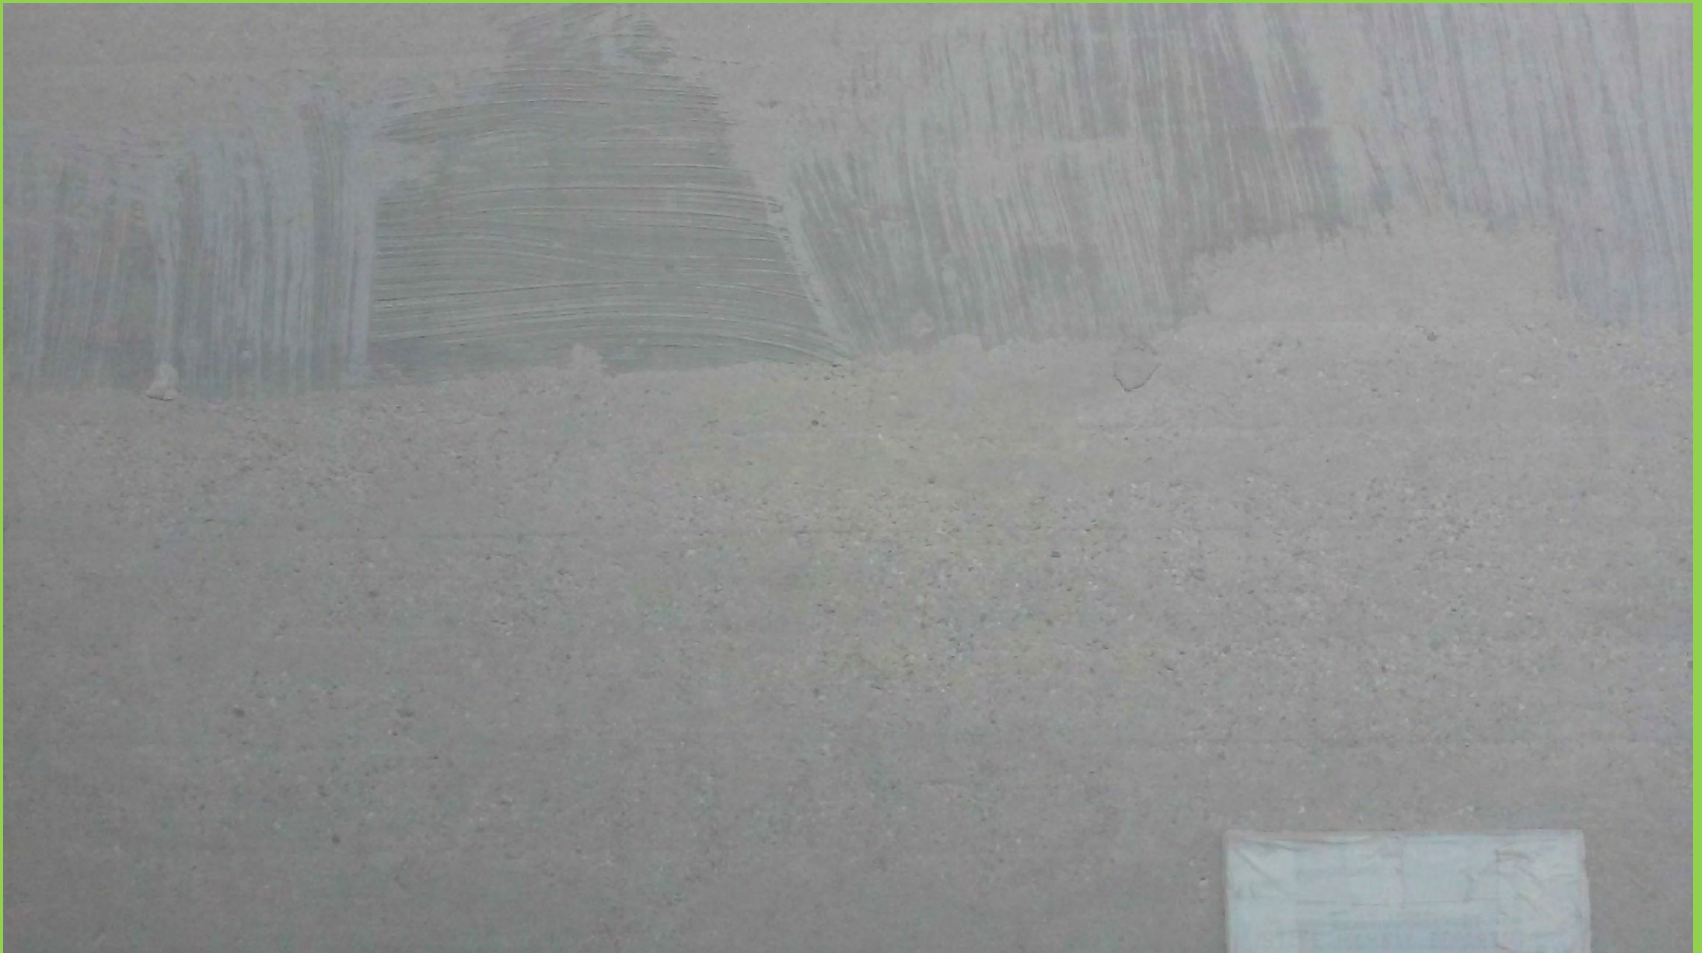
Former Epoxy Covered Area – all concrete substrate was not “perfect” – some surfaces still harbor a little epoxy

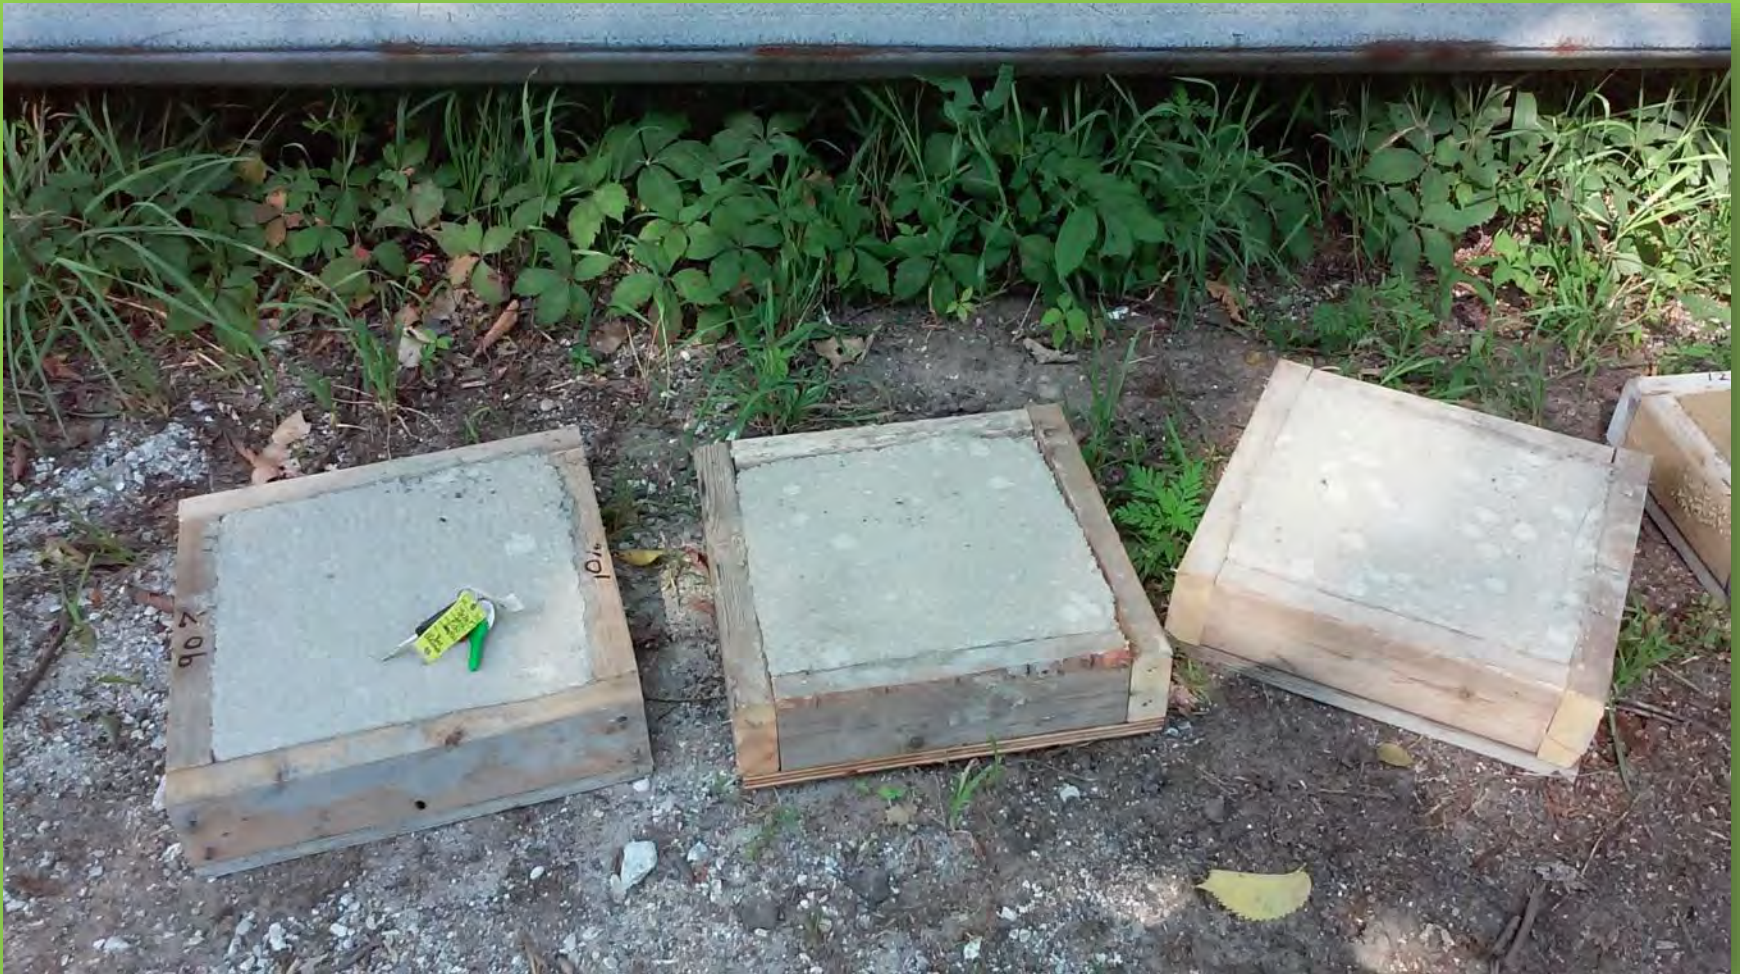
CL Mixes at 5 days – we are very concerned.....(too brown)

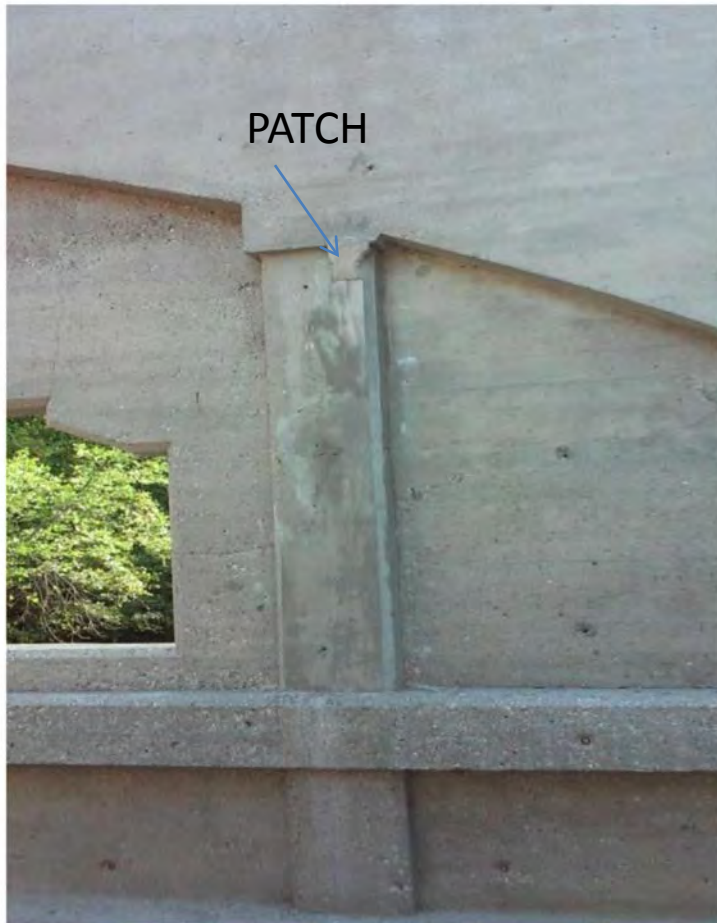
TEXTURE WILL BE
ENHANCED BY APPLICATION
OF "SAND-CEMENT"
TEXTURE

SMALL VOID –(THIS WAS
FILLED). SPRUE WAS REMOVED
TOO

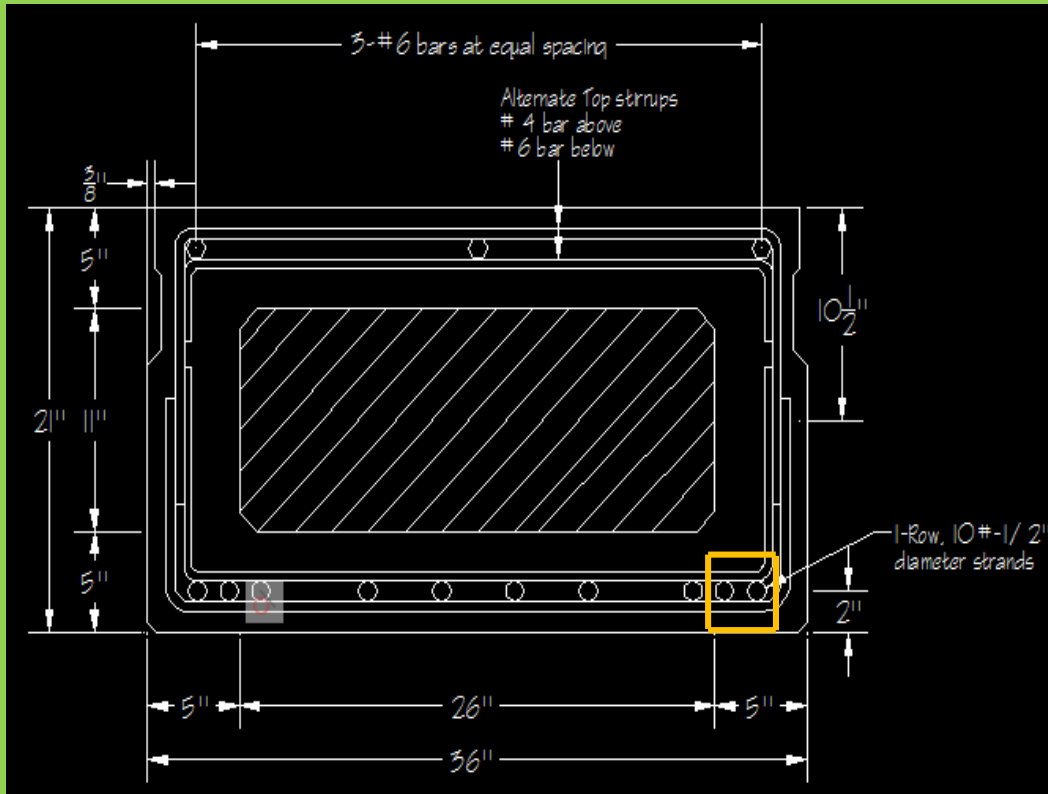
Evaluation of area **with** significant signs of corrosion

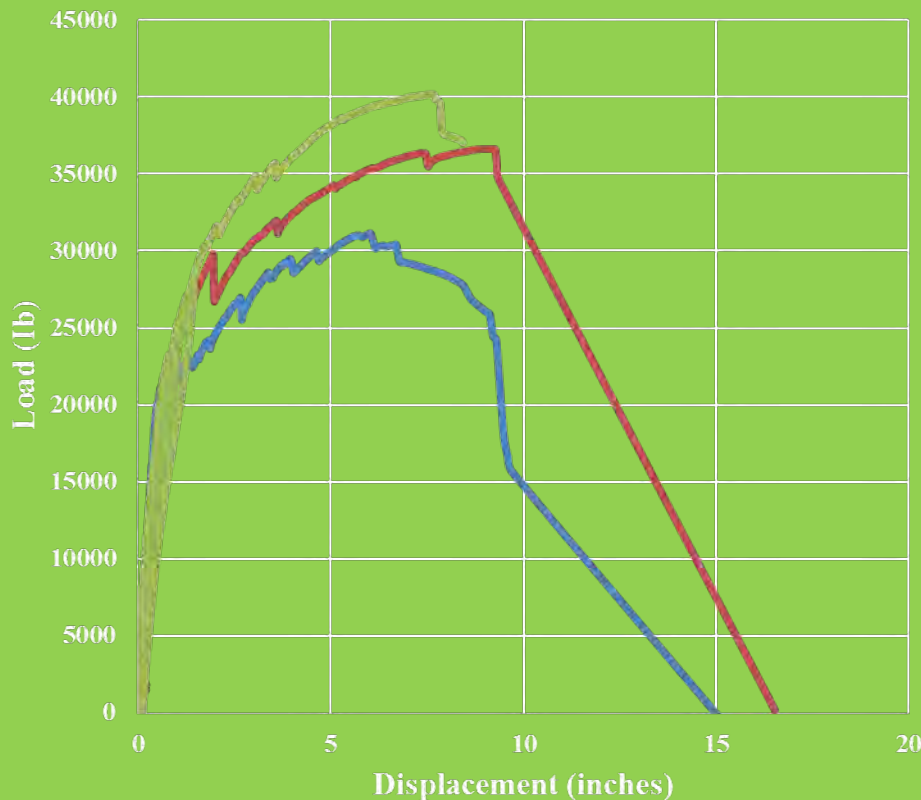
Experimental Results of Residual Flexural Testing of Salvaged Beams: J11, H6 & A1

Beams	Cal. Ultimate Load (lb)	Assumed Cross-sectional Area Loss
Beam #1 (J11)	29500	20% , 8 Strands Actively Engaged
Beam #2 (H6)	39096	20% , 10 Strands Actively Engaged
Beam #3 (A1)	42011	15% , 10 Strands Actively Engaged
	-----	-----
	Load (lb)	(inches)
Beam #1 (J11)	31200	6
Beam #2 (H6)	36970	9
Beam #3 (A1)	40160	7.5
