The Zilwaukee Bridge: from the beginning to the present

Matthew J. Chynoweth, P.E.

Michigan Bridge Conference Presentation

March 21, 2012

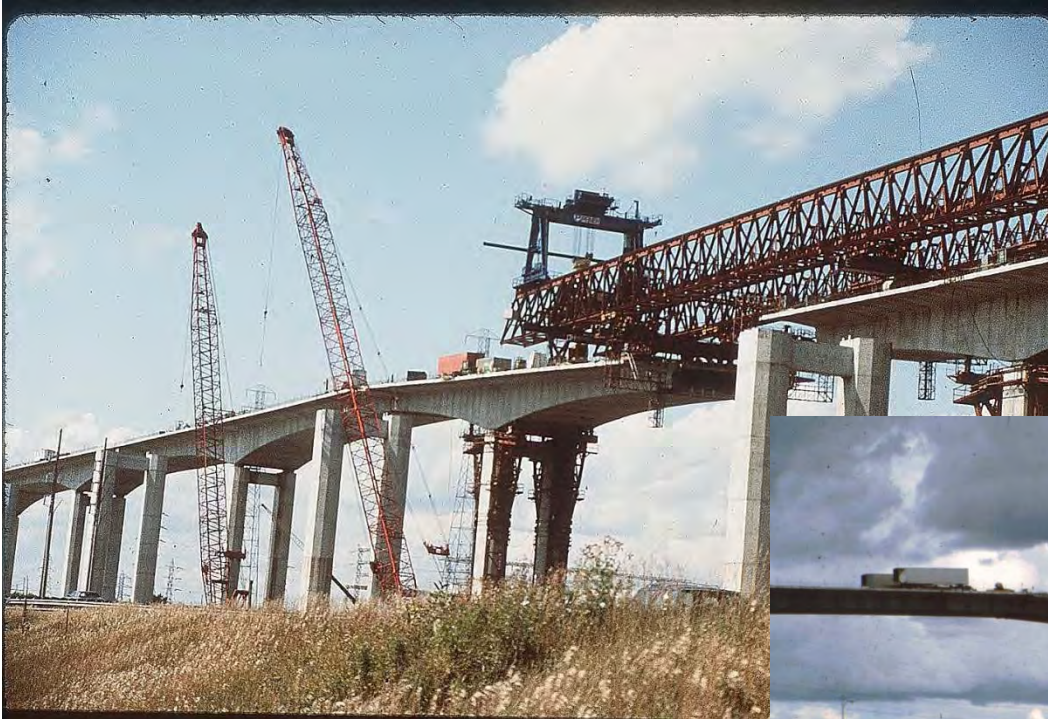
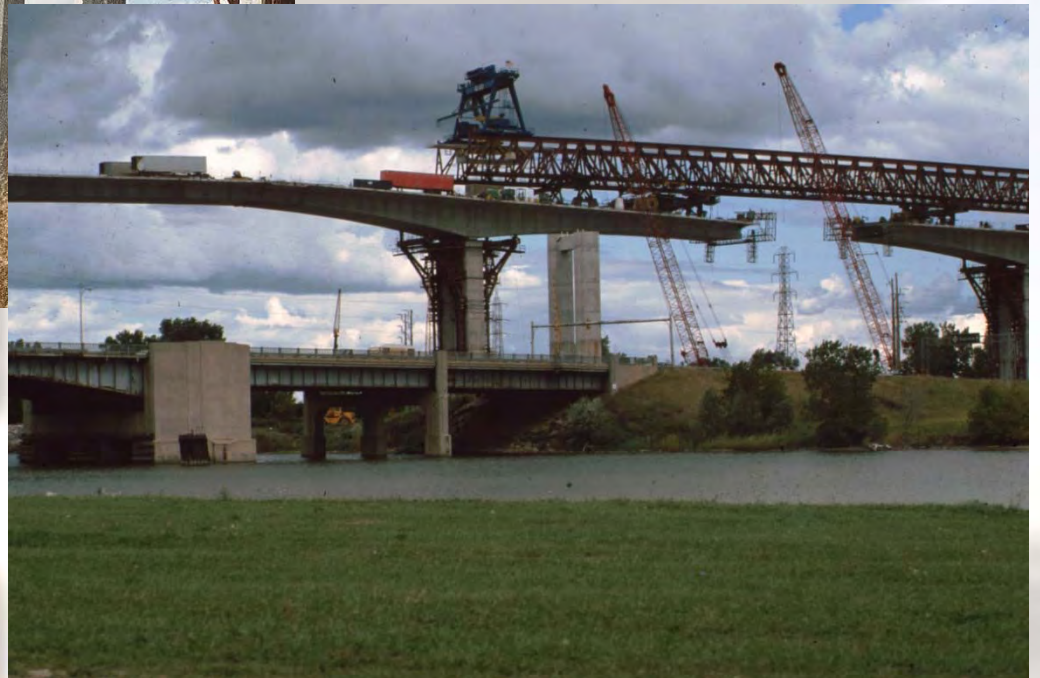
- Shortly after midnight on August 28, segment 10NSG was delivered by the segment hauler to the gantry
- The gantry began moving south, when sudden and large displacements of the 11NS cantilever resulted in a downward deflection of roughly 5'-3", and the expansion joint in span 12 deflected upward by 3'-6"
- 1200 k – 1500 k horizontal forces tilted Pier 11N 9" to the north until the northerly pile group failed in tension, cracking the footing from top to bottom
- Equilibrium was reached when the Pier 11N footing became a spring due to lack of EI, and the launching girder stiffness drew in load, effectively becoming a strut, stabilizing the overall structural system

➤ Rotation of cantilevers 11N & 11S

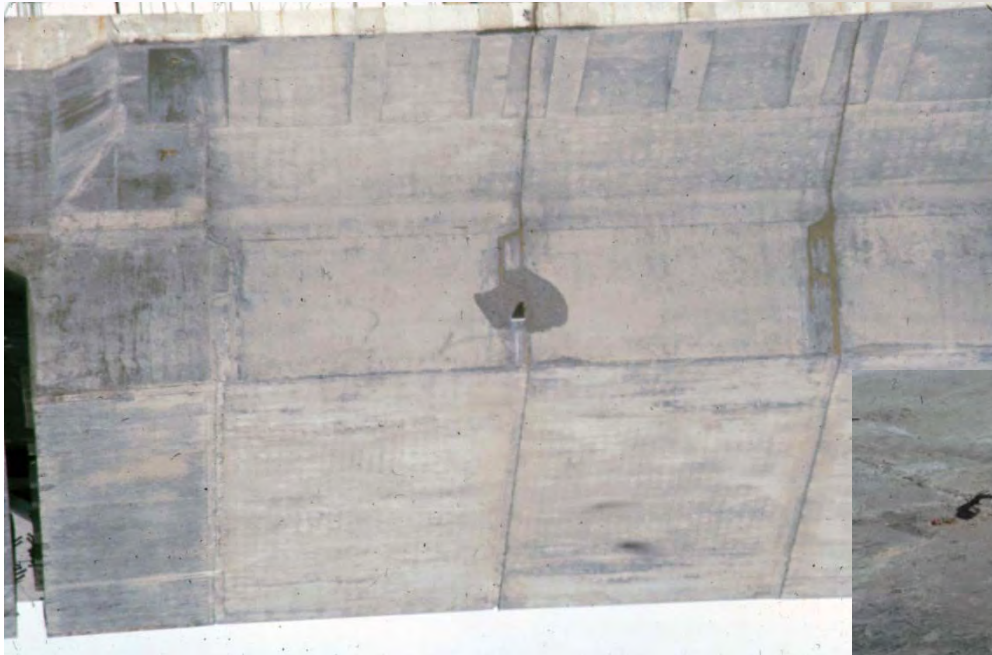
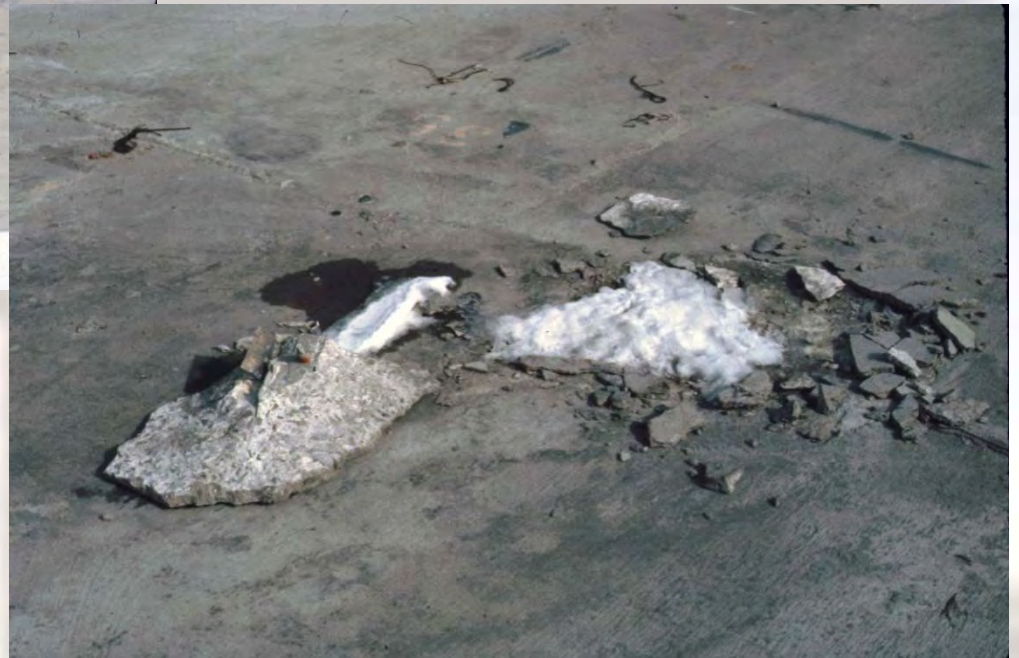
- Cantilever erection on NB continued through the winter of 1985/1986 to facilitate moving the launching girder up the completed NB structure so SB erection could begin in the spring of 1986. Several problems resulted:
 - Epoxy grout was not setting properly due to cold
 - Moisture pooled and froze in draped ungrouted longitudinal tendon ducts causing web wall spalling
 - Closure pours at the south end of NB are cracked
 - PT anchor blister on segment 7NND failed, and was retrofitted with steel plate
 - Transverse PT rib on segment 5NSB failed and was retrofitted with steel plate

➤ Segment damage due to water in tendon ducts

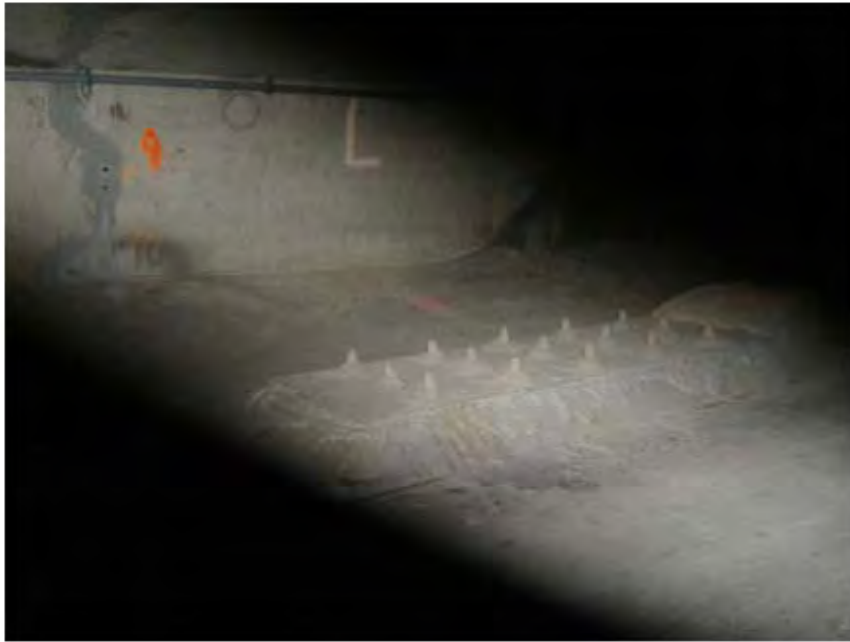
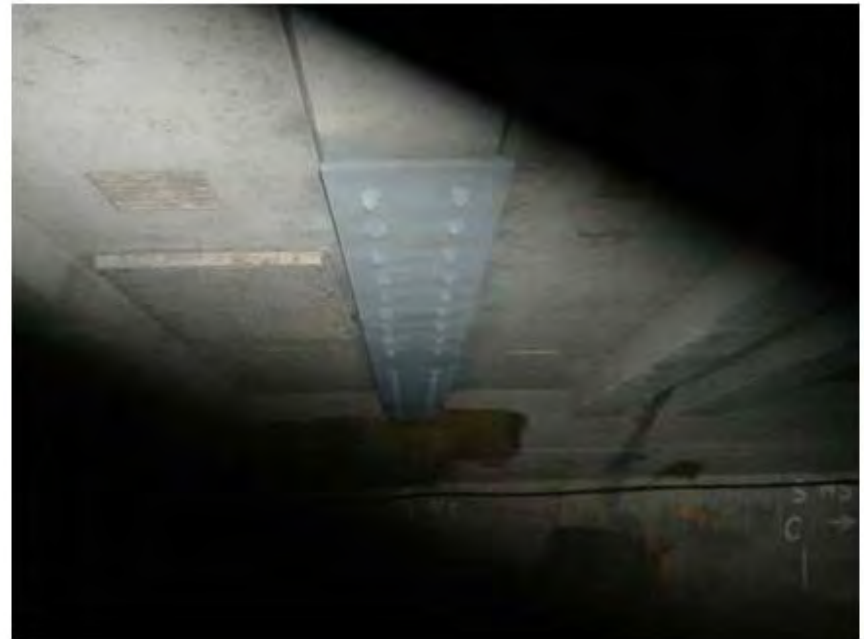
➤ Segment repairs at failed PT locations

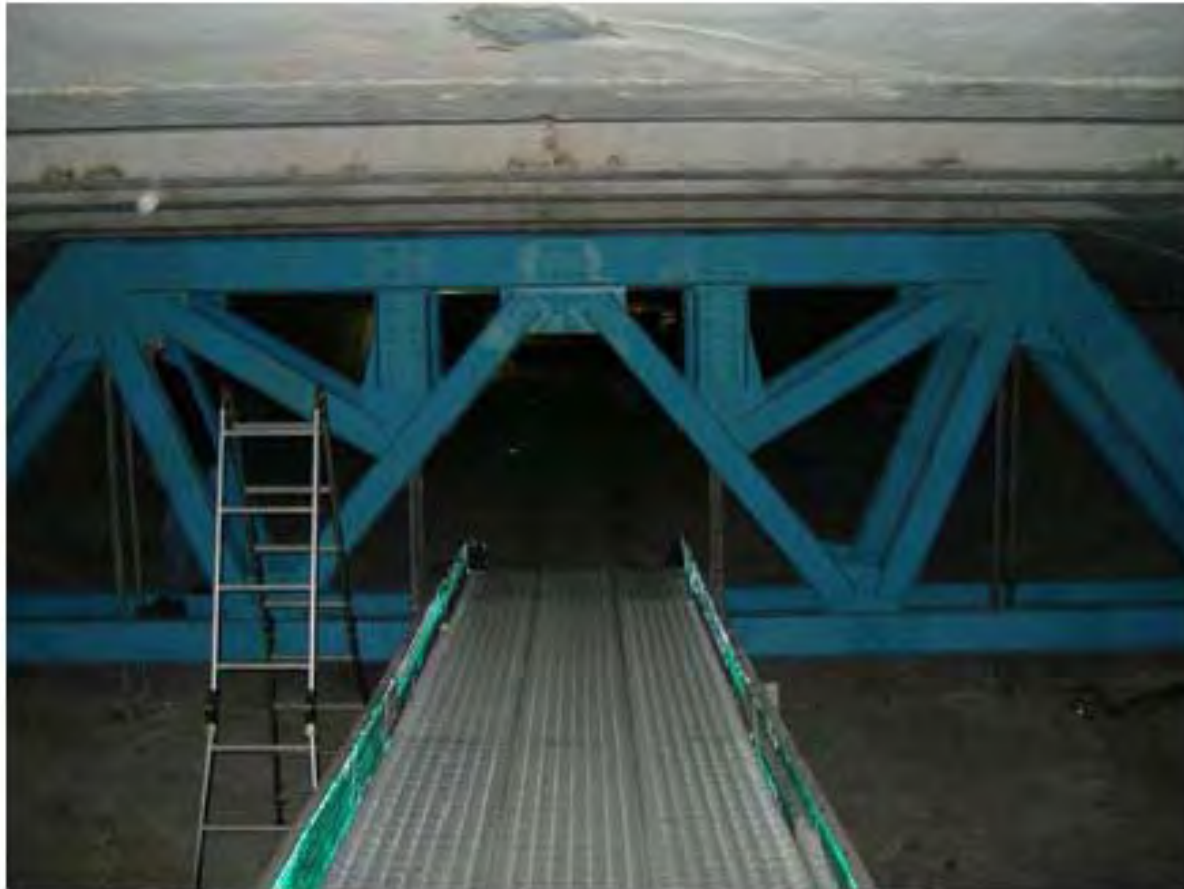
- Segments 20SNO and 20SNP bottom slabs were cast 6" too thick at one face, creating a downward thrust at the joint. This truss is vertically post tensioned into the joint to pull the slabs, counter acting the thrust

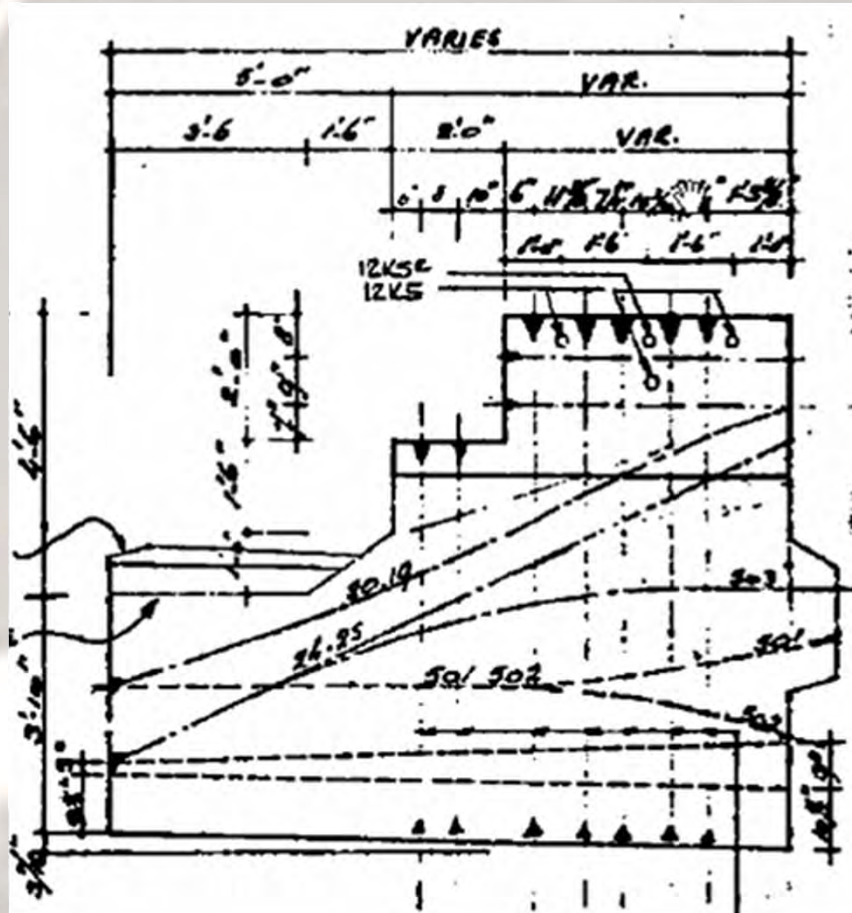
When coring commenced, primary cantilever reinforcement bars, and steel tendons used to post tension the individual segments together were unexpectedly cut

- Original Design had an option for thicker bearings
- Reinforcing Steel & Post-Tensioned strands not shown in this area
- Shop drawings are not as built, and do not accurately reflect changes made during fabrication

- 1 out of 12 strands in one tendon were cut, and 5 – 7 out of 12 strands in a second tendon were cut
- #7 cantilever bars were cut

- The project turned from bearing replacement to emergency repairs
- Parsons (designer) developed external post tensioning retrofit
- Janssen & Spaans Engineering reviewed retrofit design, and provided technical expertise during fabrication & installation

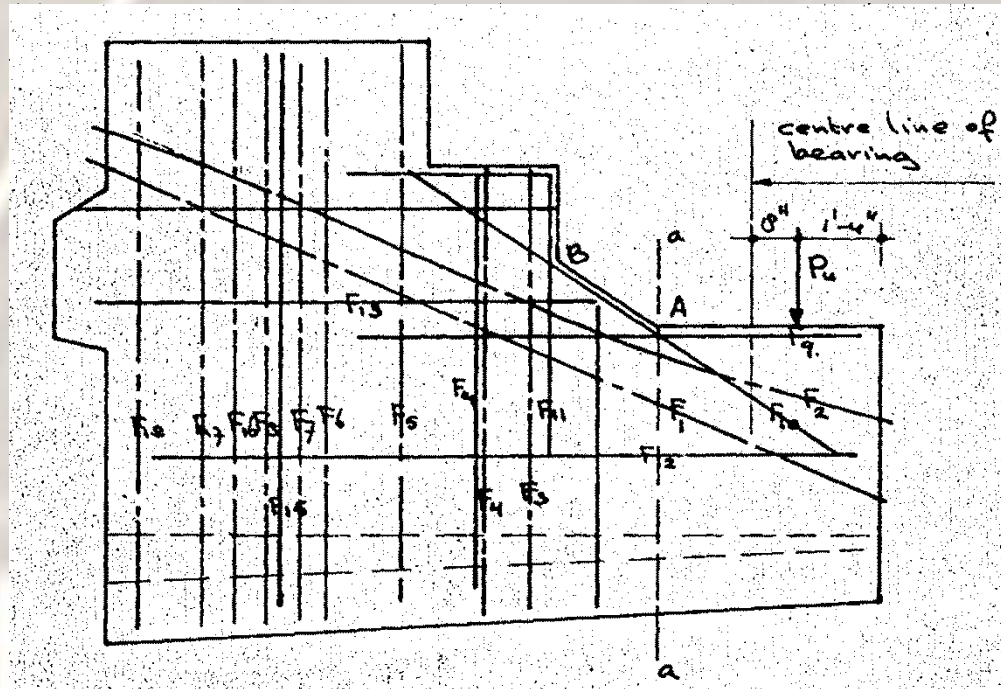
What forces were lost:

1 cut strand = $\frac{1}{12} * 0.95 * 496k = 40k$

7 cut strands = $\frac{7}{12} * 0.95 * 496k = 275k$

cut #7 bar = $0.60 \text{ in}^2 * 60 \text{ ksi} * 3 \text{ bars} = 108k$

rough total of 423k of resistance was lost

external post tensioning retrofit required to compensate for these losses
