Wadhams Road over the Black River

Constructing a big bridge with unique features

Wadhams Road over the Black River – Unique Features

- Drilled Shafts and Box Piles
- Pier footing mass pour
- Drilled earth anchors
- Structural steel testing/investigation

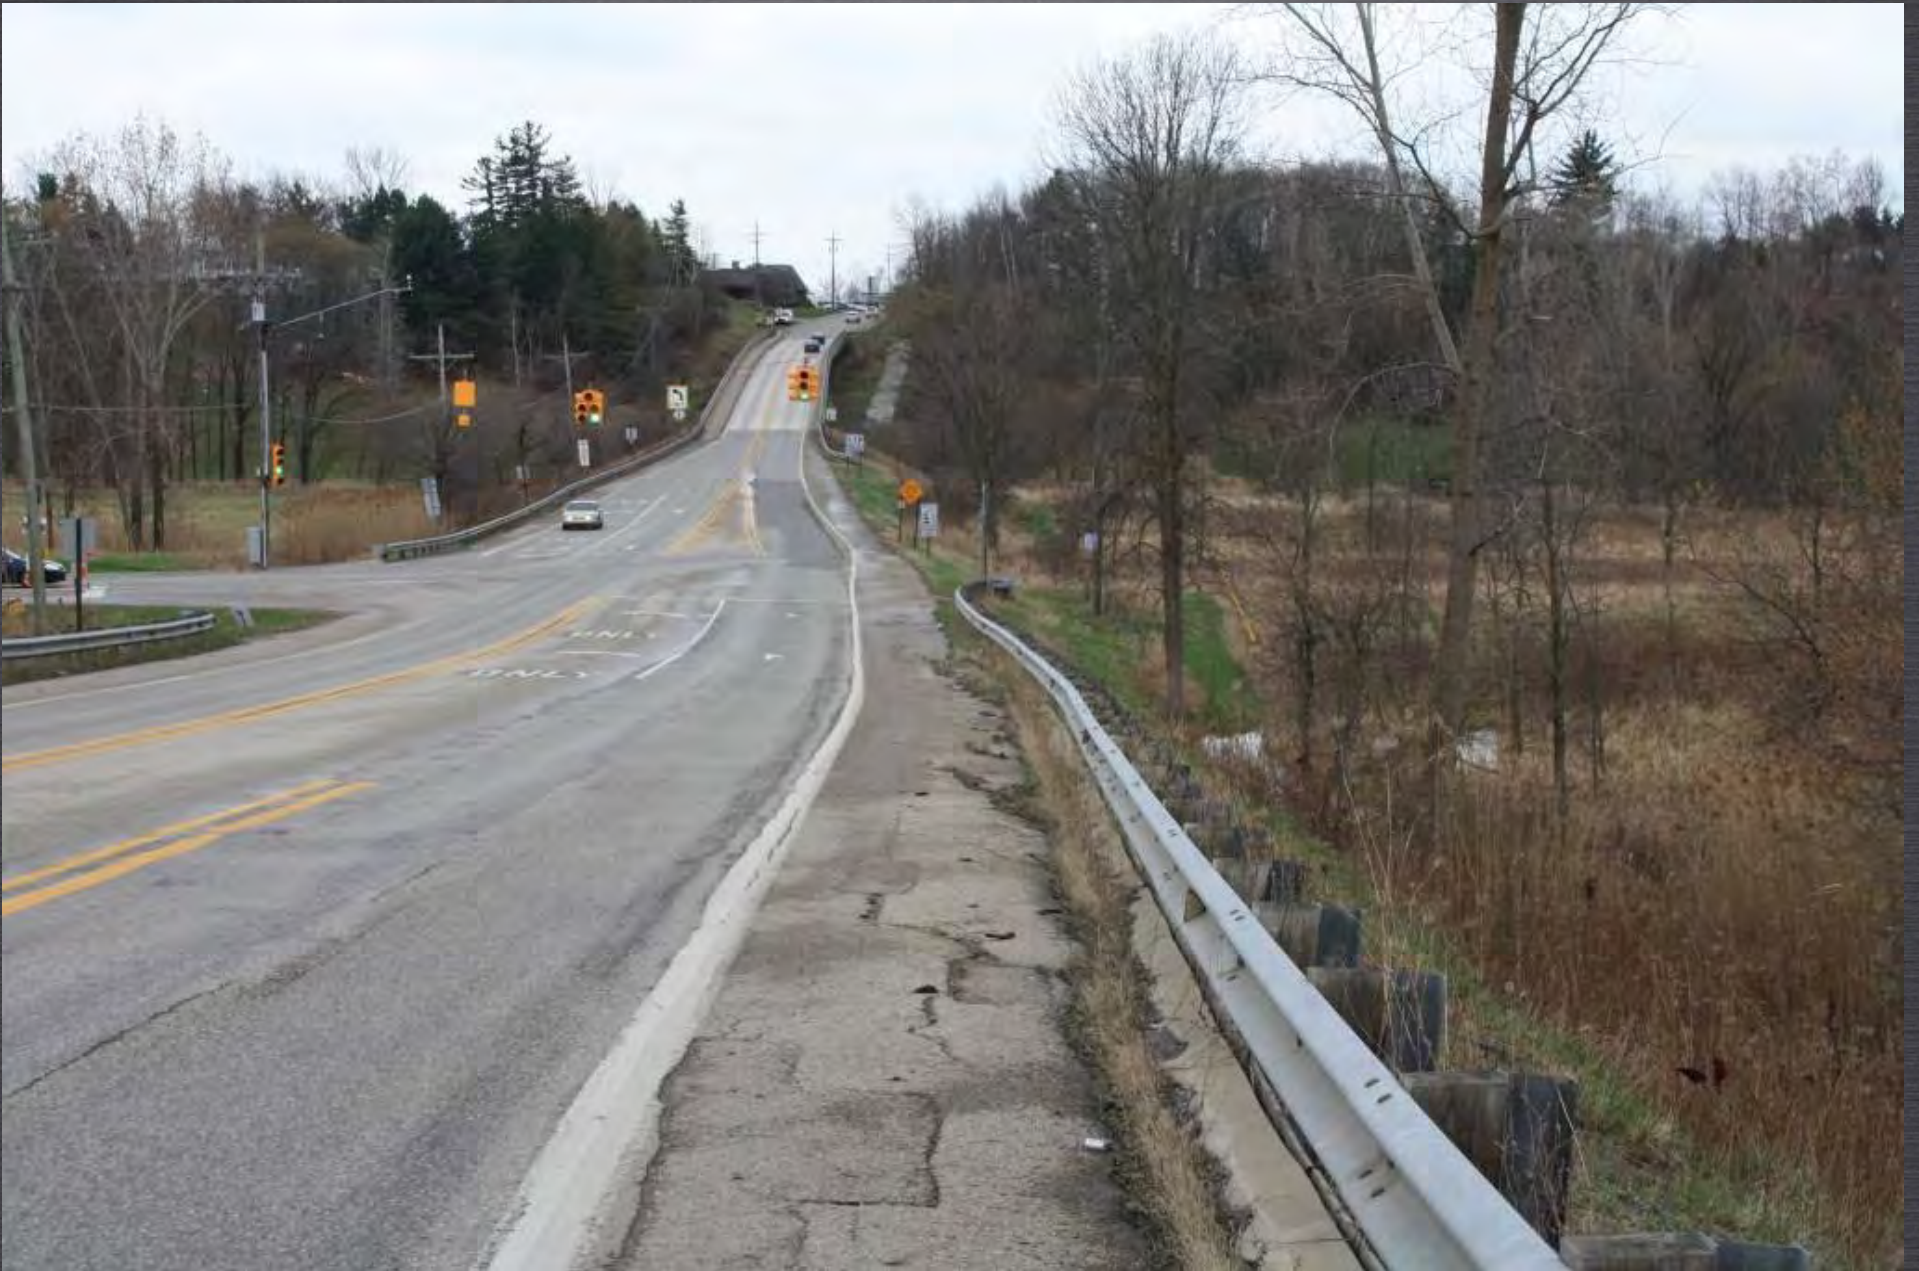
Existing Bridge

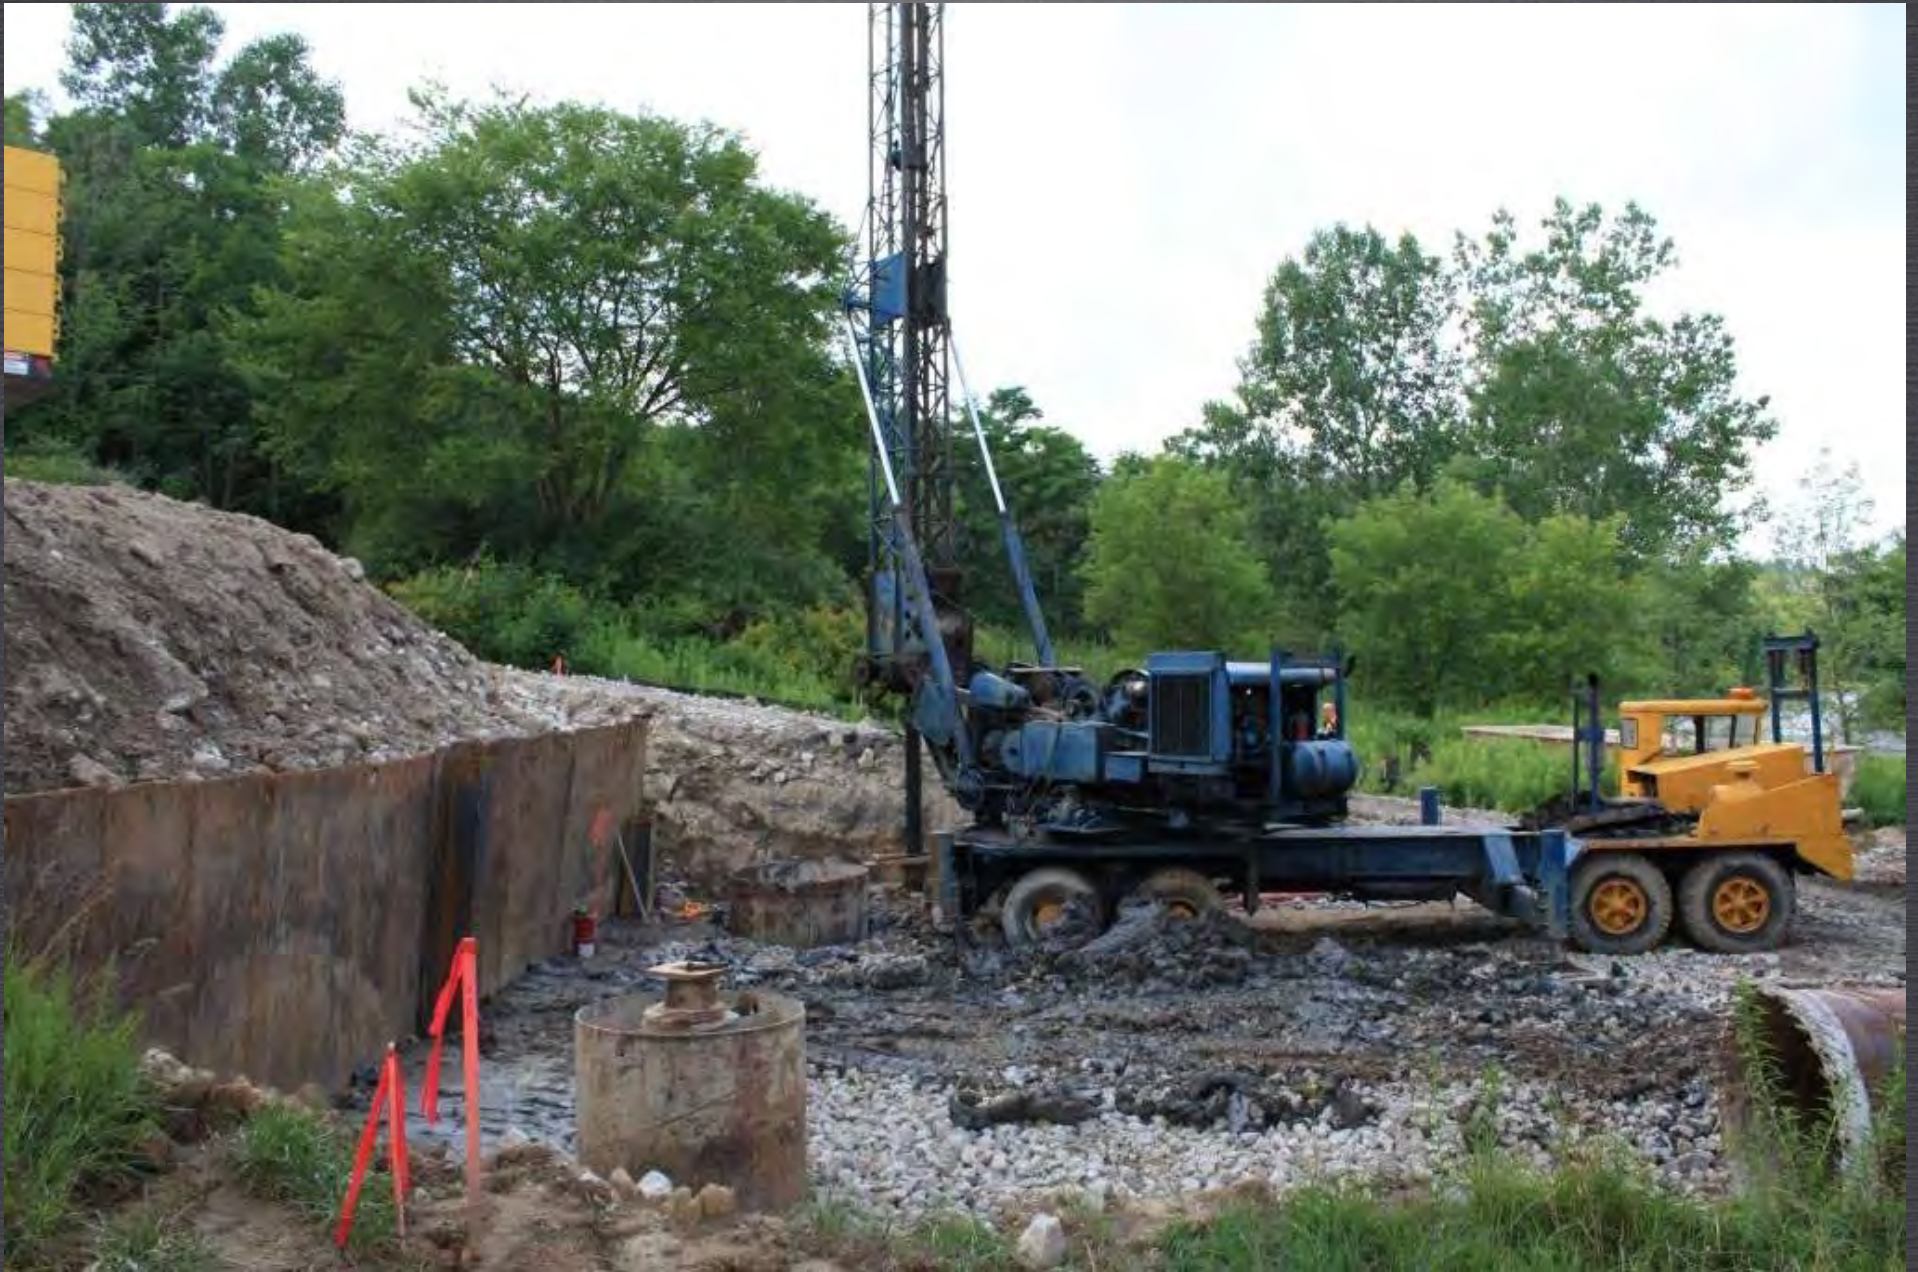
Drilled Shafts

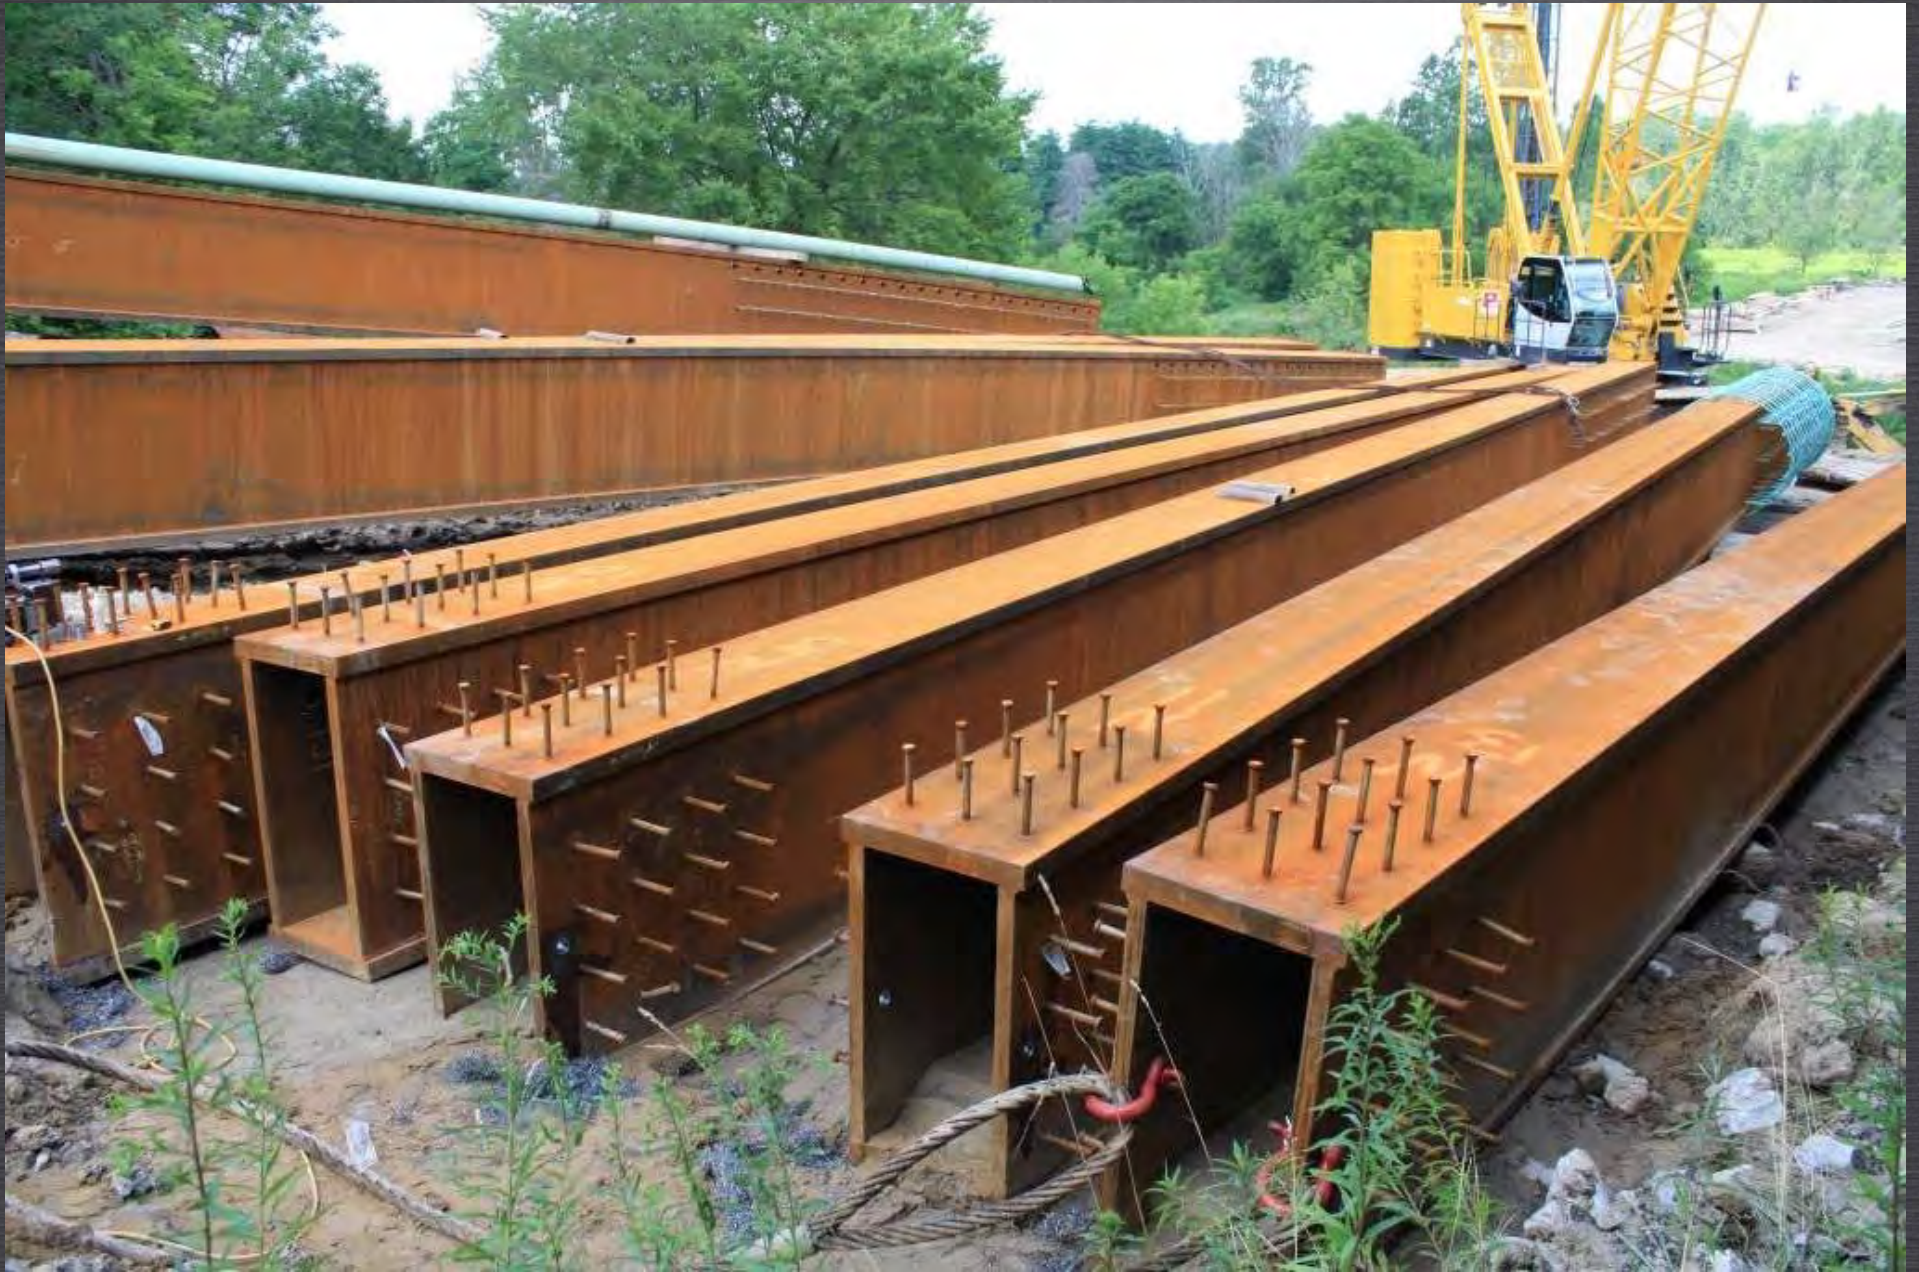
Steel Box Piles

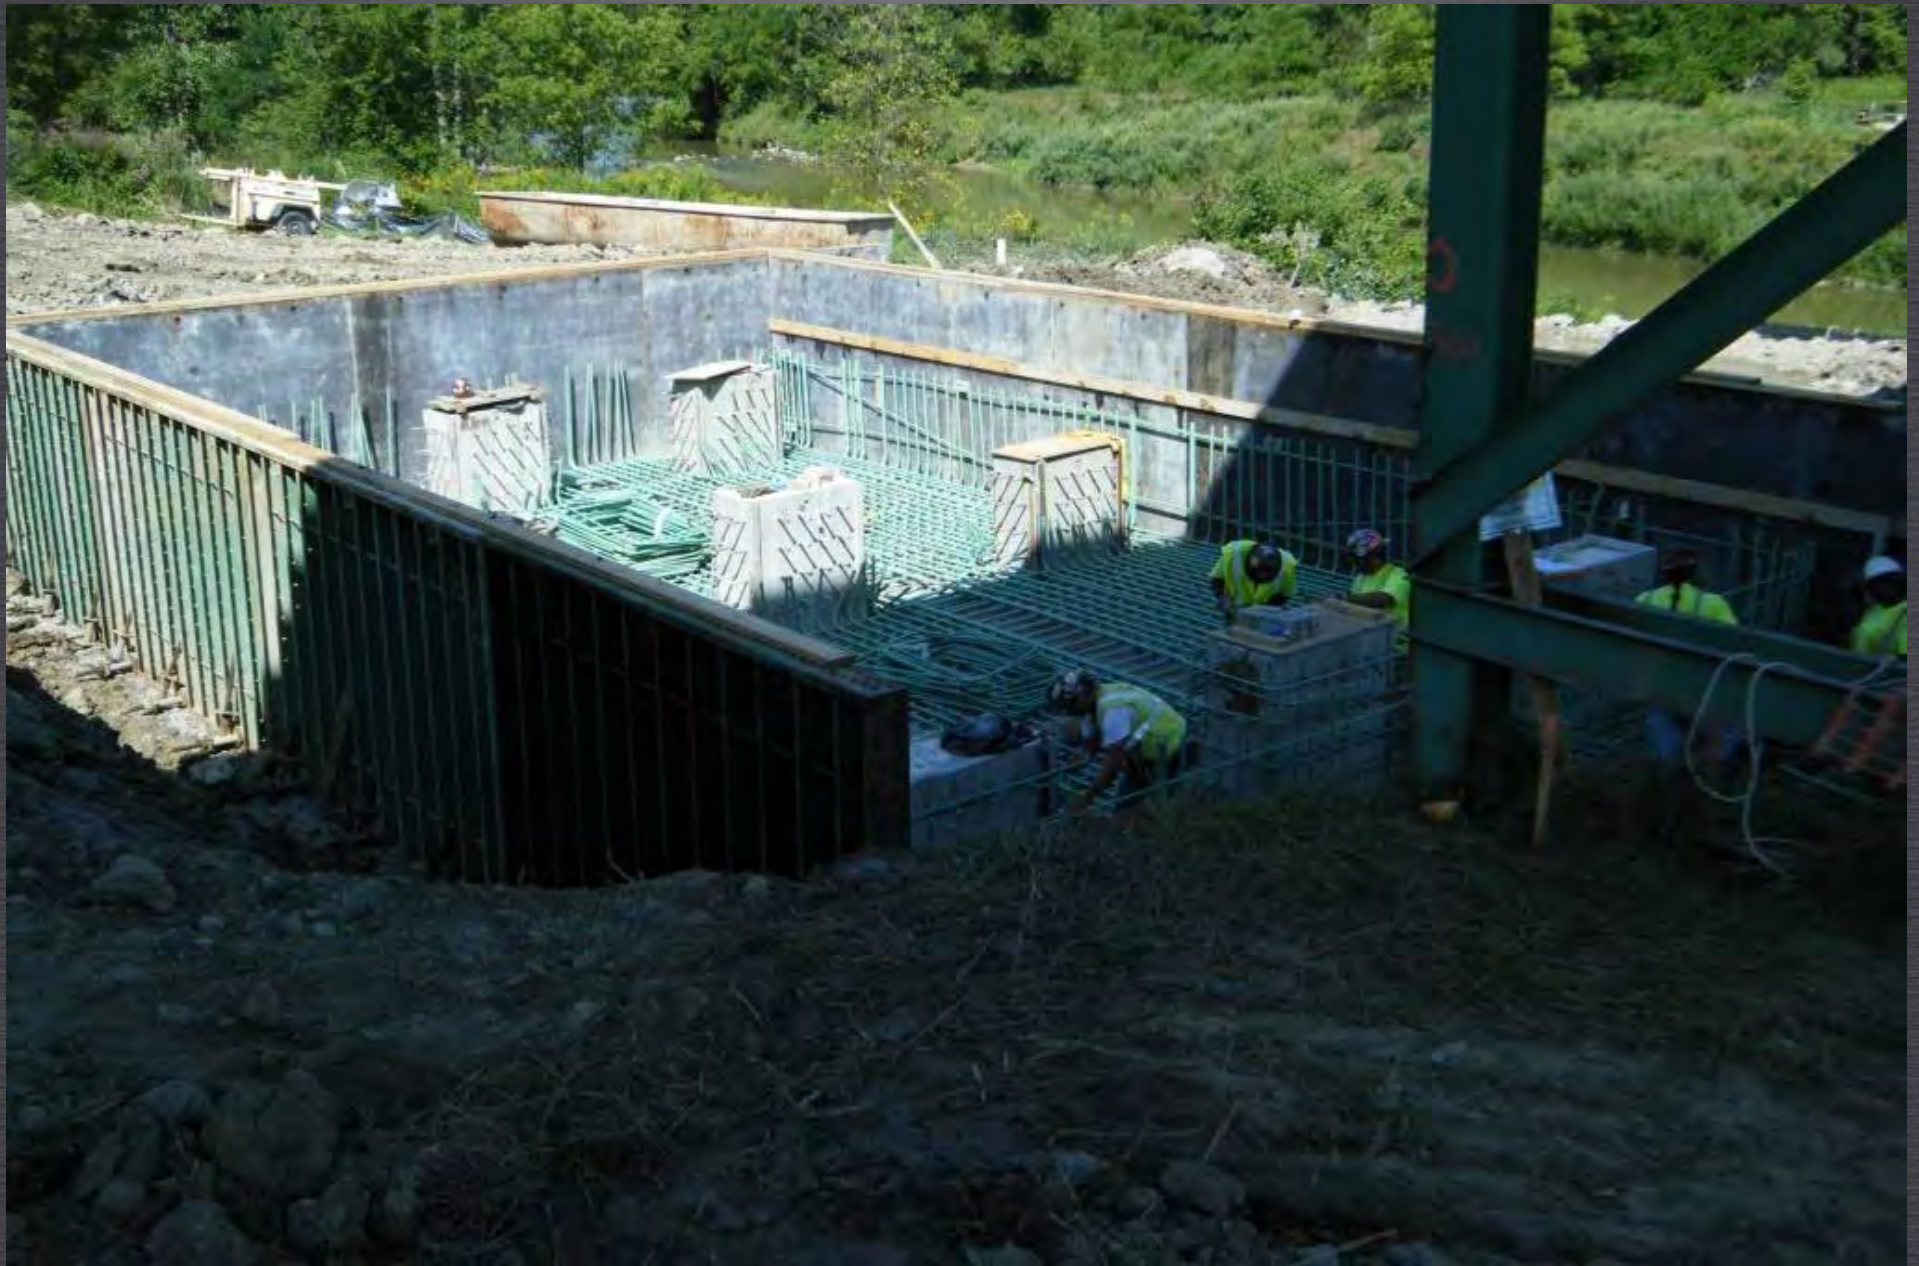
Pier Footing

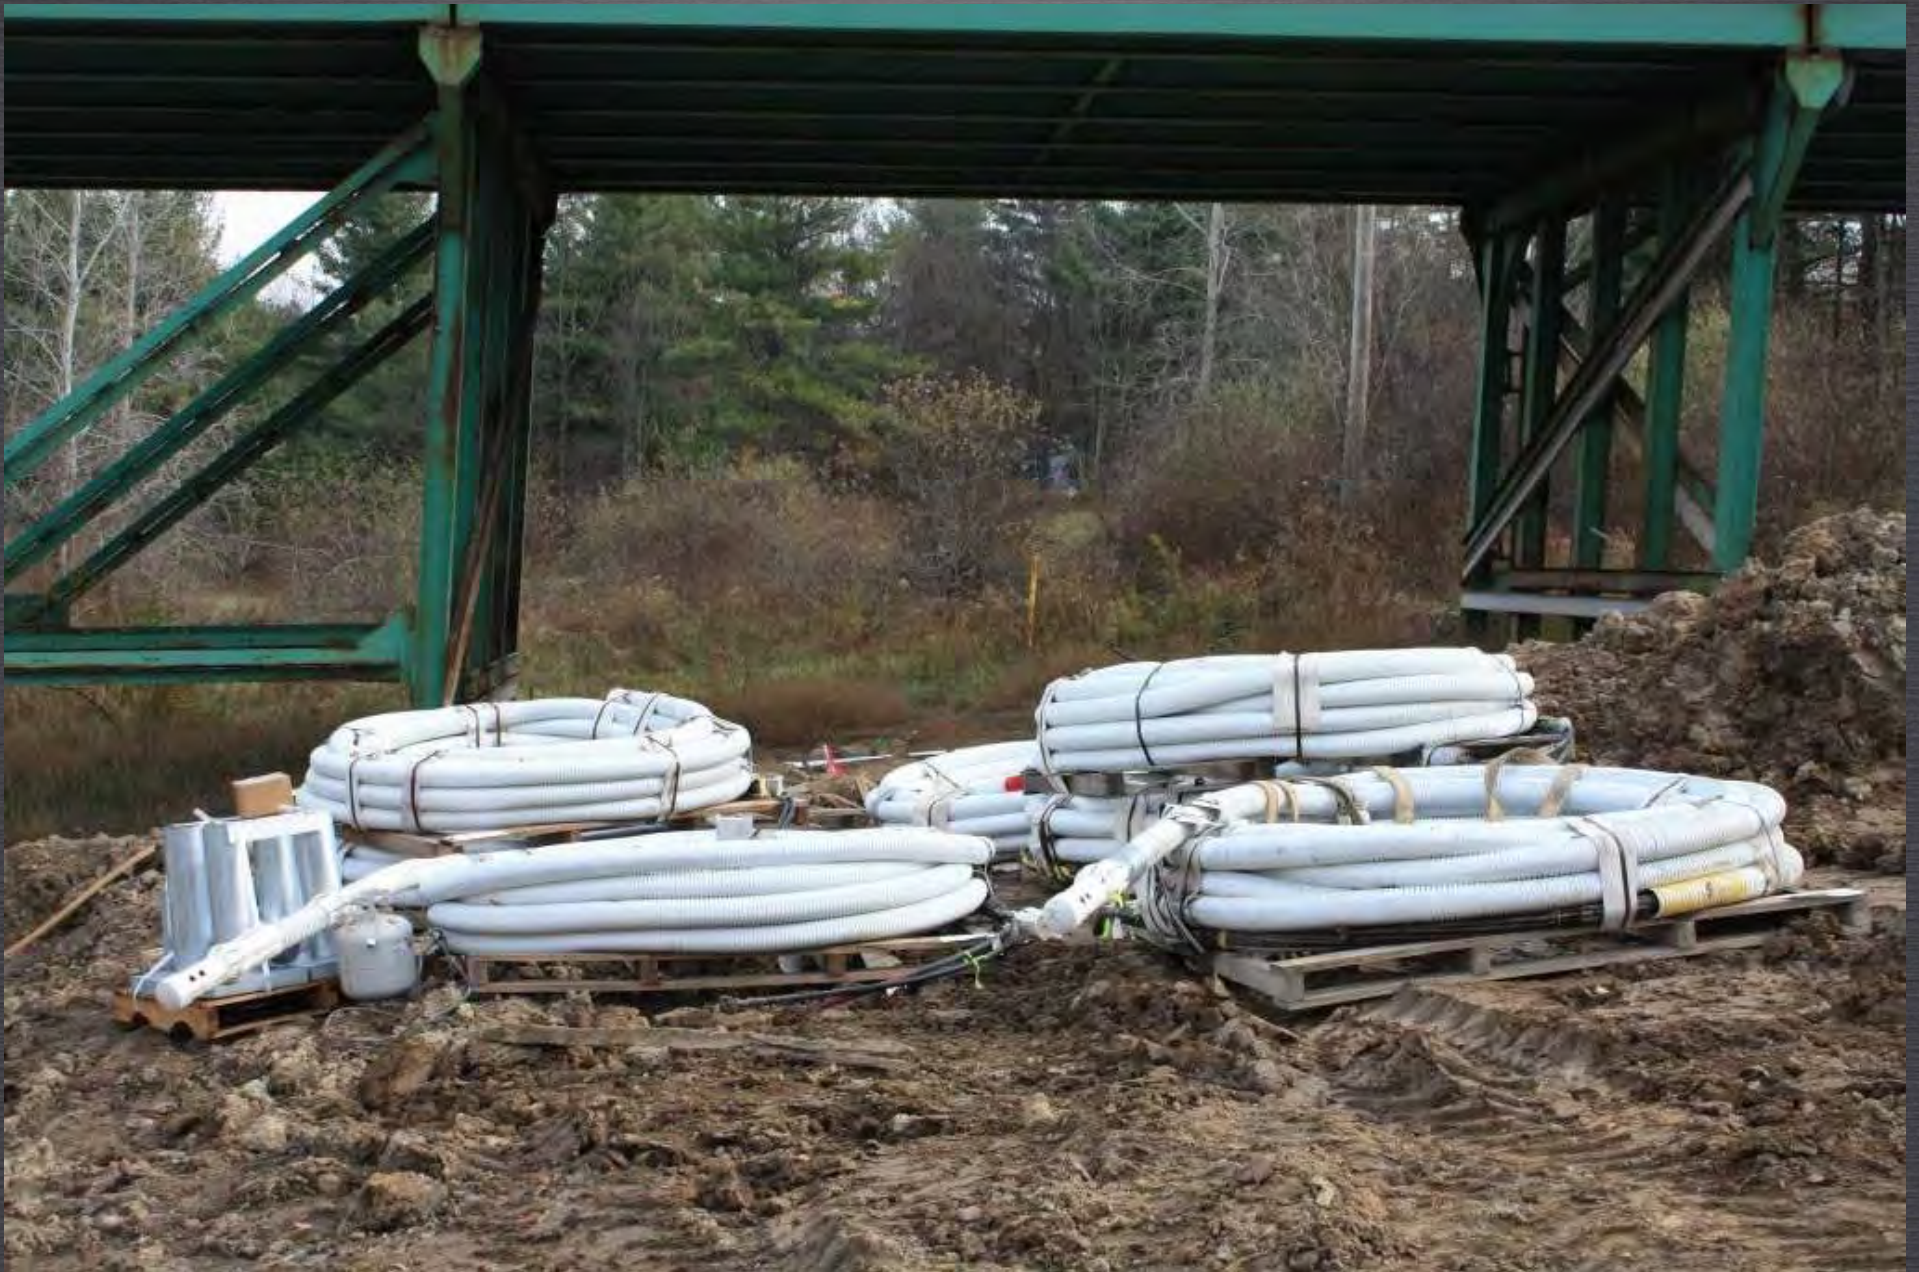
Earth Anchors

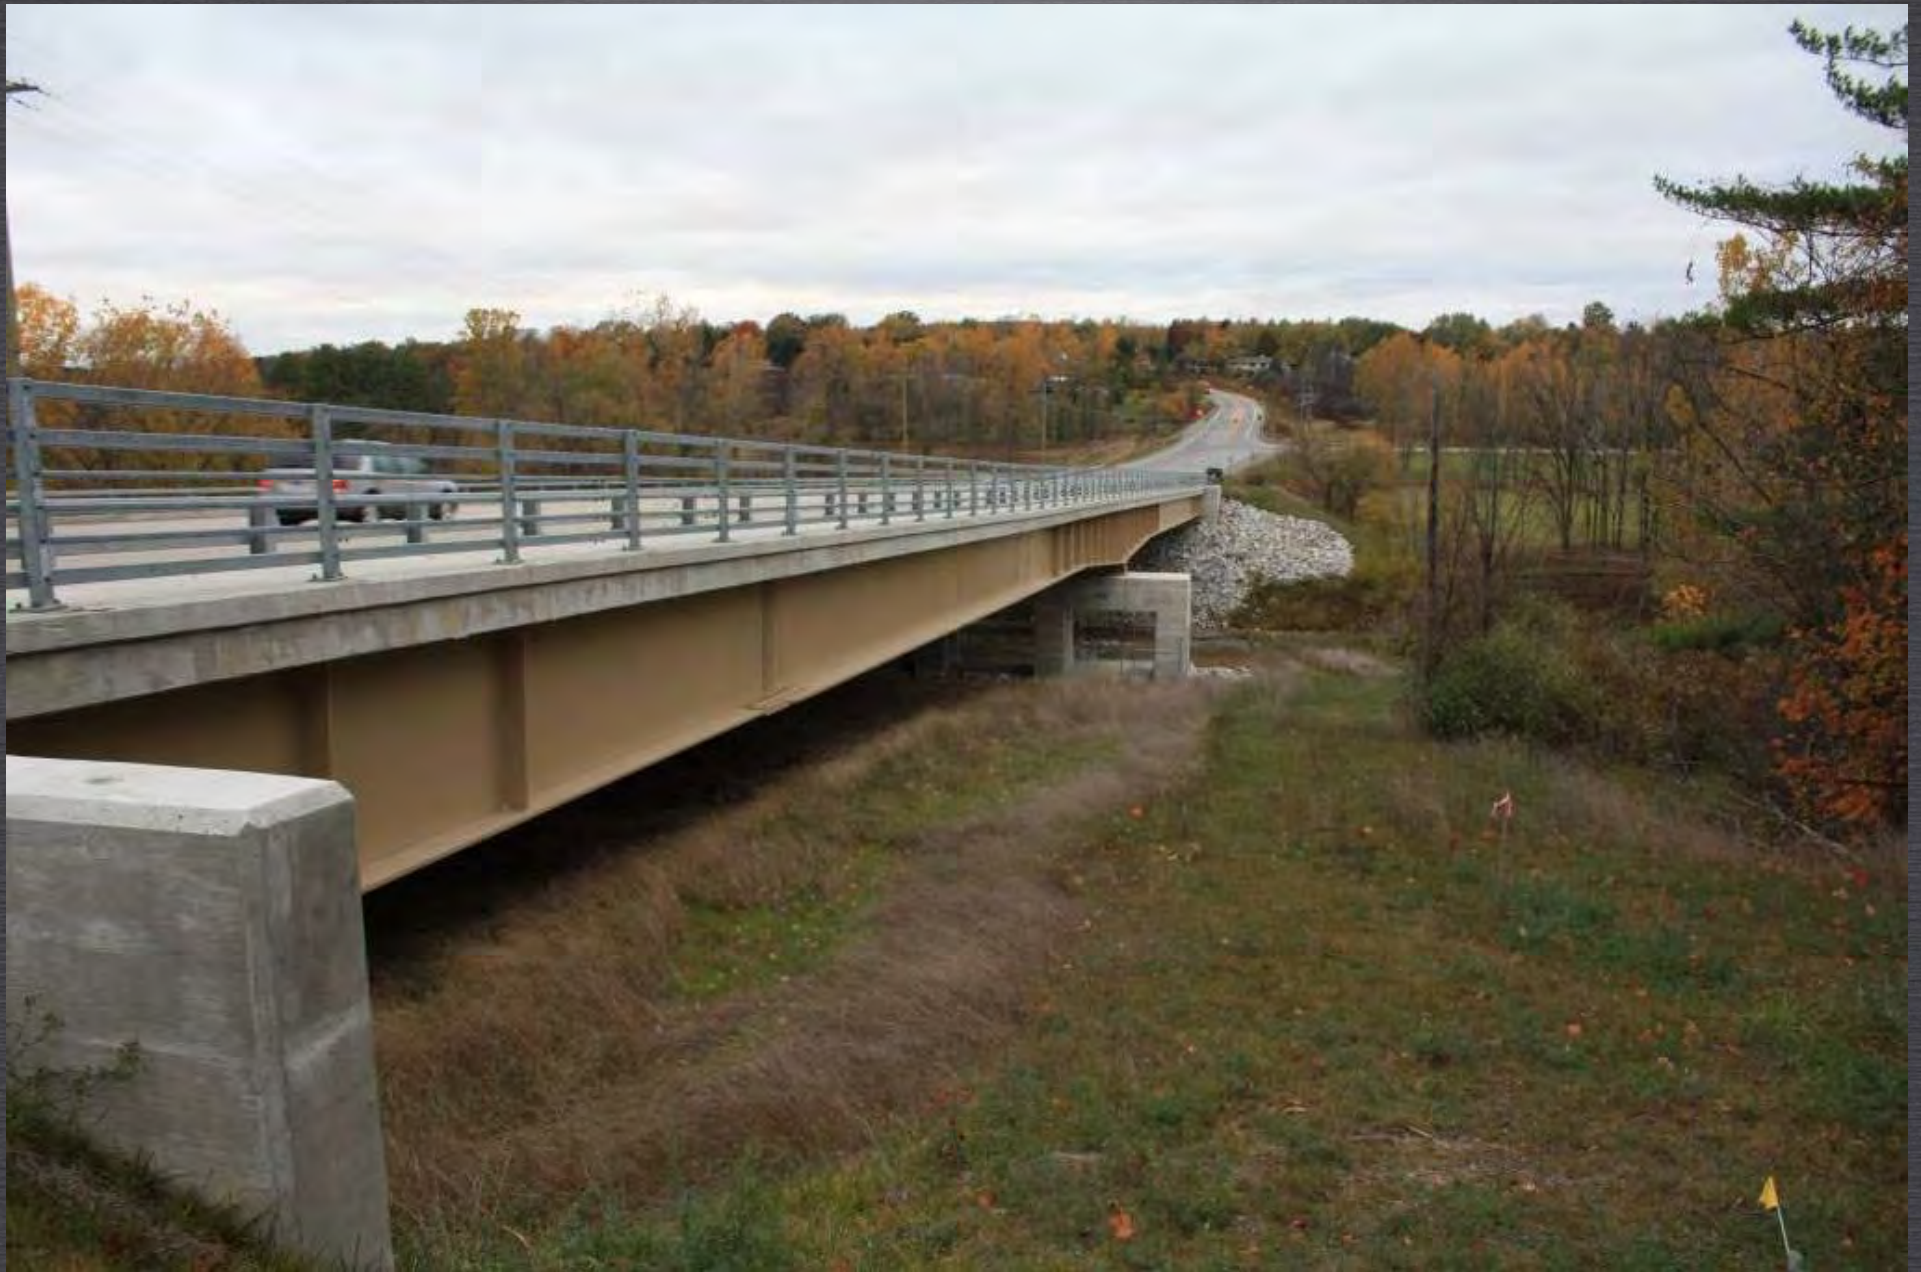
Completed Bridge
