It Can Happen to You...

INJURY INVESTIGATION

At approximately 1:00 PM on Friday, December 9, 2011 one of our KCRC employees, Joe Barbachyn, incurred a horrific injury(KCSD incident #11-68989).

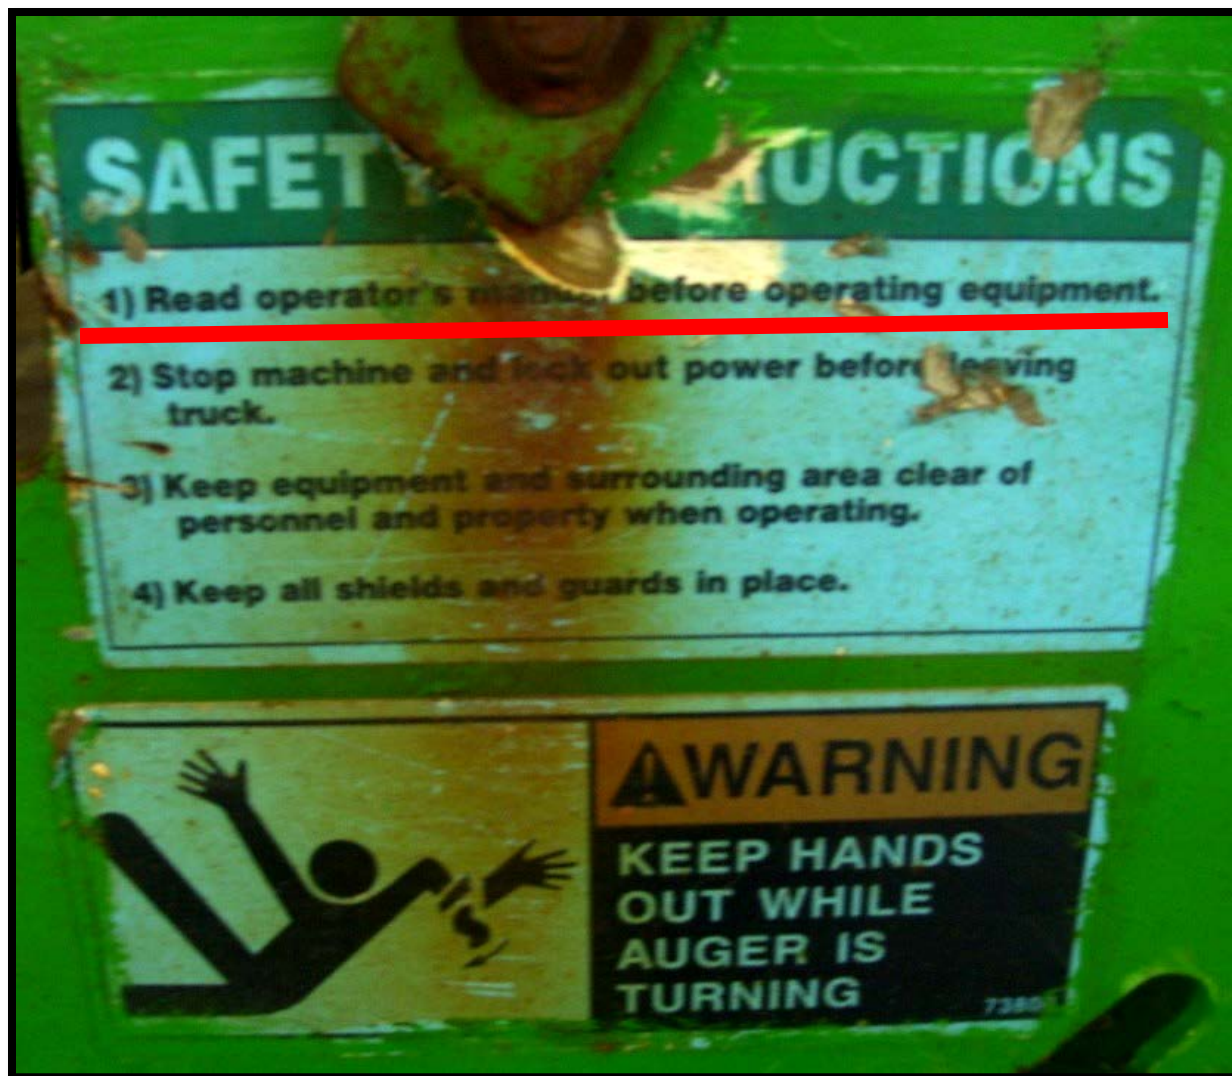
The employer allowed employees to be adjacent to an exposed auger. this is an 8-foot long salt auger mounted horizontally at the rear of road salt trucks. employees perform duties while the auger is running and are exposed an entanglement hazard. Employees are outside and wearing loose fitting clothing. this resulted in an employee suffering an amputation of his arm from becoming entangled while unloading salt from truck mounted auger.

Among others, one feasible and acceptable method to correct this violation is to establish procedures to include the following:

- Ensure that all motion is stopped before maintenance or clearing of jams occur on salt spreaders.
- Ensure that workers are trained in the hazards of working near rotating parts.
- Ensure that workers do not wear loose fitting clothing near machines or equipment with moving parts which could cause entanglement.

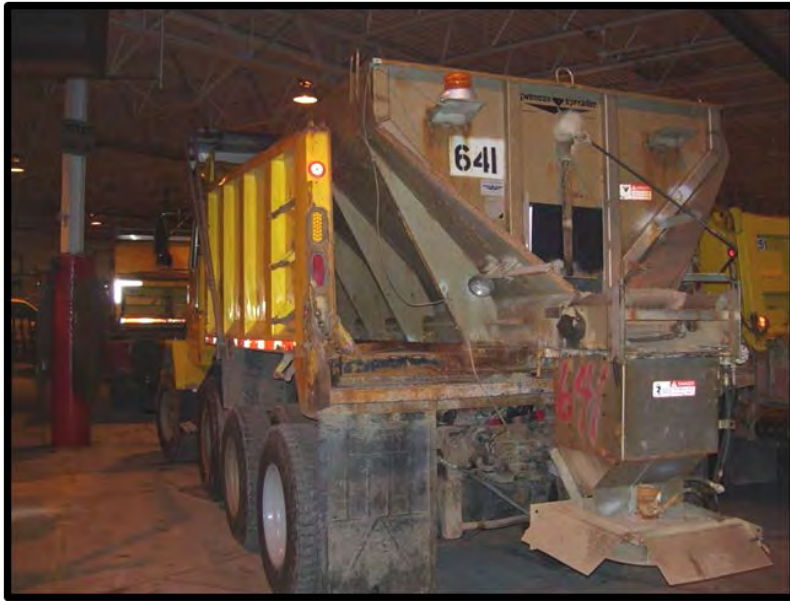
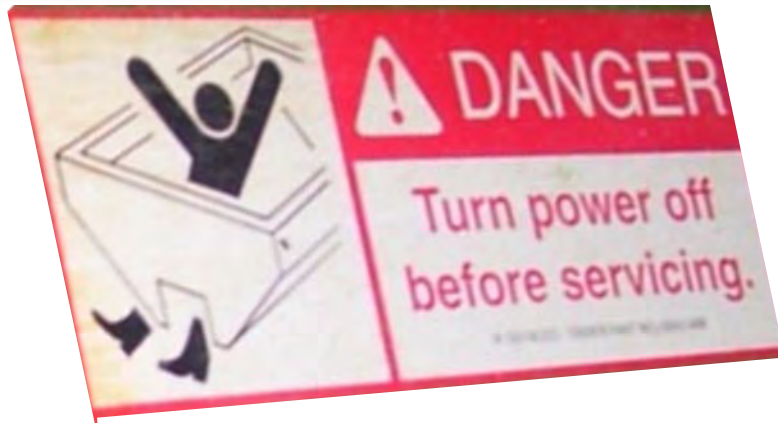
A road commission employee climbed into a “V”- Box Spreader with Flight Chain running.

His lower garments snagged and were removed and his legs were pulled through the rear gate opening.

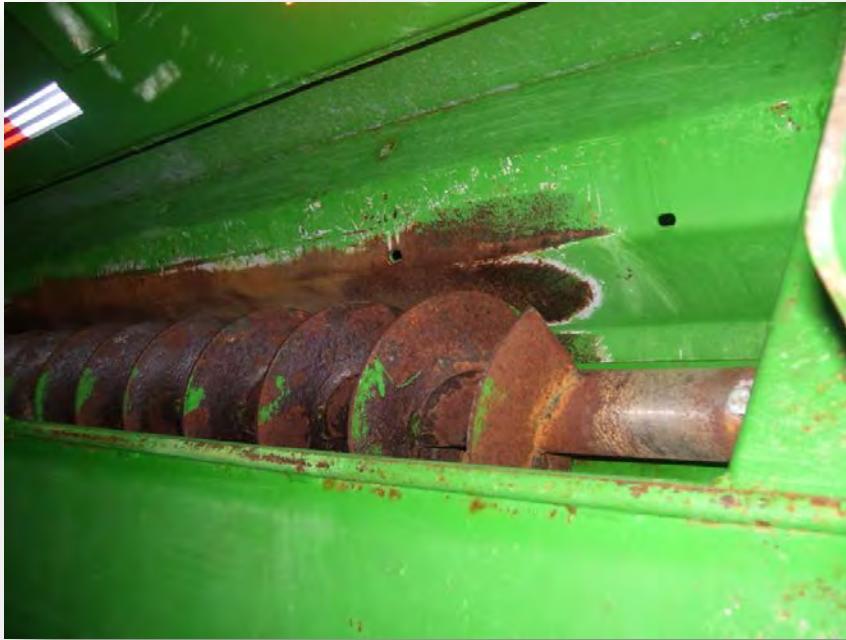
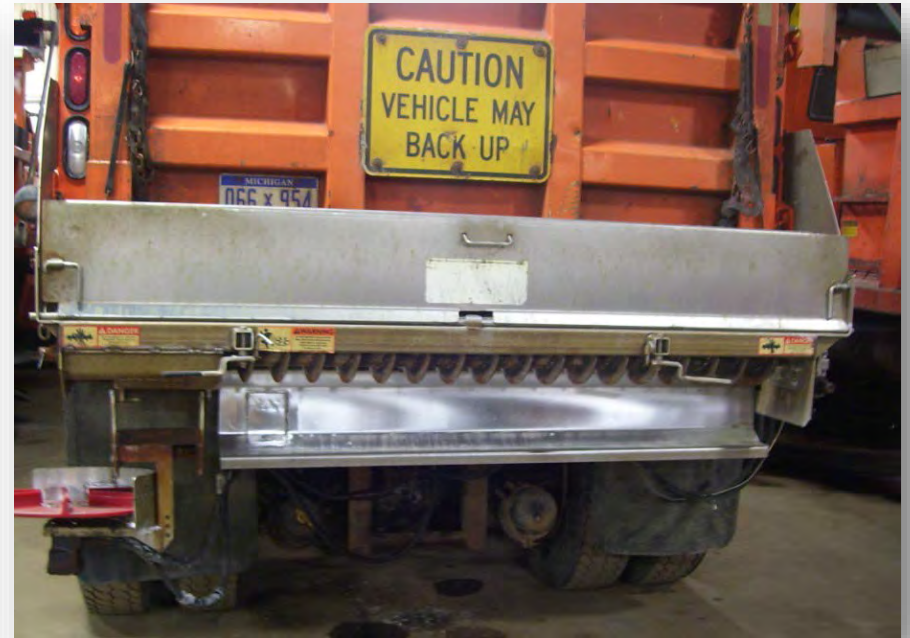
**Keep guards on all rotating machinery.
Stop all motion before maintenance or
clearing jams!**

- All original manufacturers warning labels must be maintained and legible.
- All operators should be trained in safe operation and any safeguards that should be taken.
- The vehicle Battery Disconnect Switch must be locked-out in the off position before servicing salt spreaders.
- Ensure that all guards are in place when the unit is in operation. Any missing or defective guards the unit should be lock-out/taken out of service until repaired.
- Never place hands, clothing or body parts near any moving or rotating devices. Stop motion to service or clear jams.
- Maintain a safe distance with gloves, clothing and hair that can snag causing serious personal injury.
