The Zilwaukee Bridge: CM/GC Bearing Replacement Project

Corey E. Rogers, P.E.

MDOT Bridge Construction Engineer

Michigan Bridge Conference Presentation

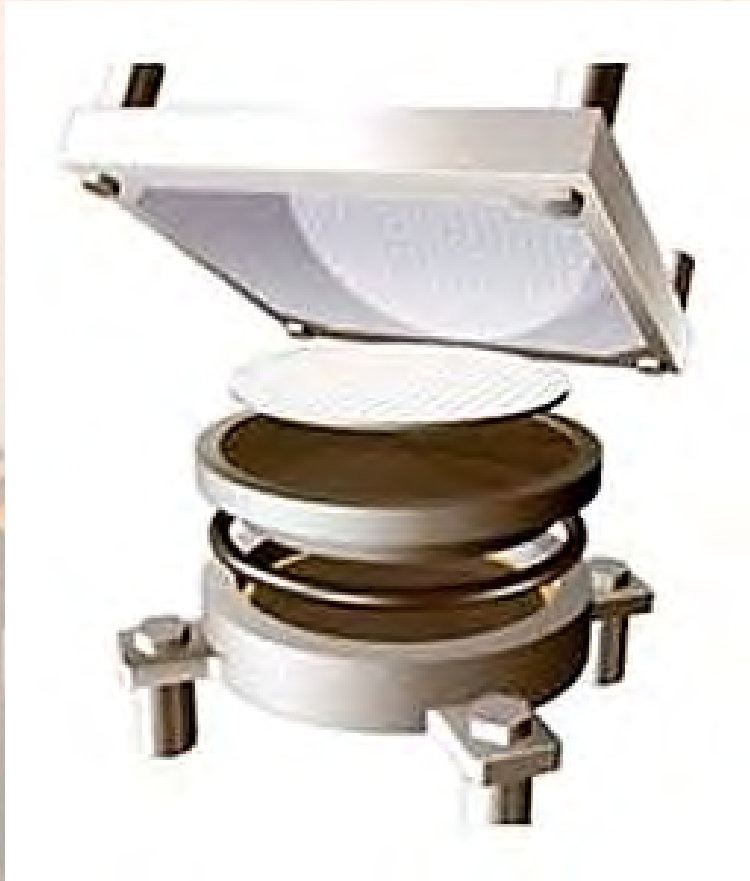
Pot Bearing

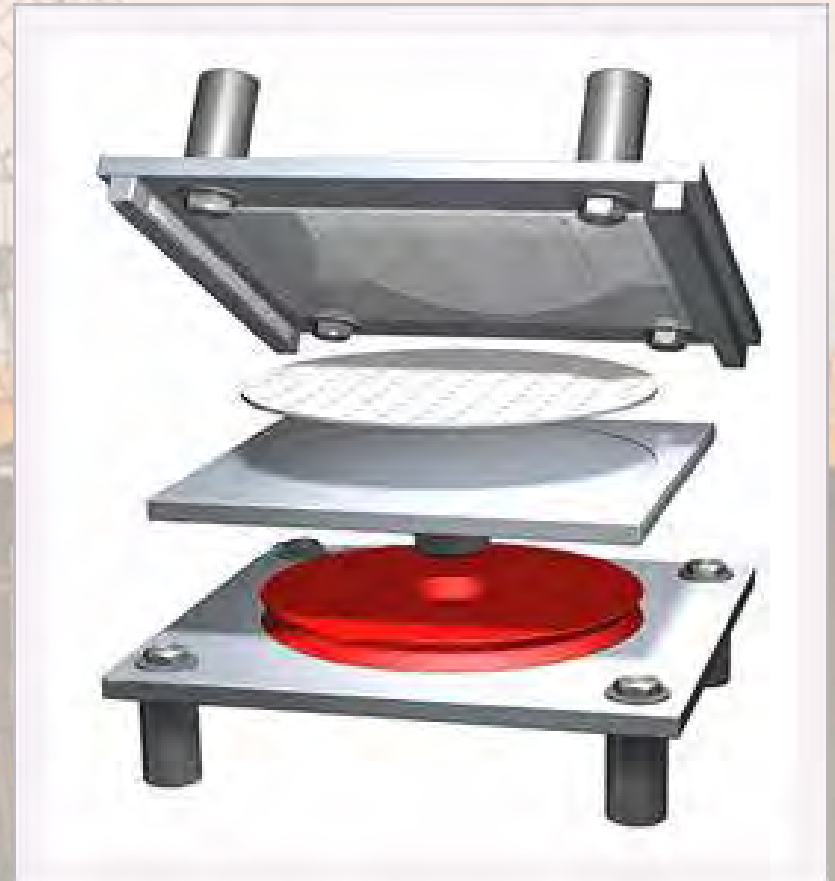
Disk Bearing

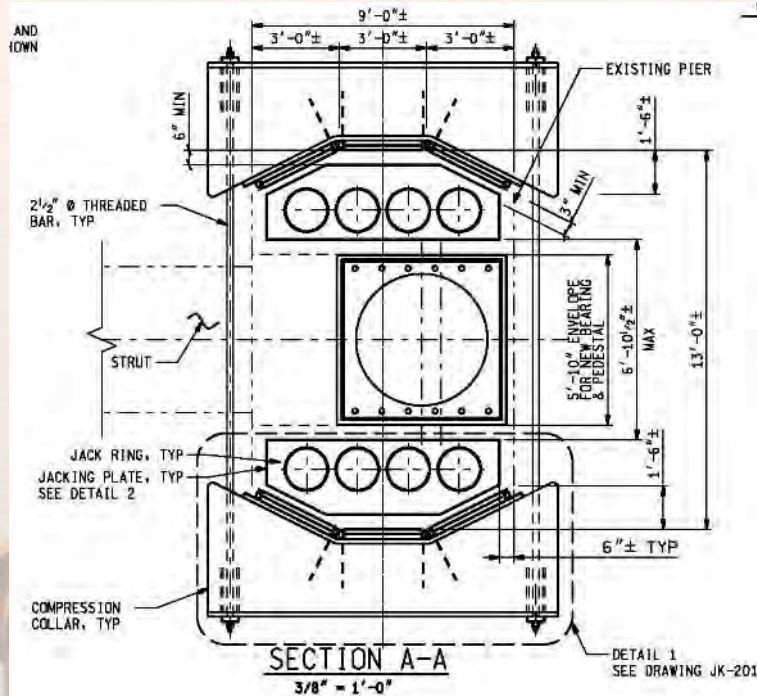
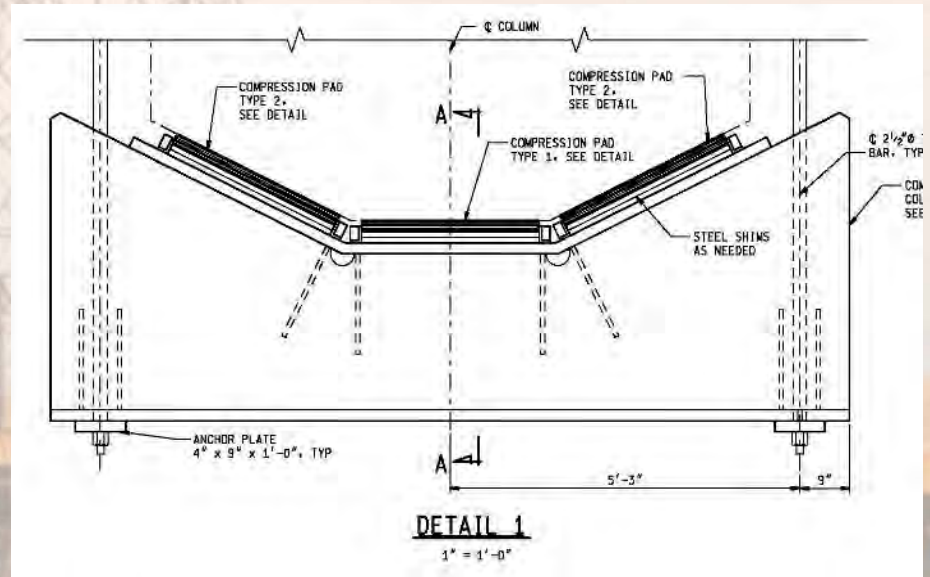
- Two 2 1/2" PT bars stressed at 540 kips each apply compression force to top of piers under jacking plates
- Plate girder collar beams comprised of 2 1/2" thick plate and bearing plates distribute the PT force

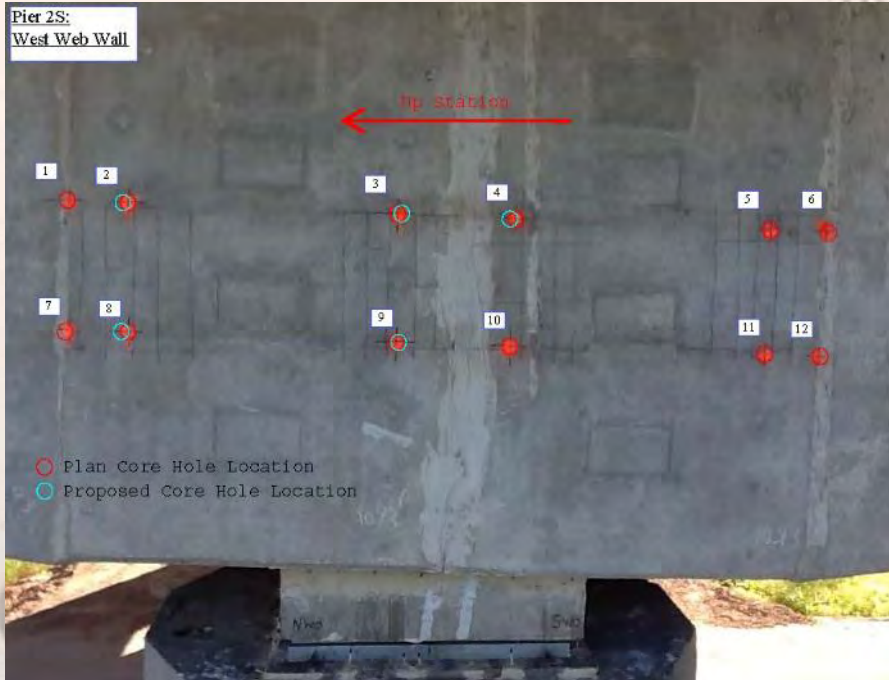
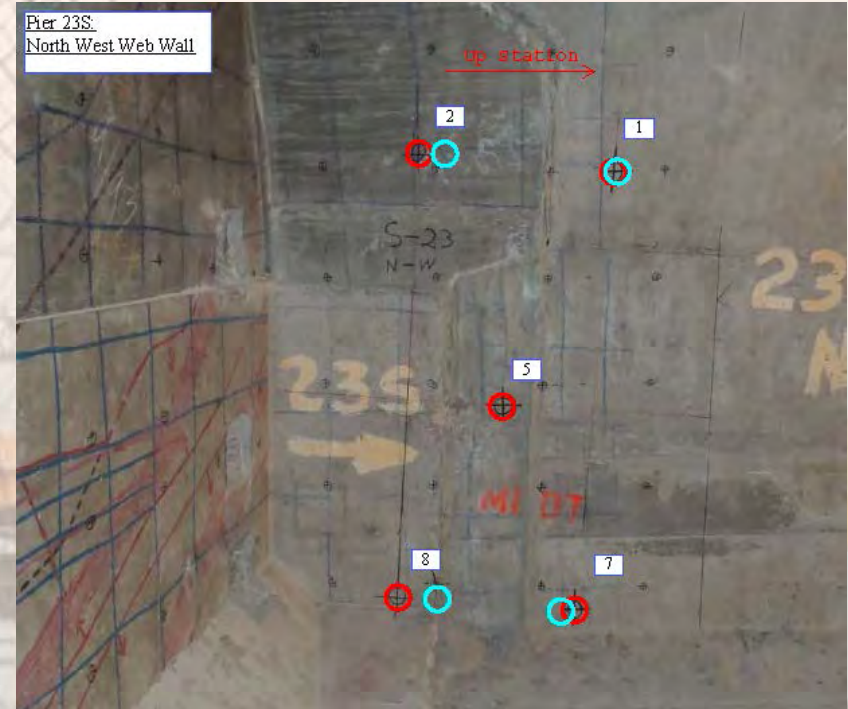
- Coring plans – NDT is performed at everyone proposed core hole location. An RFI is submitted requesting permission to core. RFI's are reviewed and approved by MDOT and the designer. Thus far, 75 RFI's have been submitted.

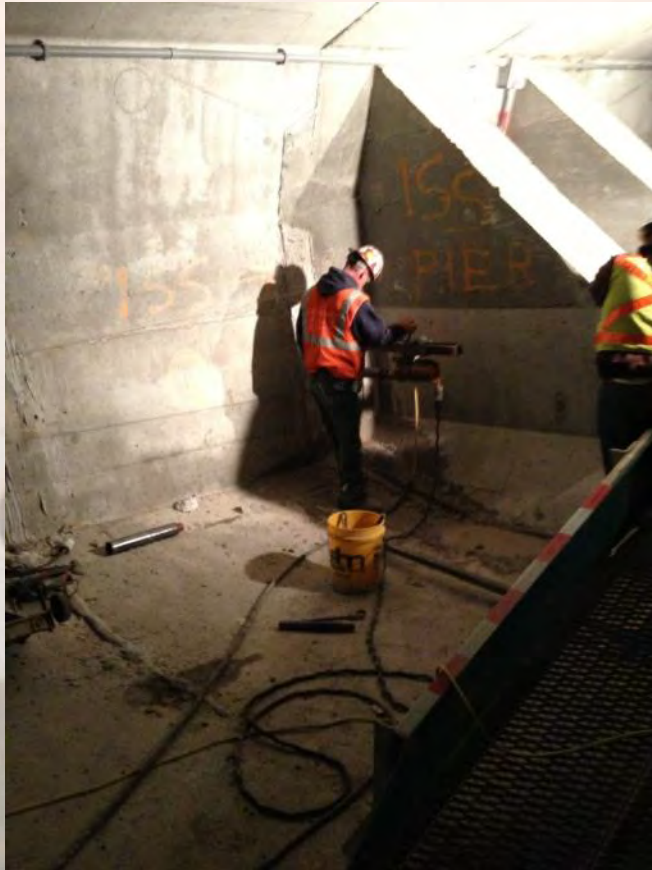
- Coring and placement of 1 3/4" transverse PT bars

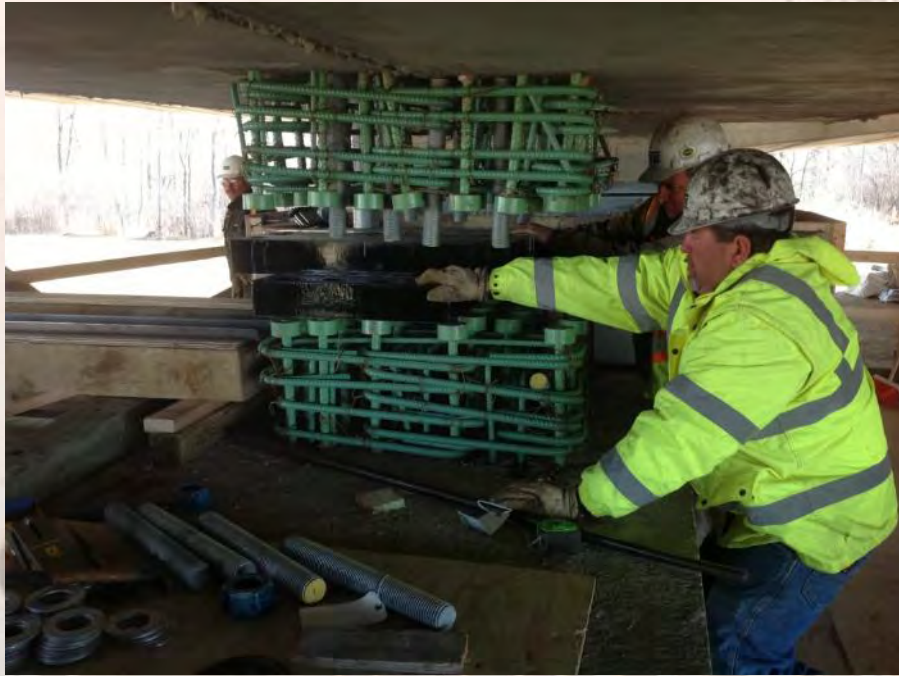
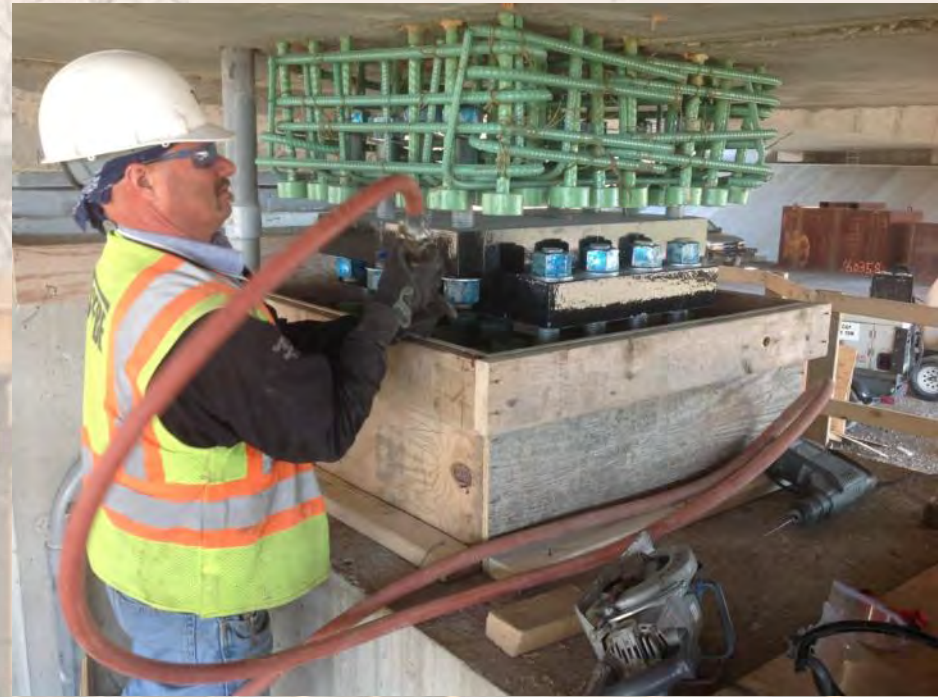
- Longitudinal restraint construction

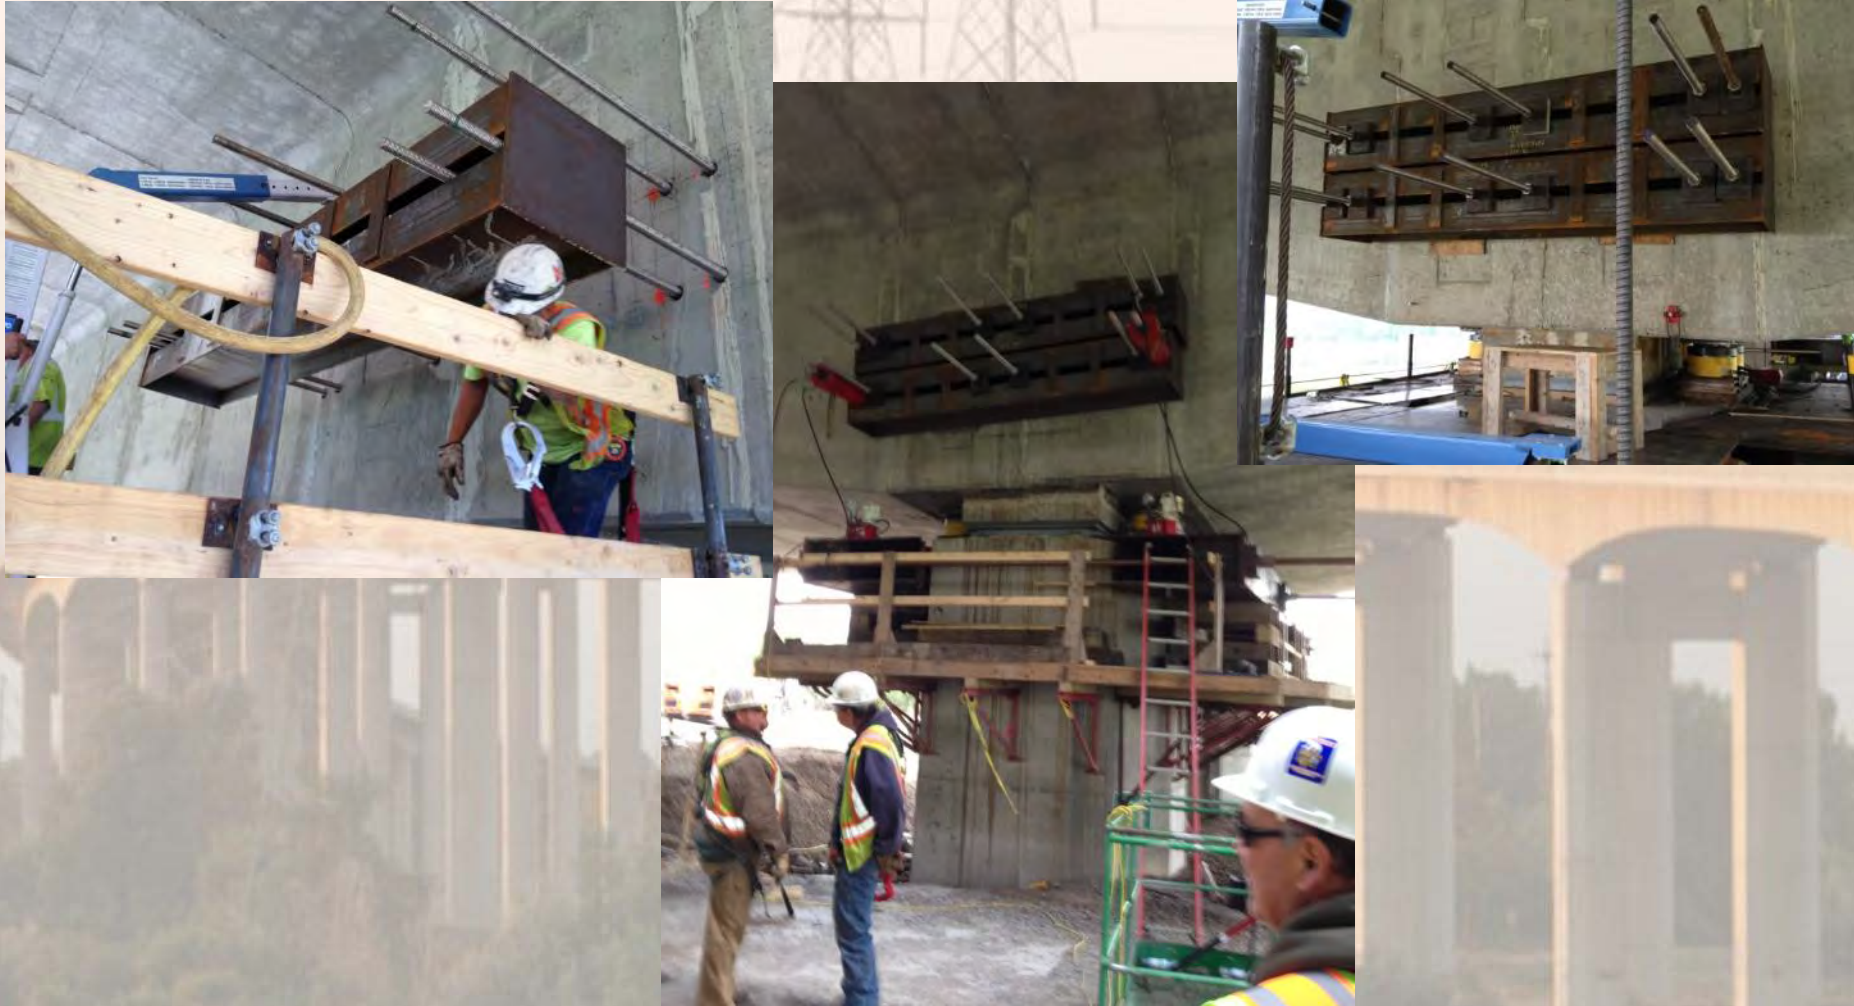
- Placement of waler beams and stressing

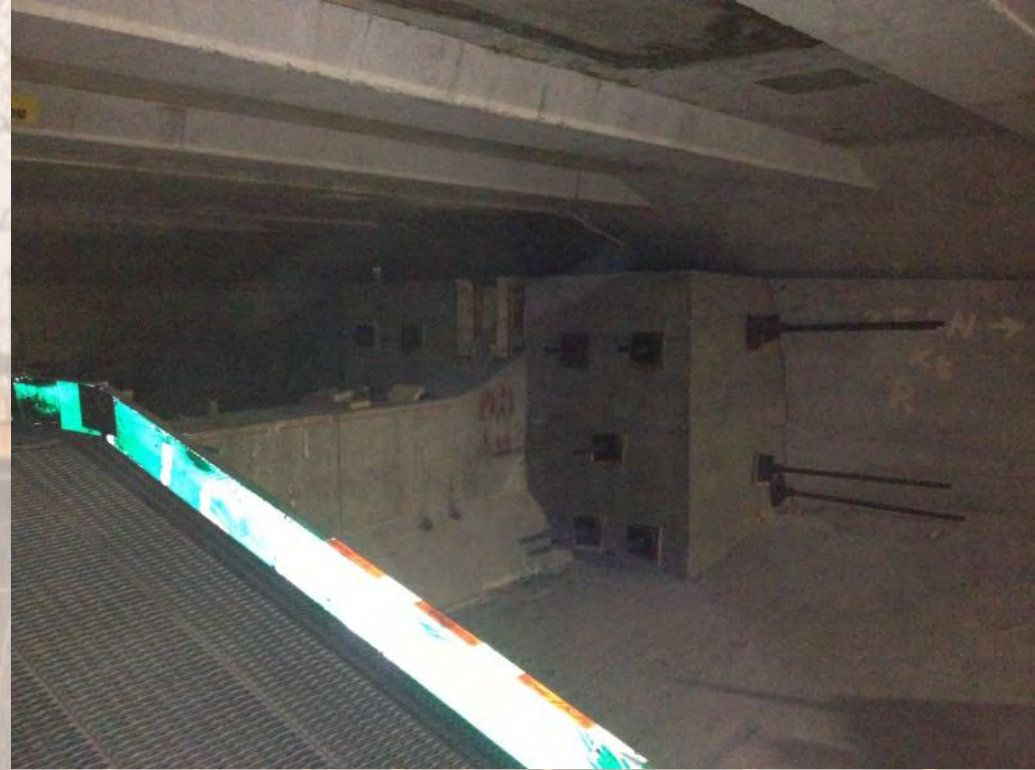
- Some pier diaphragms require strengthening

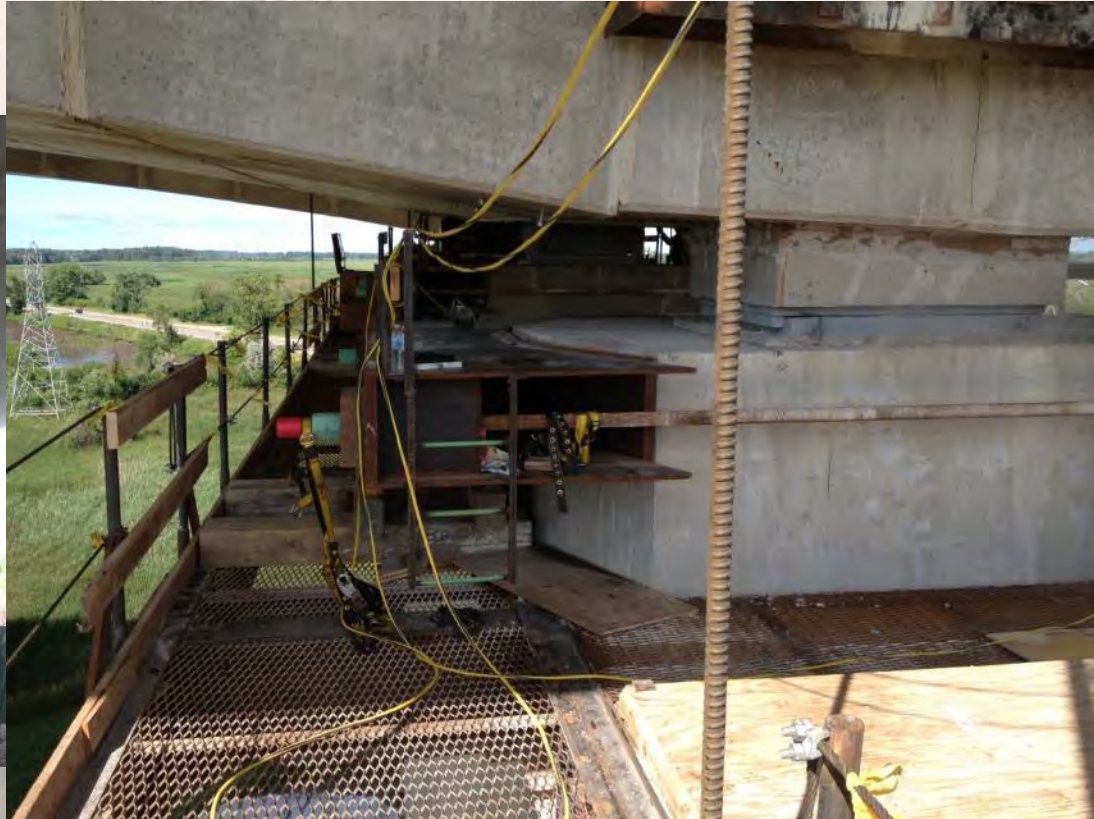
- Setting and stressing of compression collars

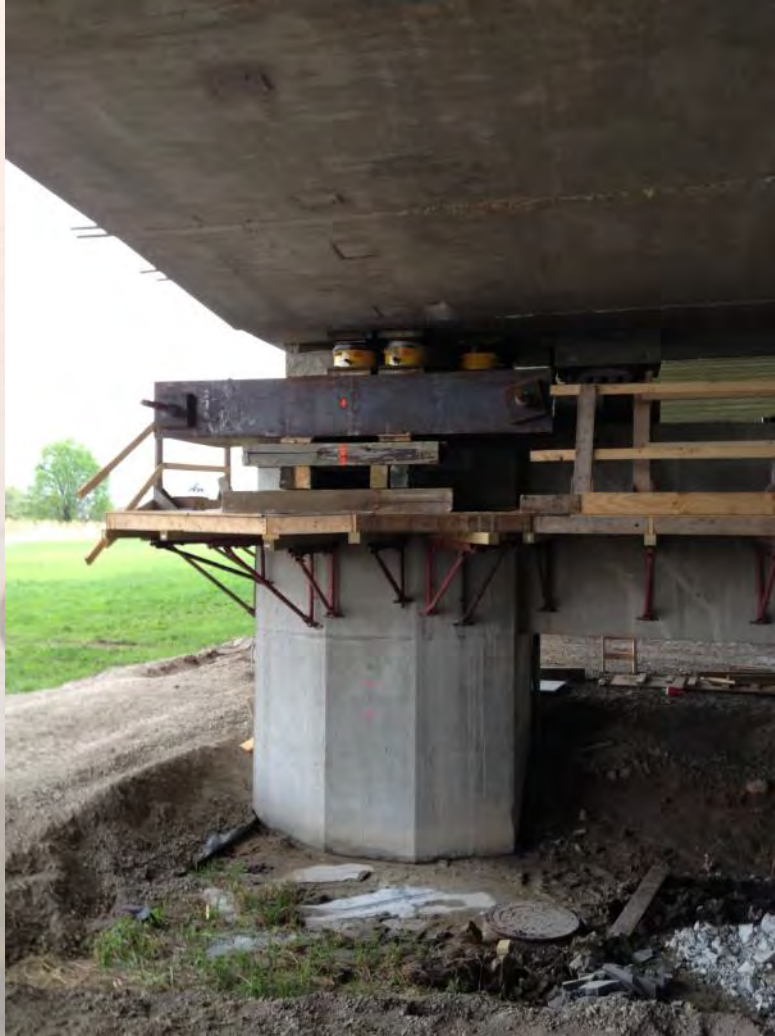
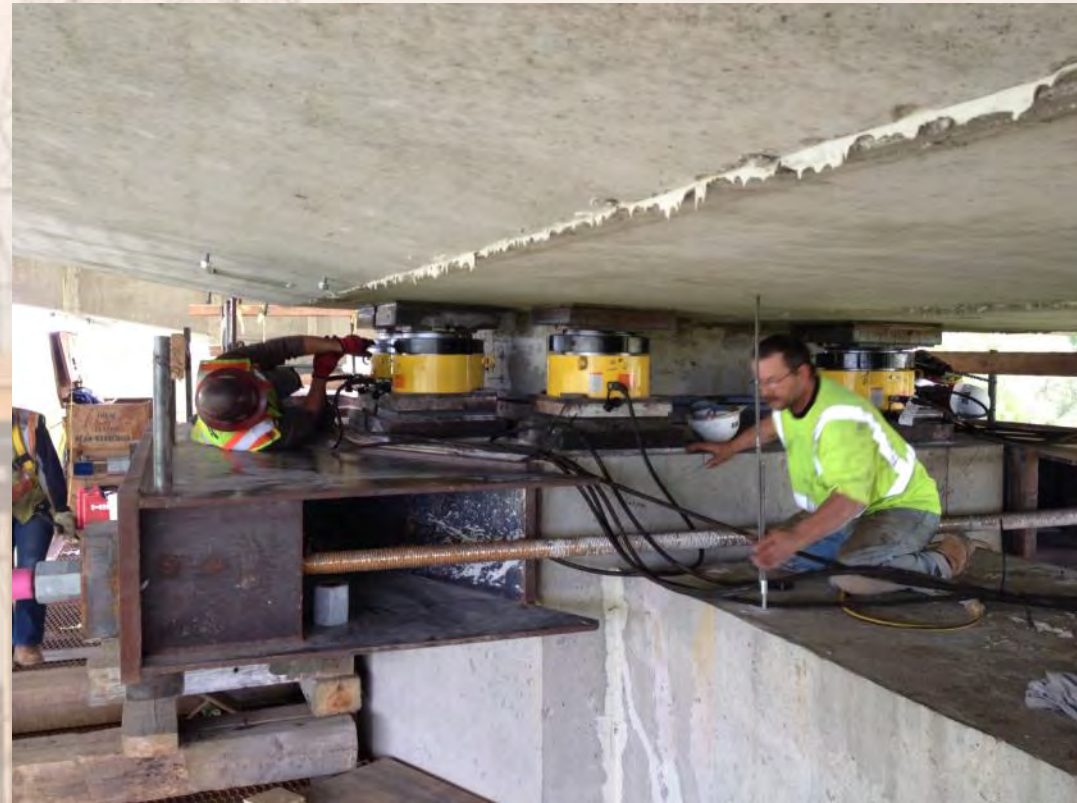
- Setting and stressing of compression collars

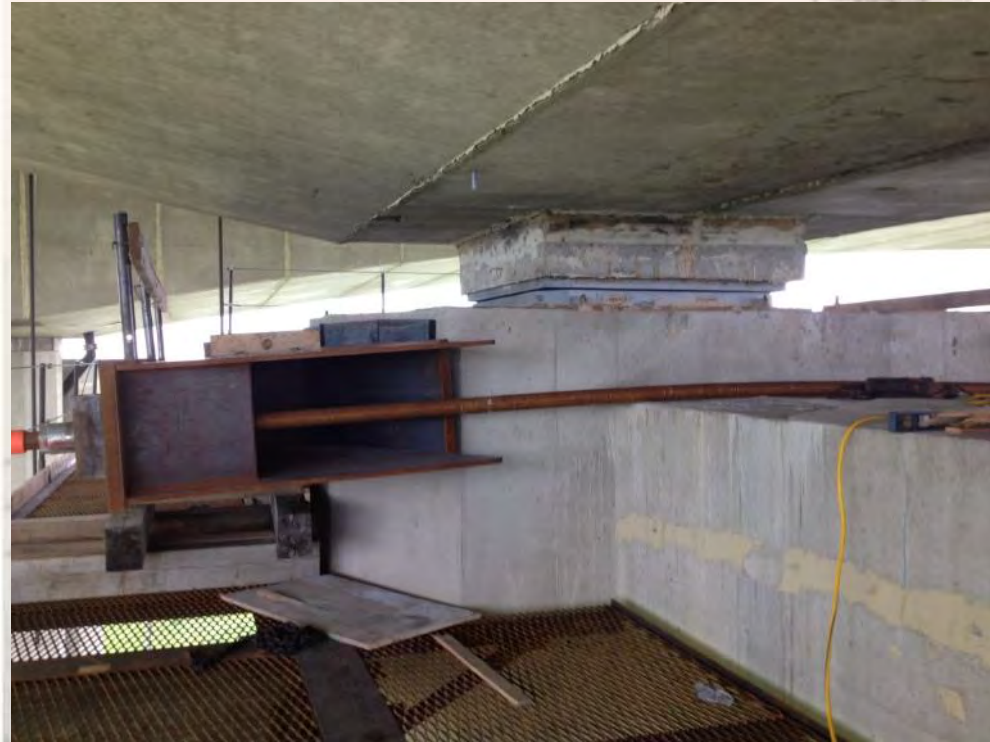
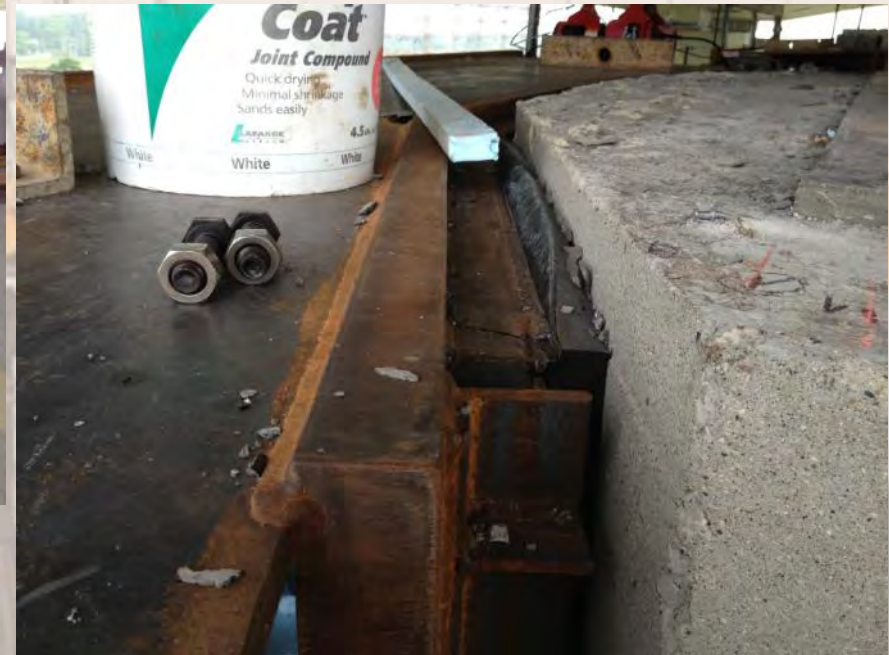
- Issues with elastomeric pads, switched to plywood

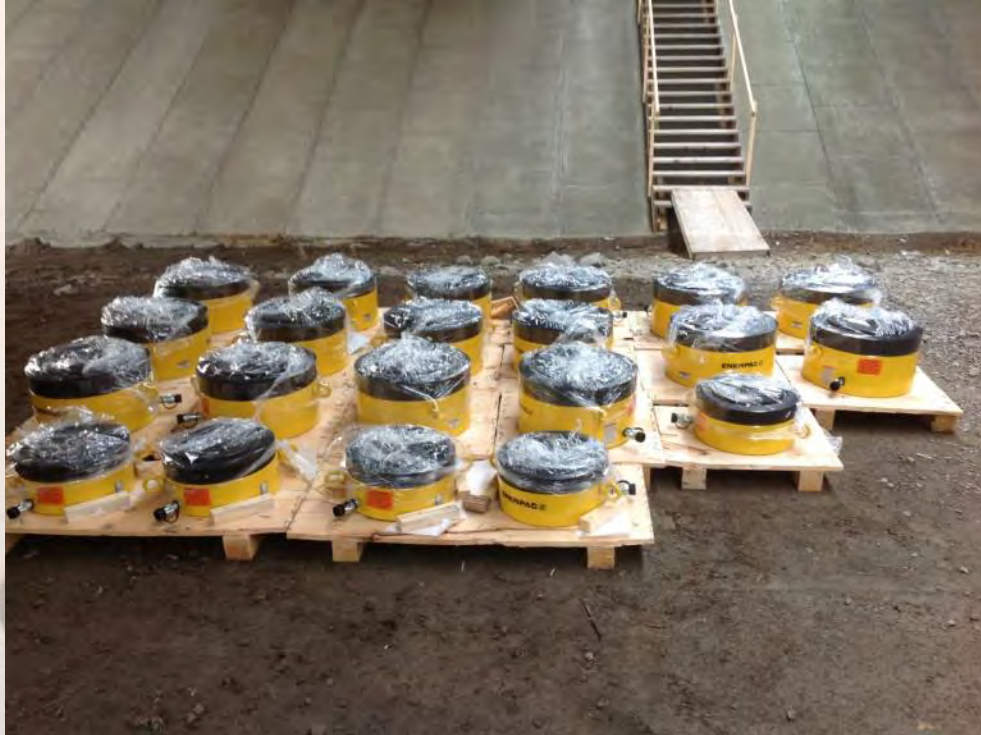
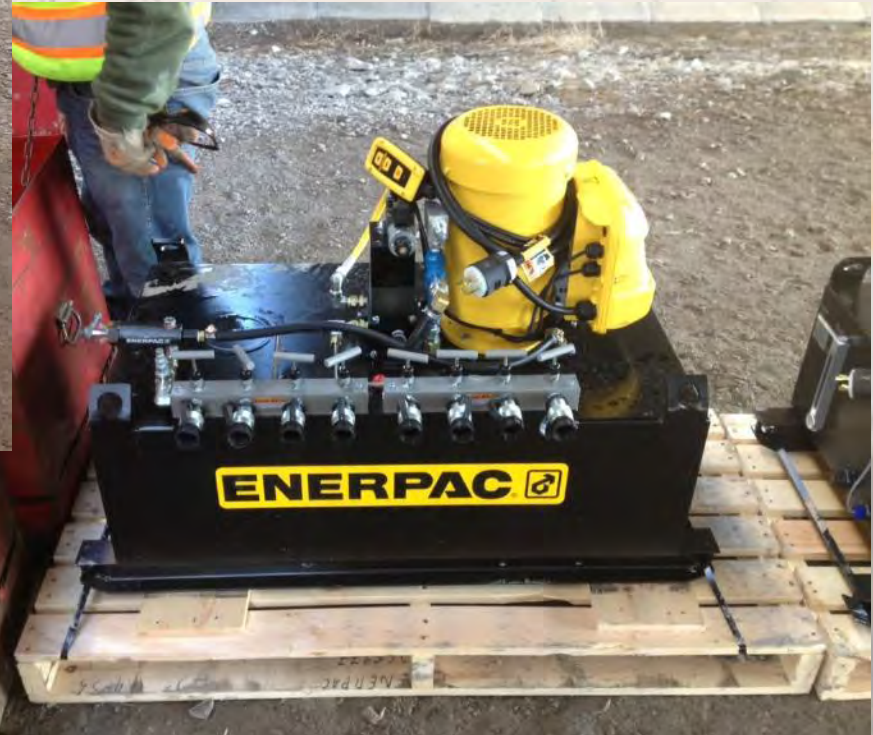
- 600 ton jacks and custom pump with 8 manifolds

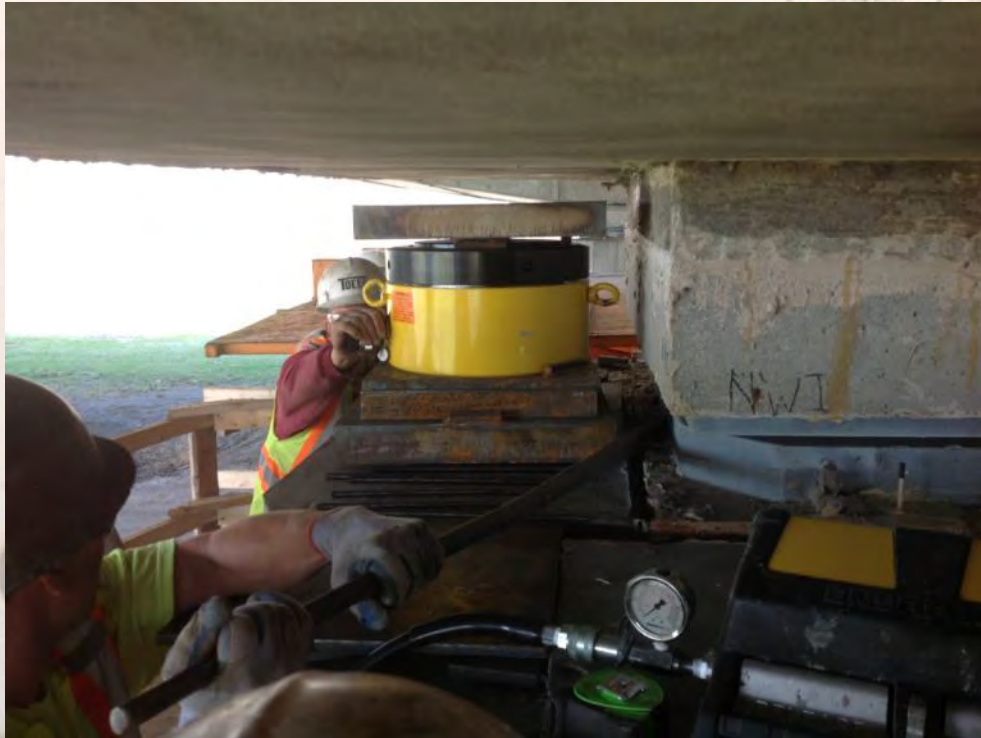
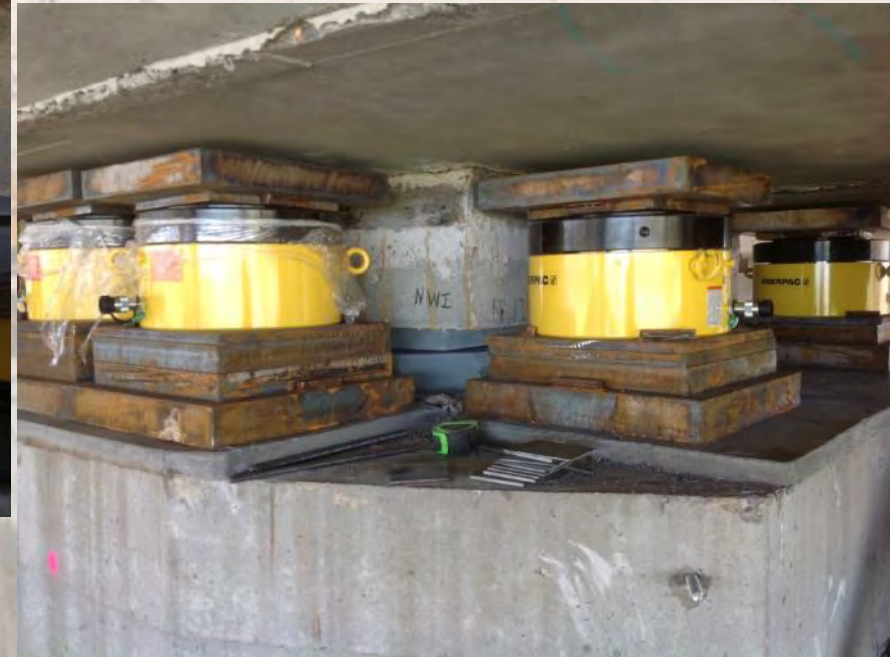
- Jacking layouts

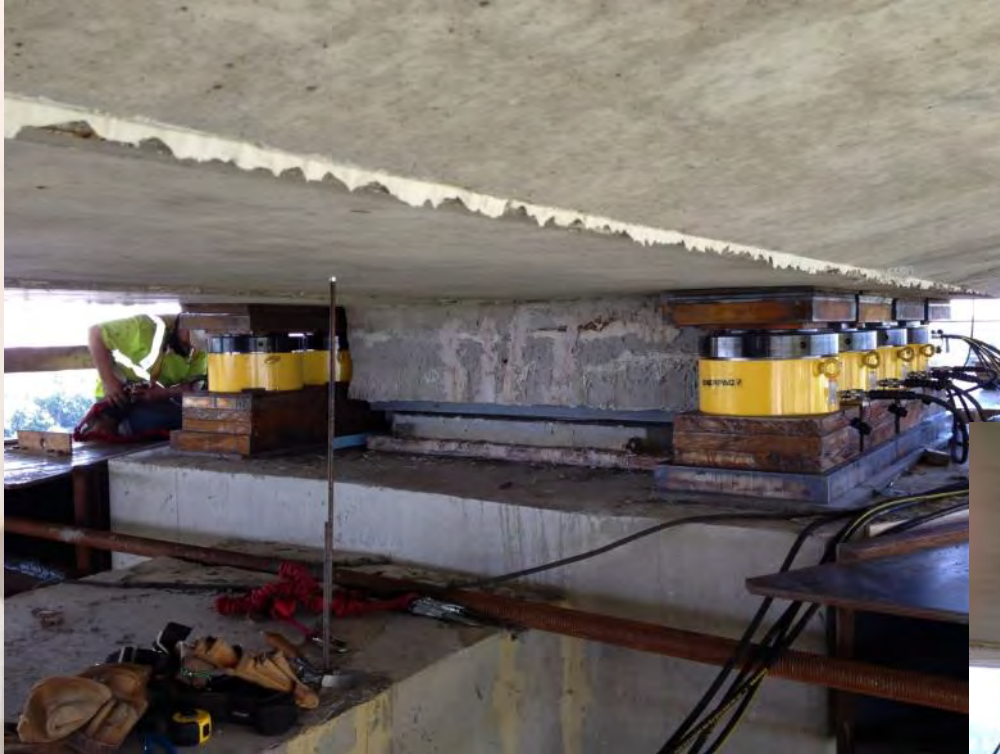
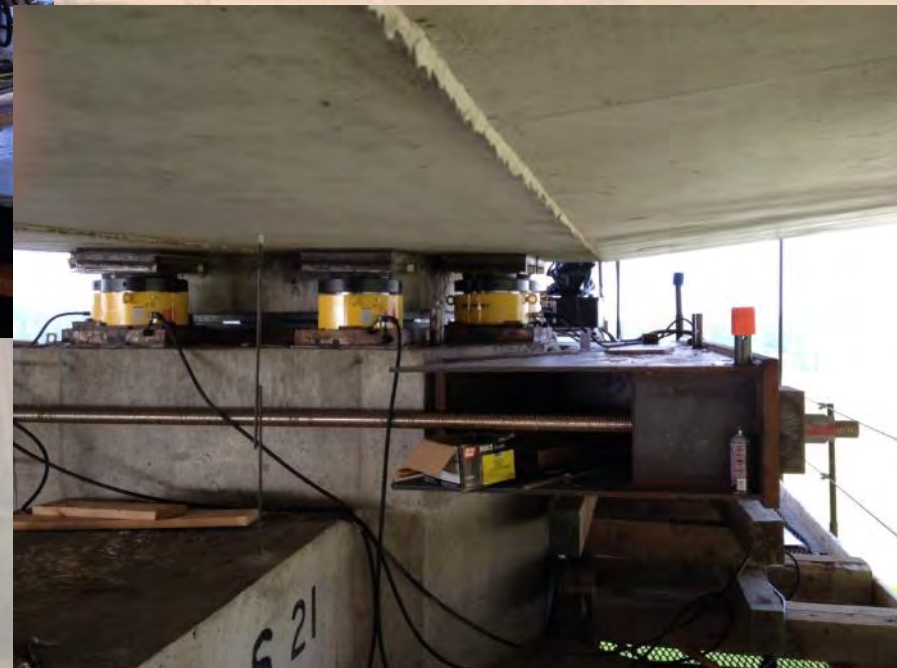
- Jacking layouts

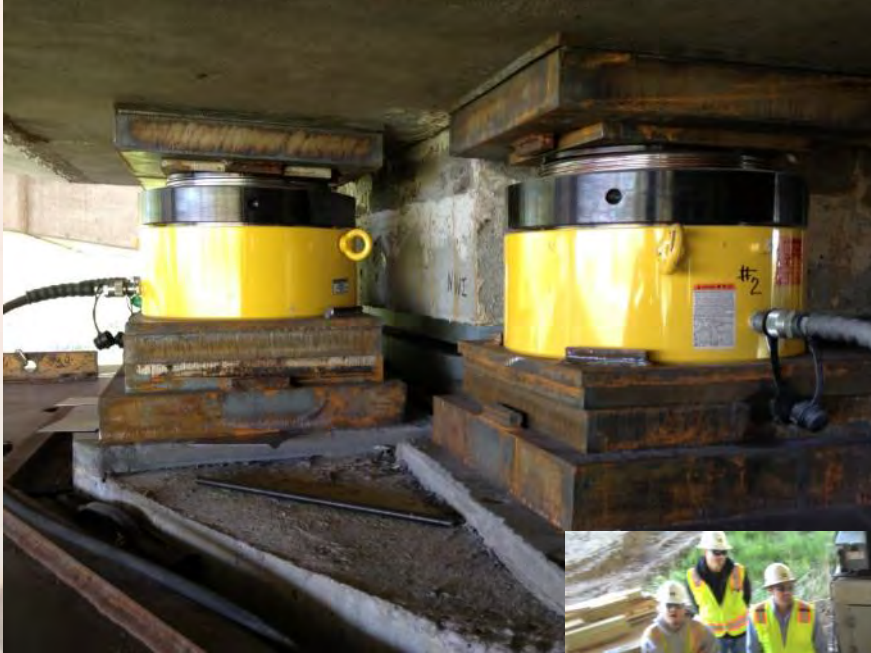
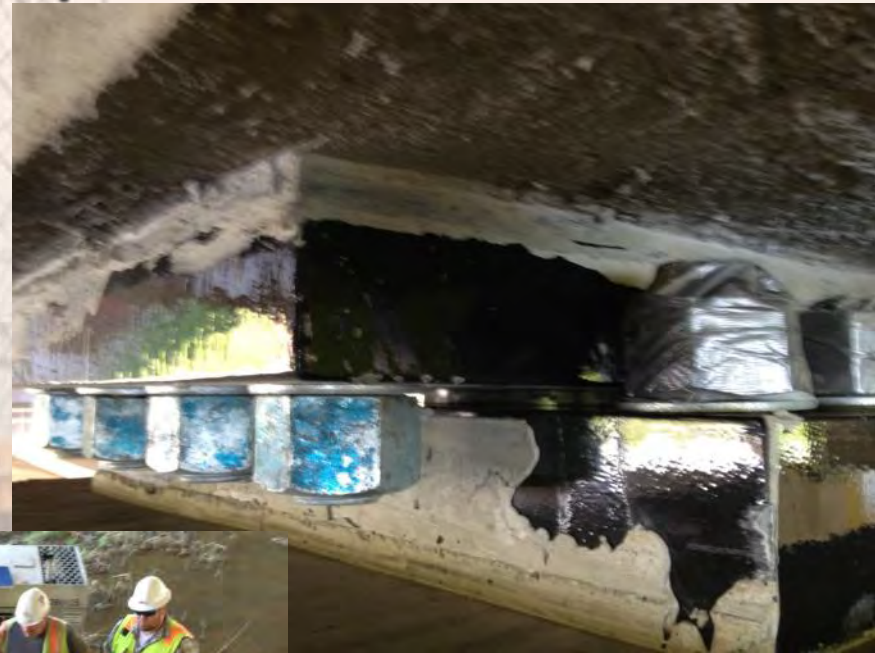
- Jacking operation – the first lift

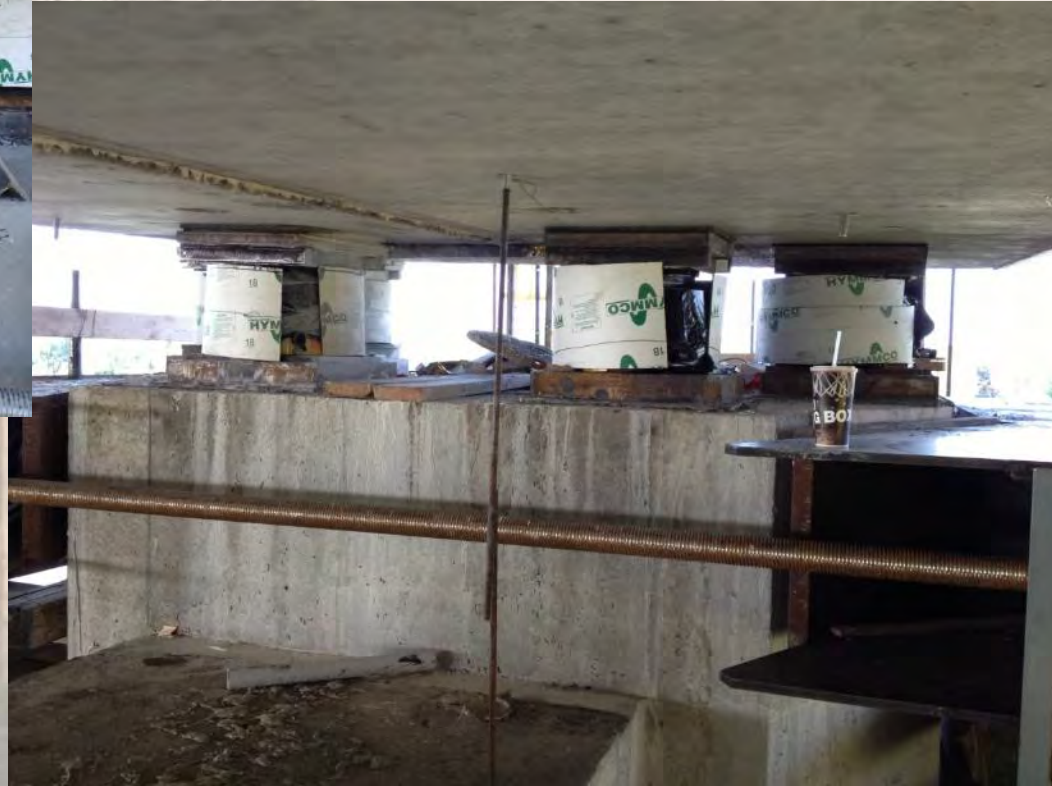
- Lift complete, lock rings engaged, hydraulics removed

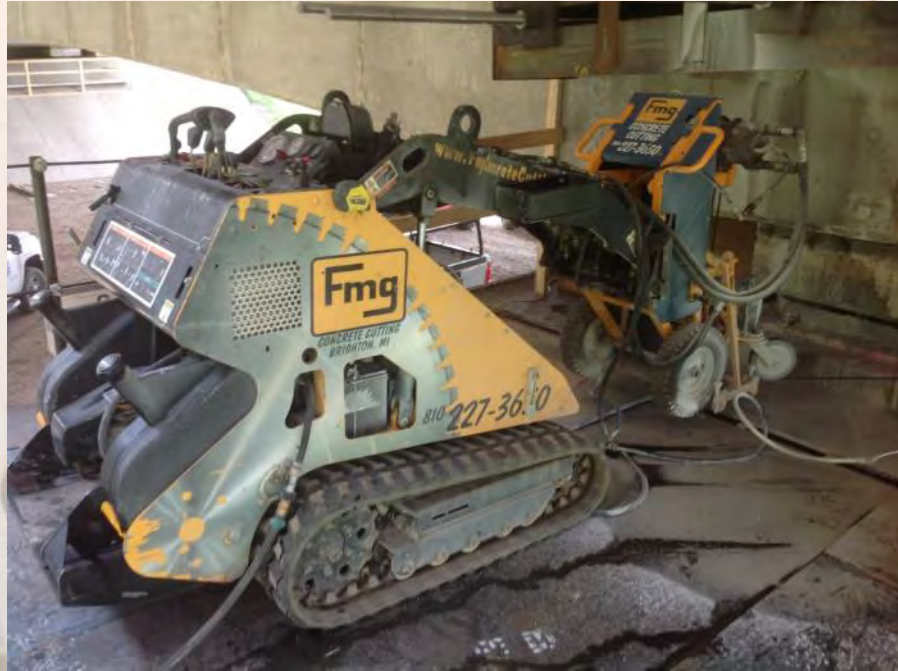
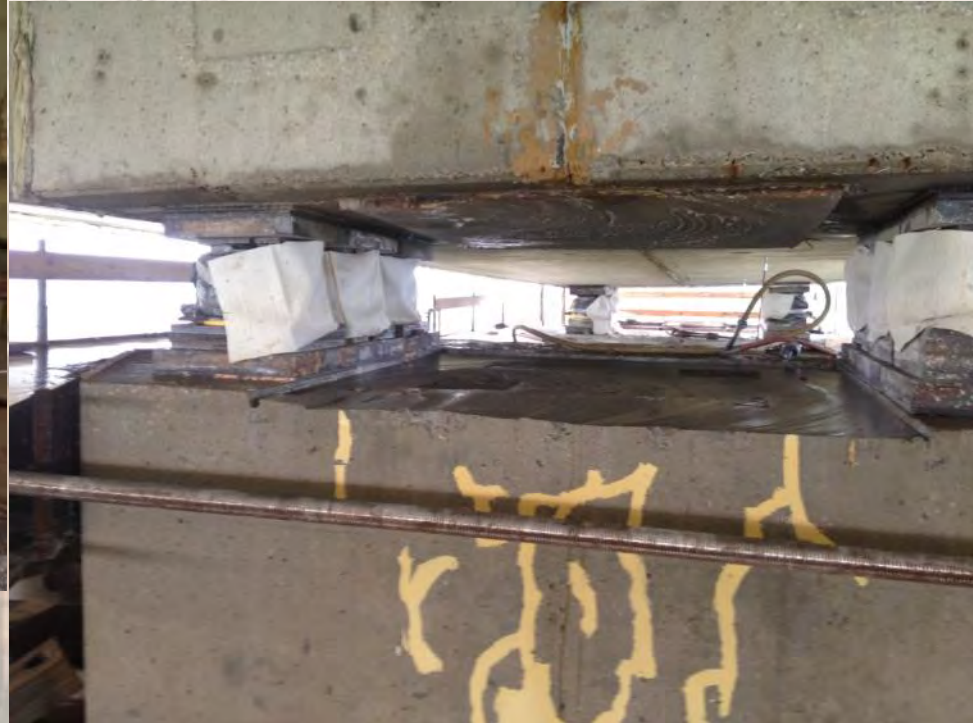
- Existing bearing removal with wire saw rig

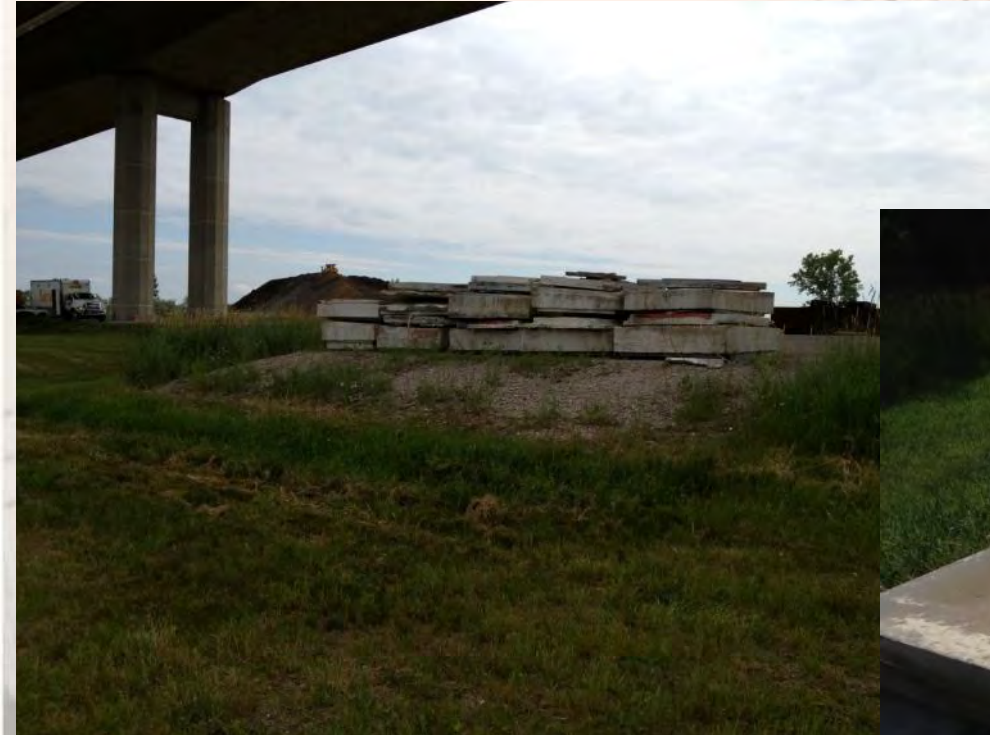
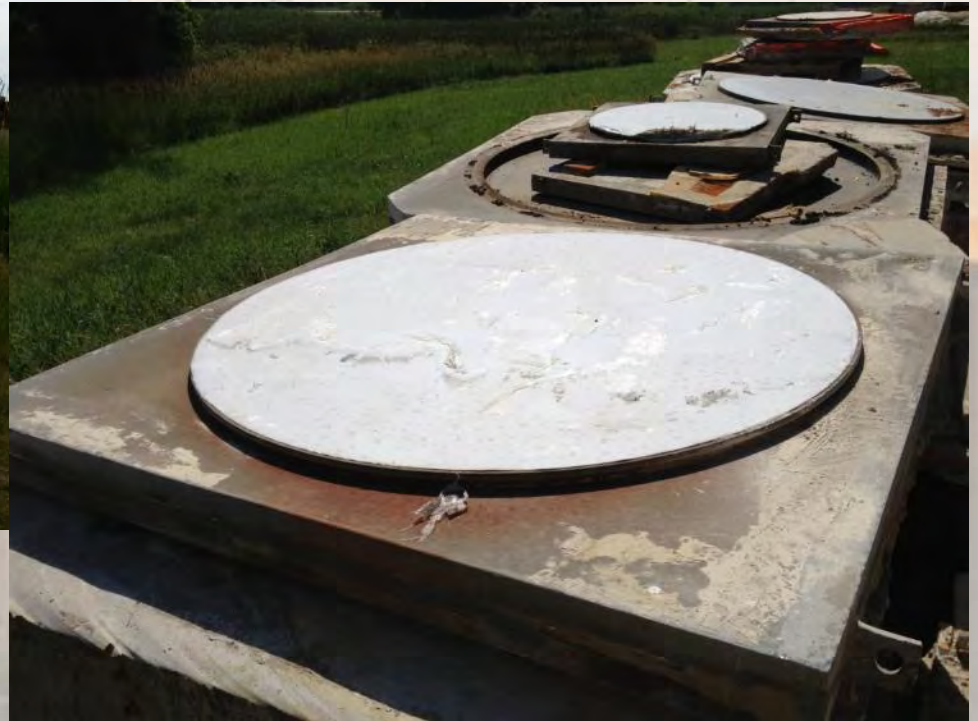
- Existing bearing stacked for inspection

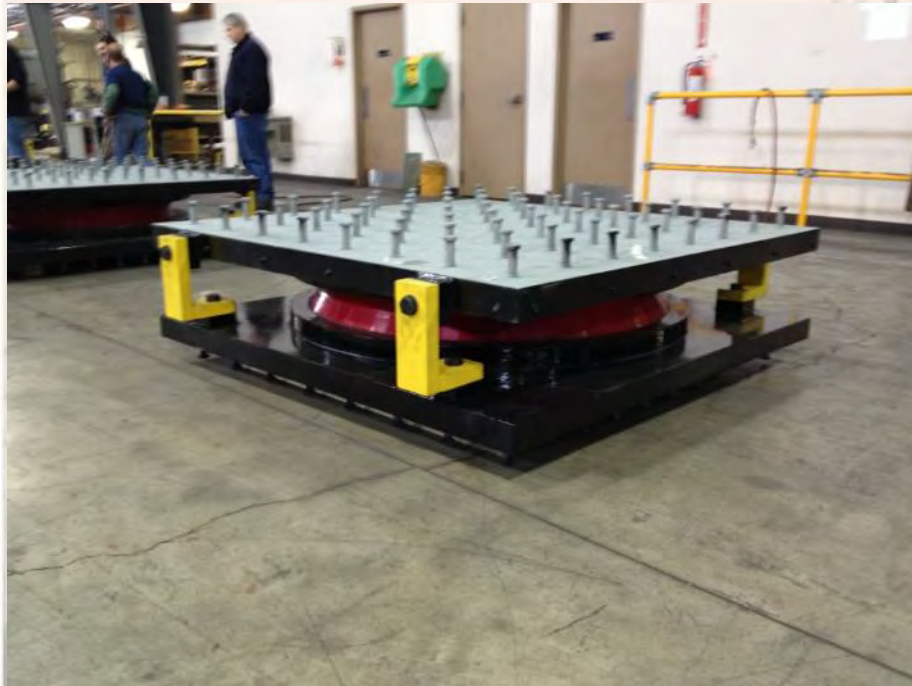
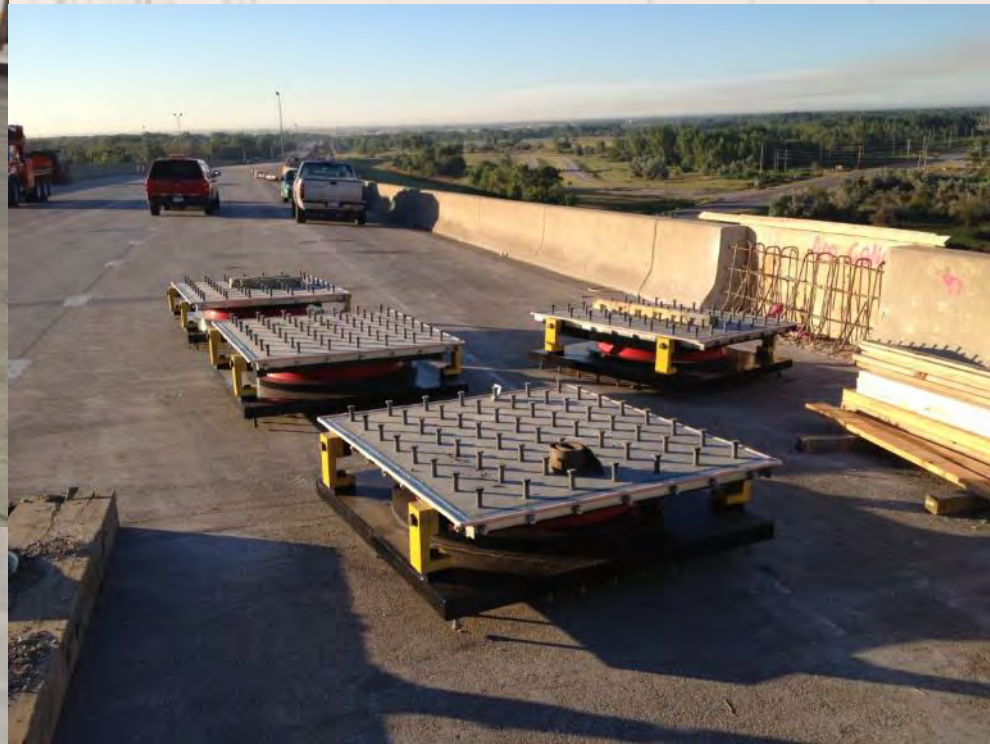
- New disc bearings – max capacity 8100 kips
