The Zilwaukee Bridge: CM/GC Bearing Replacement Project

Corey E. Rogers, P.E.

MDOT Bridge Construction Engineer

Michigan Bridge Conference Presentation

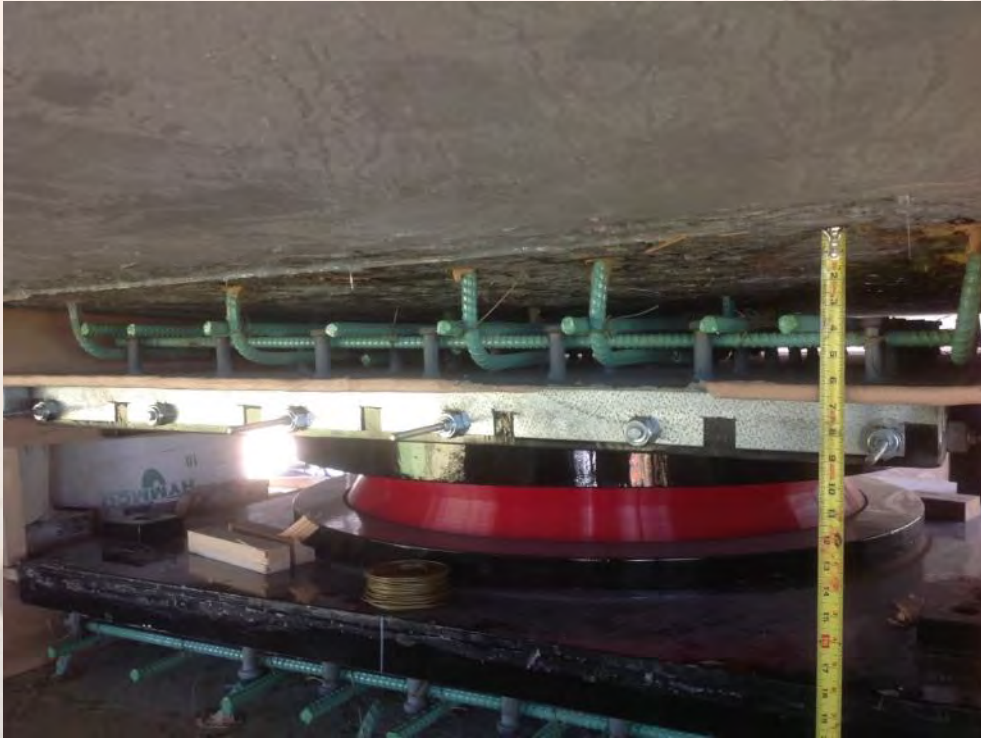
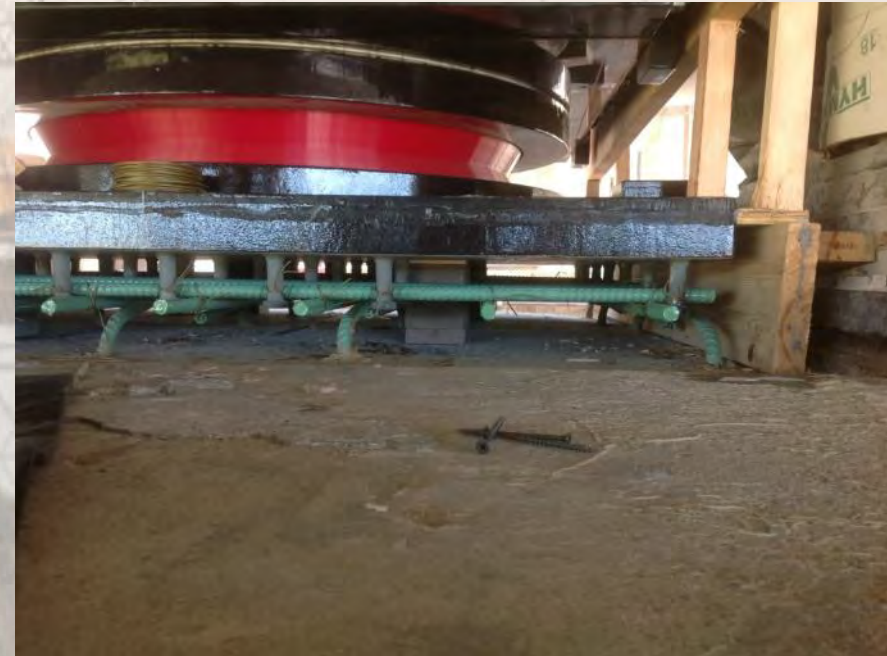
- Installing rebar and shimming bearings

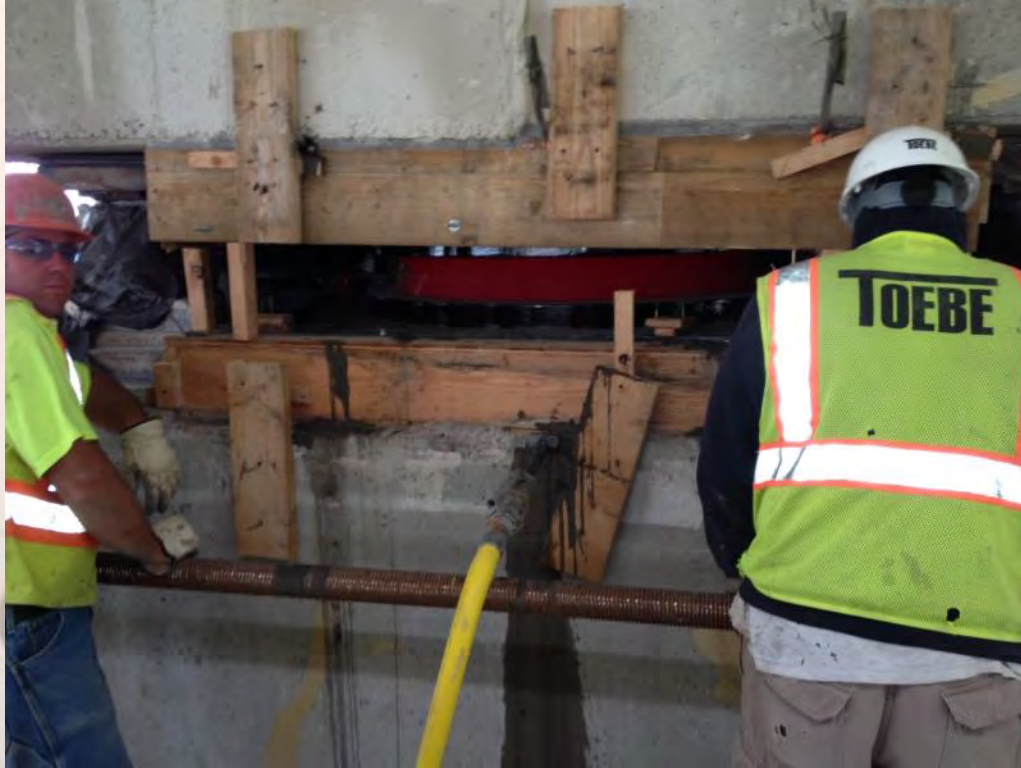
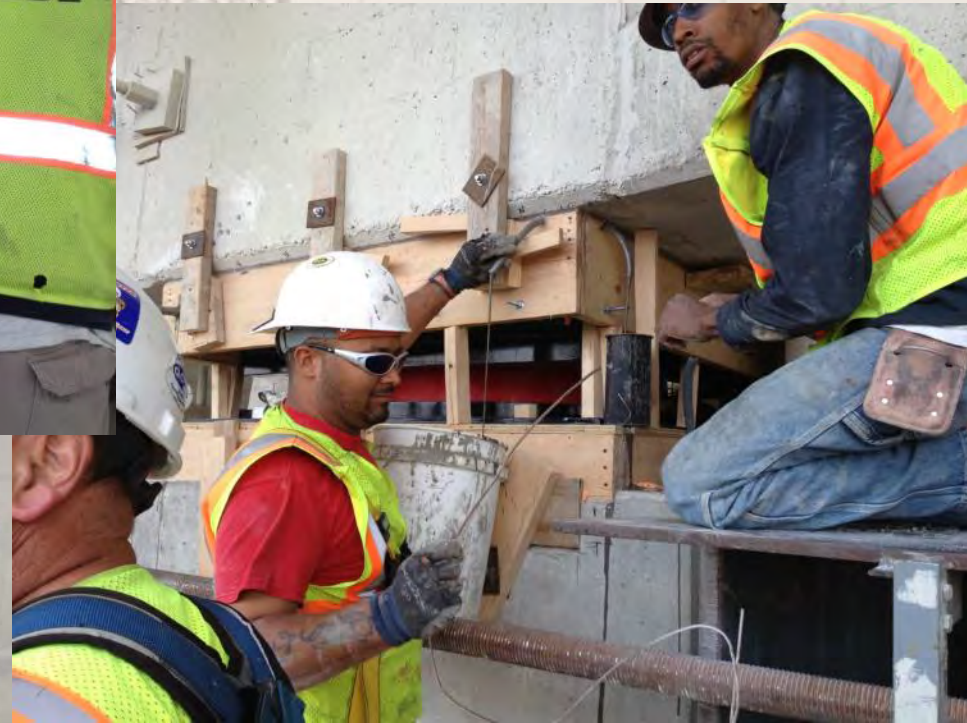
- Forming and pressure grouting

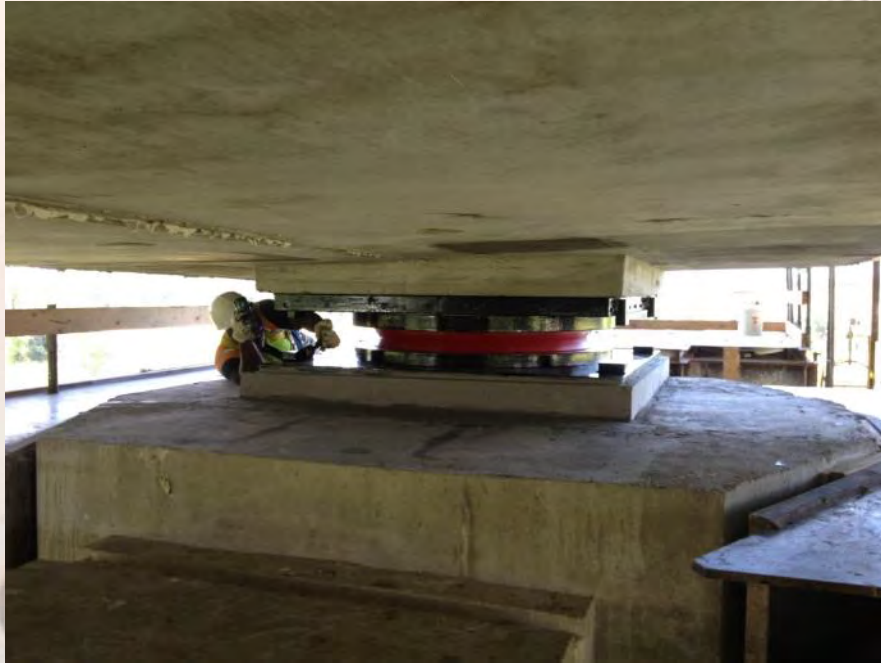
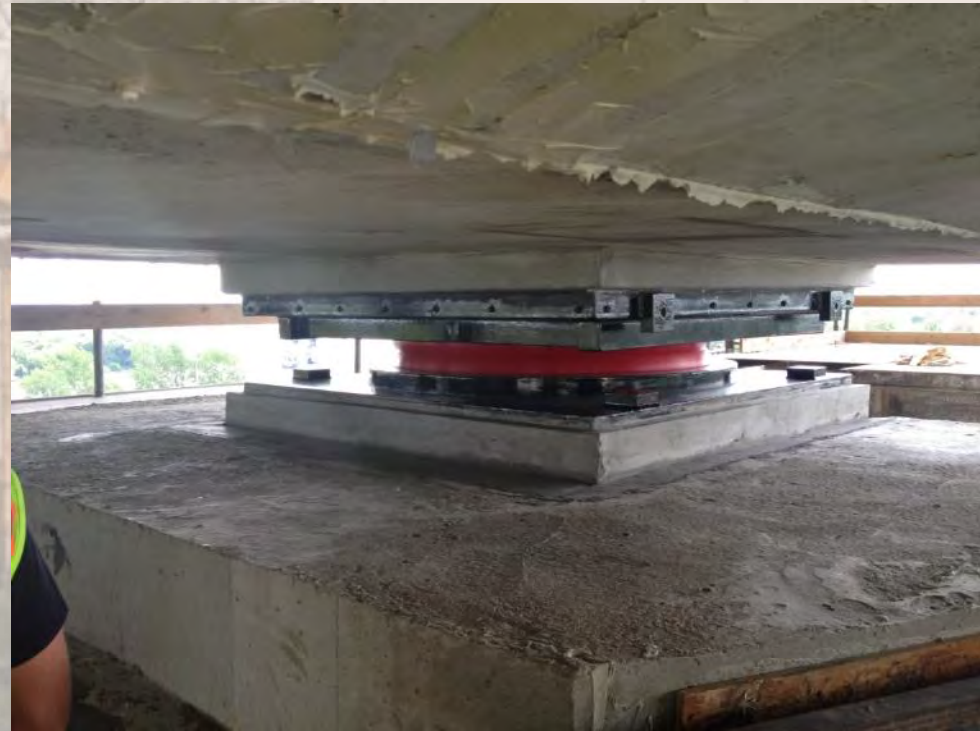
- Completed bearings

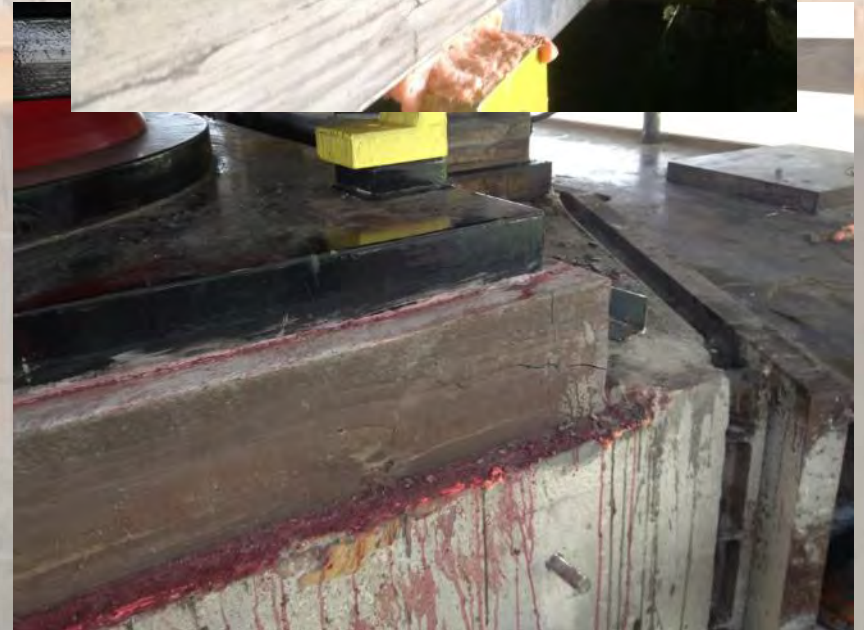
- Grouting and shimming issues addressed early

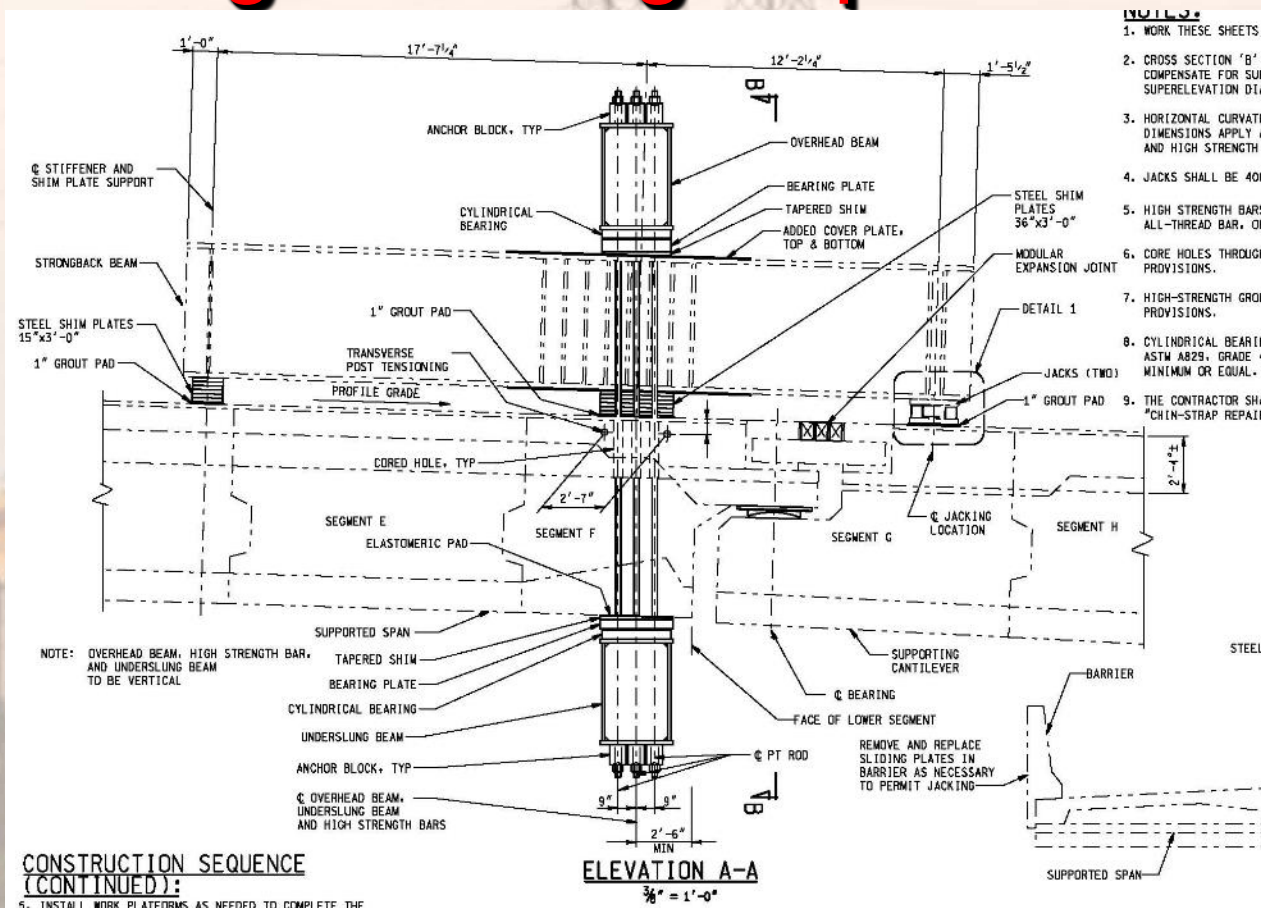
- Quarter point hinges allow for expansion and rotation
- Most complicated and sensitive portions of the structure

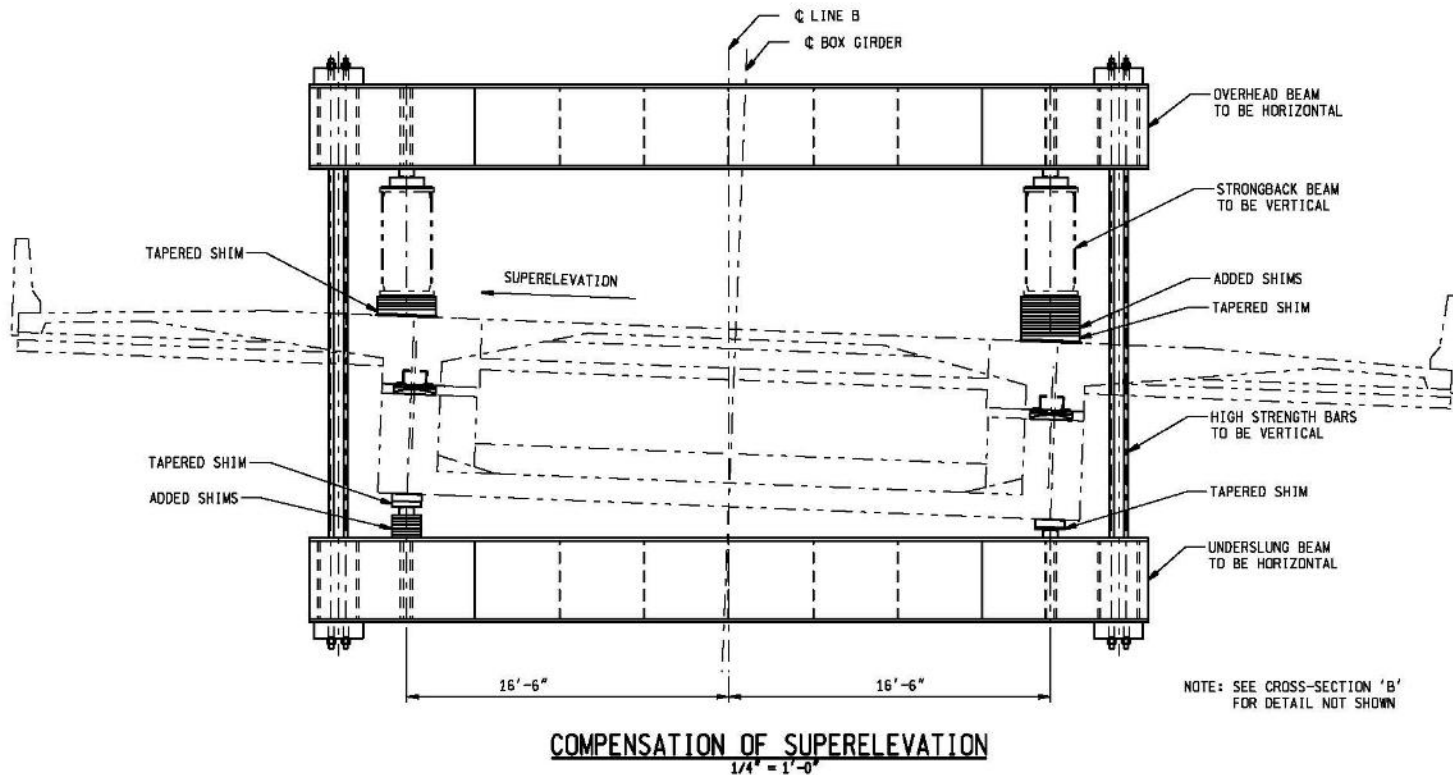
- General scheme to use strong back, overhead and underslung beams to transmit load from upper segment

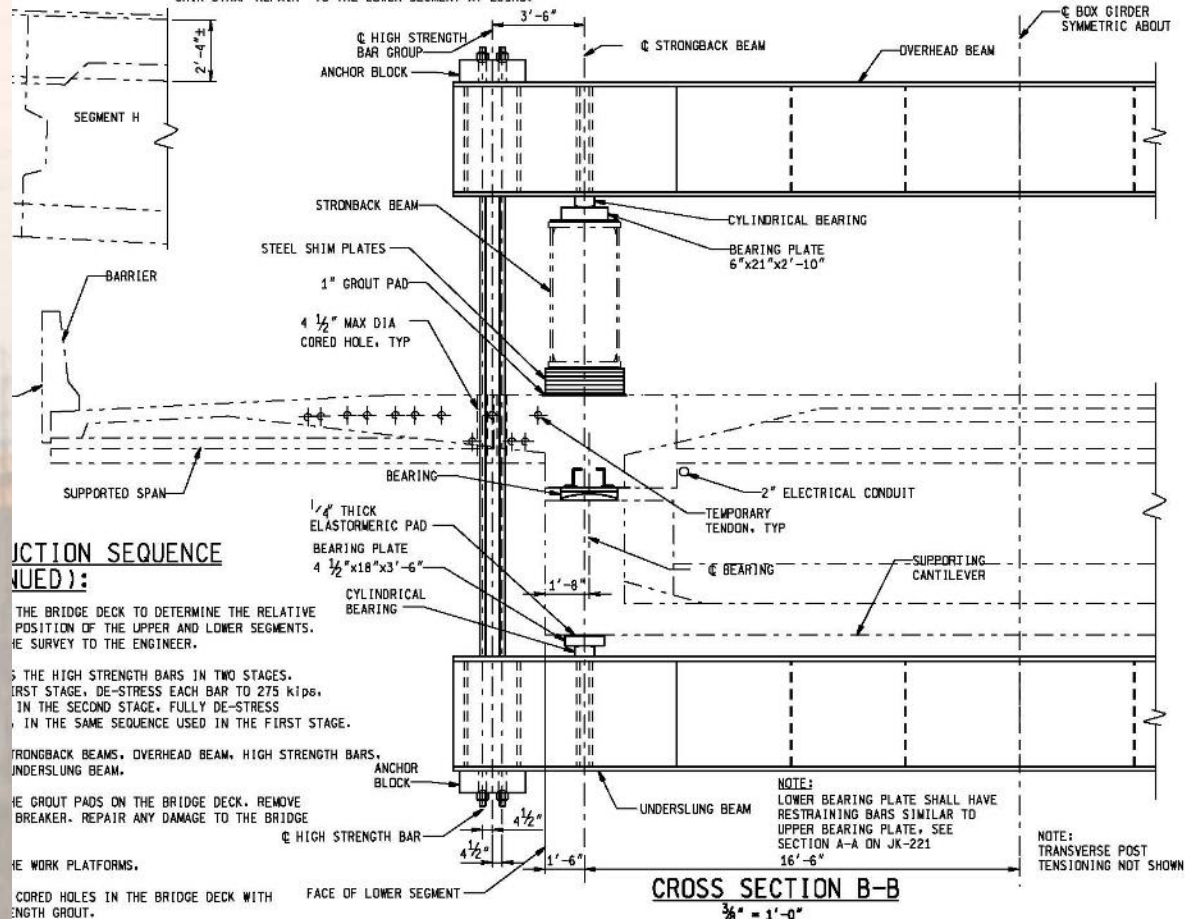
- Uses six 2 1/2" PT bars stressed at 460 kips each (each side), cored through wing section near existing PT tendons

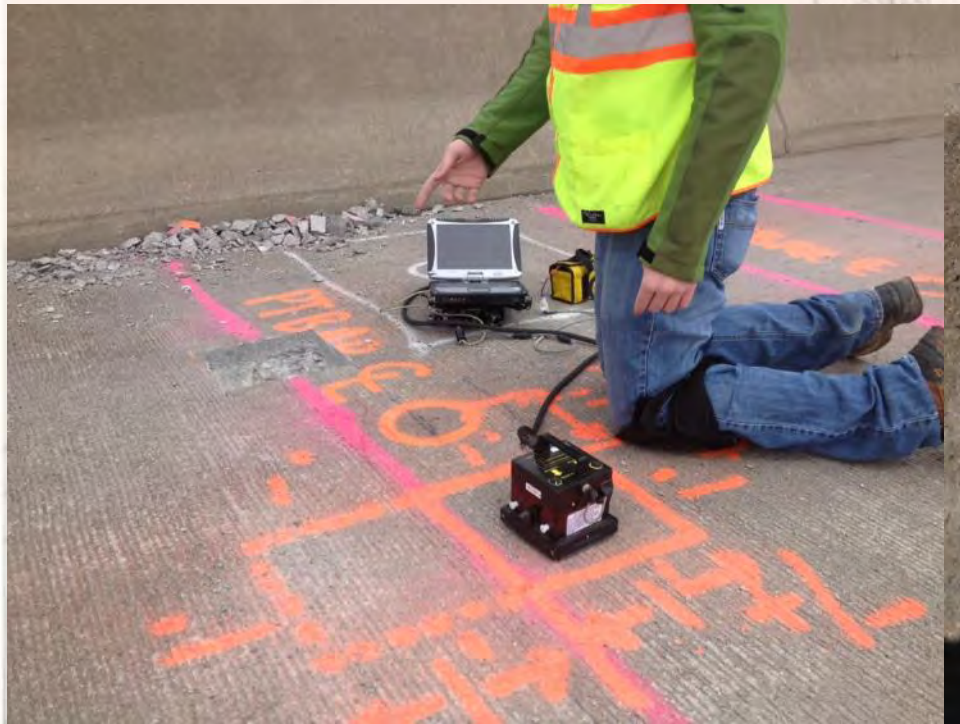
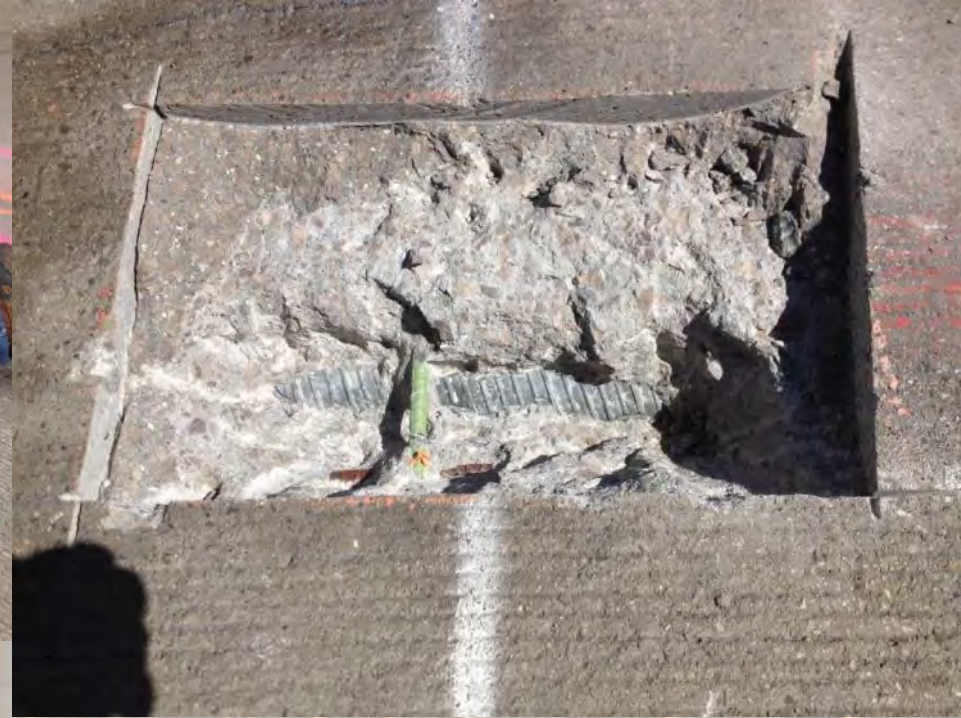
- Use of Ground Penetrating Radar to locate rebar and PT tendon conduits

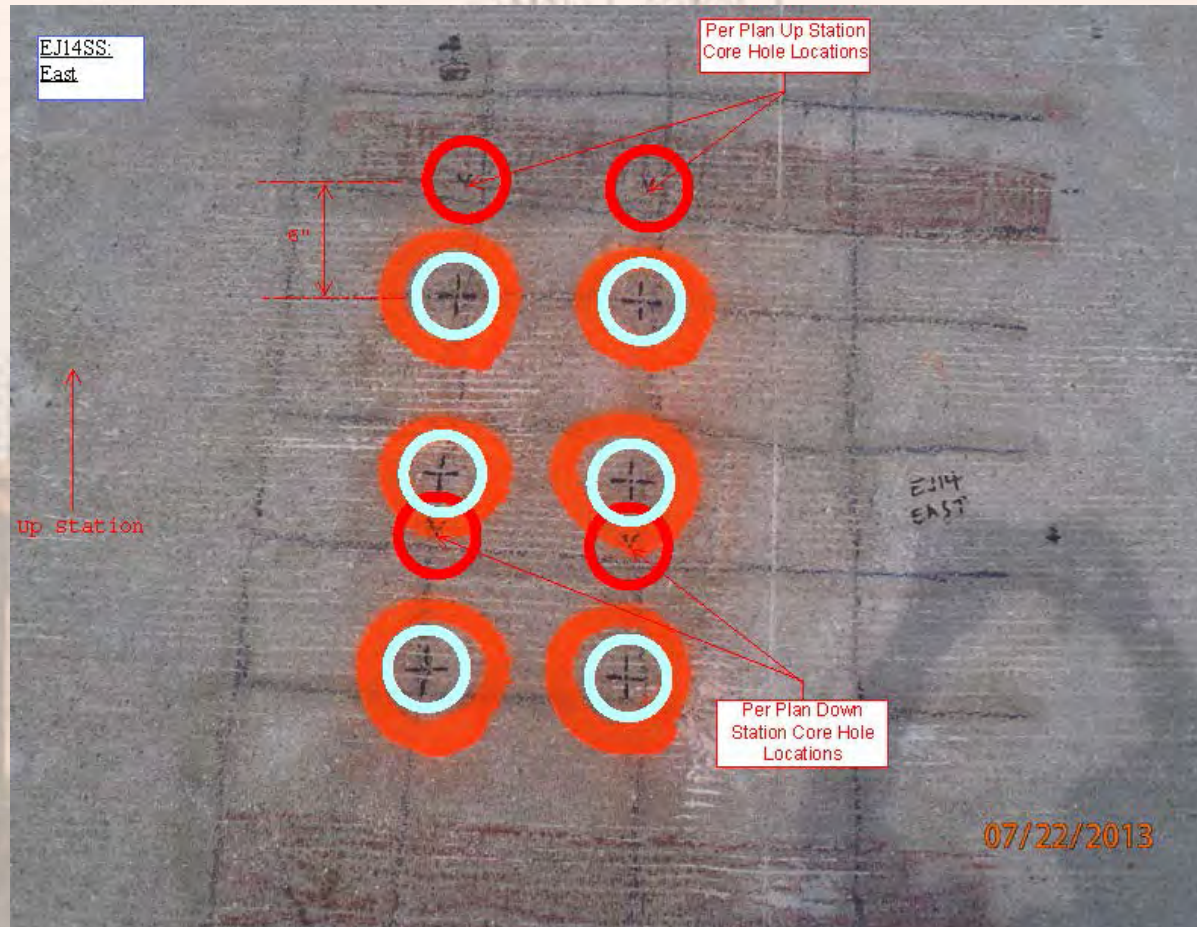
- Similar process as pier coring, contractor submits coring plan for approval

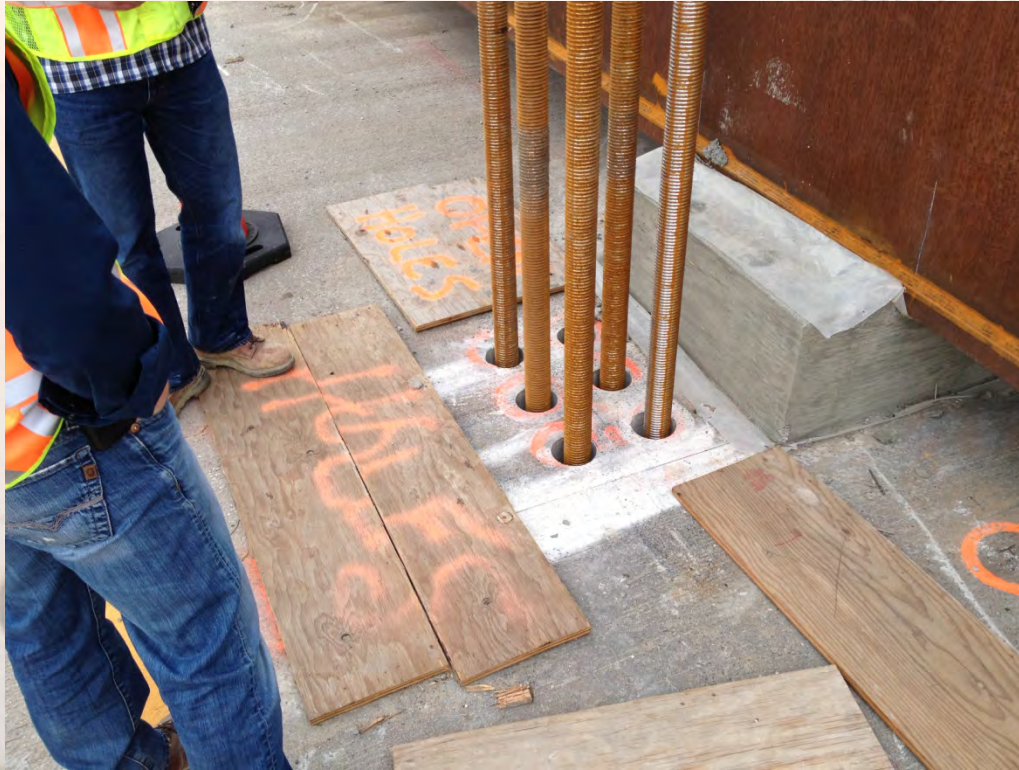
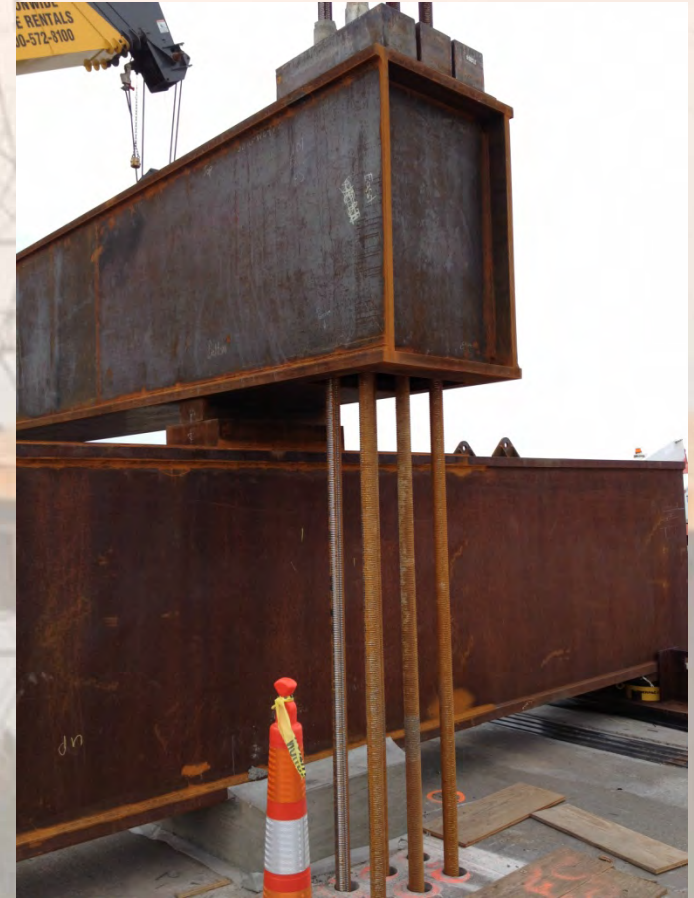
- Inserting of 2 ½" diameter PT bars through deck, overhead and underslung beams

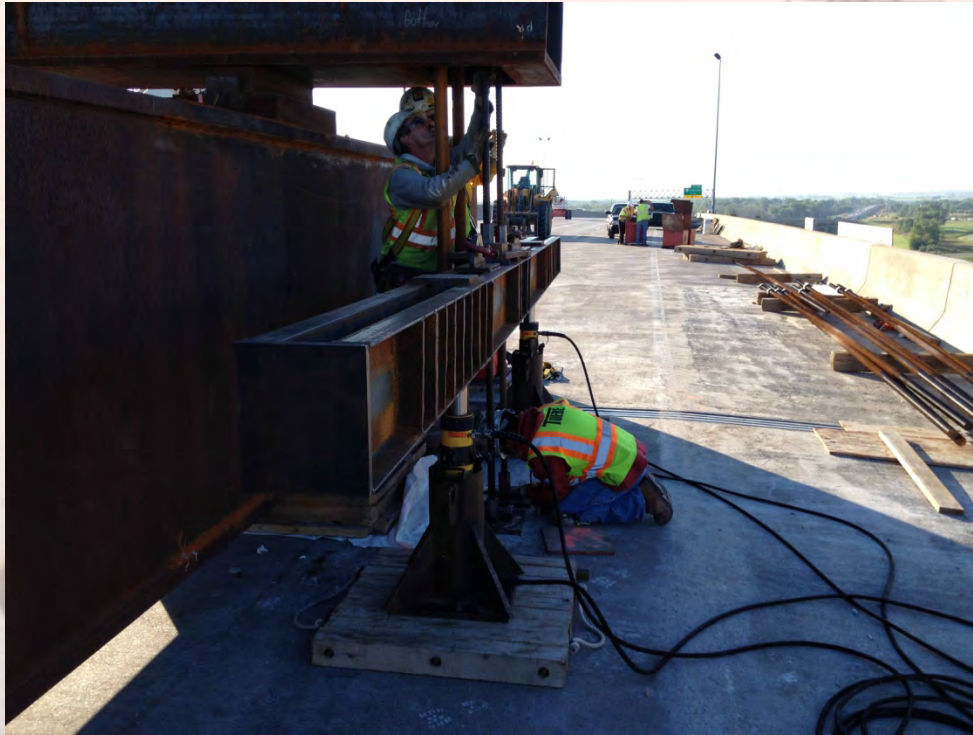
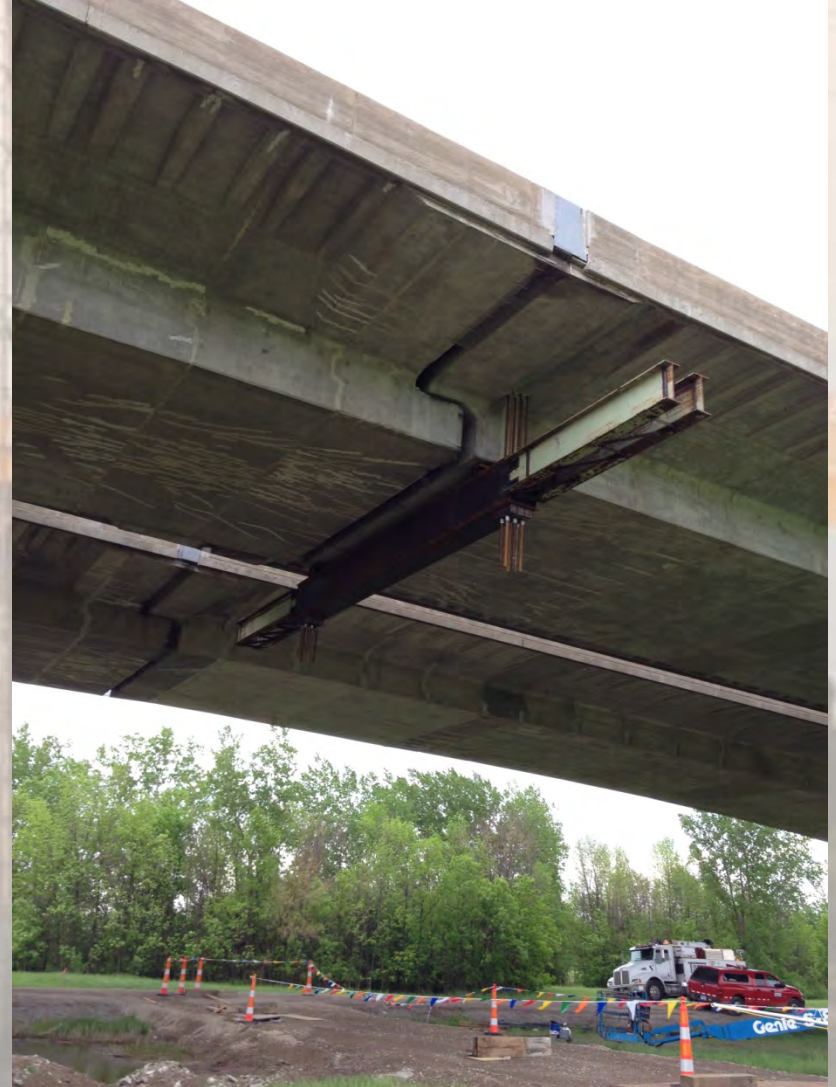
- Raising underslung beam into position

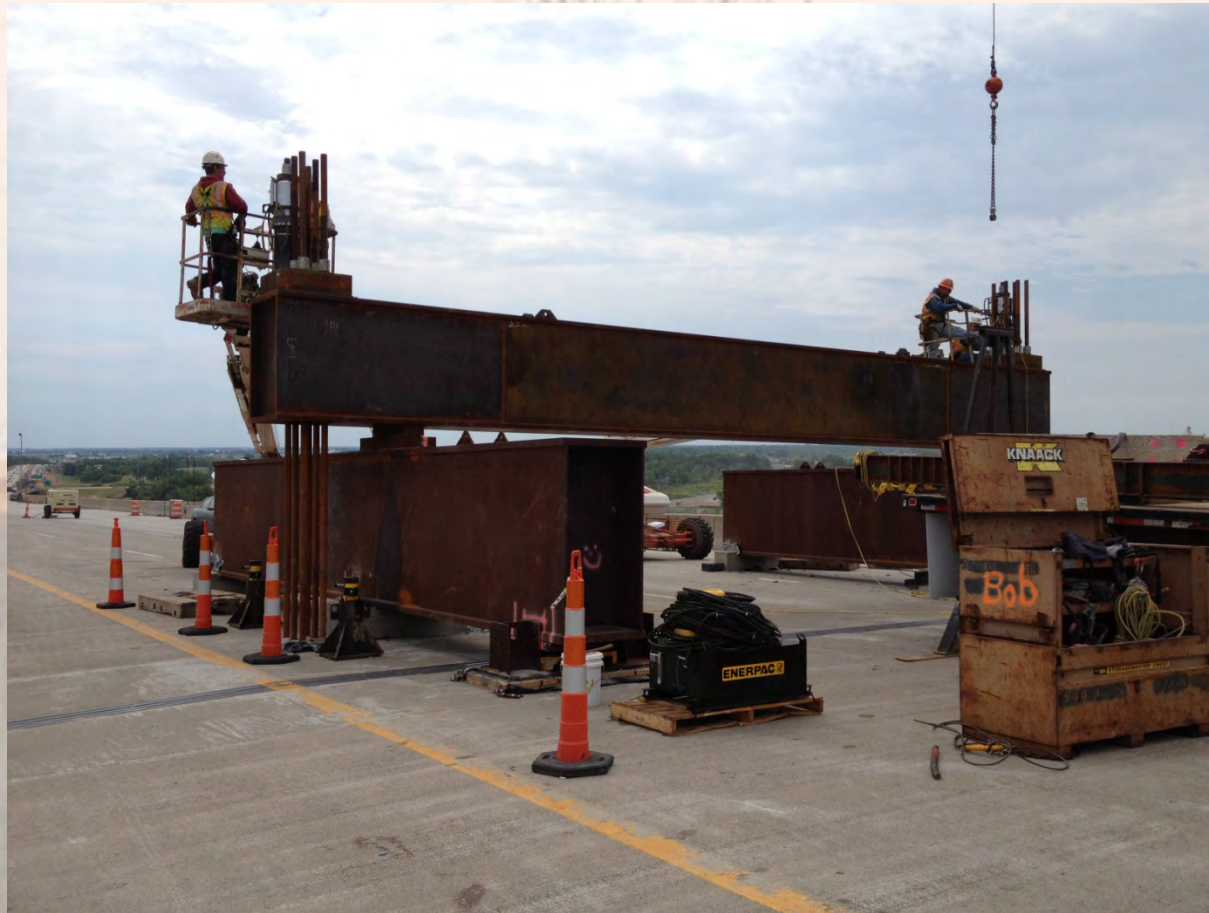
- Strong back beam assembly and stressing of 2 ½" diameter PT bars

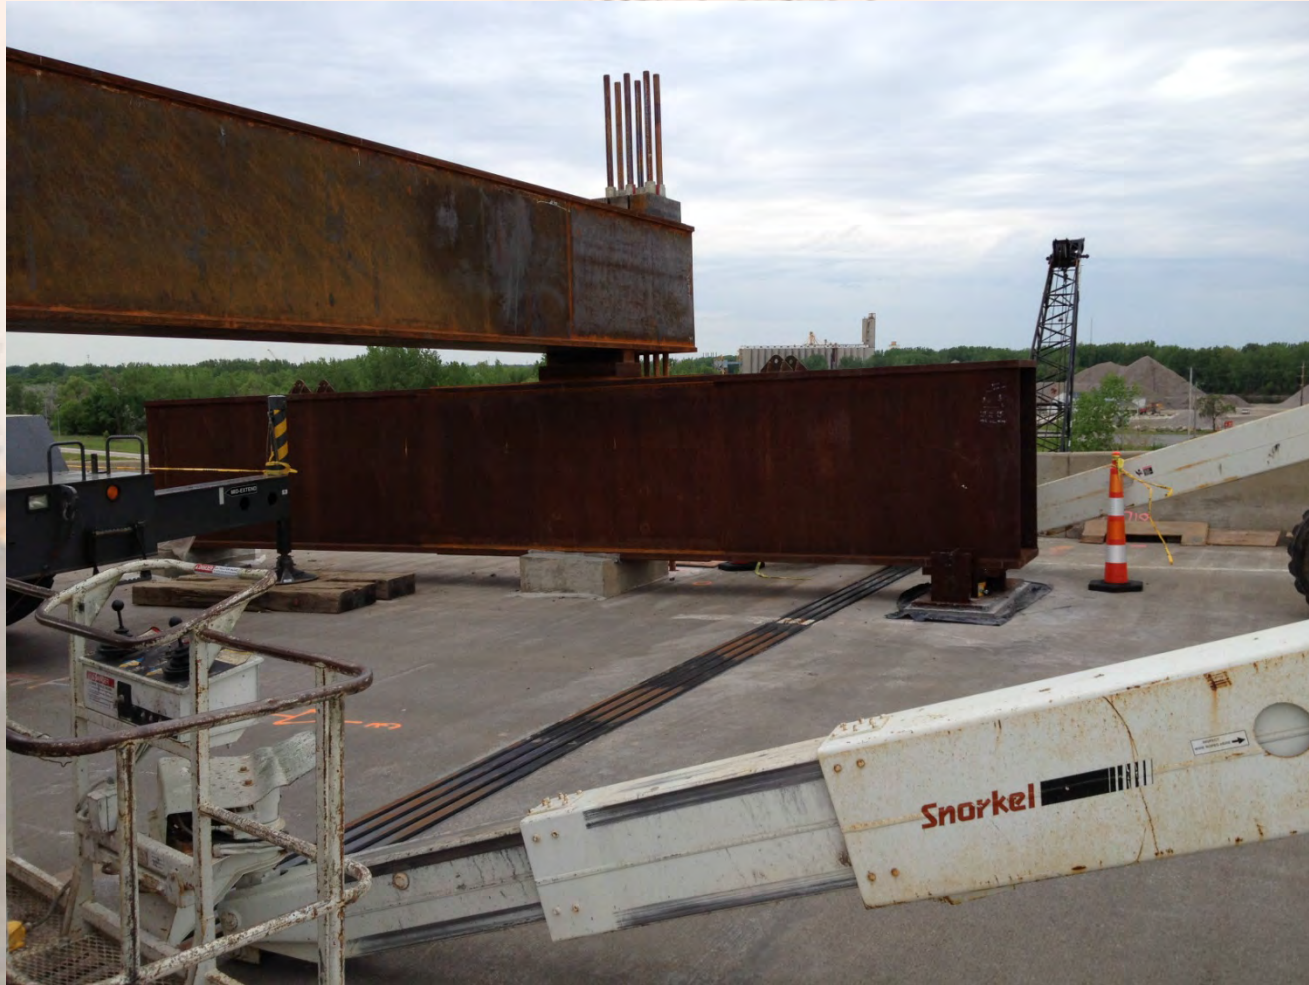
- Completed assembly, awaiting jacking

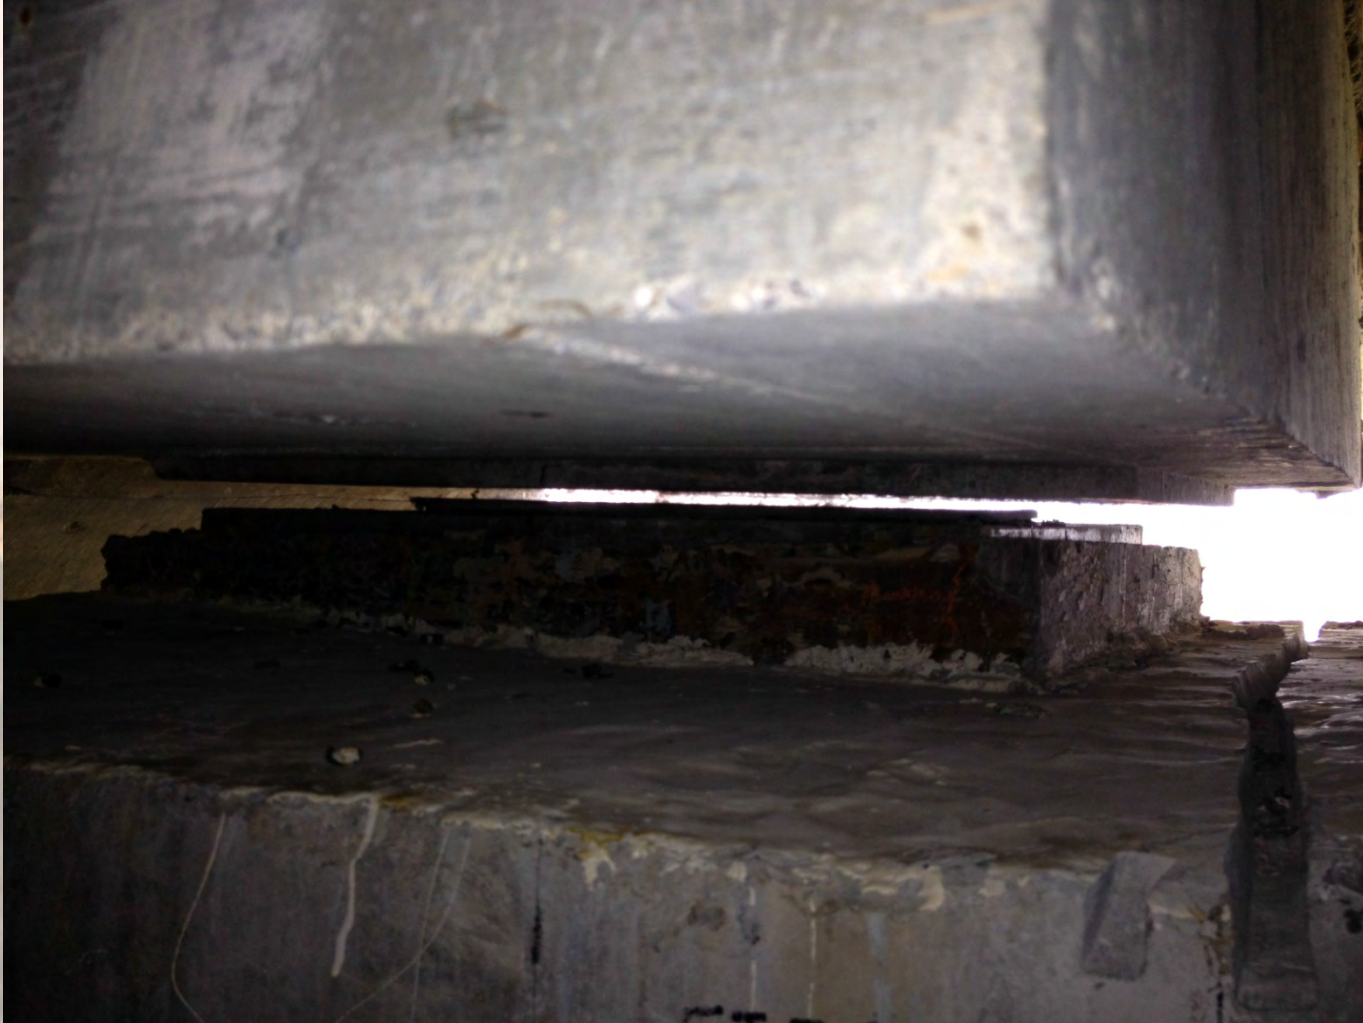
- 7/16" opening at hinge bearing

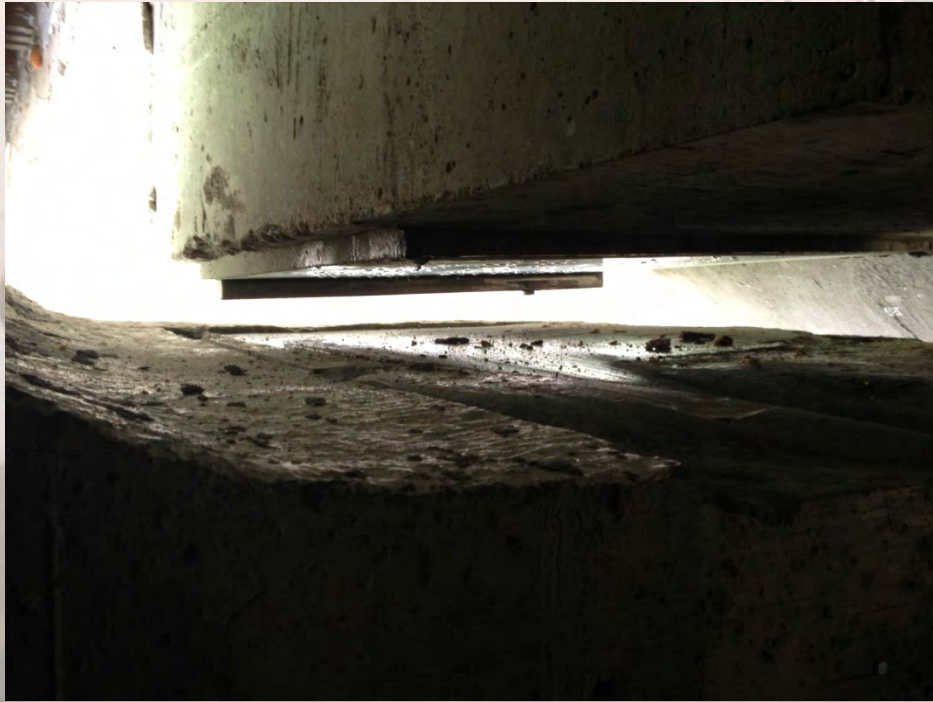
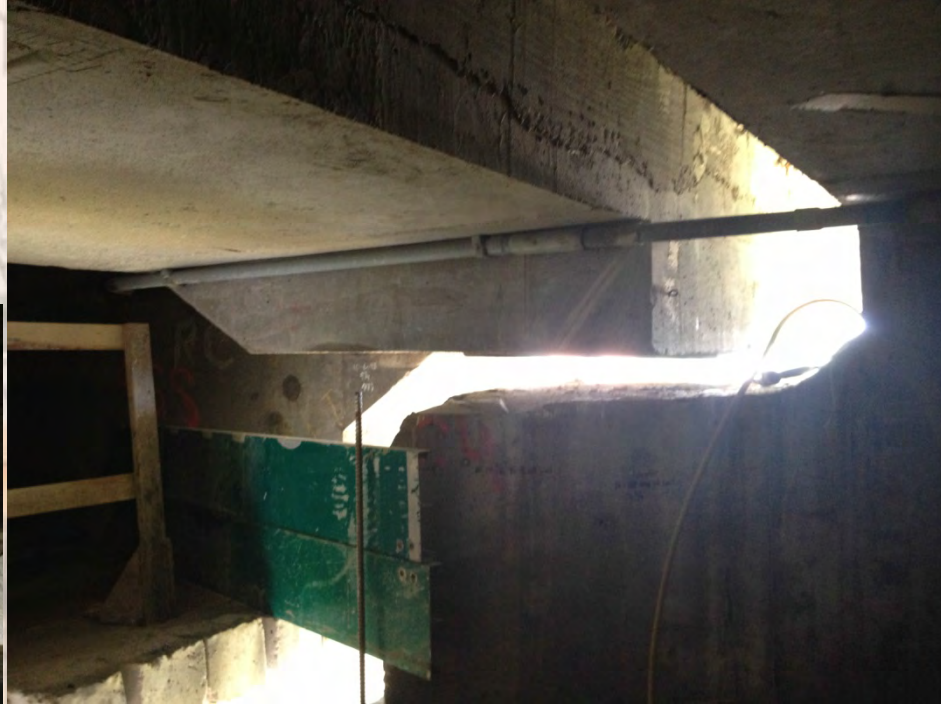
- Existing bearings are removed via wire sawing

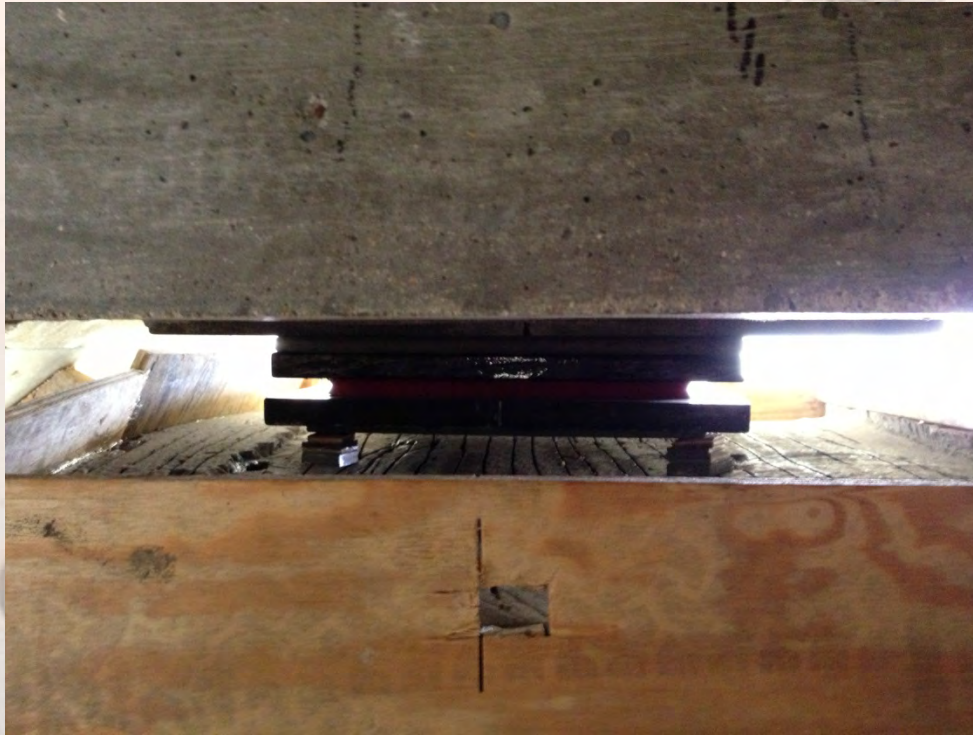
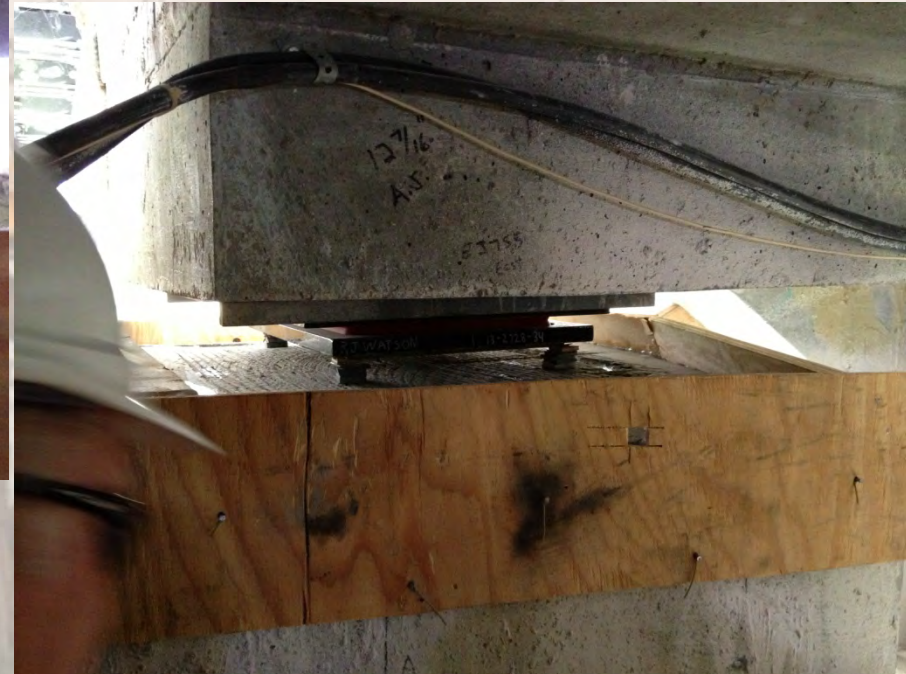
- Shimming of bearing for grout pad placement

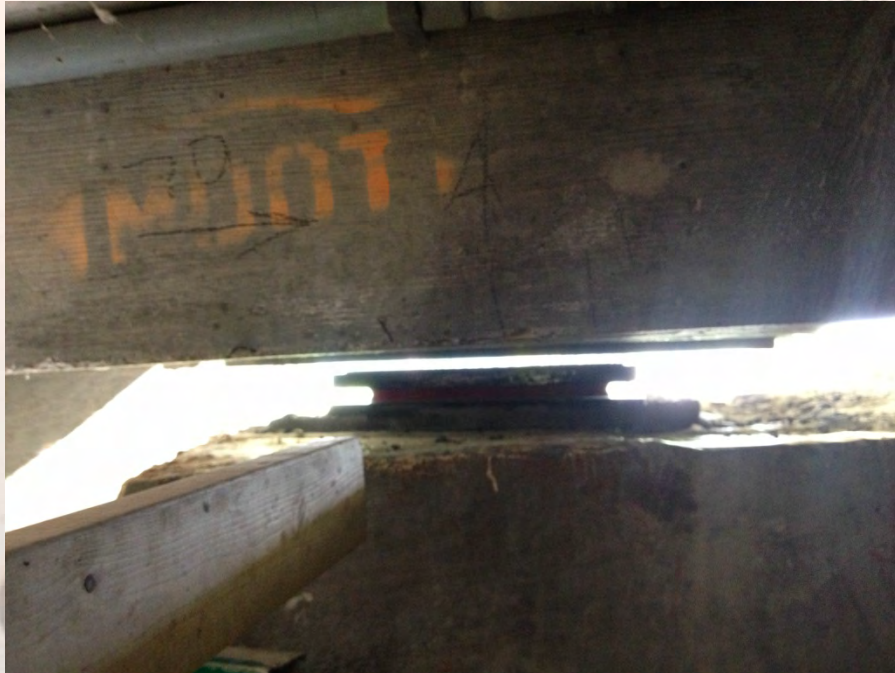
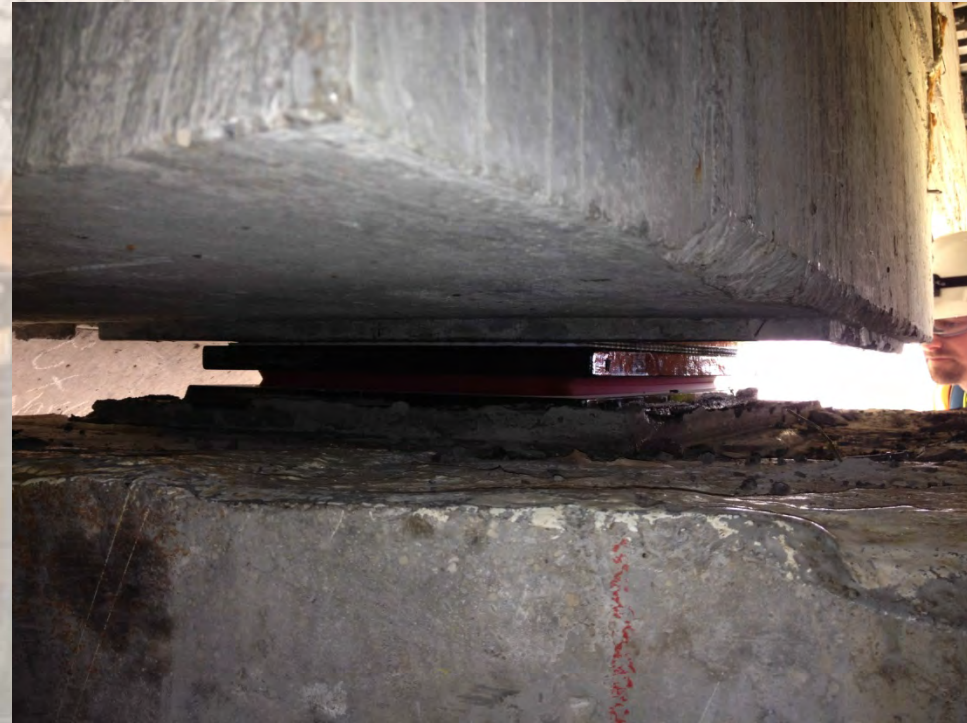
- New disc bearings set, superstructure lowered

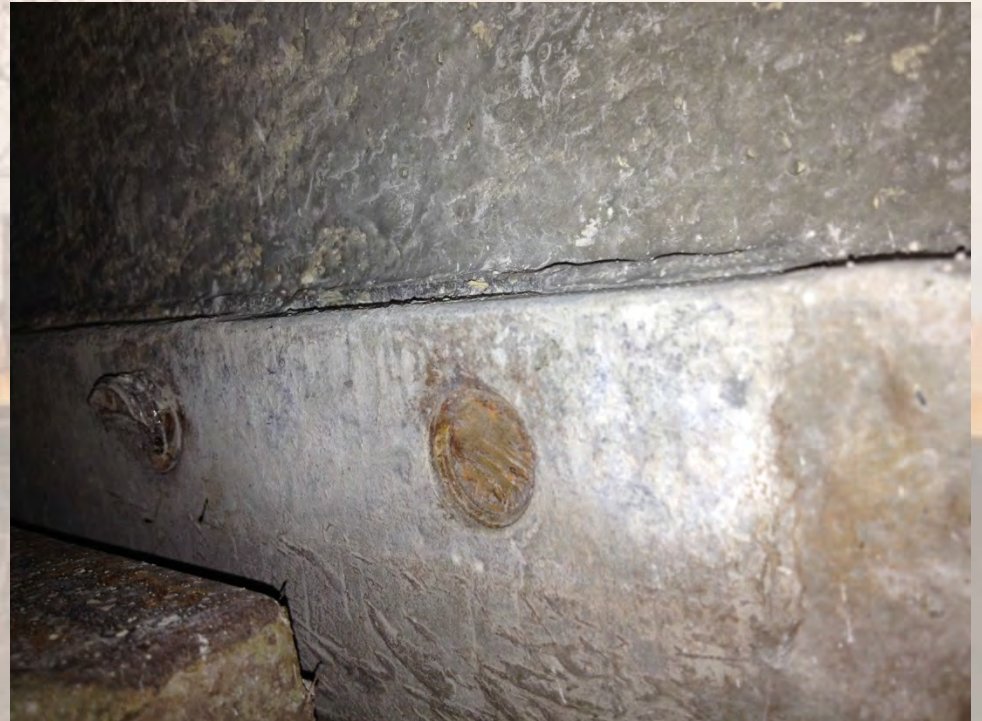
- Issue with guide bars, 5 out of 11 cap screws sheared, with loss of 72 kips lateral resistance
