The Zilwaukee Bridge: CM/GC Bearing Replacement Project

Corey E. Rogers, P.E.

MDOT Bridge Construction Engineer

Michigan Bridge Conference Presentation

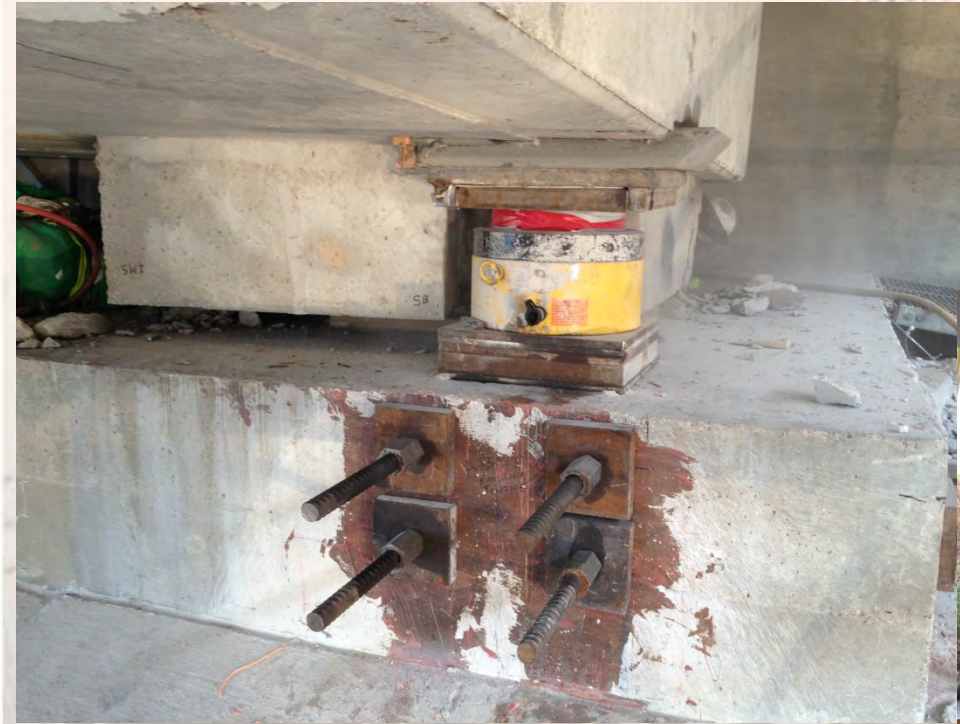
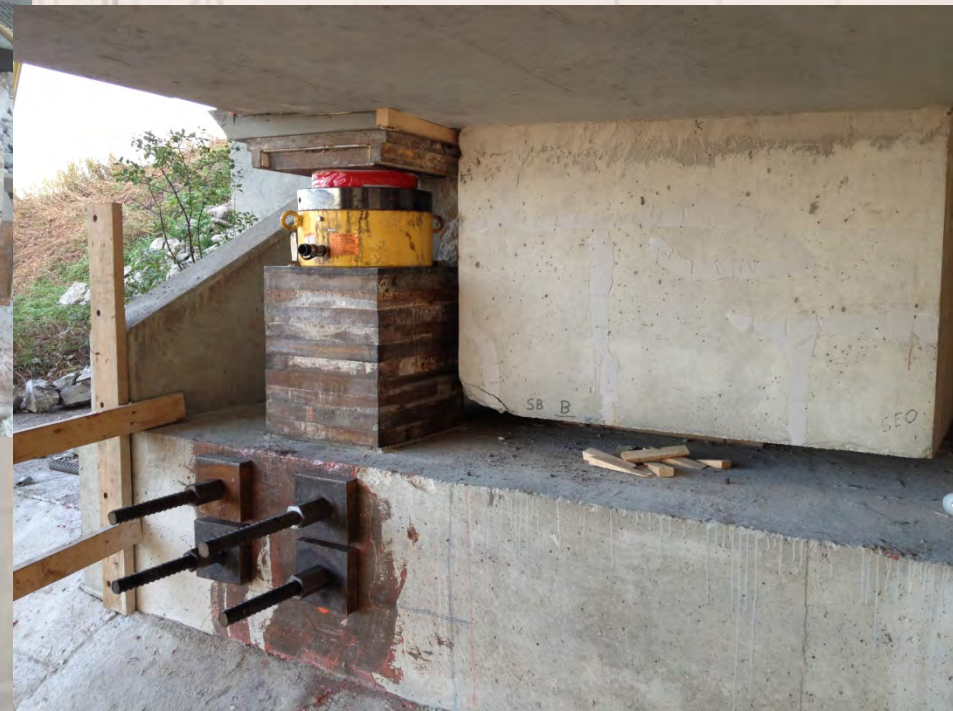
- Installation of passive PT under jacking locations

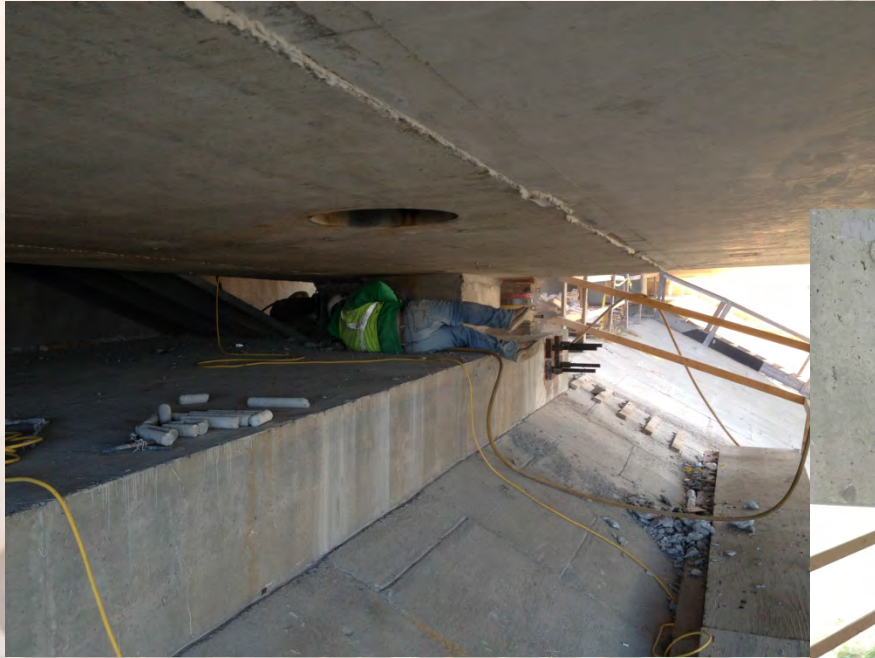
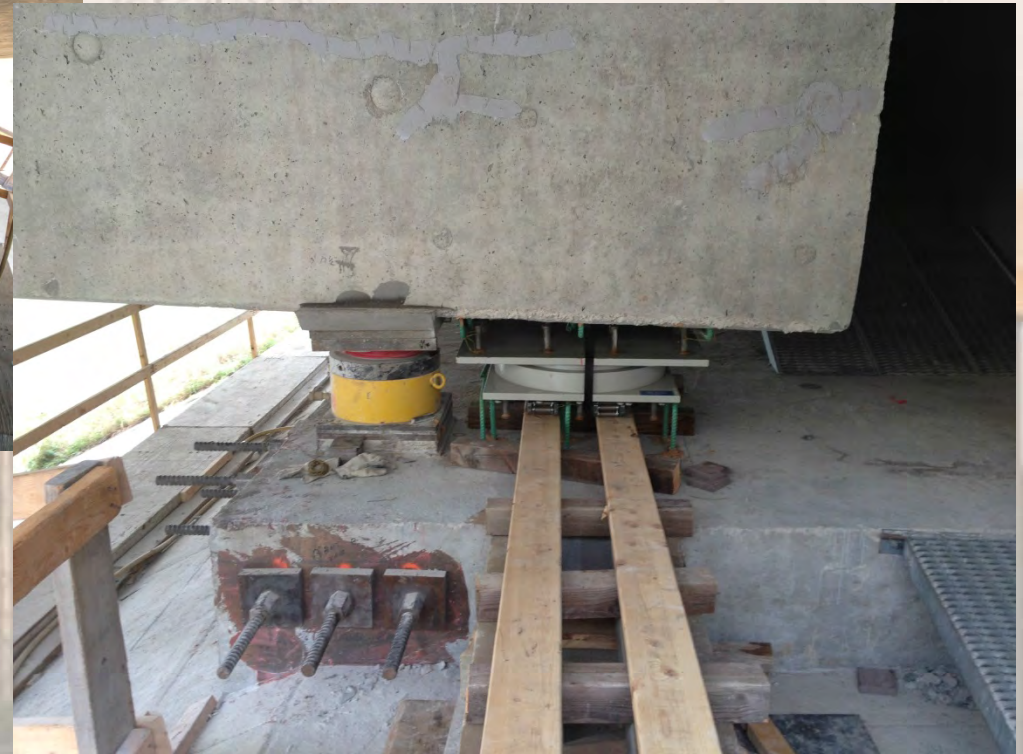
- Removal of existing bearing, and setting of new bearing

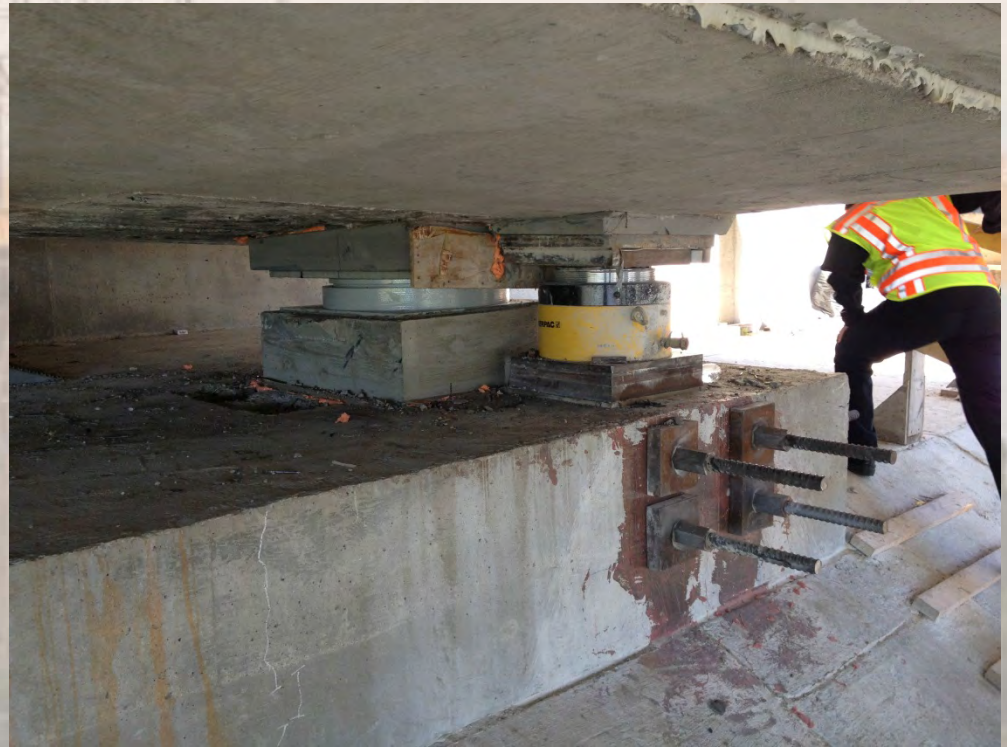
- Setting, grouting, and finished bearing

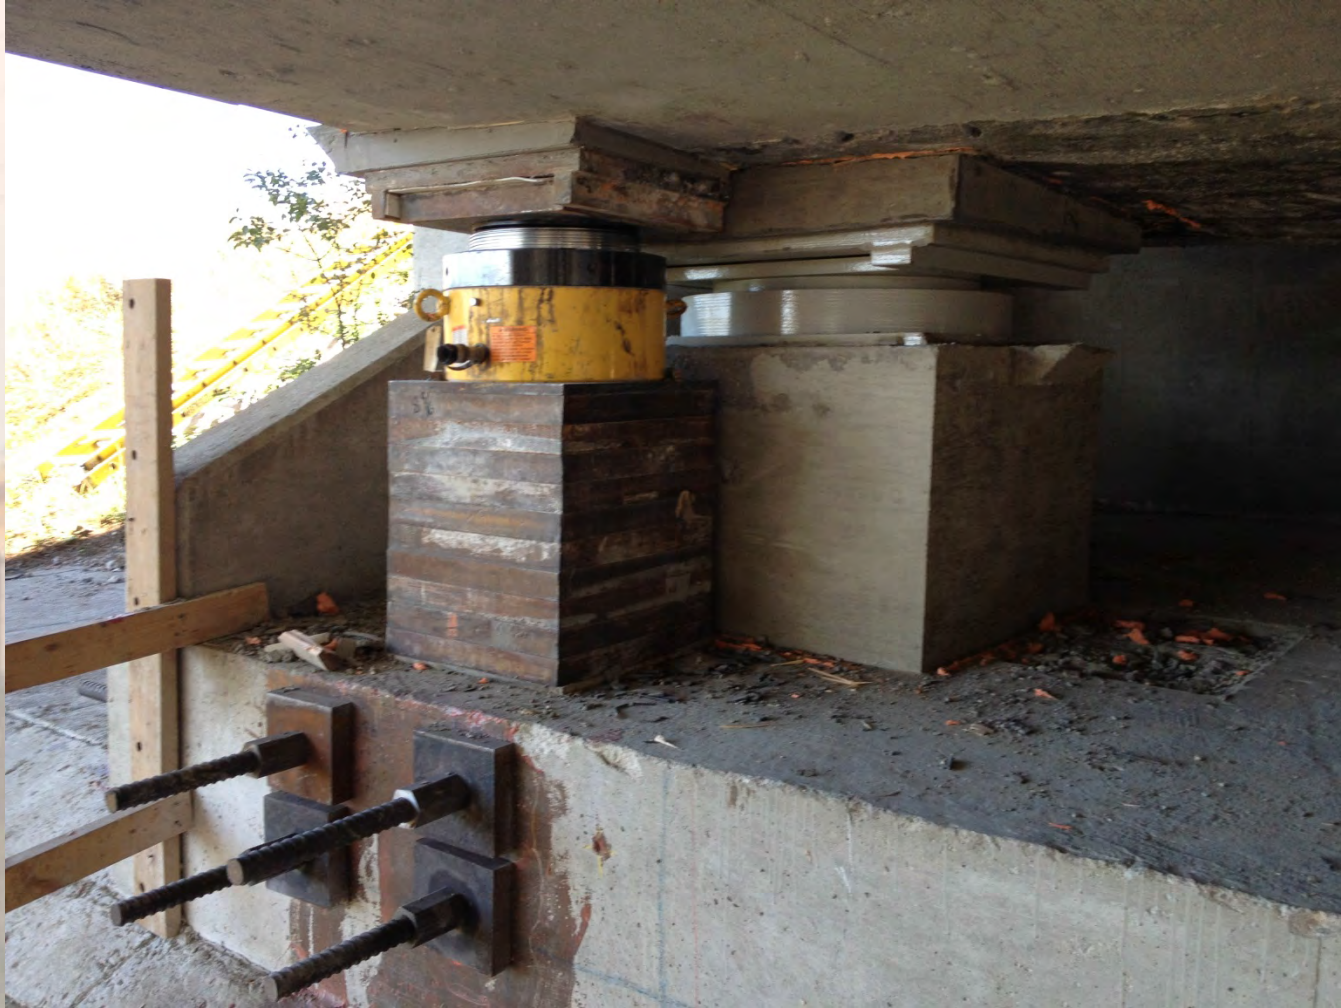
- Abutment bearings are repurposed from 2008 project
