Blue Water Bridge #1 Anchor Link Replacement

Bridge Information

- Built 1938
- Spans the St. Clair River at the mouth of Lake Huron
- Spans: 326'-871'-326'

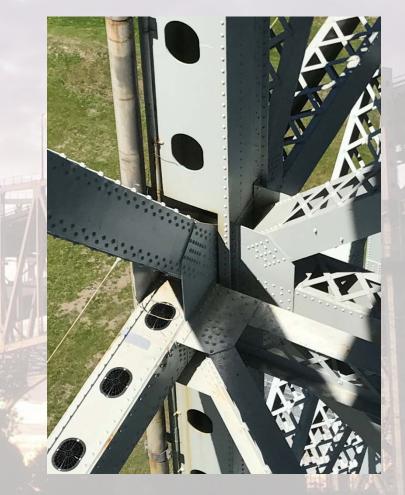
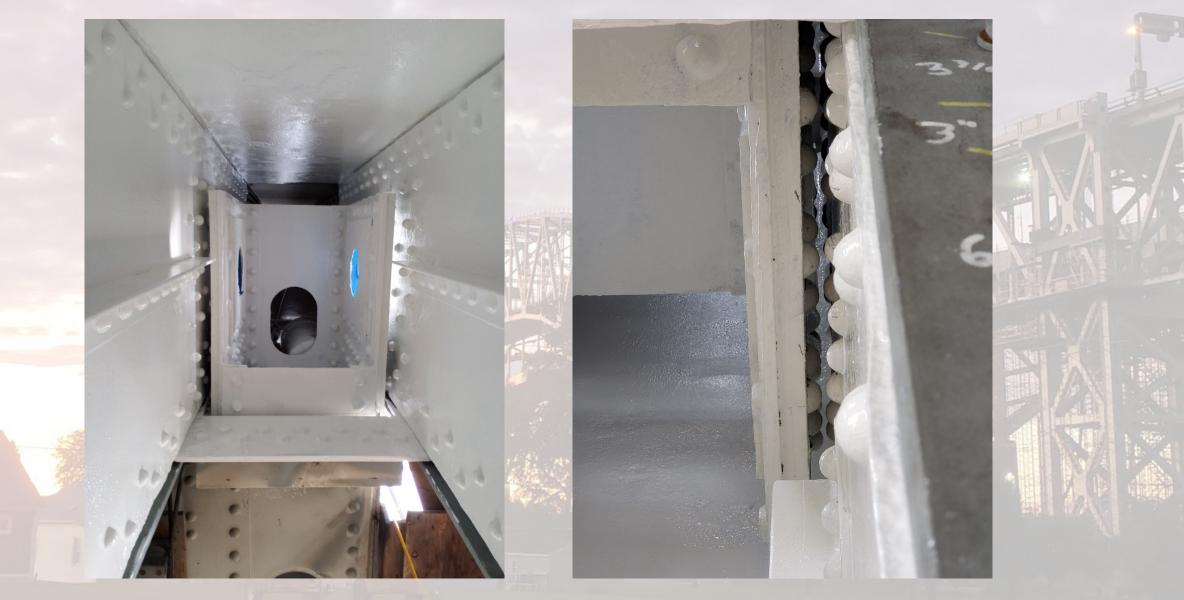
- Link is *INSIDE* the tower leg
 - Temporary support outside
 - Durable materials and coatings "get in, get out, stay out"
- Link is a Fracture Critical member
 - Multiple link plates: A709 GR HPS 70W
 - Forged Pin Material: Stainless Steel A705 UNS S45000/XM-25/Custom 450
- Geometry and alignment
 - Did not re-use existing bearing surfaces
 - Slotted holes in lower pin plates

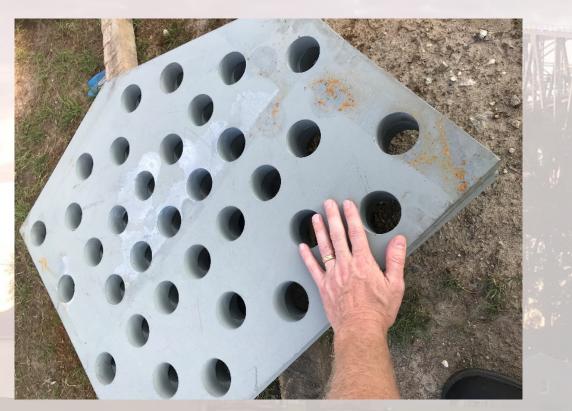
- Temporary support away from work
 - Connect to gusset using special cheeseplate fill and long bolts

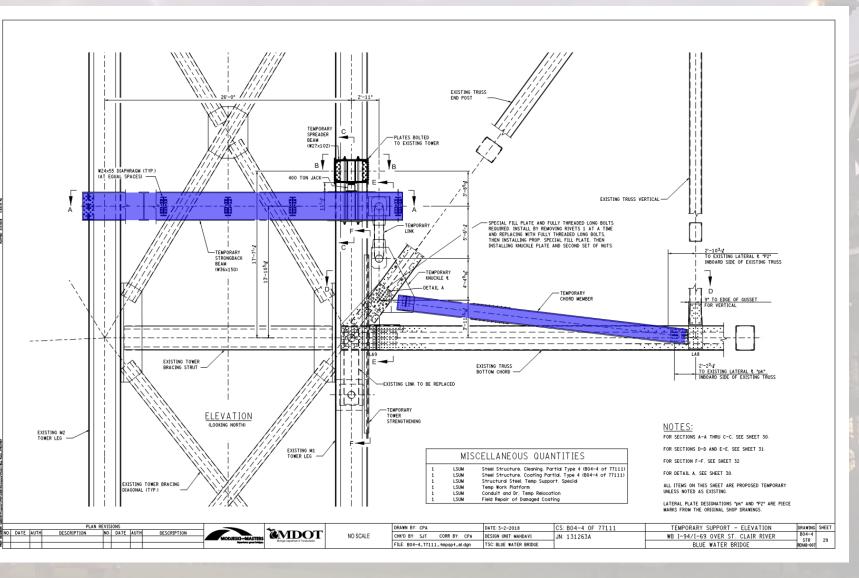
- Temporary support Eccentric connections
 - Temp bot. chord
 - Temp strongback

Removal of tower cover plate for access

- Lane closure for removal
- Temp. strengthening angles for work duration

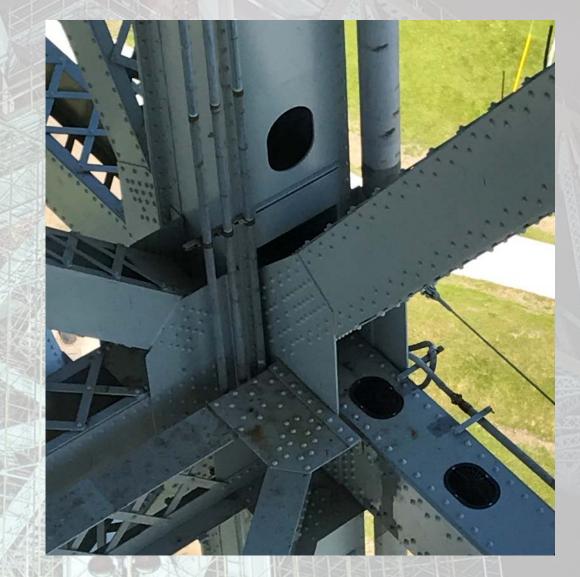
- Electric, fiber optic, ITS
- Storm water drainage
- Fire Suppression Line
- Limited to man lifts
- Solutions:
 - Relocation of:
 - Fiber Optic
 - ITS
 - Electrical
 - Drainage
- Two weeks to relocate

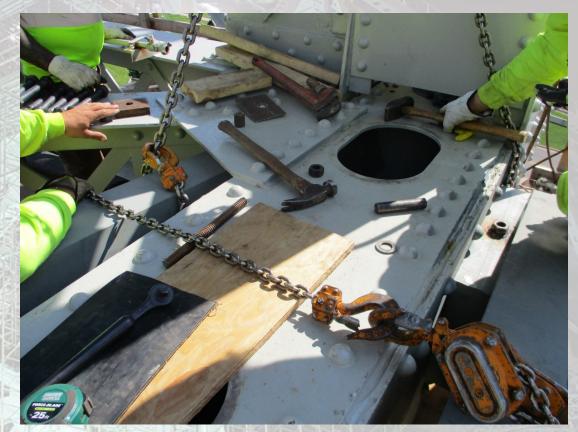
Location of anchor links

- 85 ft +/- above ground
- 20 Kip Shoring/Scaffolding
- Man Lifts

• Limited access at tight spots

- Inside tower legs (roughly 2'5" x 3'3")
- Inside horizontal chords of truss tower
- Inside existing truss bottom chord

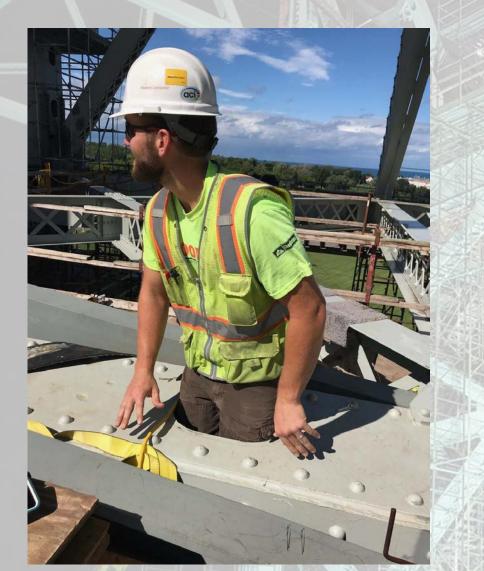
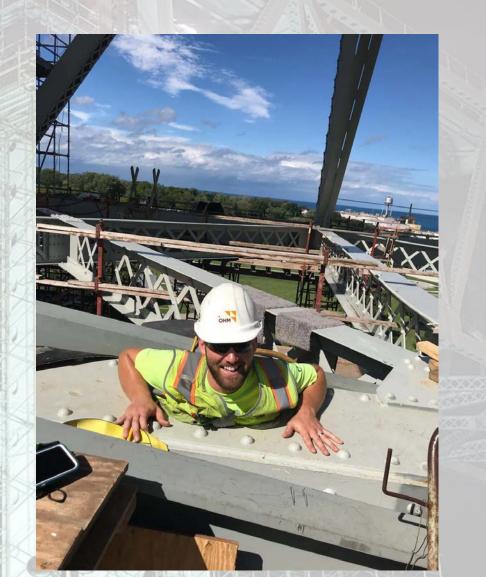
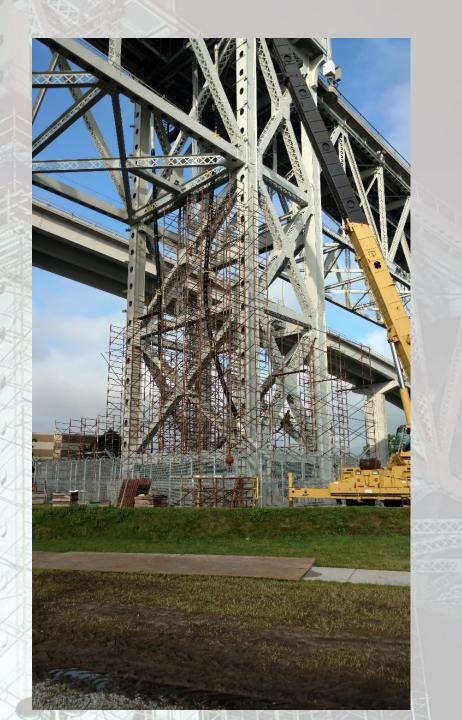
Accessing the Bridge

- 20 Kip Shoring/Work Platform
- Stair Tower
- 32 Scaffold Towers total, capacity of 20 kips each
- 4 weeks to install

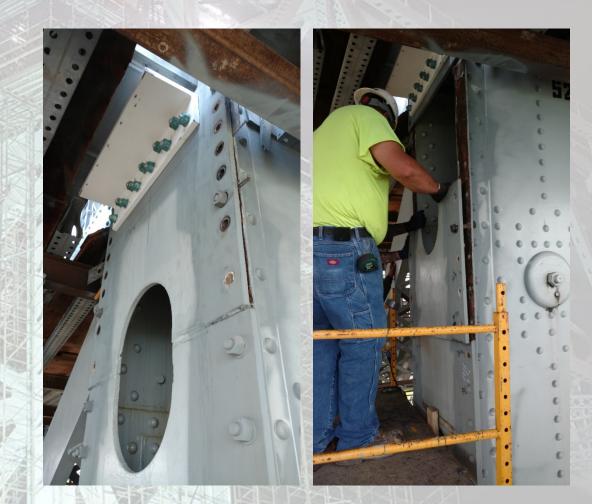
Perforated Cover Plate Removal

- M1Tower Legs at Links
- Allowed for removal of old links, placement of new links
- Coincided with Tower Strengthening

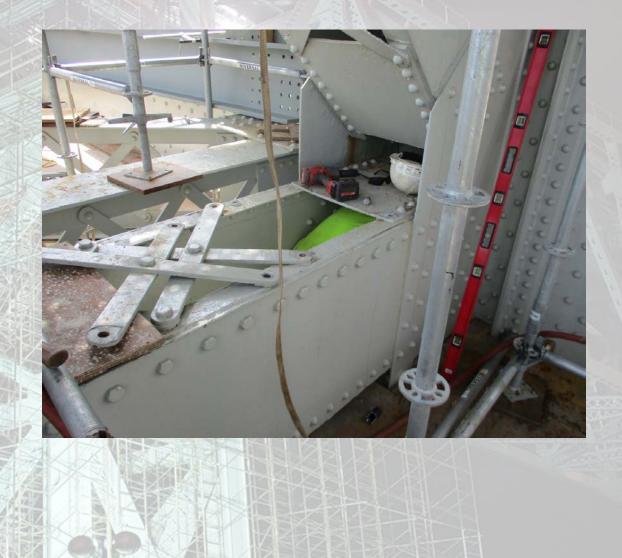
Access Solutions Temporary Lacing Removal

- Approved for removal (wind loading member)
- Access to:
 - upper pin for removal
 - line boring
 - painting
 - placement of new pin

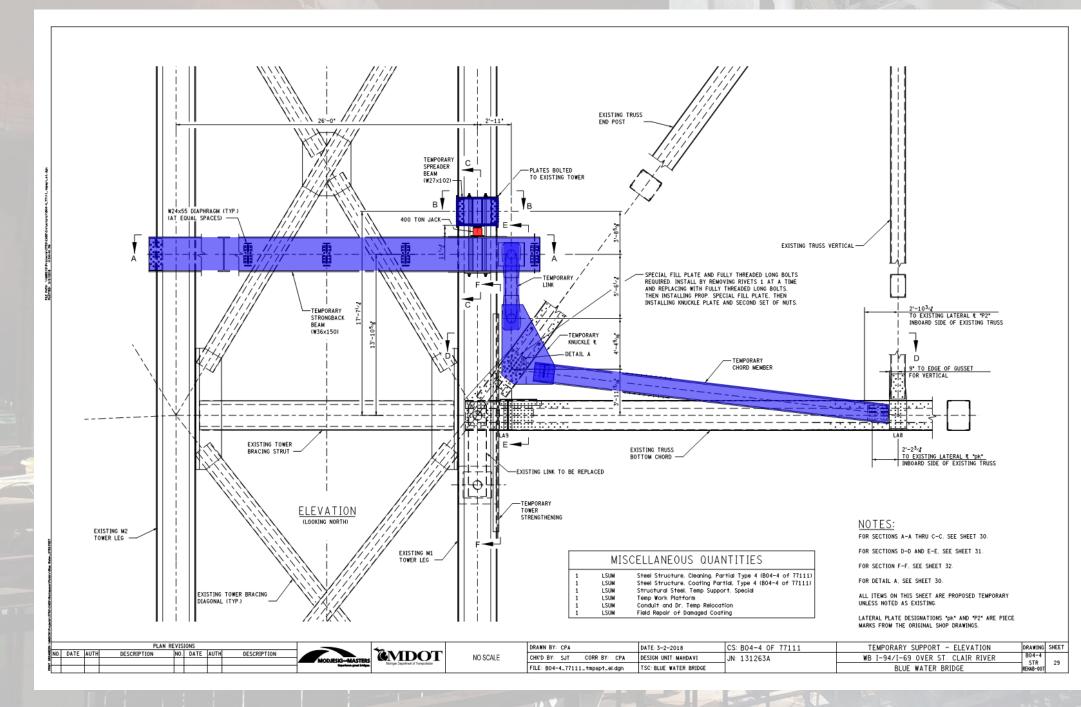
Temporary Support System

- Multiple components:
 - Tower Strengthening
 - Connection Plates to Tower Legs
 - Strong Back Beams/Diaphragms
 - Spreader Beams
 - Pins/Links
 - Knuckle Plates
 - Lower Cords/Diaphragms

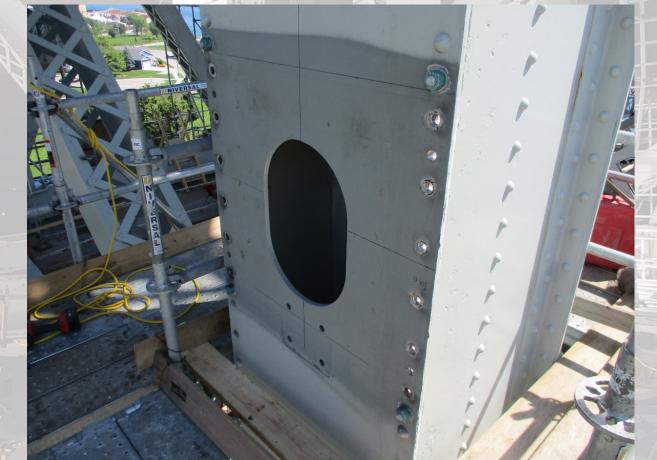
Temporary Support System – Rivet Removal

- Rivet Removals Required at:
 - Connection Plates
 - 72 Rivets
 - Tower Strengthening Angles
 - 72 Rivets
 - Knuckle Plates
 - 140 Rivets
 - Lower Cords
 - 12 Rivets

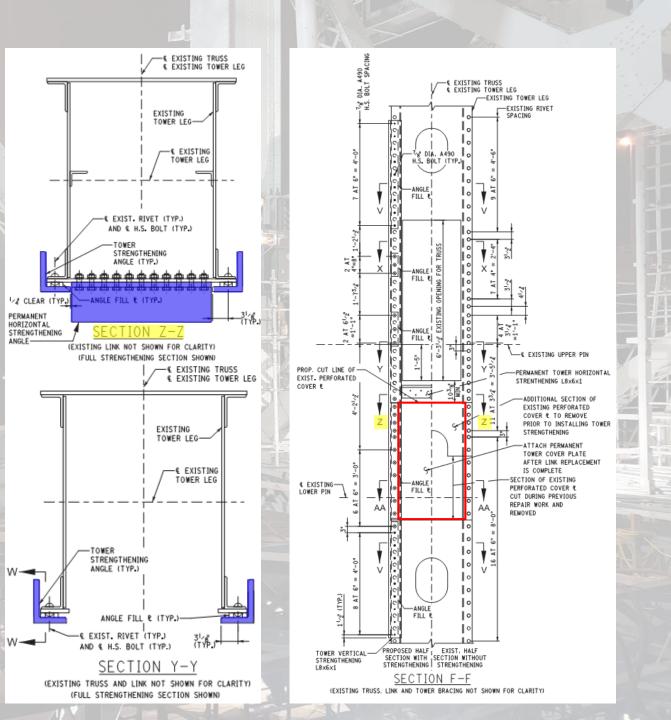
Temporary Support System Tower Strengthening

- Tower Strengthening required after removal of perforated cover plate
 - Vertical Angles
 - Multiple Fill Plates
 - Permanent Horizontal Angle

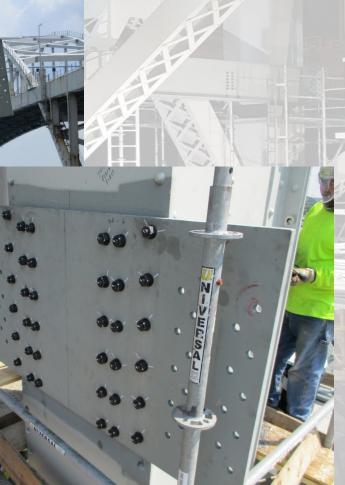
Temporary Support System Connection Plates to Tower Legs

M1Tower Legs:

- Connection Plates
 - Provided connection for Spreader beams
 - Both sides of Tower leg
 - Jacking forces transferred to tower leg through connection plate
 - Required field cut access hole

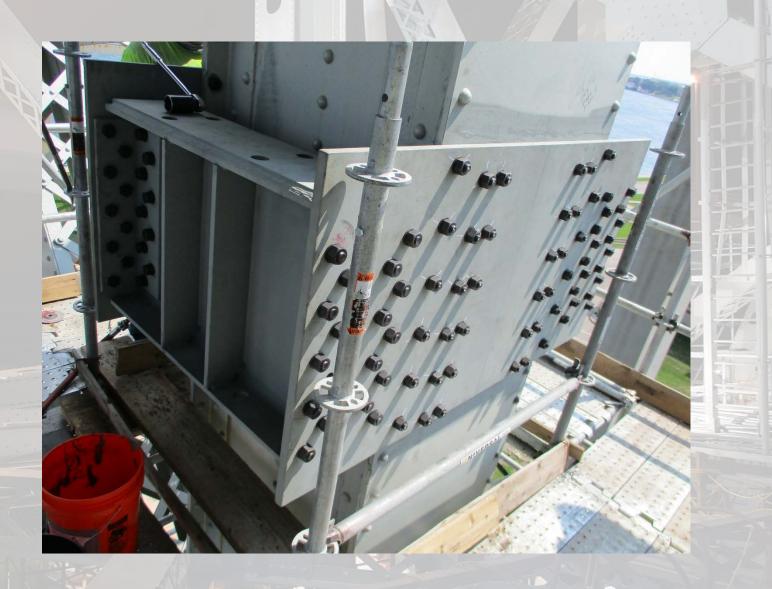
Temporary Support System Spreader Beams (M1)

- Means for jacking truss during load transfers
- Threaded rods through spreader beams supported Strong Backs
- N and S sides of M1 tower legs

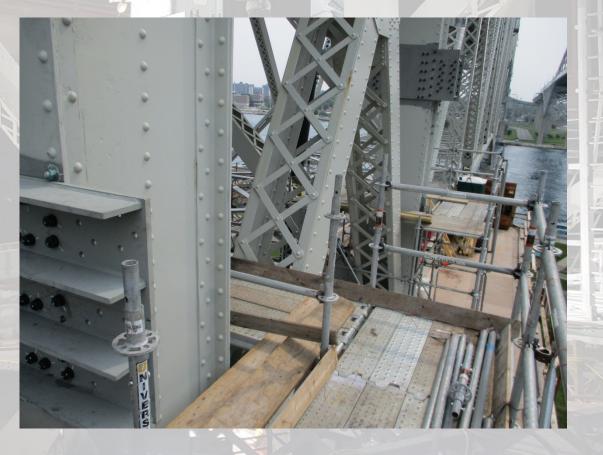
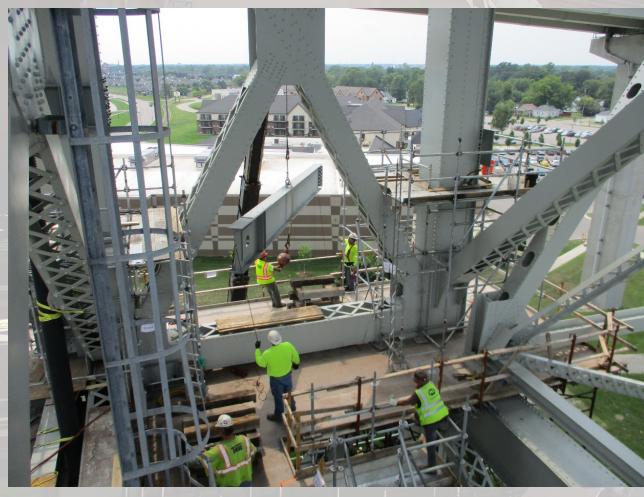
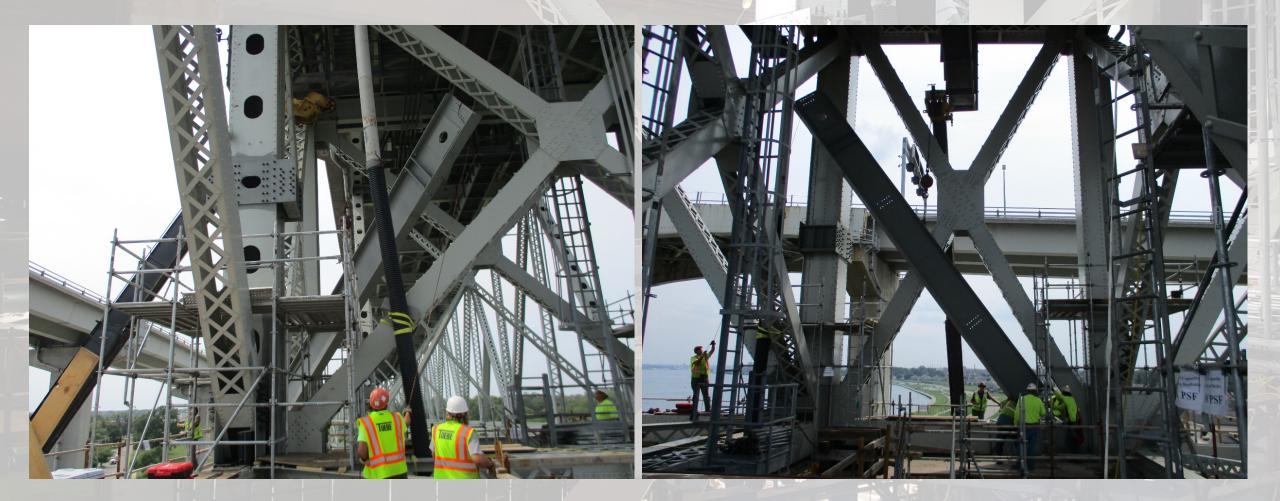
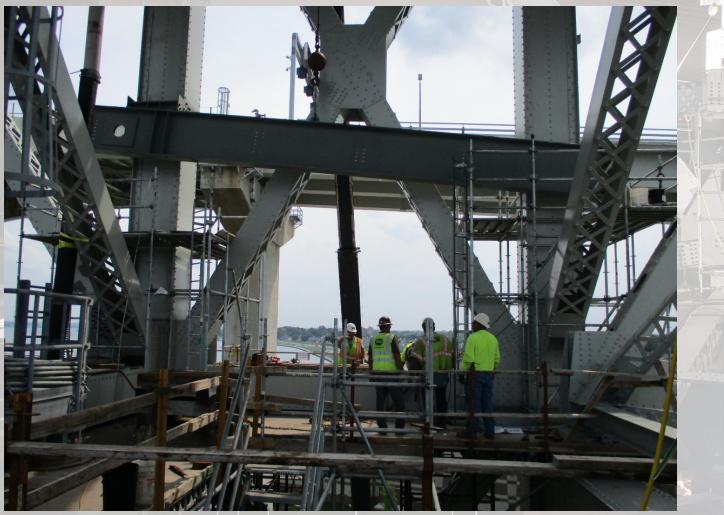
- Strong Back Beams/Diaphragms
 - Installation challenging Length of beams greater than width of Truss Tower
 - Scaffolding conflicted with placement
 - Heavy
 - Connected at M2 stiffened connection plates, suspended at M1 Spreader Beam
 - East end of Beams supported Temporary Pins/Links
 - Four Diaphragms each

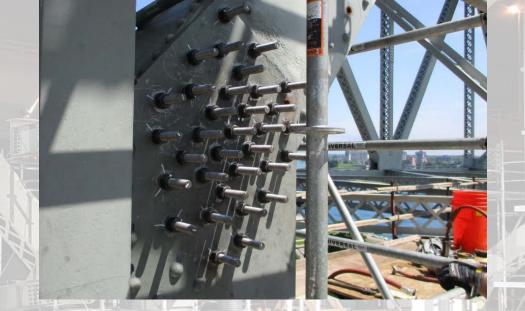
Temporary Support System Knuckle Plates

- A490 HS Bolts replaced rivets, removed one at a time
- Templates used to punch mark holes
- Required installation of temp pins/links prior to placement
- "Cheese" plate between truss diagonal and knuckle plate
- DTI Washers, did not function as desired
 - Used torque on wrench as guideline

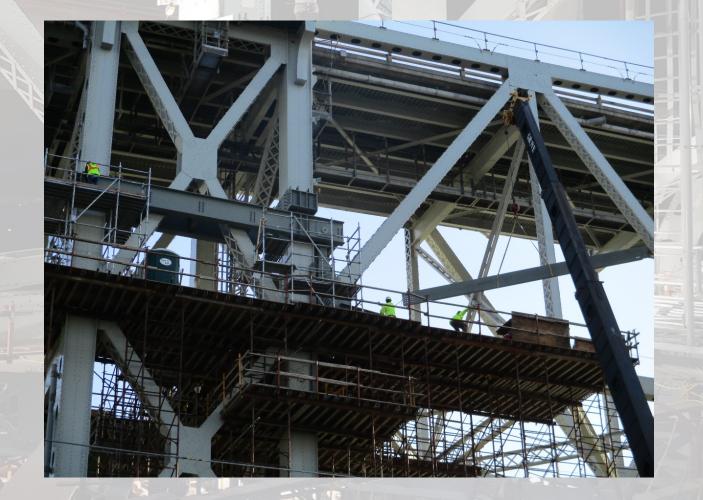
Temporary Support System Lower Cords

- Two diaphragms required
 - Between knuckle plates
 - Inside existing bottom cord
- Batten plates for bracing
- Tight spots challenging
- Field drilling 23 holes at existing bottom cord
- Field coping at inside lower cords for fitment

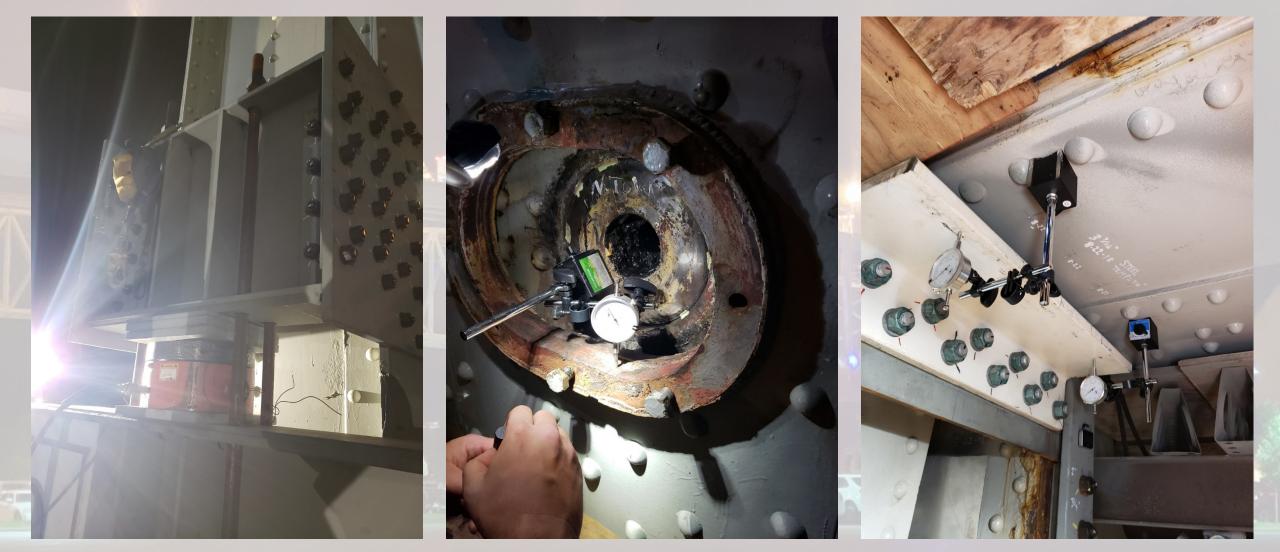
Load Transfer to Temp Support

- Bridge closure during jacking to
- enable assessment of Dead Load
 - Anticipated DL = 290 kips
 - Max allowable was 410 kips
 - Actual Jacking load ~350 kips
- Identifiers for point of "lift-off"
 - Nail polish cracking
 - Measurement of gaps closing up
 - Acceleration of movement observed with dial gauge
- Locked the collars on jacks tightened threaded rods

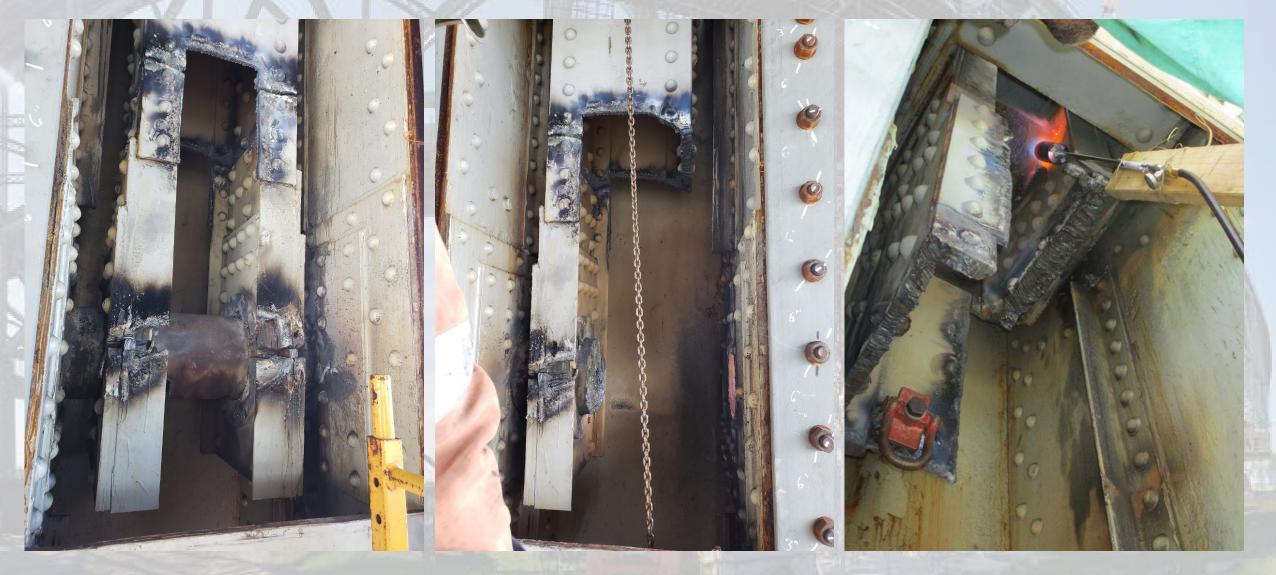
Anchor Link Removal

- Torch cutting to remove portions of link
- Jack system used to pull pins
- Pipe struts to prevent bending during jacking
- Seized pins cut into pieces
- Oxygen Lance to burn out center of pin, relieve pressure on bores

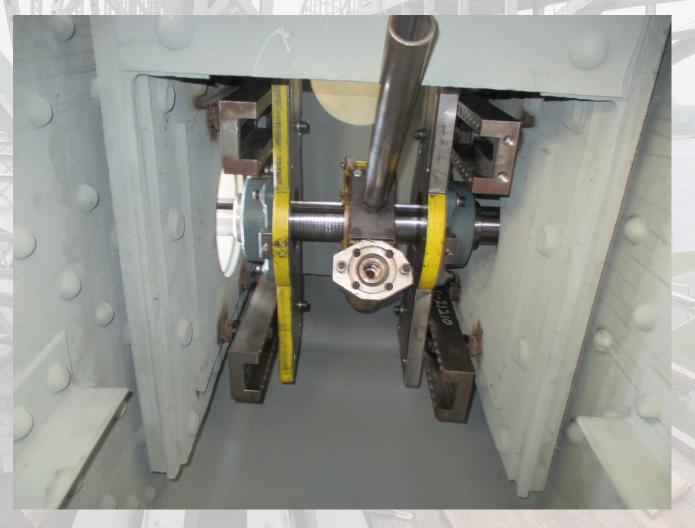
Line Boring Upper Pin Bores (Truss)

- Bore to 9.875" dia (+0.002 to +0.005)
- Inner Pin Plate Conflict
- Bore Bar leveled to earth, verified centered with bores
- Rough cuts (20 thou) and final cuts (5–10 thou)
- Carbide Tip on Carrier

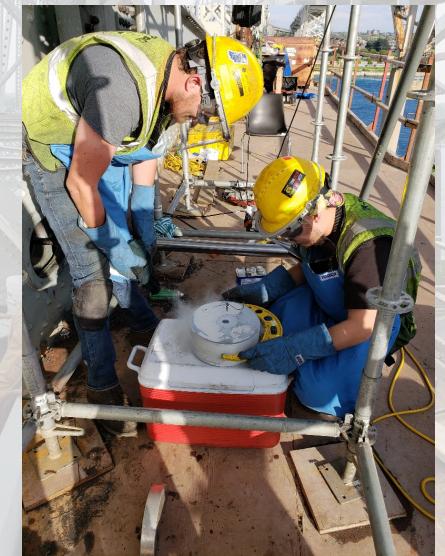
Line Boring Bushing Installation - Upper Pin Bores (Truss)

- "Sandwich Plates"
- Liquid Nitrogen
- Example- North Bushing:
 - Initial O.D. = 9.882"
 - Bore machined to 9.878"
 - O.D. after Liquid Nitrogen = 9.864"
- 45 minutes submerged in Liquid Nitrogen

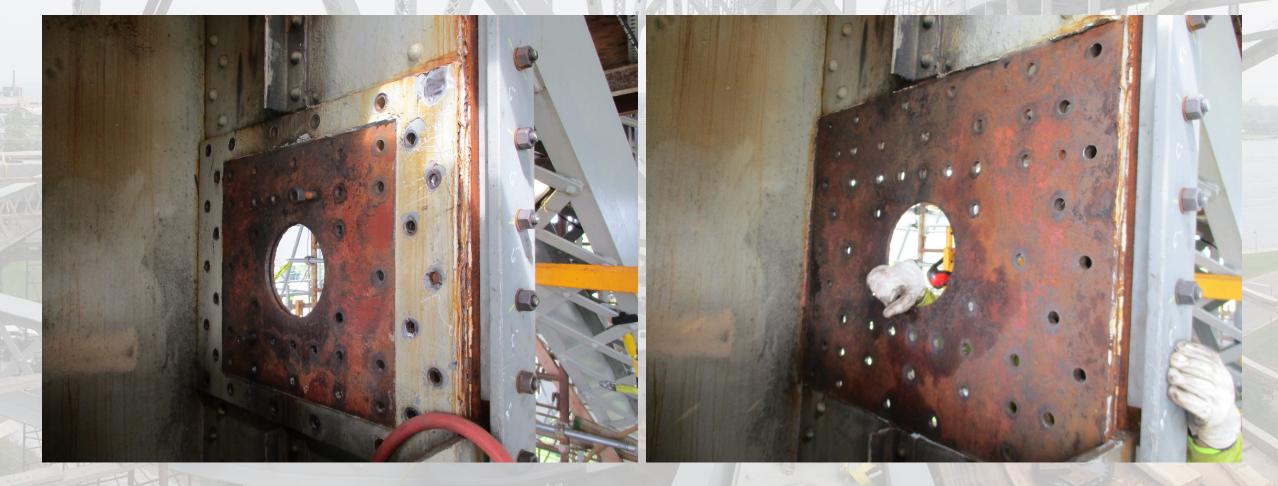
Lower Pin Plates Installation Removal of Existing Pin Plates

- Rivet Removal Required
 - 112 Rivets each leg
- Thickness of multiple plates
 - Drilling to remove
- Blasting/Priming prior to placement of new pin plates
 - Complete blasting/priming inside tower leg

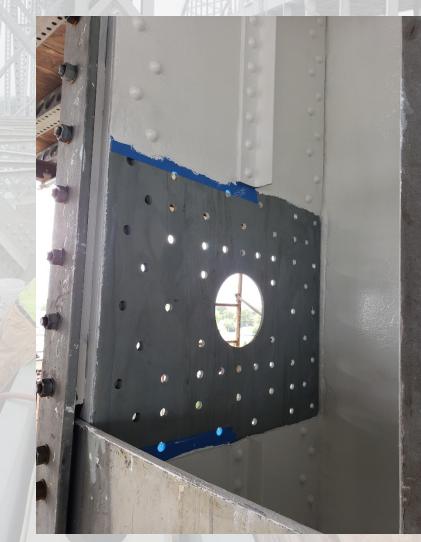
Lower Pin Plates Installation Placement of Plates Prior to Link Installation

- Lower Pin Plates fabricated with slotted holes
- Outer Pin Plates required fill plates
- Plates heavy, 2.5" thick
 - Outer Plate: 337 lbs each
 - Inner Plate: 402.5 lbs each
 - Multiple come alongs used to position
- Temporary Strengthening Angle conflicted with bolts

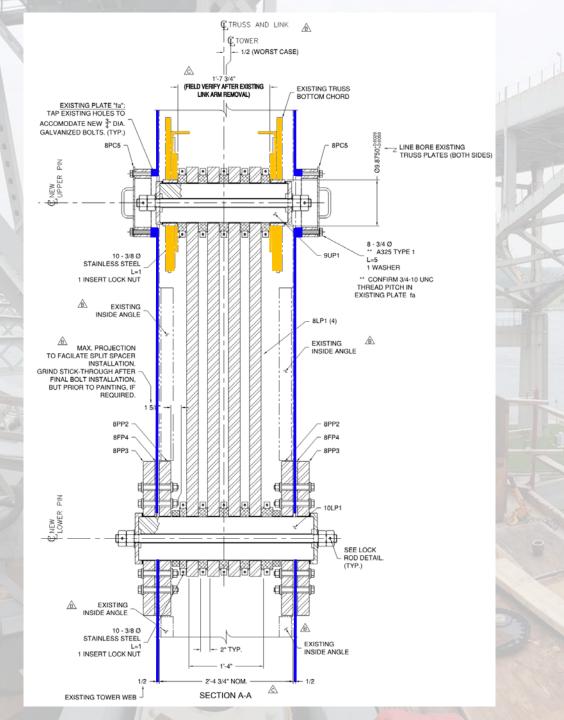
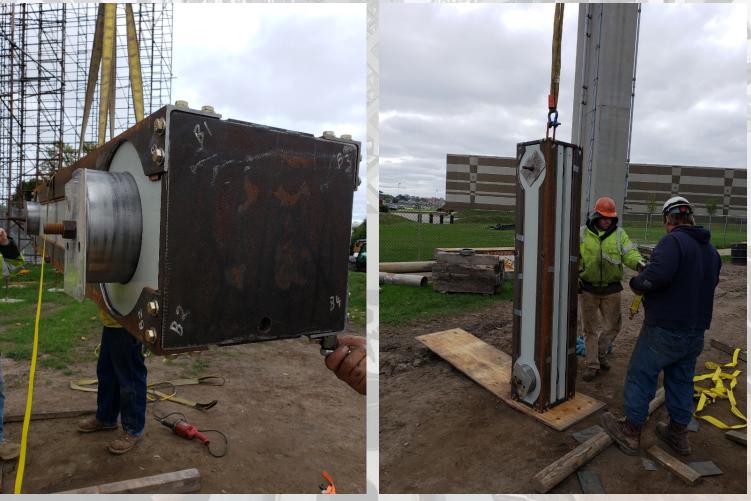
- Contr. elected to assemble links prior to placement
- Steel "cage"
- Sheaves and cable through tower leg opening at truss
- Jack used inside tower leg to raise assembly
- Temporary Pins to be pushed and removed by permanent pins once positioned

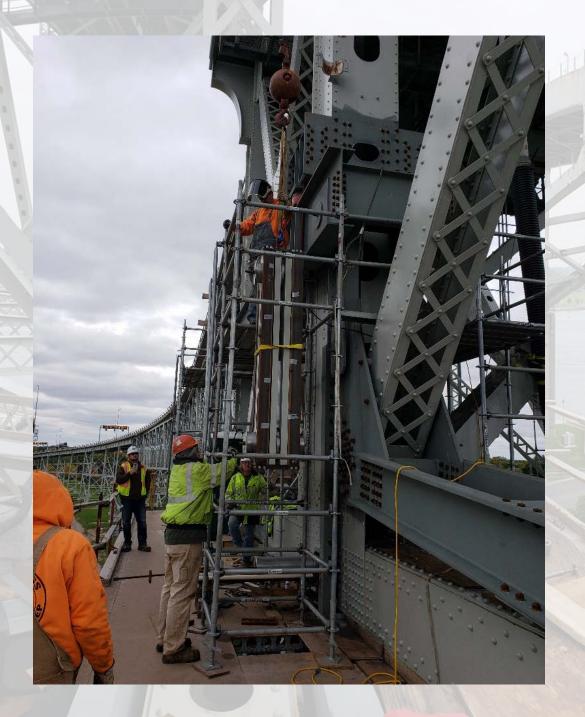
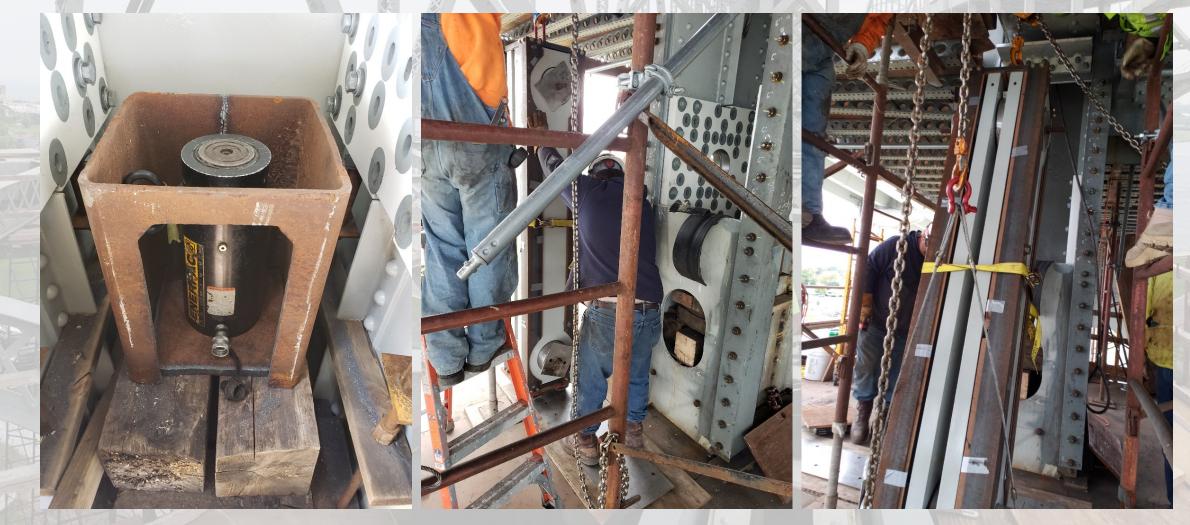
- Come alongs and crane to pull into Tower Leg
- Set on Pancake Jack
- Jacked vertically to align Temporary Upper Pin
- Upper Pin installed, pushing out Temporary Pin
- Jack Truss (if needed) and install lower pin, pushing out Temporary Pin

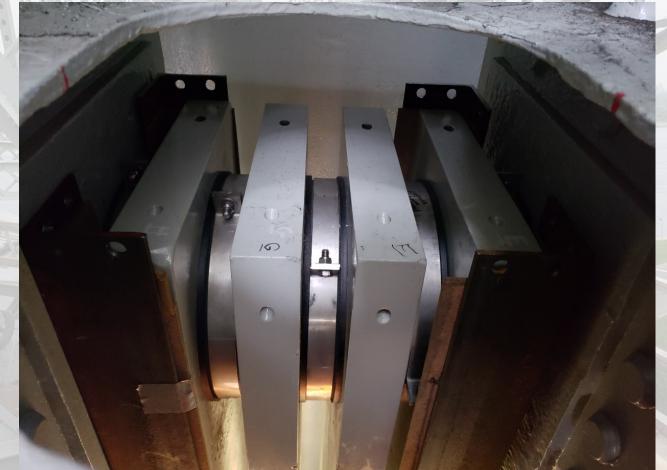
Temporary Pins/Permanent Links Upper Pin Installation

- Chairs to support Pins (Heavy)
 PTFE Dry Lubricant only
- Threaded Rod and nut with wood "jack chair" on opposite end
- Protecting and monitoring Non-Metallic Bushings critical (5 Total @ Upper Pin)

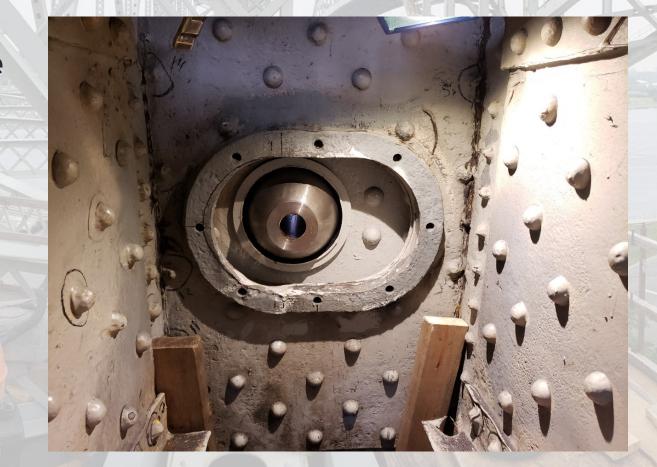
Permanent Anchor Link Installation Upper Pin Installation – Issue

- Pin placed through south Bore and links/Spacers (0.002" tolerance)
- Cone entered north Bore, off alignment
- Upper Pin and Cone rested on Non-Metallic at N Bore while pulled through
- Damage to Non-Metallic Bushing visible

- Spare Bushings, Non-Metallic bushing removed and re-used
- Local shop machined aluminum block for contr.
- I.D. of Steel Bushing checked vs. 0.D. of new Non-Metallic, 3 thousandths difference, acceptable
- Liquid Nitrogen used to shrink Non-Metallic and insert

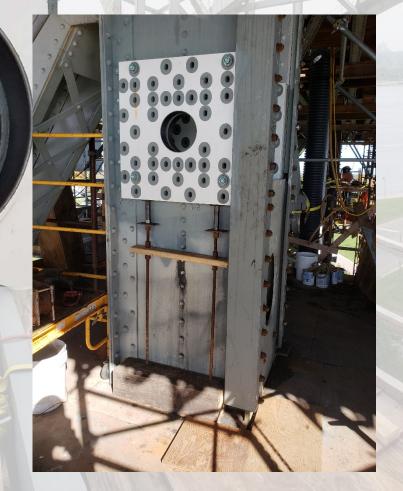
Lower Pin Installation

- Links hanging
 Temporary Lower Pin not aligned with bores
- Truss jacked to original position plus 1/16"
- Threaded Rod to pull Permanent Lower Pin
- Steel Bushings on each end of Pin, PE spacer bushing between outer links and steel bushings
