Inspection Exercise

Bridge – John Doe over John Doe River

- Overview: built in 1950, 3 span steel stringer bridge over water

Bridge – Willoughby Road over the Sycamore Creek

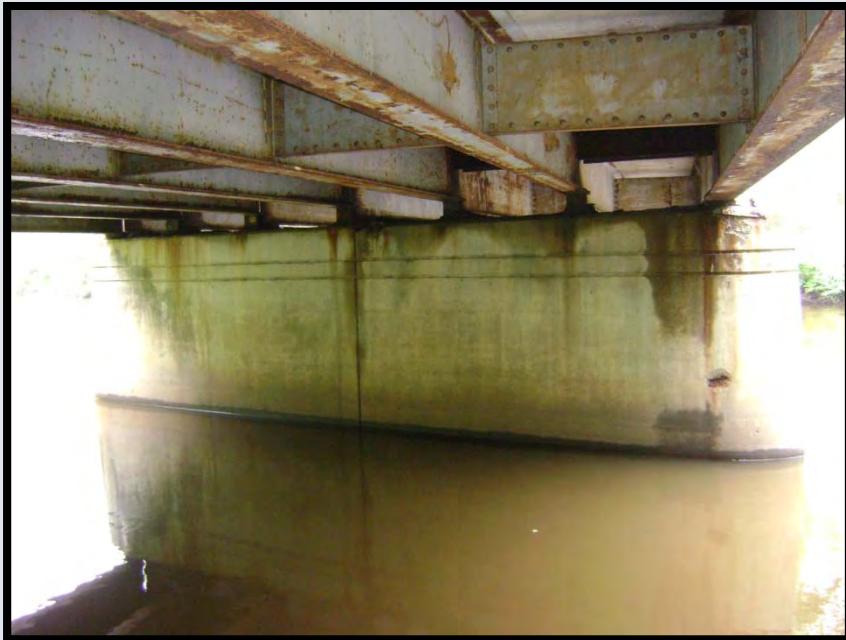
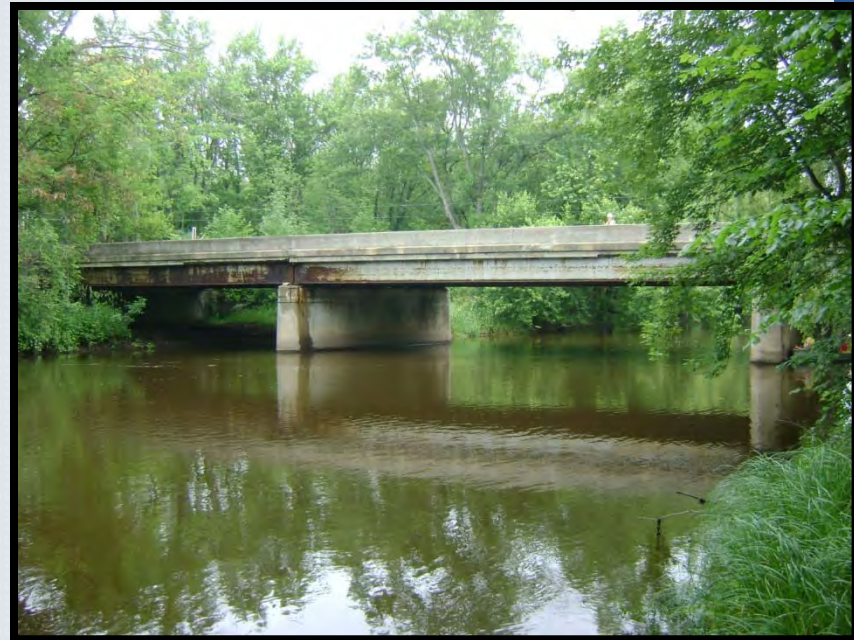
06/27/2007 Previous Inspection Report

- Superstructure, deck, and surface were rated a 4
- Expansion joints were rated a 3
- Posted at 42T/67T/75T
- On a 24 month inspection frequency

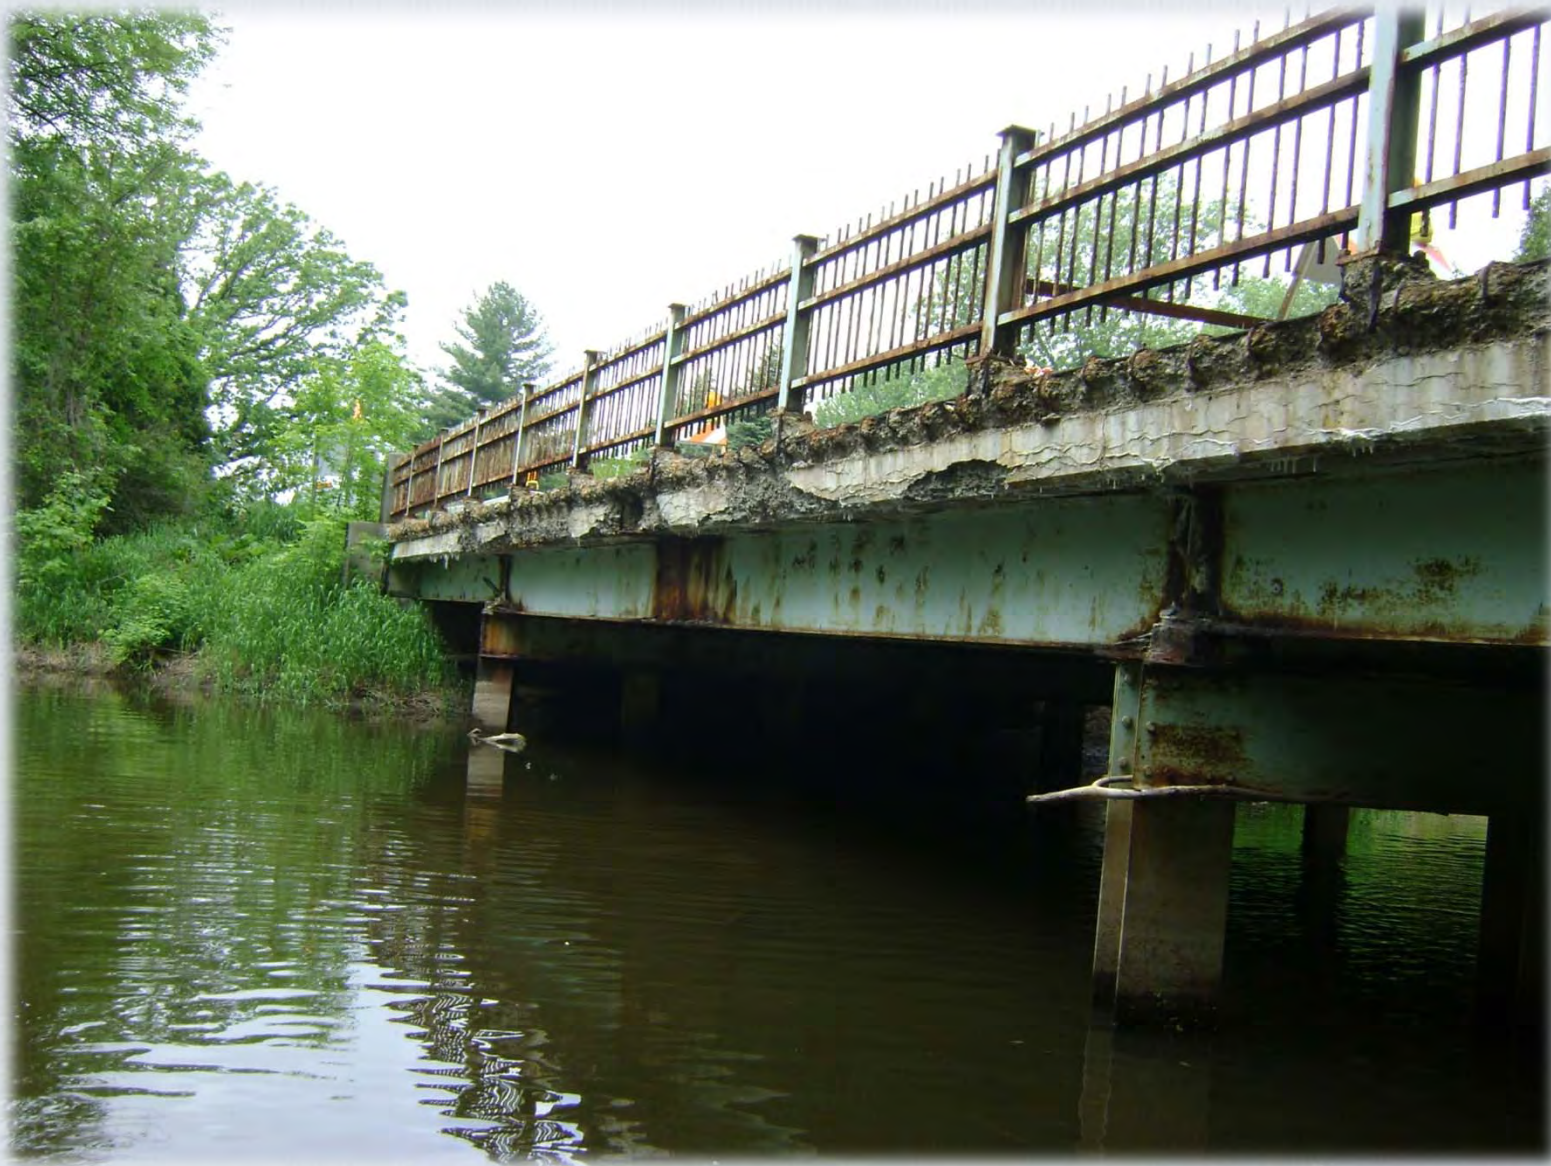
- Overview: built in 1939, 3 span steel stringer bridge over water

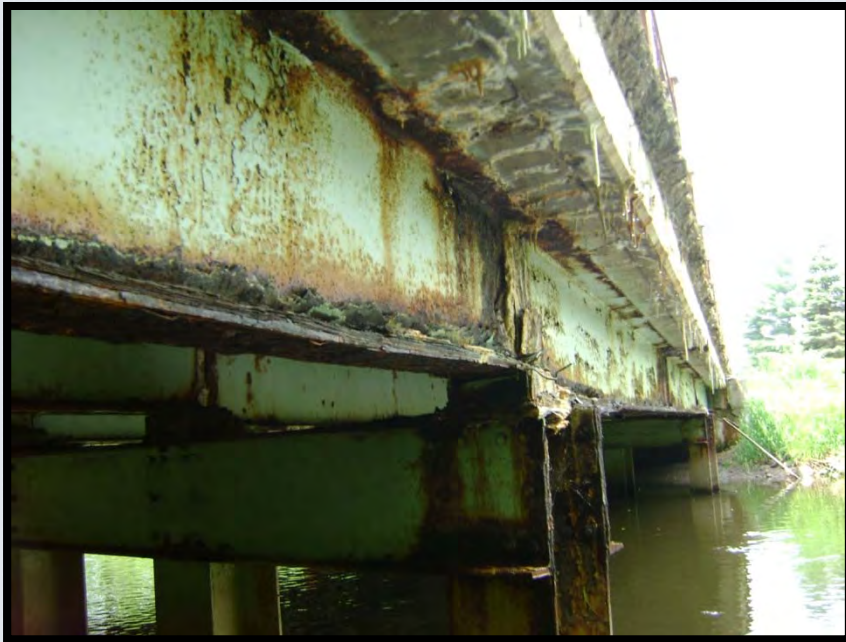
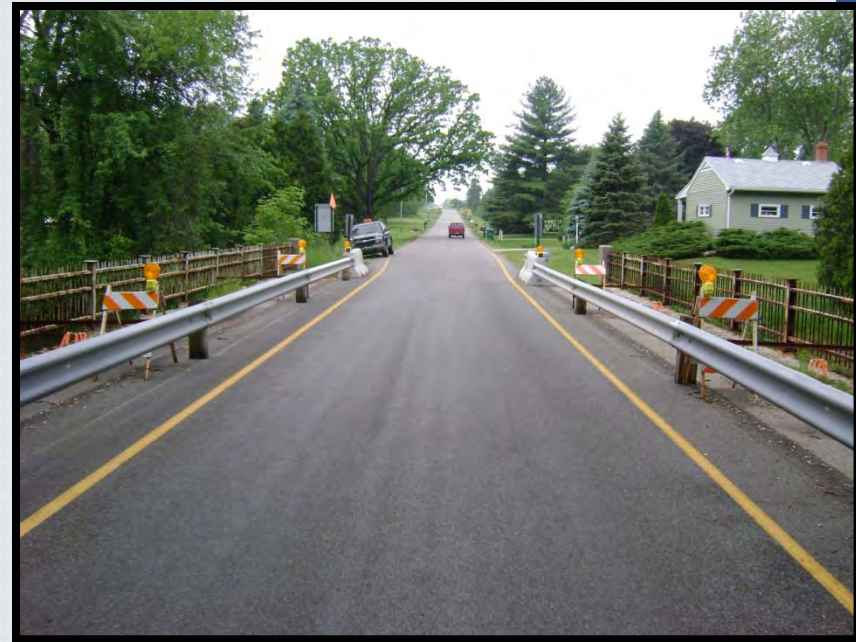
06/21/2007 Previous Inspection Report

- Superstructure, deck, and substructure were all rated a 3
- Posted at 19T/22T/30T
- Reduced to a single lane
- On a 24 month inspection frequency

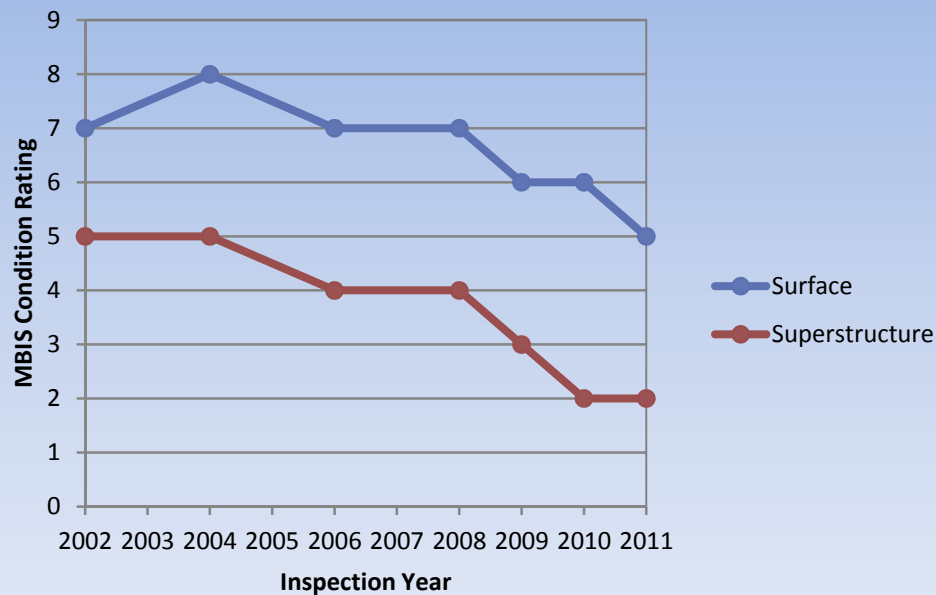
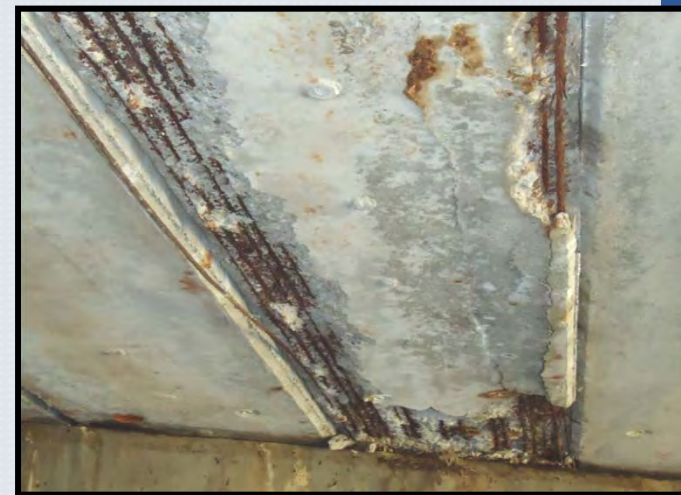
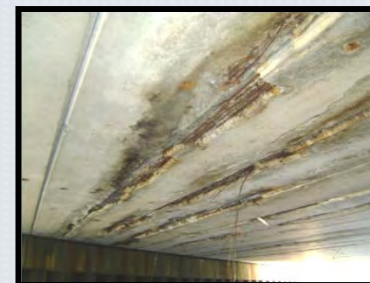
Livernois Road over Clinton River

Facility	Year Built	Wearing Surface	Surface Rating							Superstructure Rating							Load Posting
			02	04	06	08	09	10	11	02	04	06	08	09	10	11	
LIVERNOIS ROAD	1972	Bituminous	7	8	7	7	6	6	5	5	5	4	4	3	2	2	21 Tons
