Michigan Bridge Conference

Use of NDT Tools in Preserving Pre-stressed and Reinforced Concrete Substructures

Siva Venugopalan

Siva Corrosion Services, Inc.

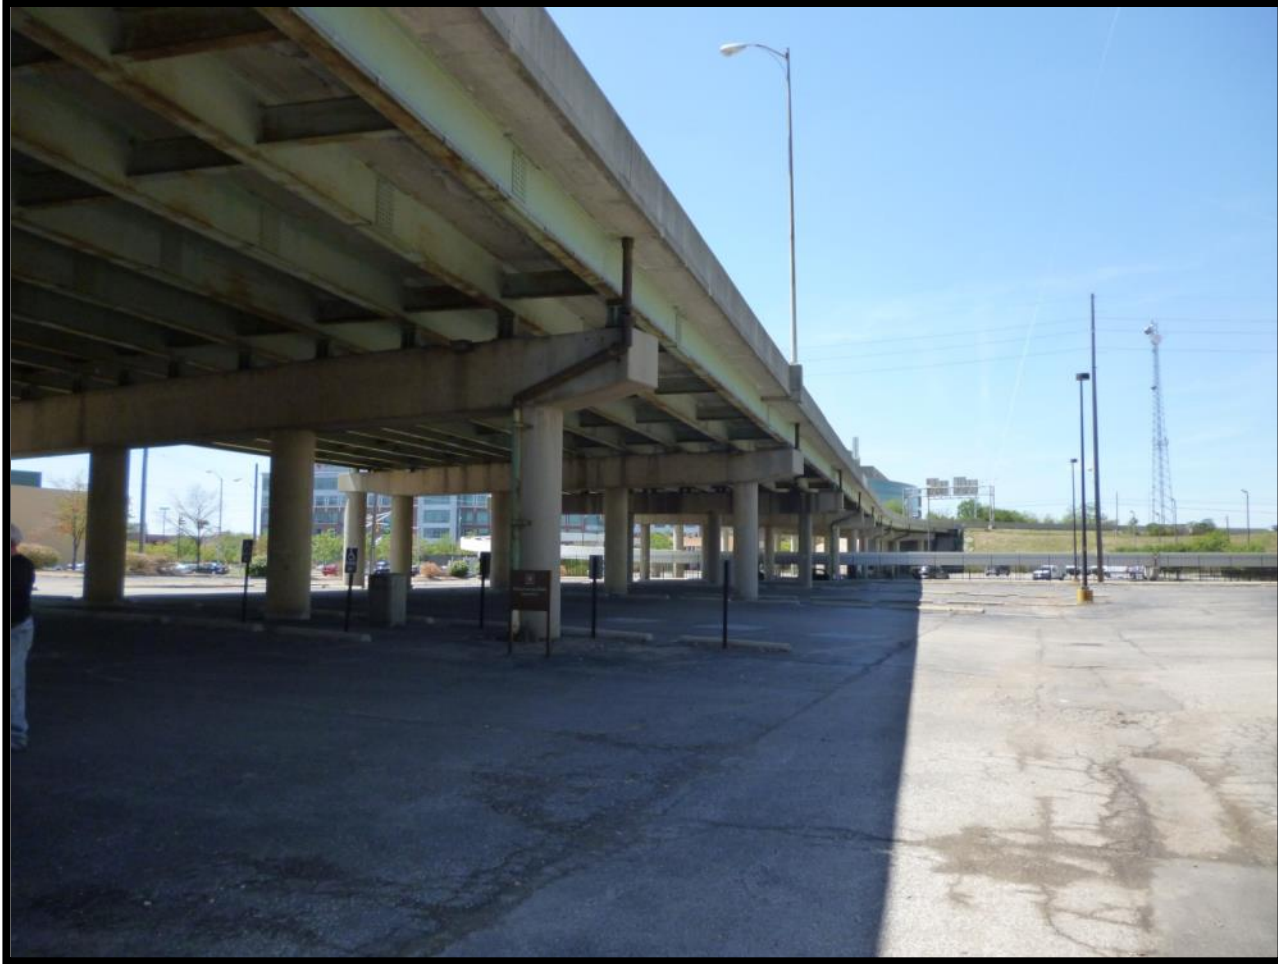
InfraRed Survey: IN I-65 Bridge

- Highway I-65 in Indianapolis, Indiana passes over seven city streets and was constructed in 1972 of reinforced concrete
- The substructure of its 45 spans showed significant corrosion-related damage
- SCS evaluated the deck and substructure components to determine whether corrosion mitigation methods may be used to extend the structure's life
- IR quickly and effectively identifies areas of delamination

- IR quickly and effectively identified areas of delamination
- Delamination was used in conjunction with other data (cover, chloride profiles, etc.) to estimate remaining service life & life cycle cost of various repair options
- Recommended installation of an ICCP system at expansion joint piers to extend the life of the substructure

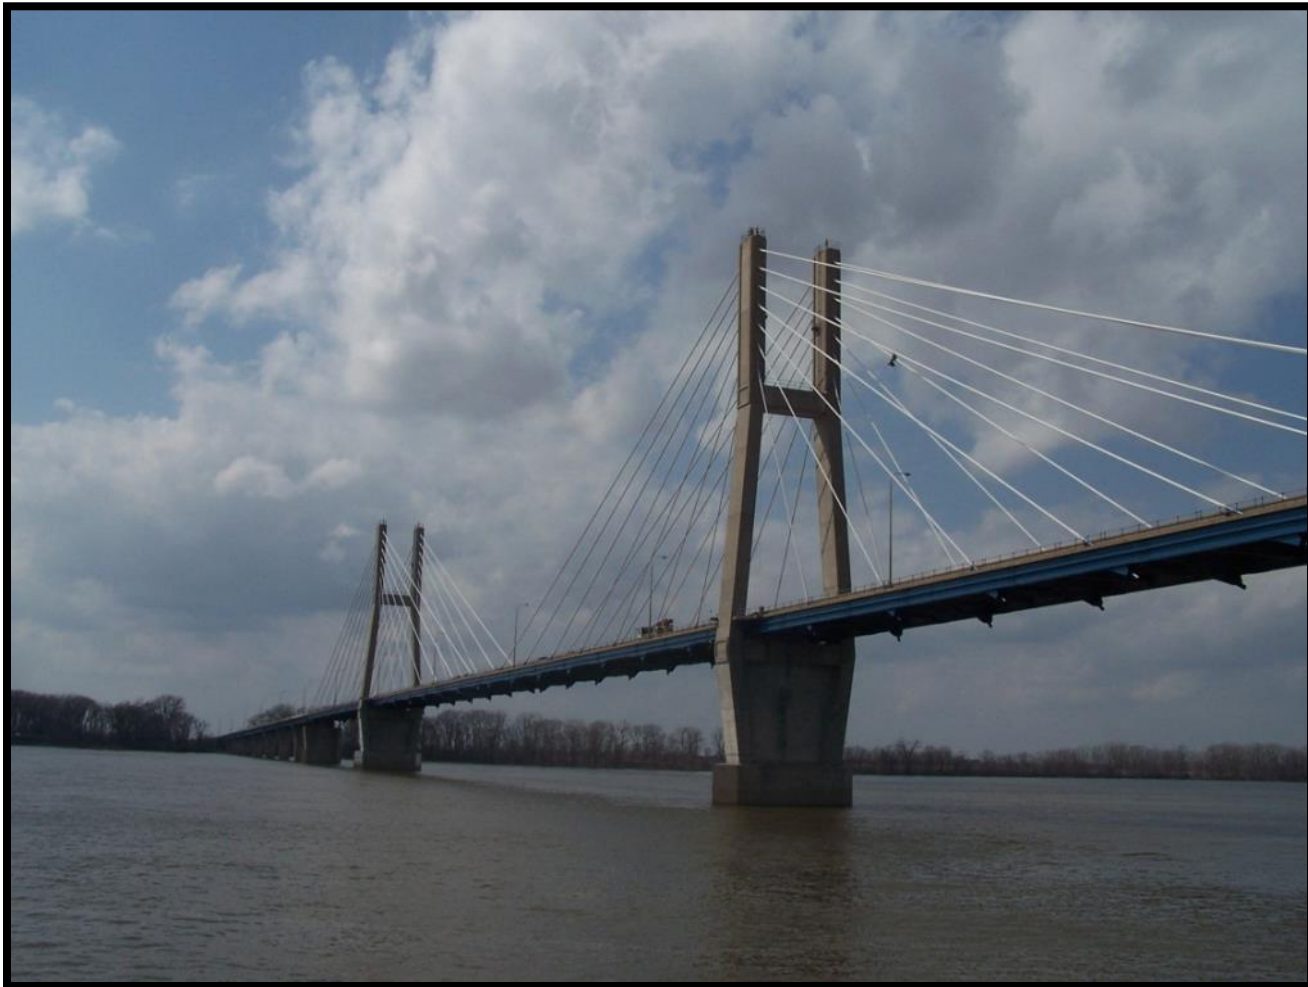
GPR & IR: IL Cable Stay Bridge

- During past inspections, cracks and voids were observed in the HDPE stay pipes
- Water was observed inside the tendon anchorages and neoprene boots
- Water or voids within grouted stay cables could lead to corrosion of the strands

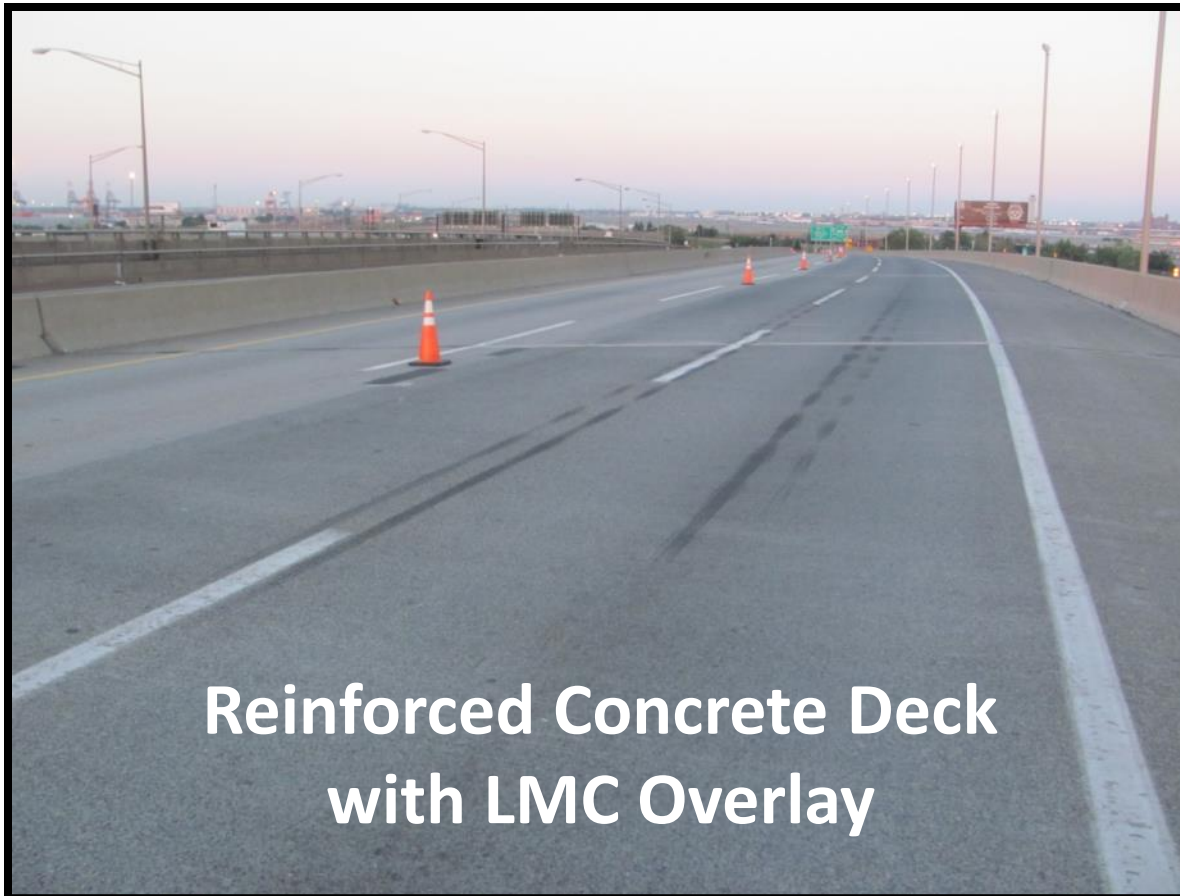
GPR: NJ Deck Survey

- The NJTA deck was over 100,000 sq. ft.
- The overlay placed in 1994 had current significant delamination and spall, cracks, and growth of spall
- Requested to determine the cause of delamination and quantify the extent of damage on the riding surface
- Use Ground Penetrating Radar (GPR) to identify deck delamination and confirm results via sounding and coring at select locations.
- Perform petrographic analysis and chloride content testing on cores

- Extent of delamination quantified
- Petrographic analysis revealed:
 - Cause of delamination was improper finishing of the base concrete leading to a weakened layer at the overlay-base interface
 - High chlorides at the rebar due to escalating delamination
- Replacement of overlay recommended

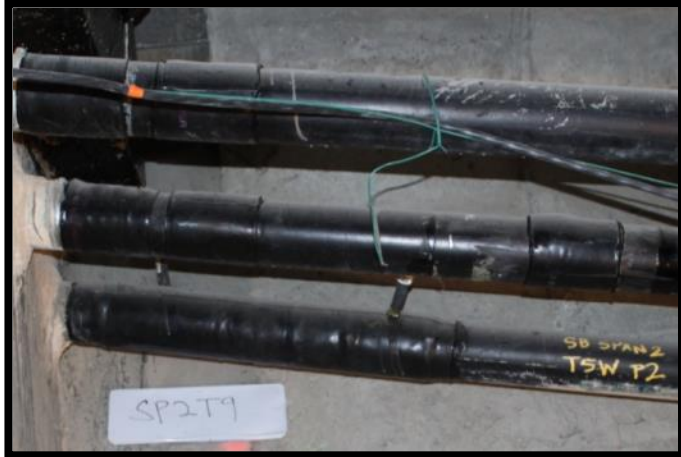
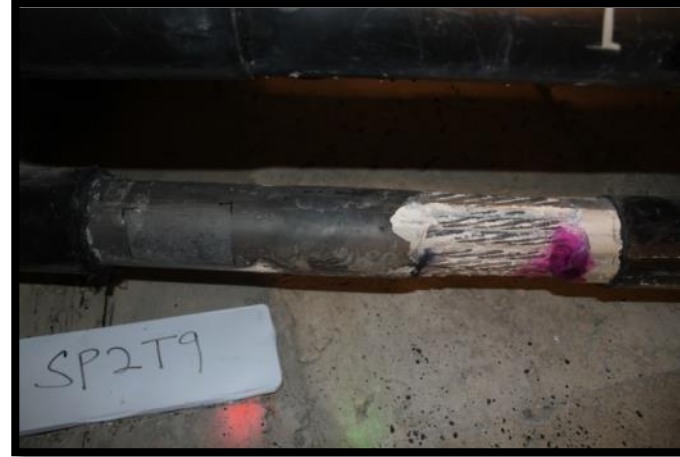
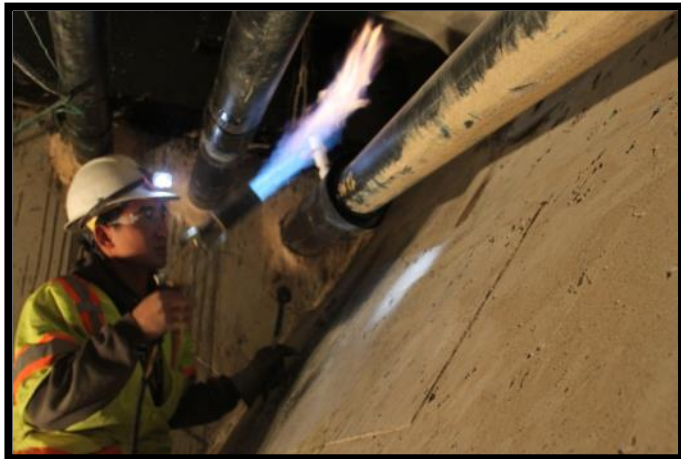
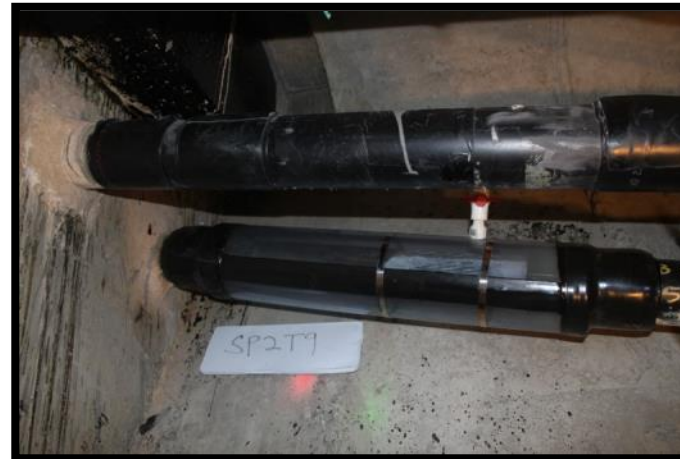
PT Tendon & Bars Evaluation: VA Varina-Enon Bridge

- During previous inspections, voids were identified in the tendons and PT bar ducts
- Some tendons had experienced significant corrosion (broken wires)
