**Applications of Non-Destructive Evaluation (NDE)
for Detection, Ranking and Quantifications of Deterioration**
Prestressed Concrete Box Beams
Reinforced Concrete Bridge Decks

Elin Jensen, Lawrence Technological University

March 19, 2014

Michigan Department of Transportation

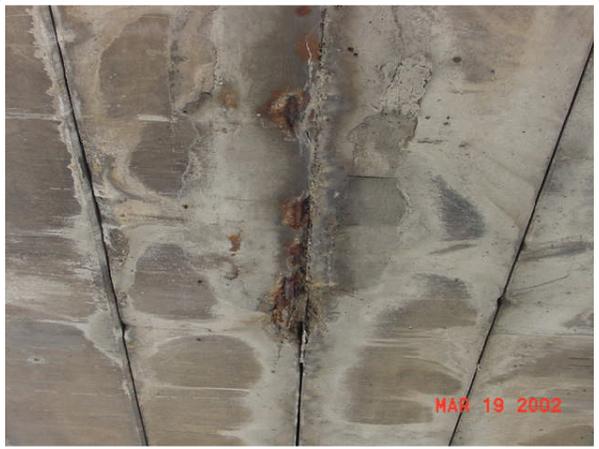
Corrosion of steel & concrete spalling

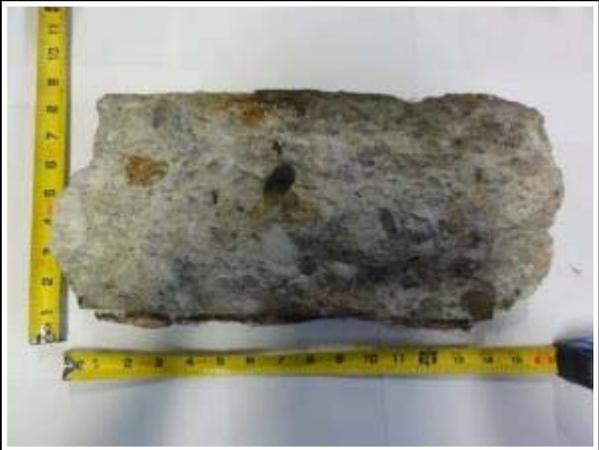
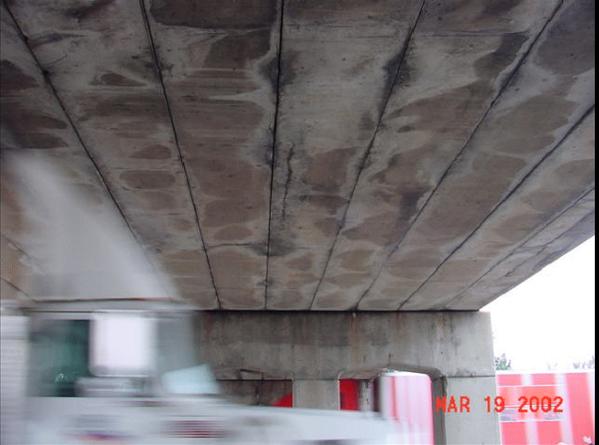
Box beam deterioration due to corrosion of prestressing strands and steel reinforcement

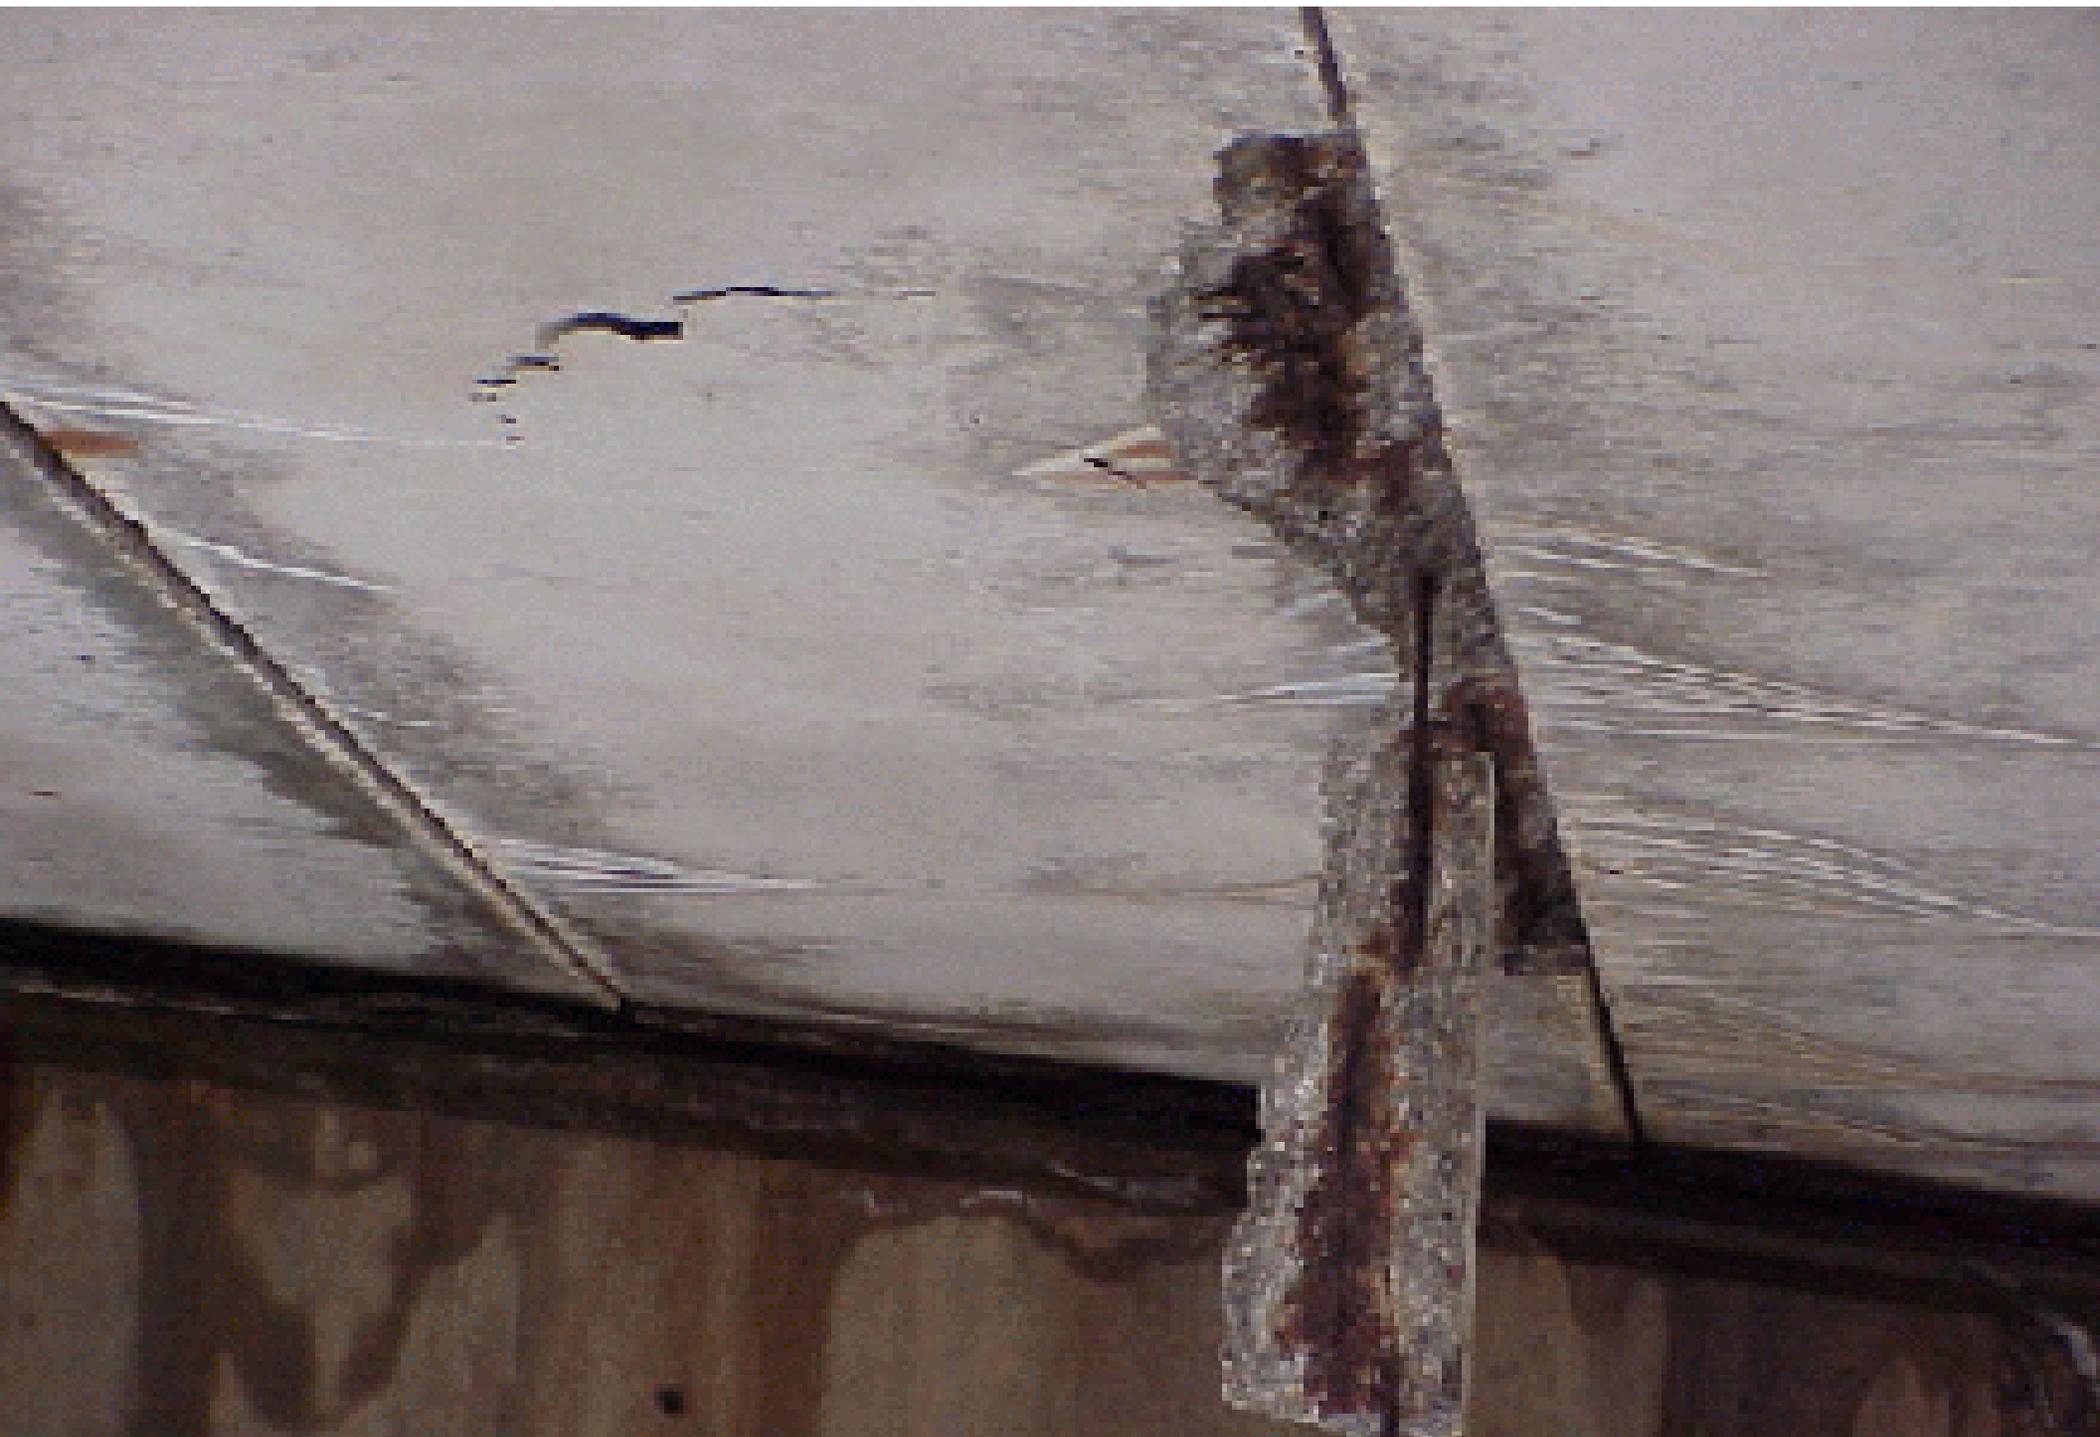
Lake View Drive Bridge failed under service loads

- Fabrication errors: inadequate bottom flange thickness, bottom concrete cover as well as wall thickness
- High chloride levels and carbonation.
- Clogged drain holes
- Strand exposures and ruptures due to collision and corrosion damage

- Longitudinal cracking near bottom strand
- Exposure, corrosion, and fracture of prestressing strands
- Spalling of bottom concrete cover
- Efflorescence as well as leakage of water between beams.

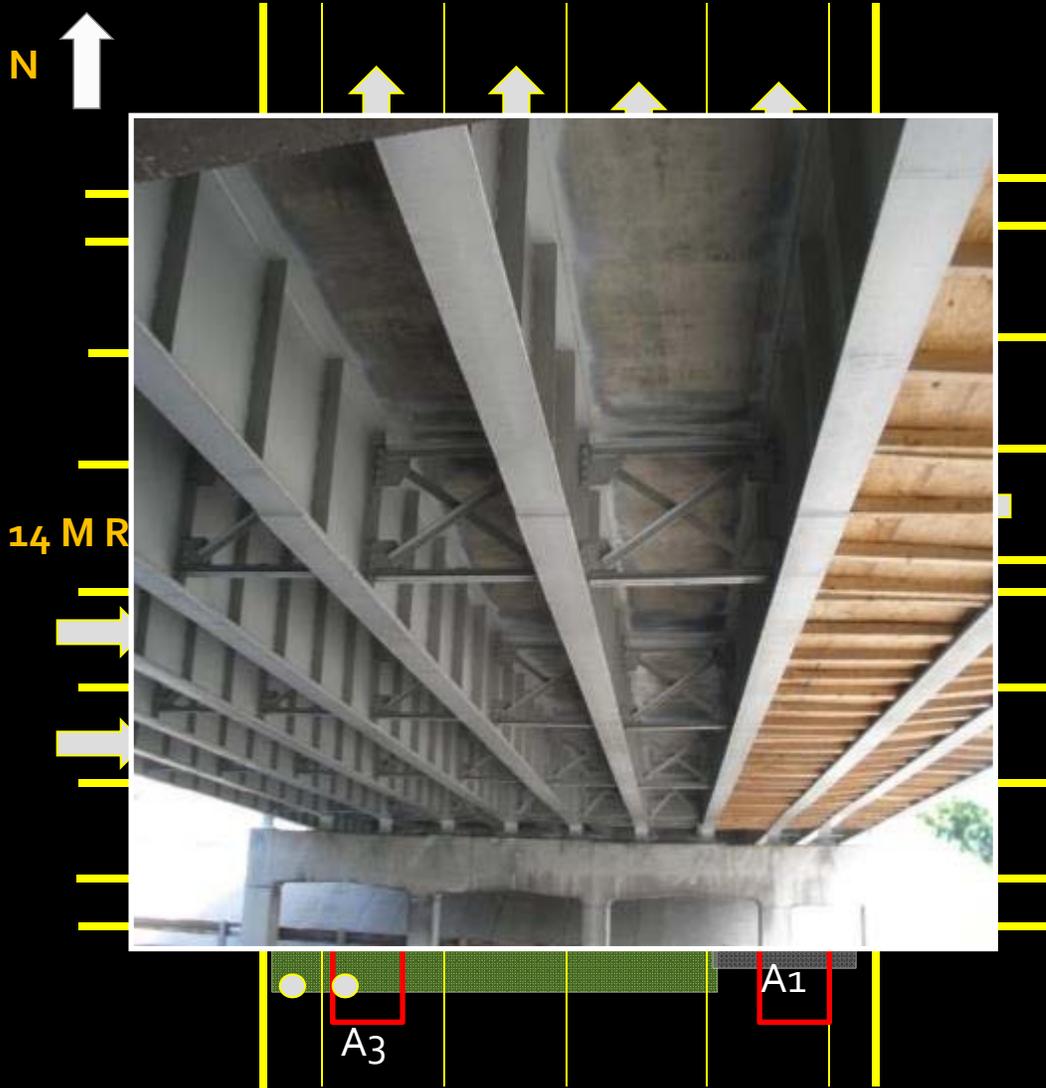
63174-S05-1 I-75 NB 14 Mile Rd

Chance of Corrosion of I-75 NB over 14 Mile Road

Location	A1	A2	A3
Average half-cell potential (mV)	-315	-220	-150
Corrosion rate ($\mu\text{m}/\text{year}$)	78	36	20
COV (%)	13.4	14.4	9.1
Chance of rebar corrosion	50%	50%	5%
# of data points	36	36	36

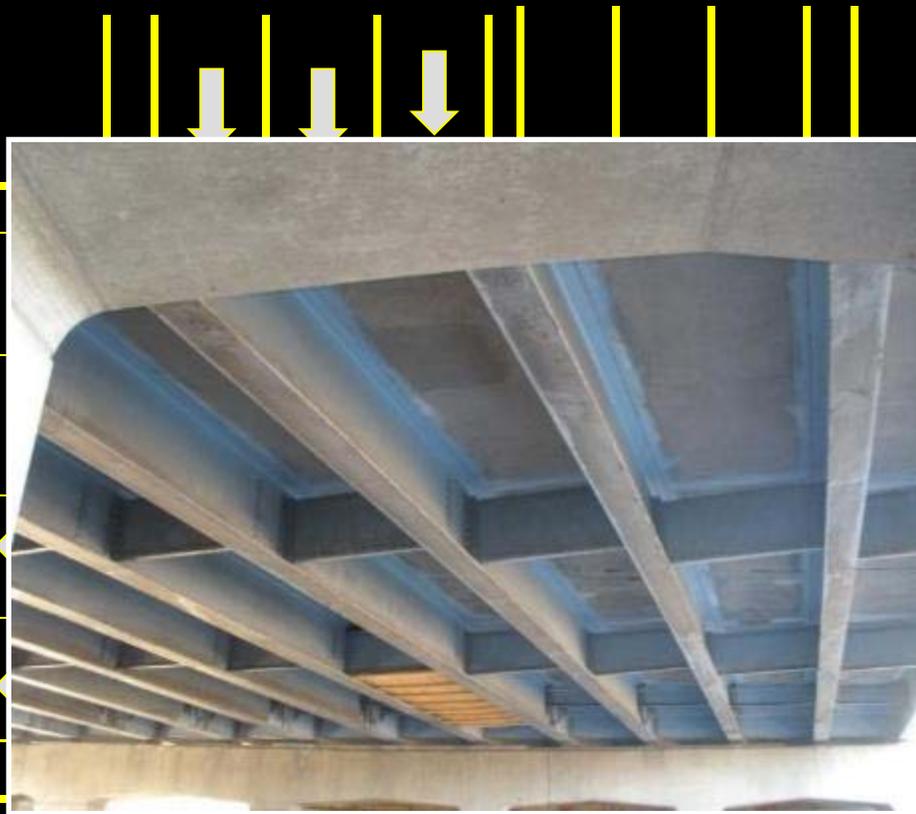
3022-S02-3 I-96 WB Milford Rd

Chance of Corrosion of I-96 WB over Milford Rd

Location	A1	A2	A3
Average half-cell potential (mV)	-405	-400	-368
Corrosion rate ($\mu\text{m}/\text{year}$)	>120	>120	114
COV (%)	4.5	7.6	7.3
Chance of rebar corrosion	95%	95%	95%
# of data points	36	36	36

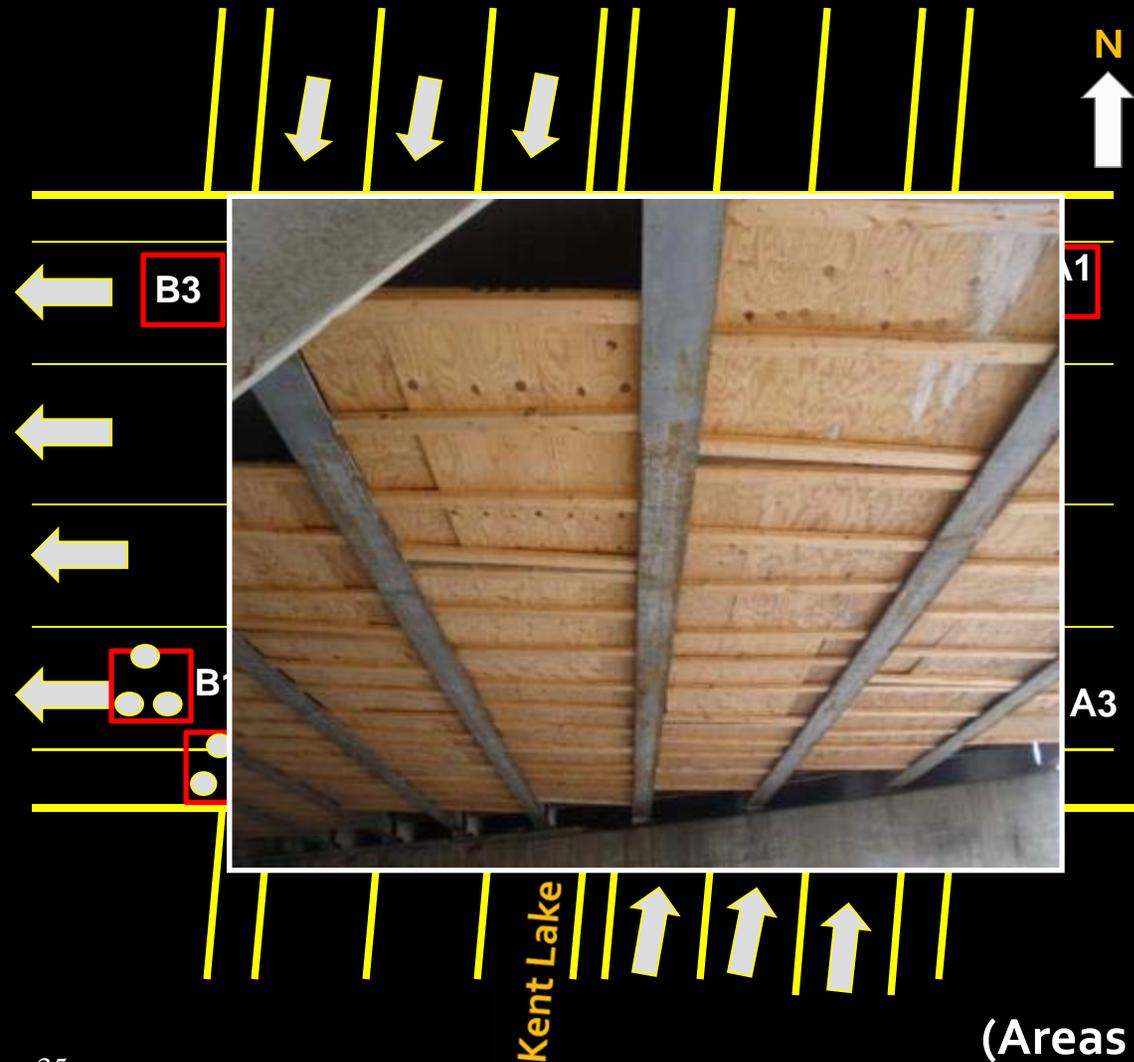
63022-S01 I-96 Kent Lake Rd

Chance of Corrosion of I-96 WB over Kent Lake Rd

Location	A1	A2	A3	B1	B2	B3
Average half-cell potential (mV)	-411	-406	-344	-207	-397	-547
Corrosion rate ($\mu\text{m}/\text{year}$)	>120	>120	97	42	110	>120
COV (%)	18.1	15.3	12.7	12	15.9	8.7
Chance of rebar corrosion	95%	95%	50%-95%	50%	95%	Visible evidence
# of data points	36	36	36	36	36	36

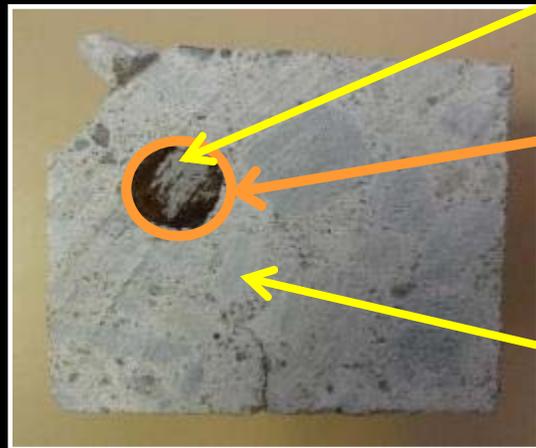
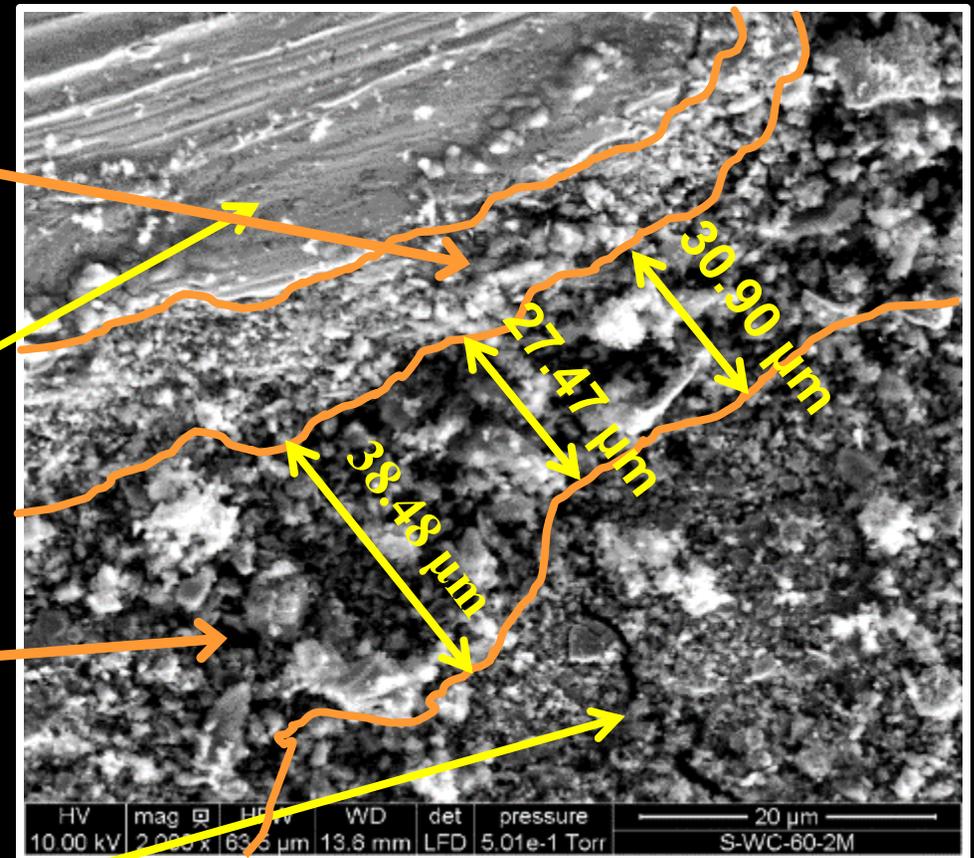
2,000X magnified & examined using
Environmental Scanning Electron Microscope

The thickness of the porous zone is typically considered in the range of 10-60 μm

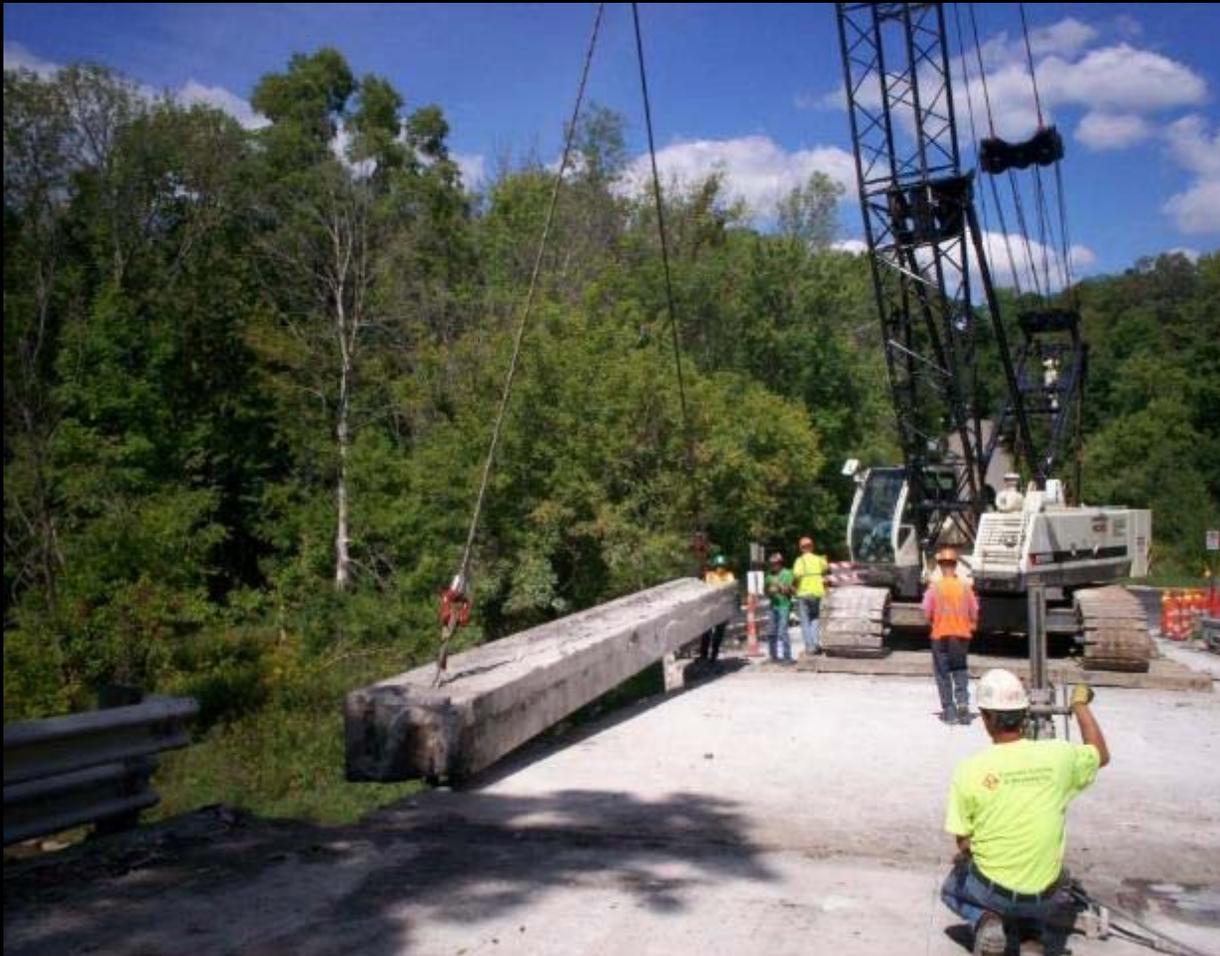
Exterior box
beam being
decommissioned

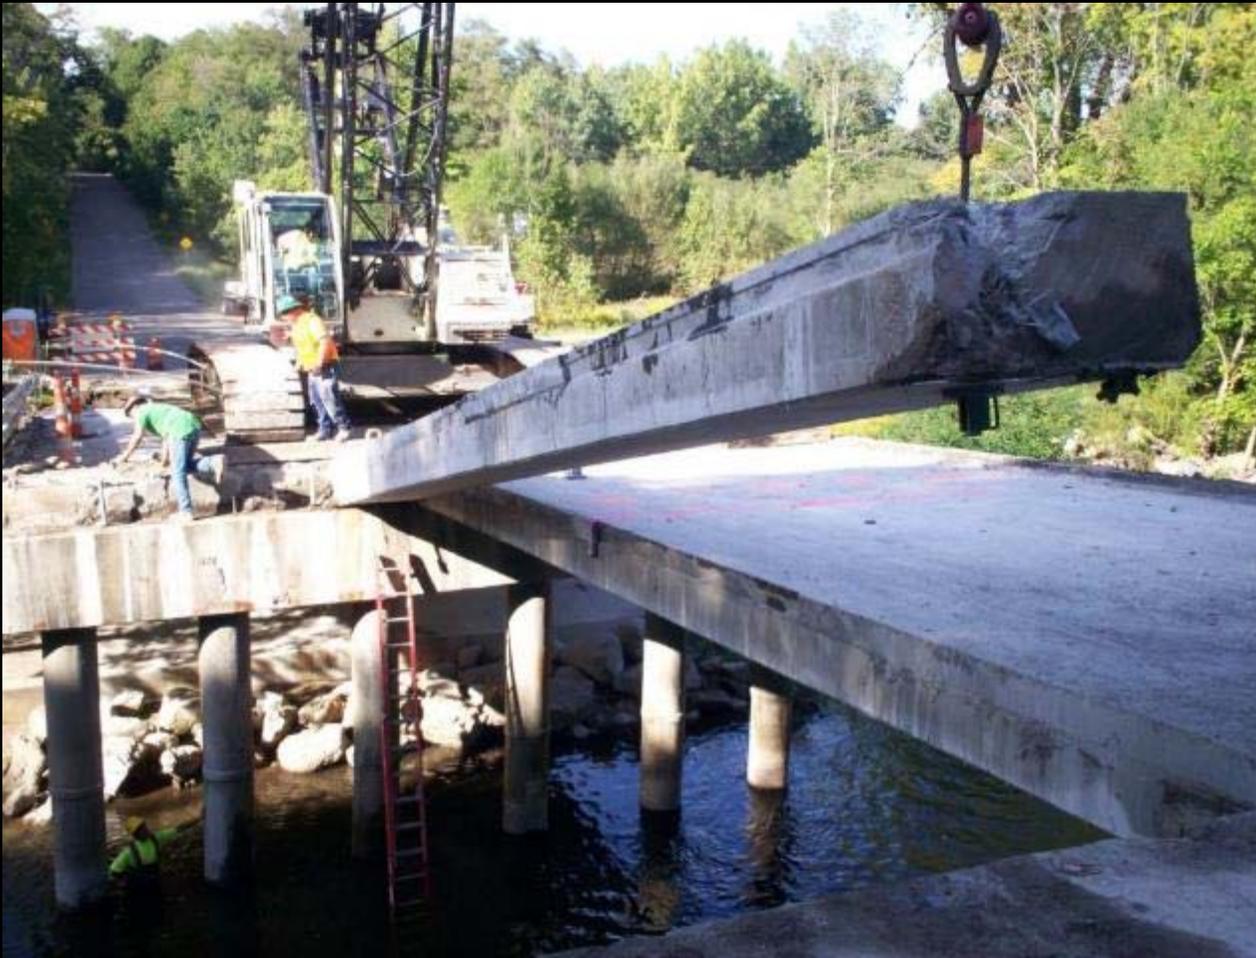
Interior box
beam being
decommissioned

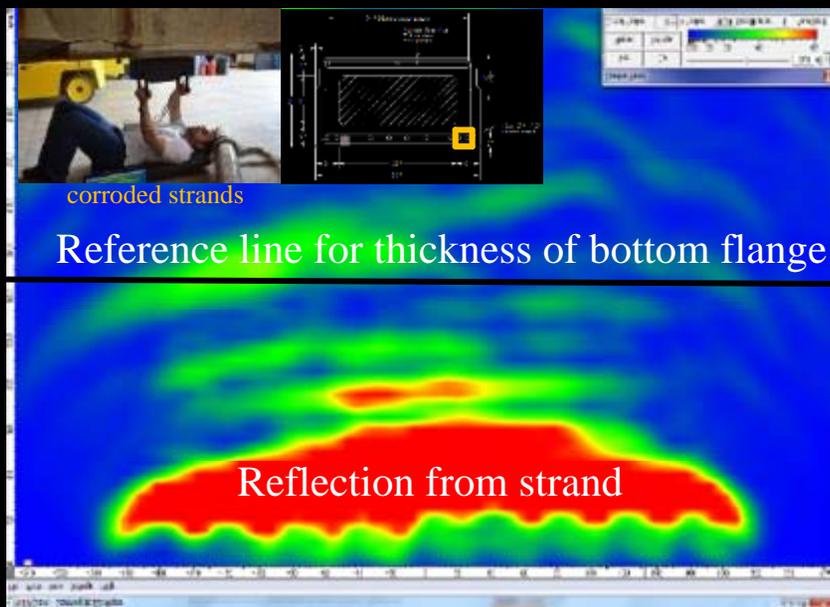
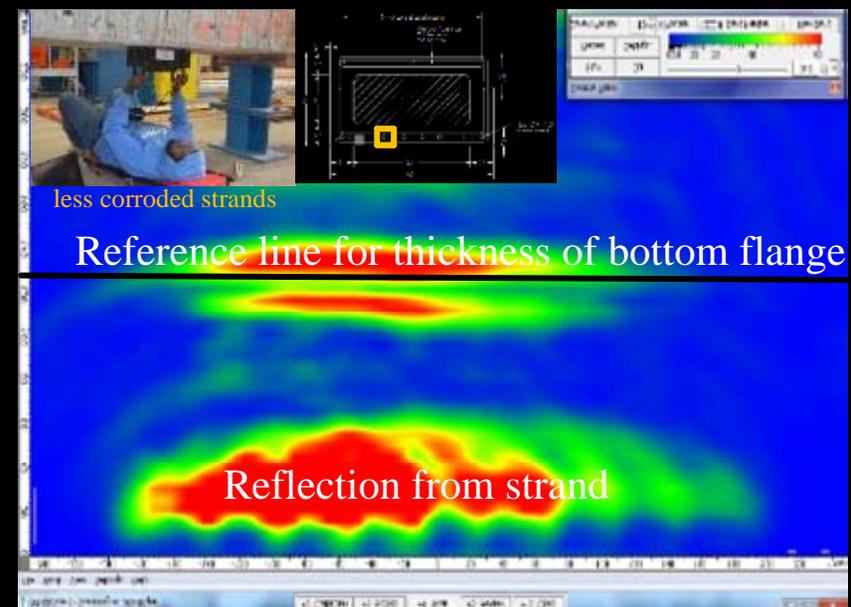
Scanning on Corroded & Less Corroded Strands Locations along Salvaged Beams

Scanning at 100 kHz

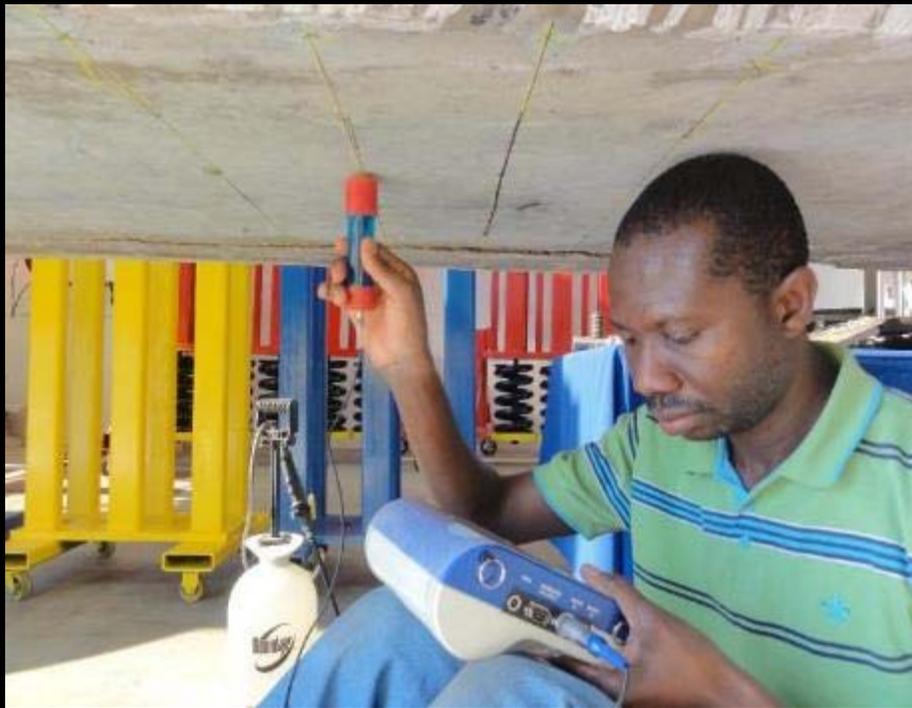
Half-Cell Potential Testing on MDOT Salvaged Beam

Measurement in grids of 6"x6"
on the bottom of the box beams
(742 readings)

- < -500 – Visible evidence of corrosion
- $-350 - -500$ - 95%
- $-200 - -350$ - 50%
- > -200 - 5%

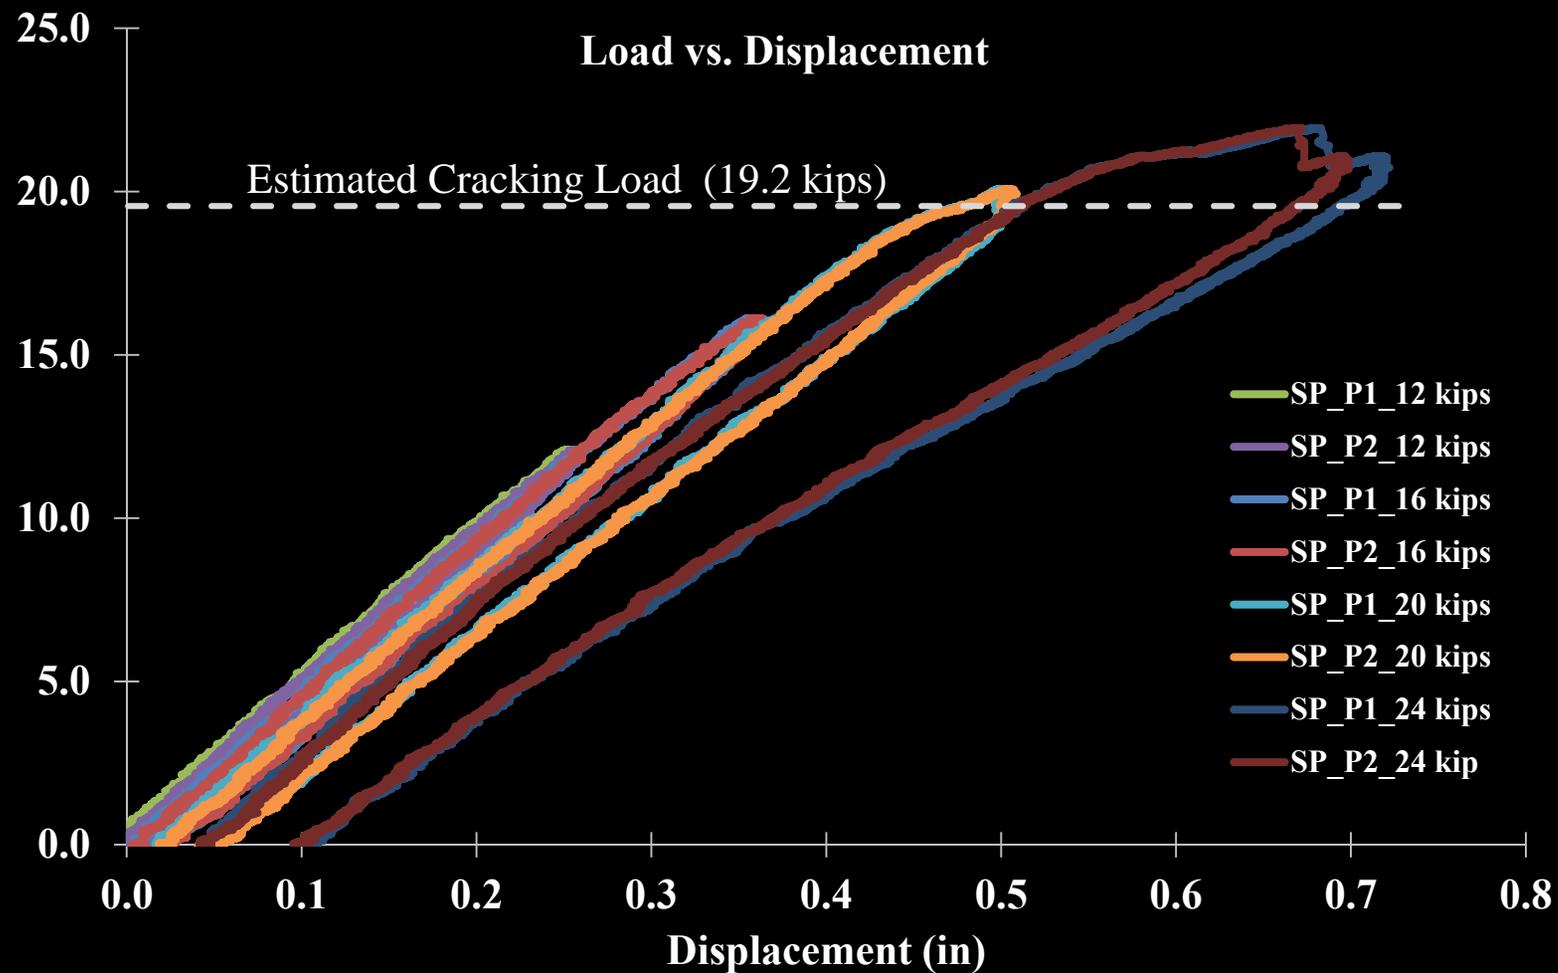
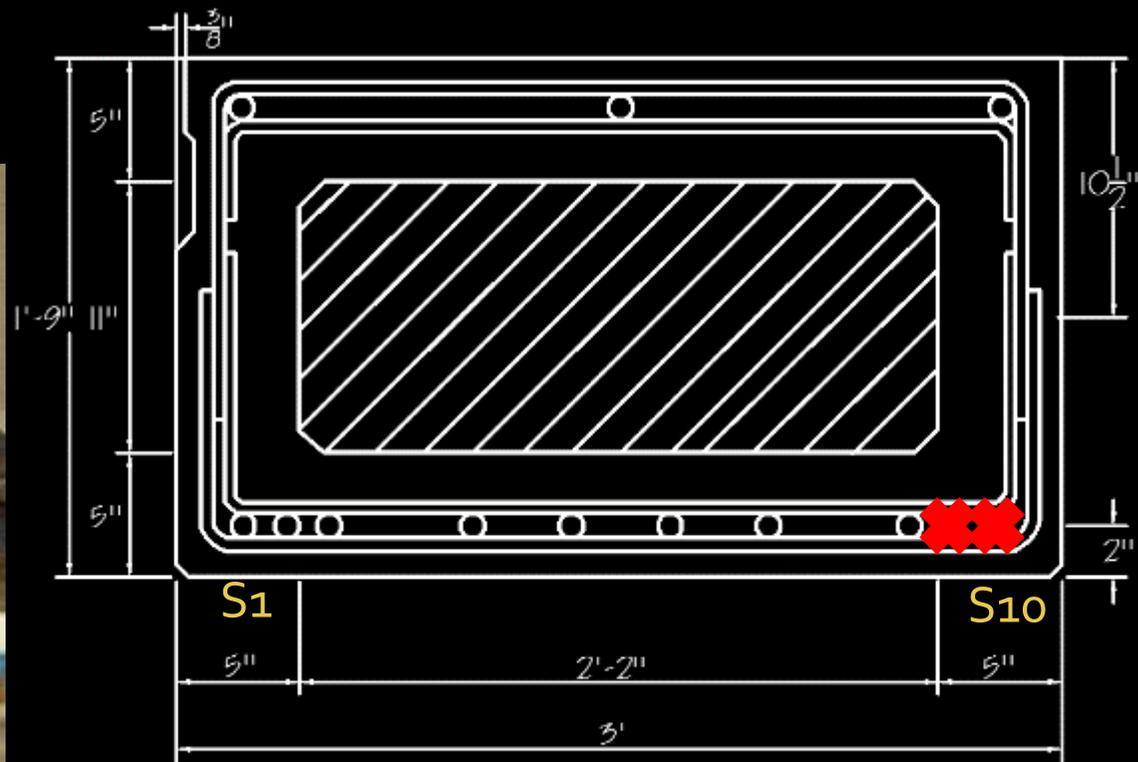
Experimental Results of Residual Flexural Testing of Salvaged Beam, J11

24 kip Load Cycle

- Strand #9 Rupture at 21.9 kips

- Flexural Cracking at 18.5 kips

- The flexural beam failure progressed as expected with the assumption of 20 % average loss of cross section area and 2 of 10 strands broken.
 - The fracture was a brittle shear failure
- Analysis of MFL data as well as visual (microscope) quantification of loss of cross section of the strands will provide further calibration of the MFL method to detect and quantify corrosion
