Kent County
Road Commission

2015 Bridge Conference

Pine Island Drive Bridge Restoration

LTU Beam Testing Update

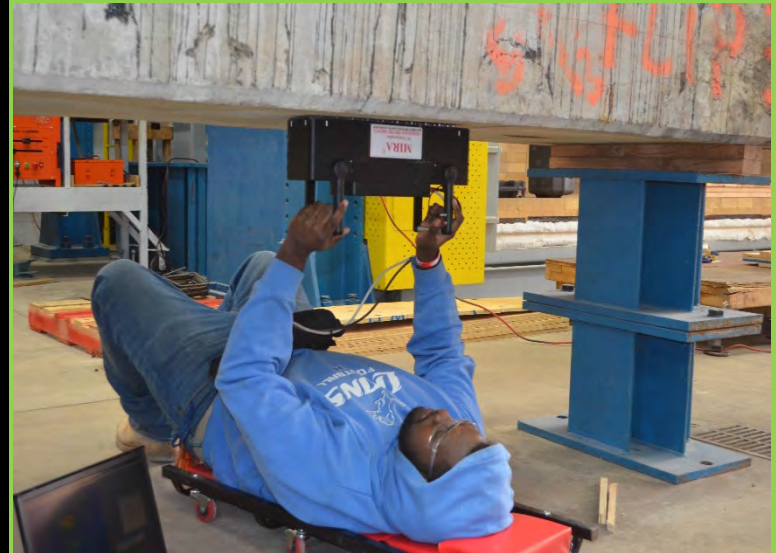
Scanning Strand
#4

Scanning on Less
Corroded Strand

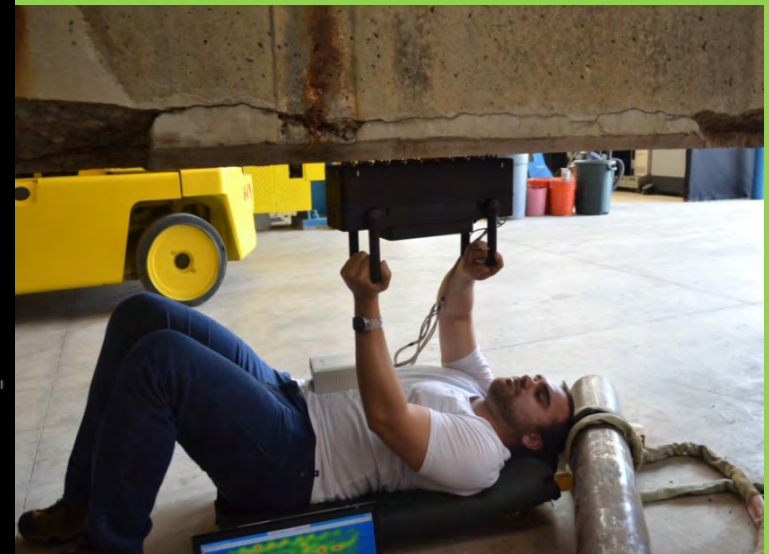
Scanning Strands 9 & 10

Scanning on Corroded Strands

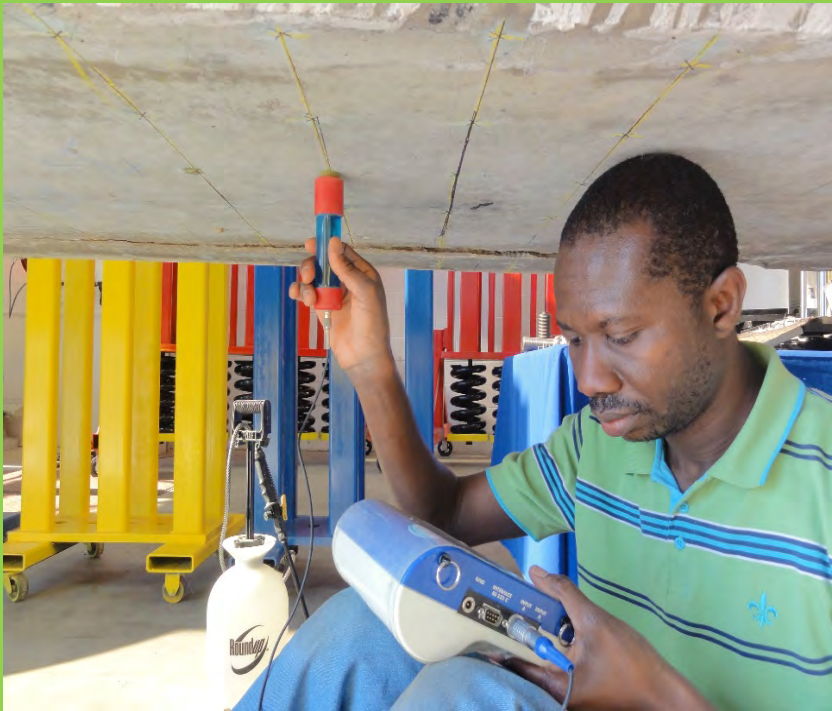
Half-cell potential measurement of bottom strands

6"x6" grids mapped at the bottom of the box beams.

Readings taken from the intersection of these grids.
