The Zilwaukee Bridge: from the beginning to the present

Matthew J. Chynoweth, P.E.

Michigan Bridge Conference Presentation

March 21, 2012

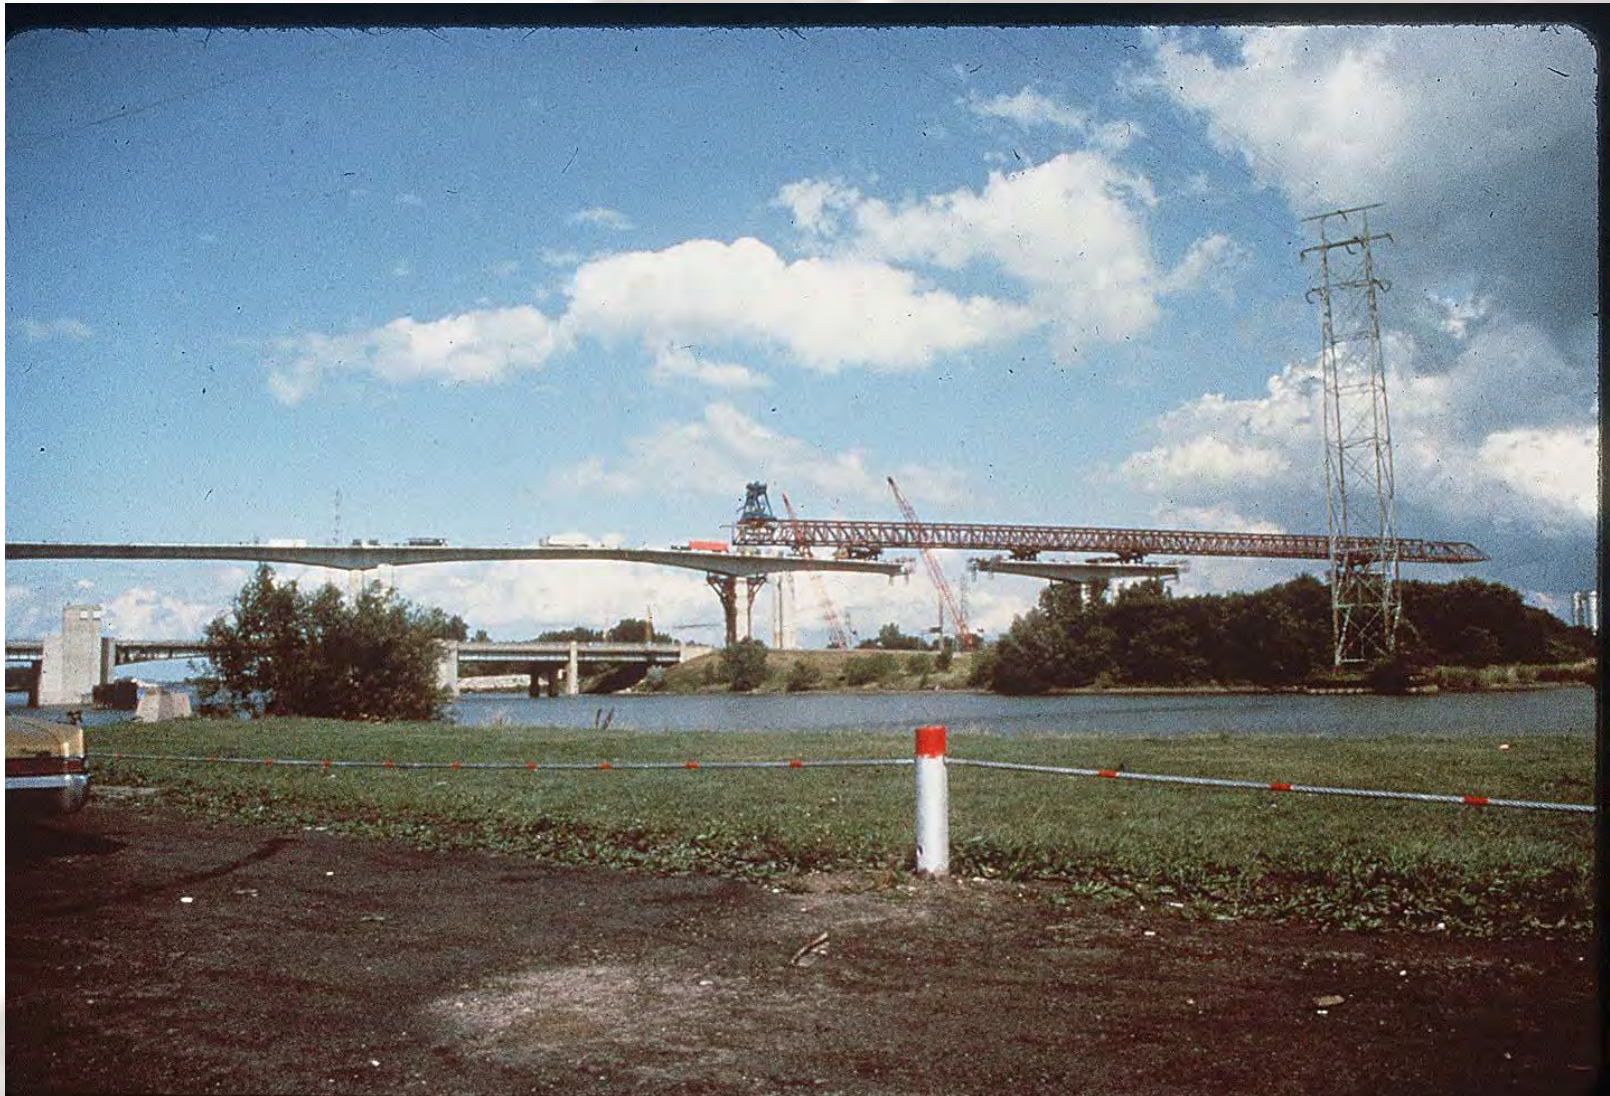
August 28, 1982 Construction accident

- Shortly after midnight on August 28, segment 10NSG was delivered by the segment hauler to the gantry
- The gantry began moving south, when sudden and large displacements of the 11NS cantilever resulted in a downward deflection of roughly 5'-3", and the expansion joint in span 12 deflected upward by 3'-6"
- 1200 k – 1500 k horizontal forces tilted Pier 11N 9" to the north until the northerly pile group failed in tension, cracking the footing from top to bottom
- Equilibrium was reached when the Pier 11N footing became a spring due to lack of EI, and the launching girder stiffness drew in load, effectively becoming a strut, stabilizing the overall structural system

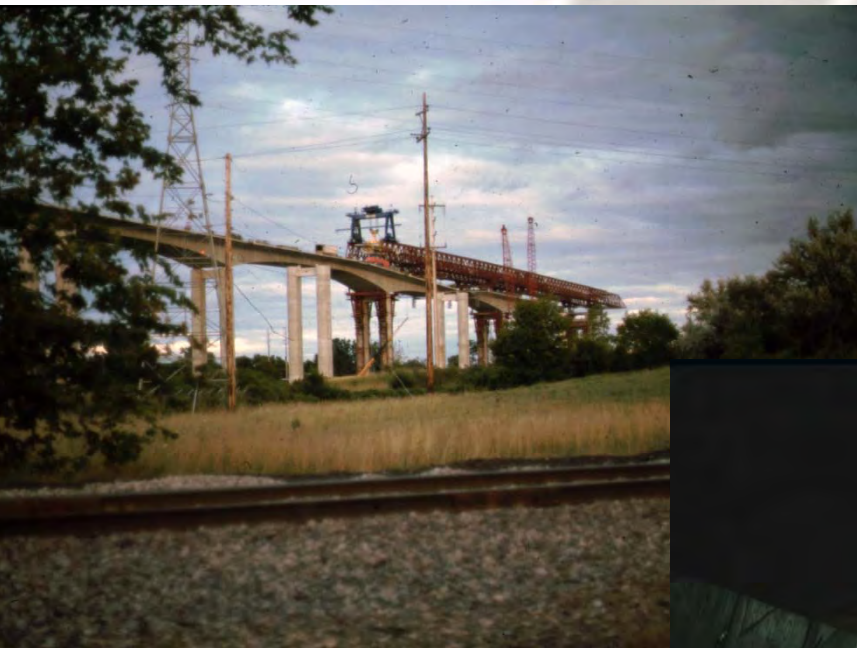
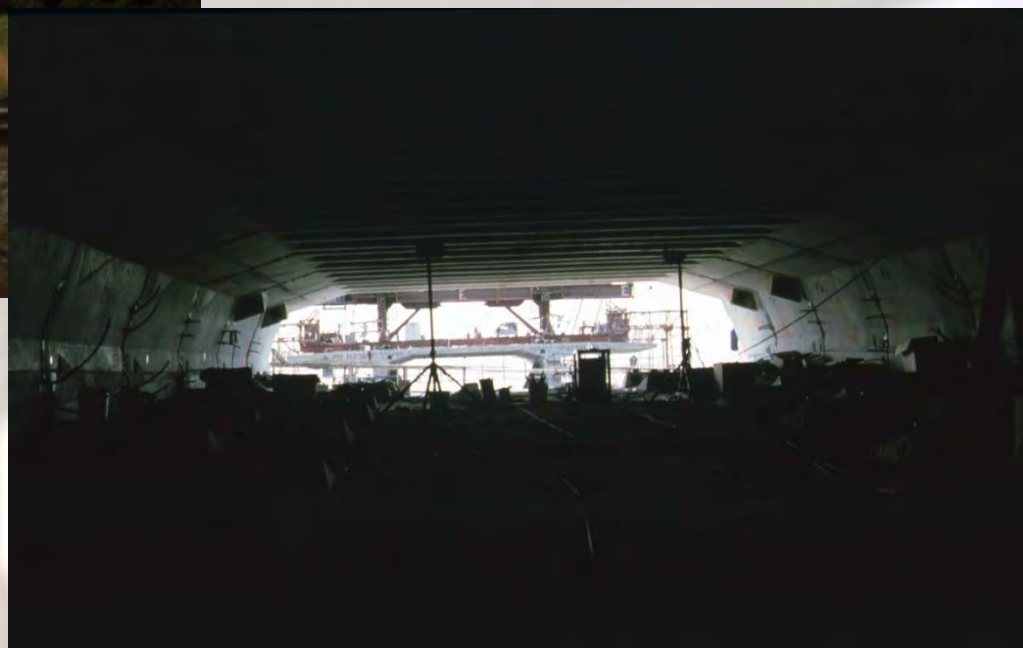
August 28, 1982 Construction Accident

➤ Rotation of cantilevers 11N & 11S

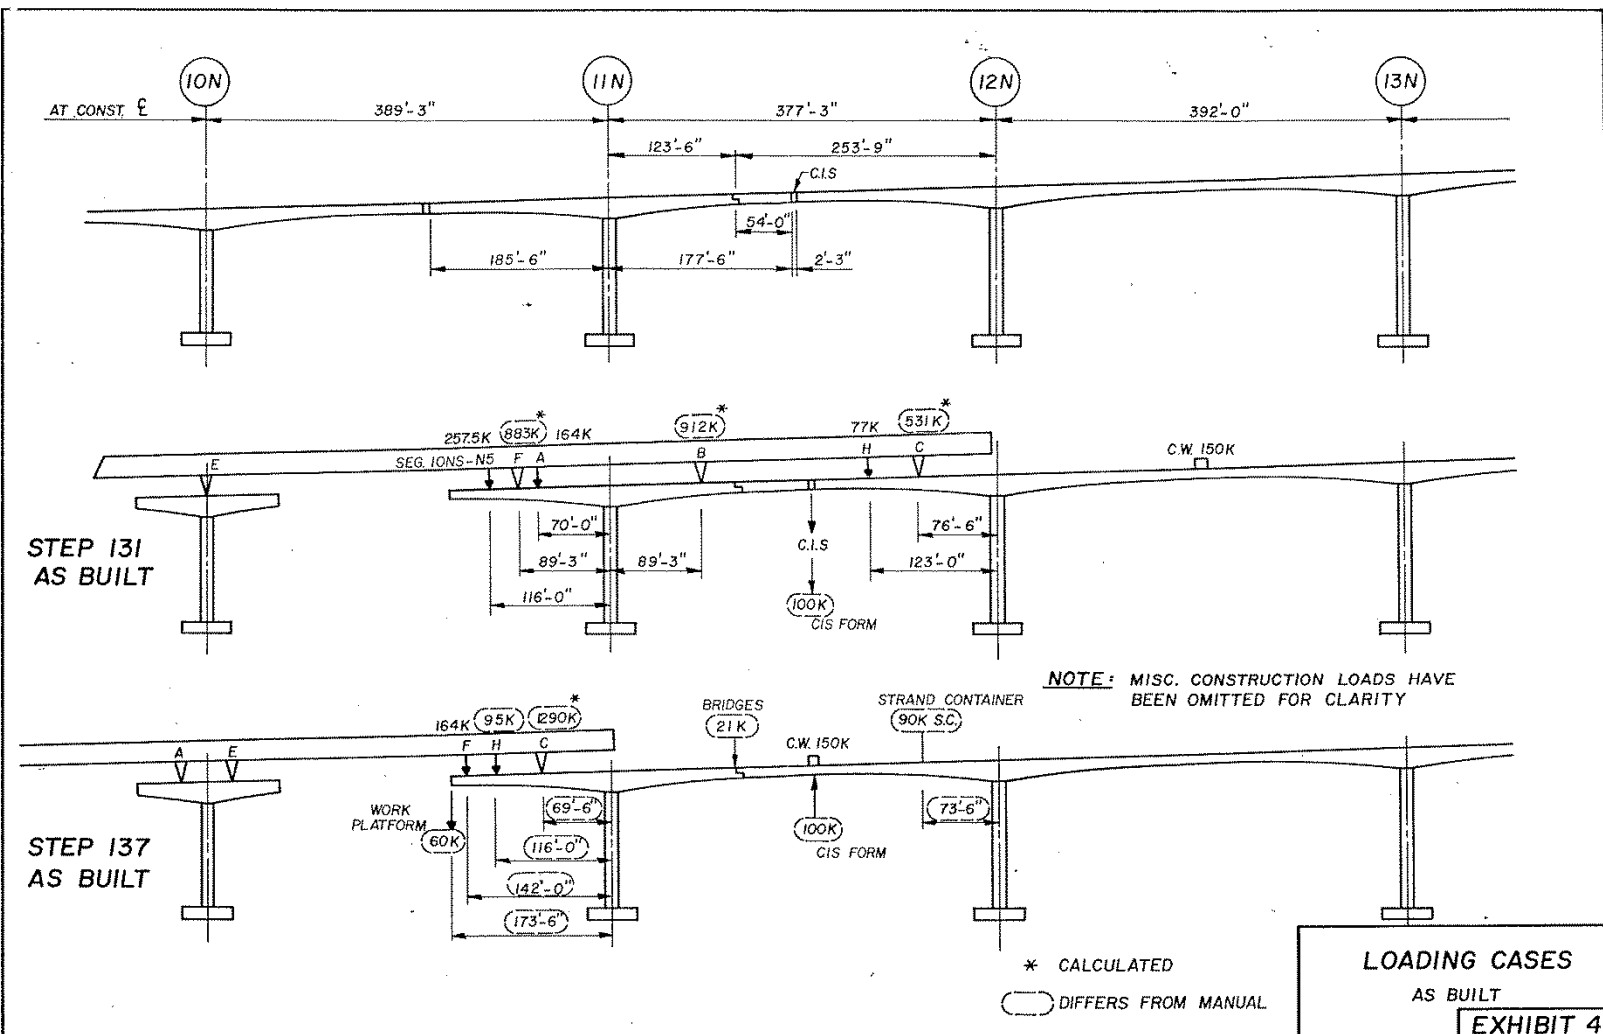
August 28, 1982 Construction Accident

- Construction was out of sequence, some segments were erected before the girder was to move to next position
- The work platform (60 kips) at the end of segment 11NSC was supposed to be removed, but was left in place
- The actual position and reactions of launching girder support legs differed from positions outlined in the erection procedures
- Factor of safety for construction loads for erection procedure was determined to be 1.0

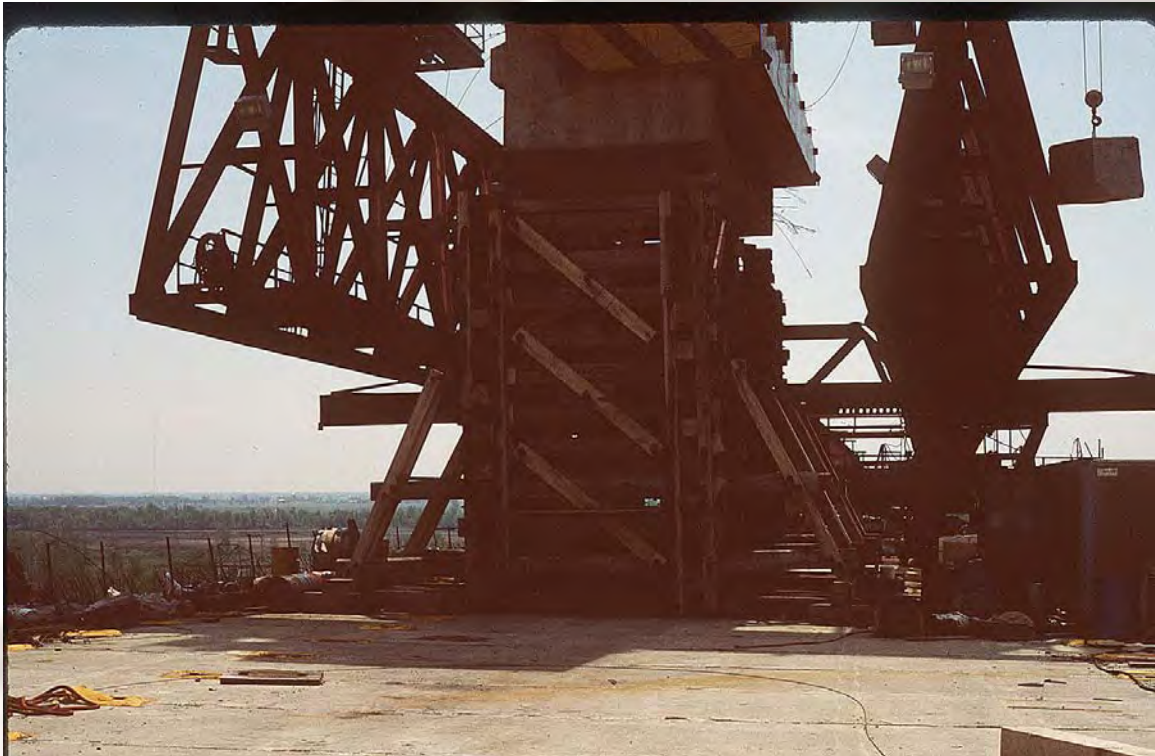
- Uncertainty remained that Pier 11N was still moving
- Launching girder was not to move until footing was stabilized

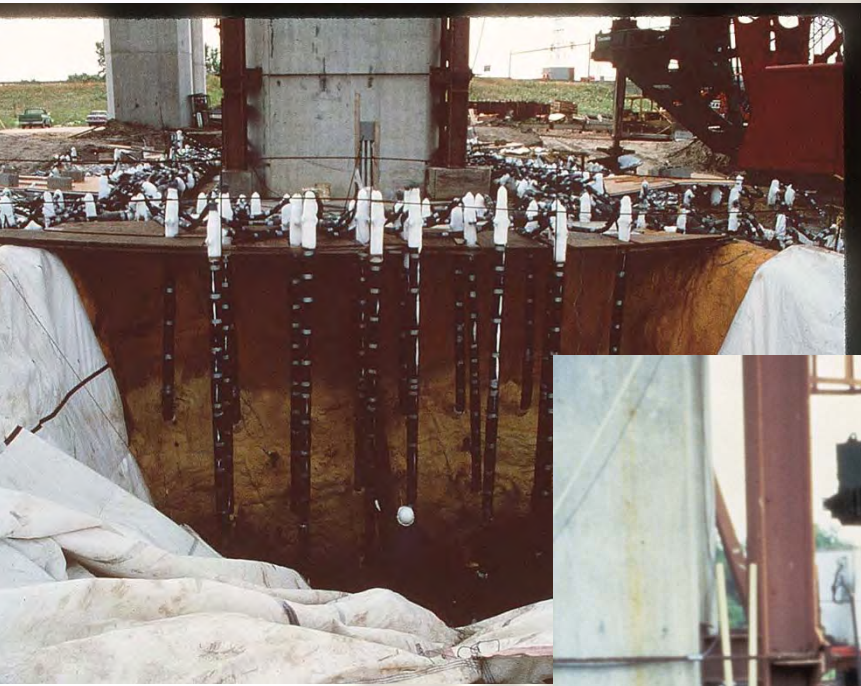
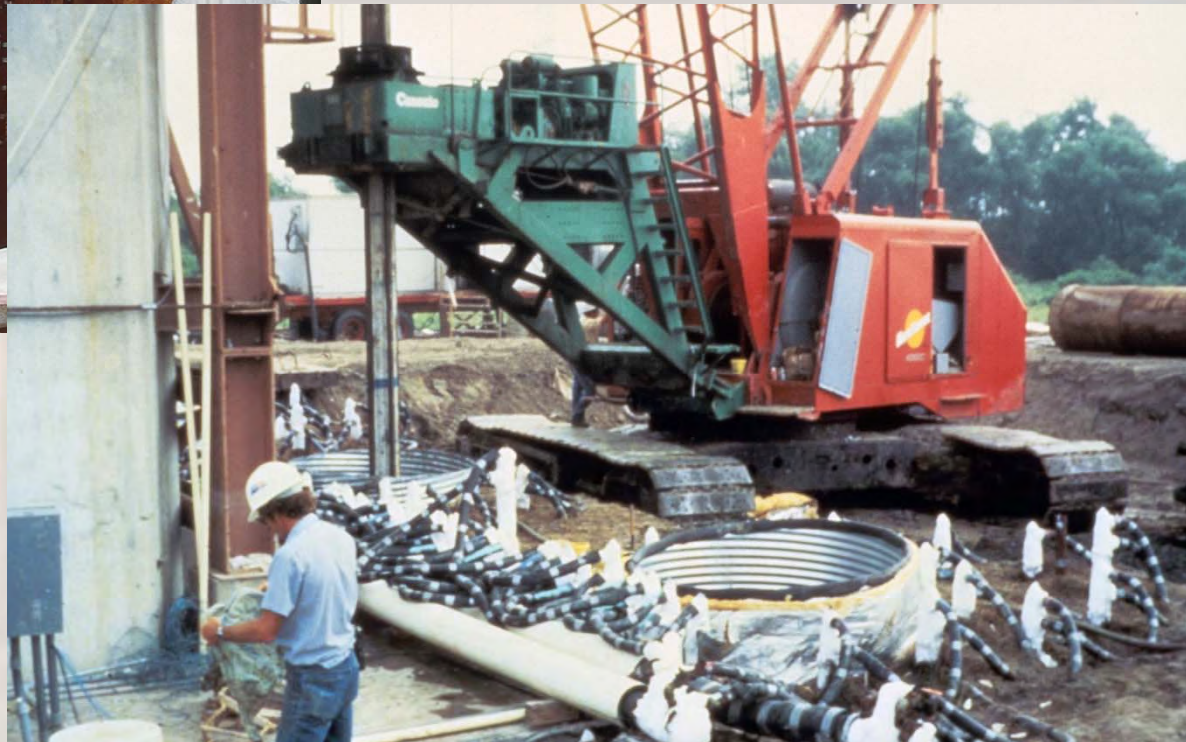
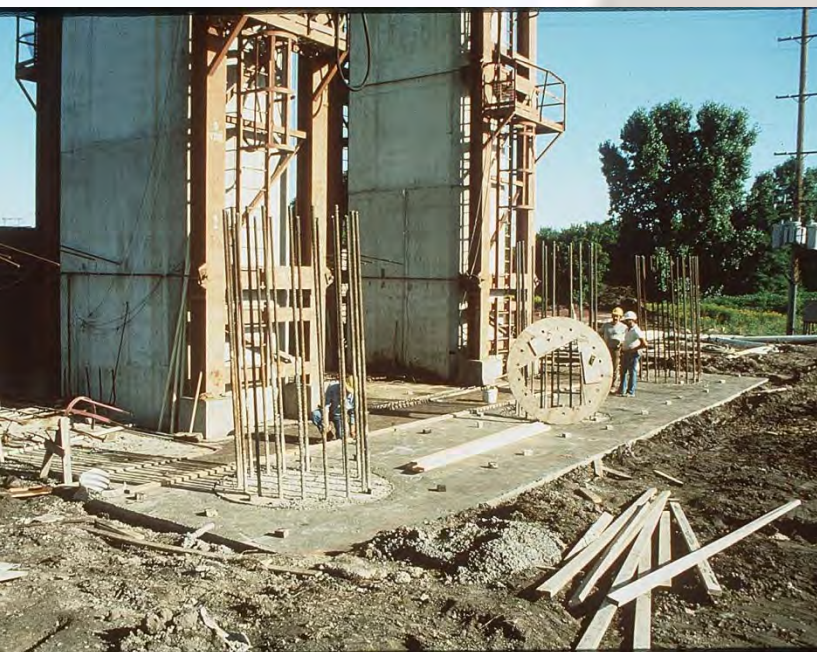
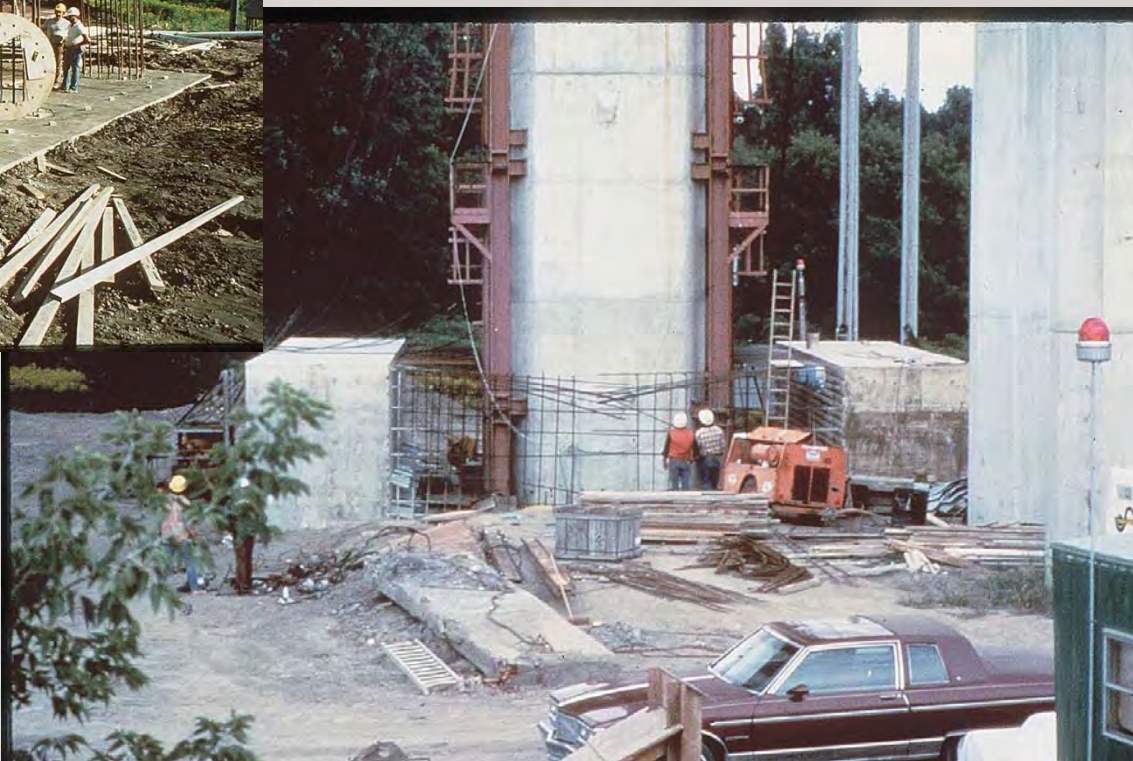
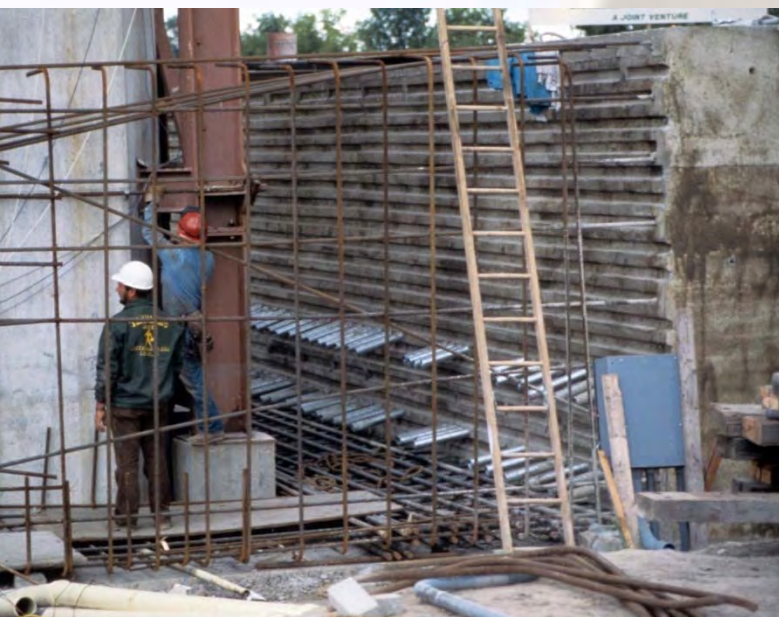
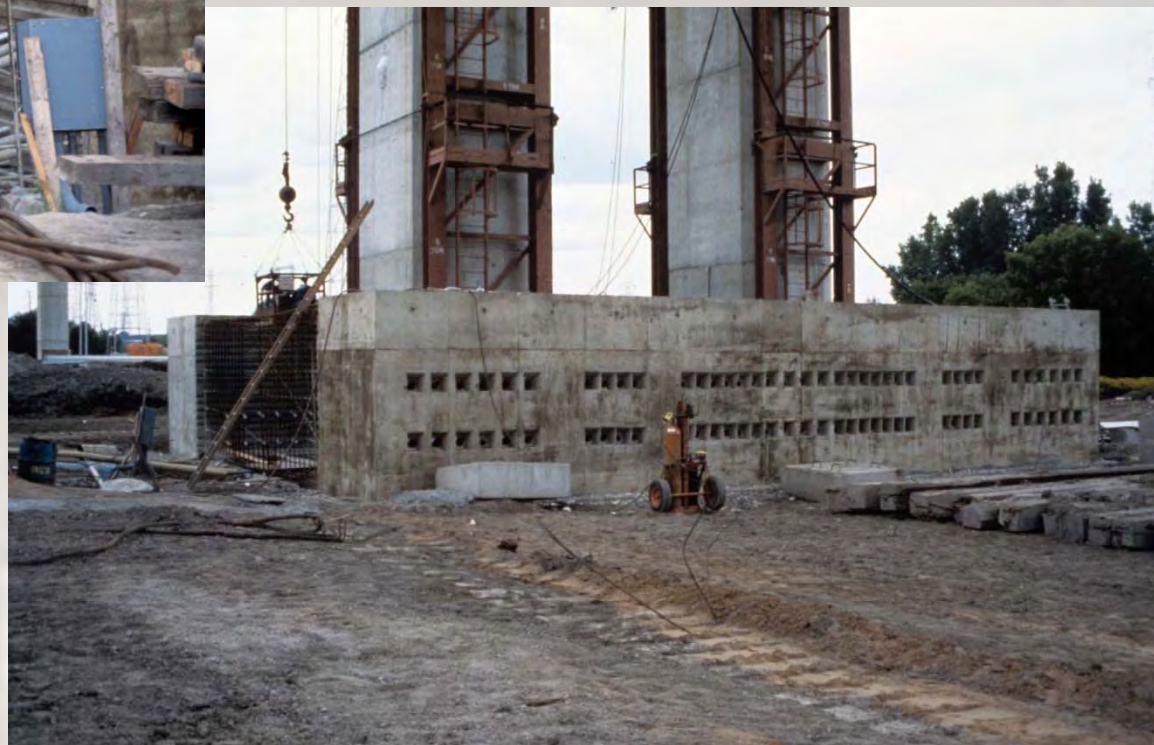
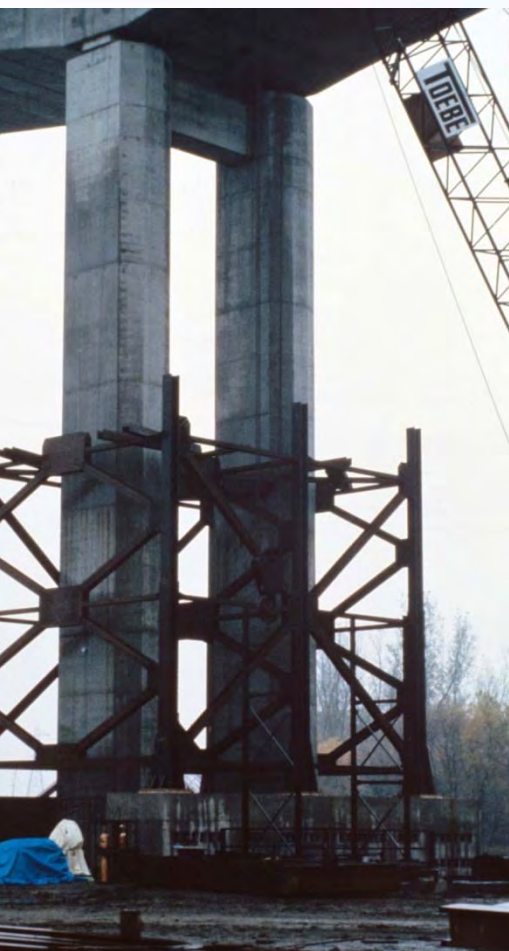
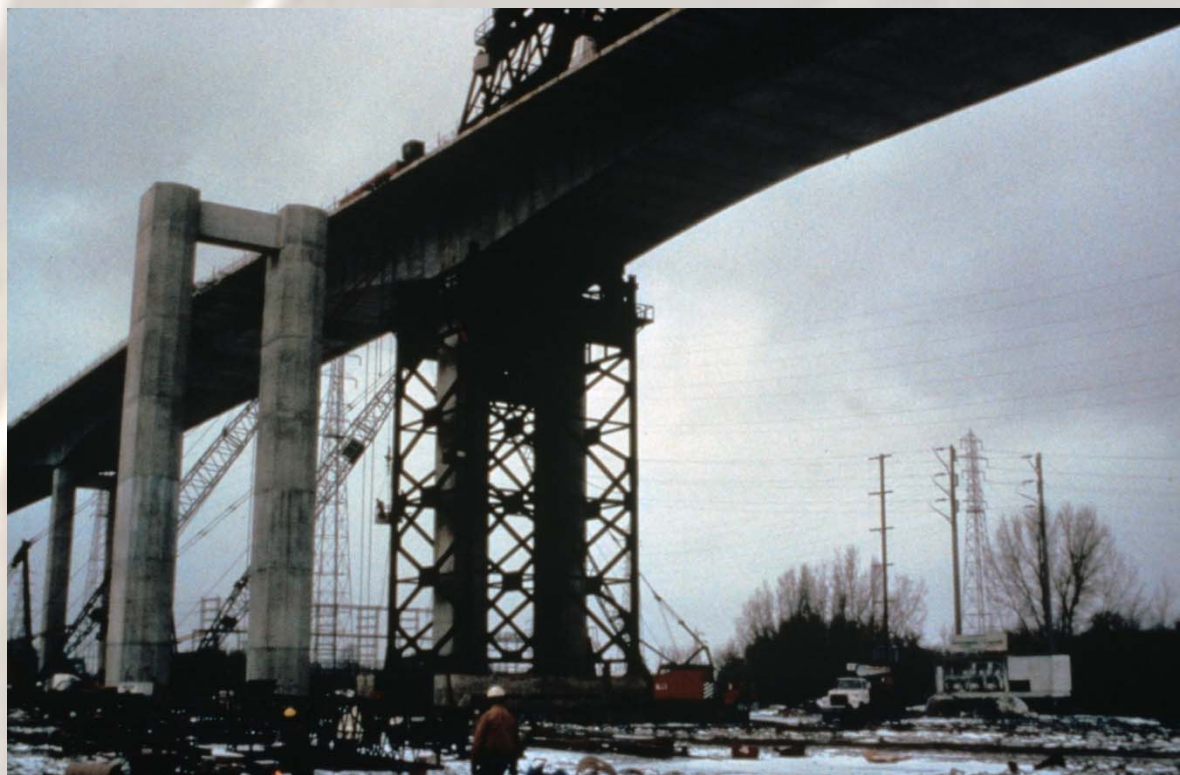
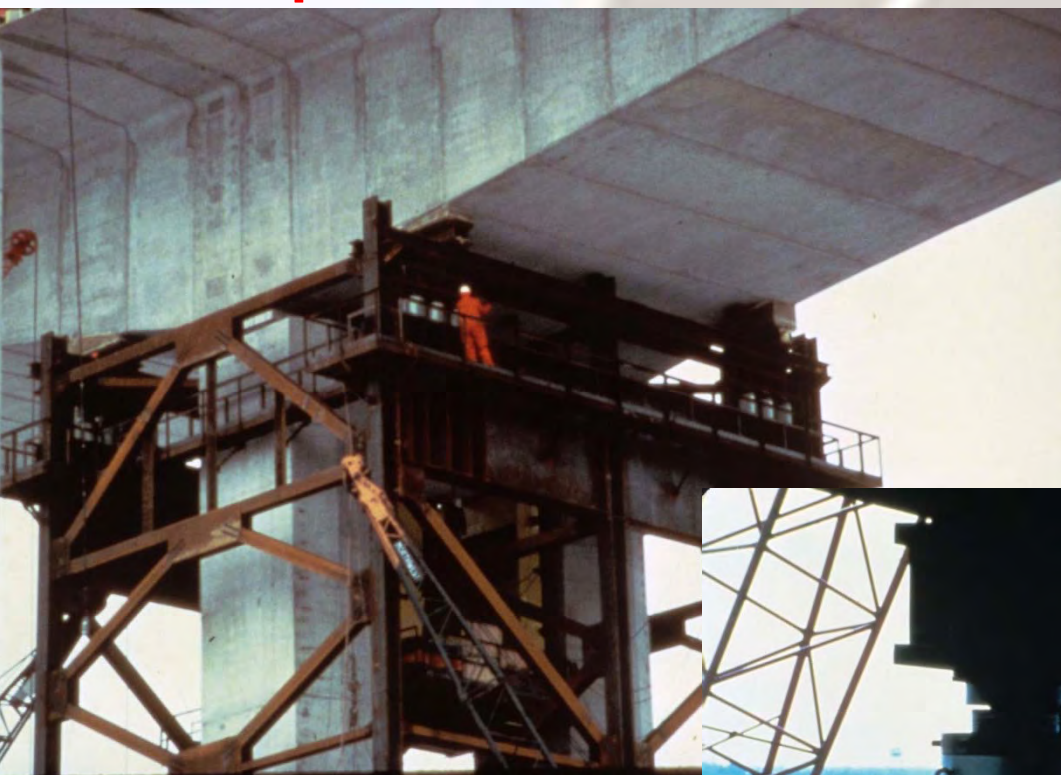
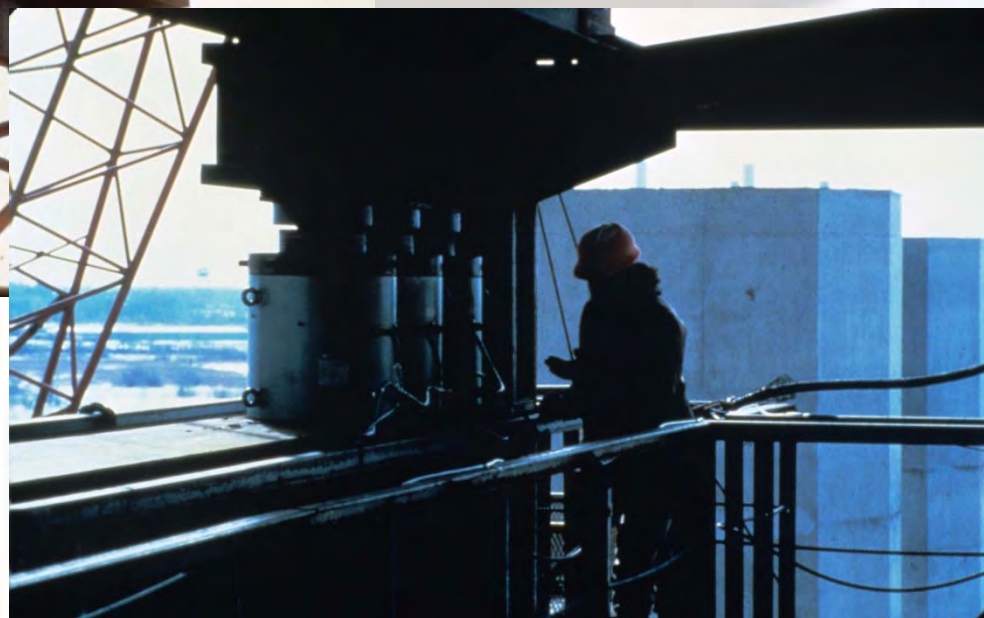
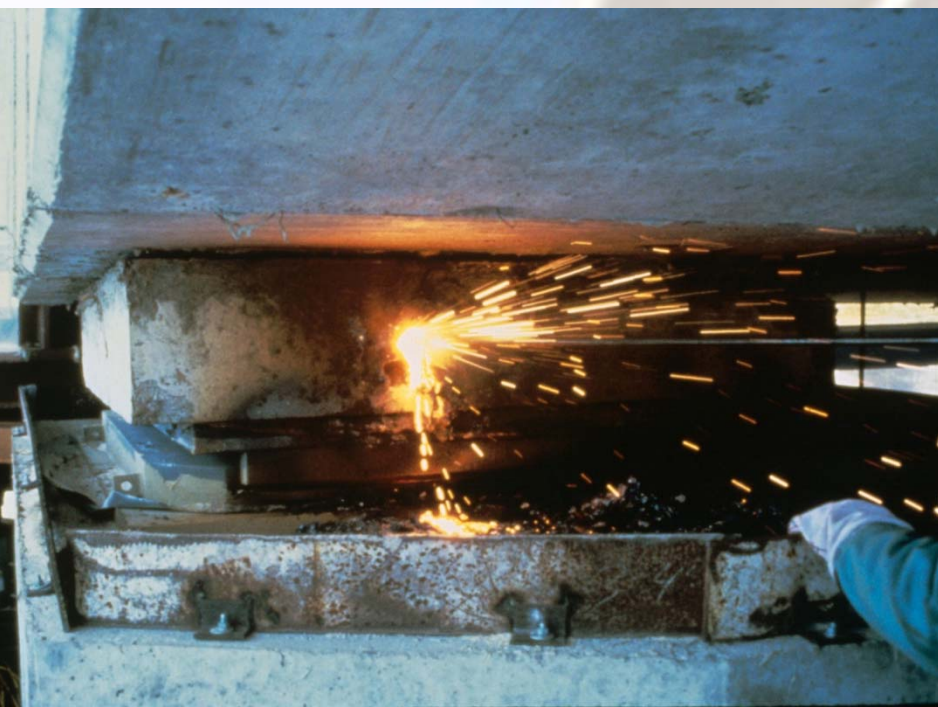
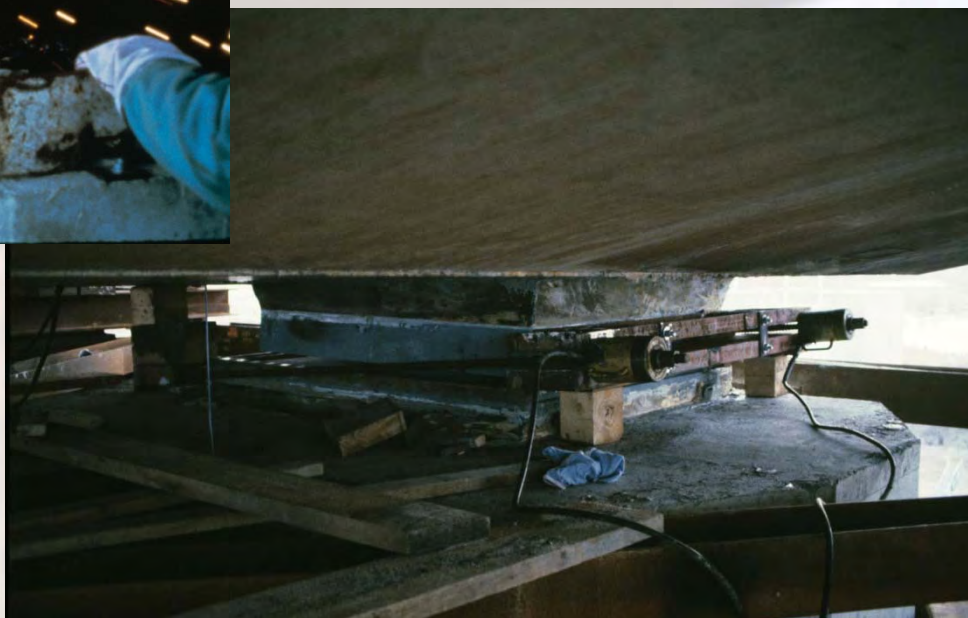
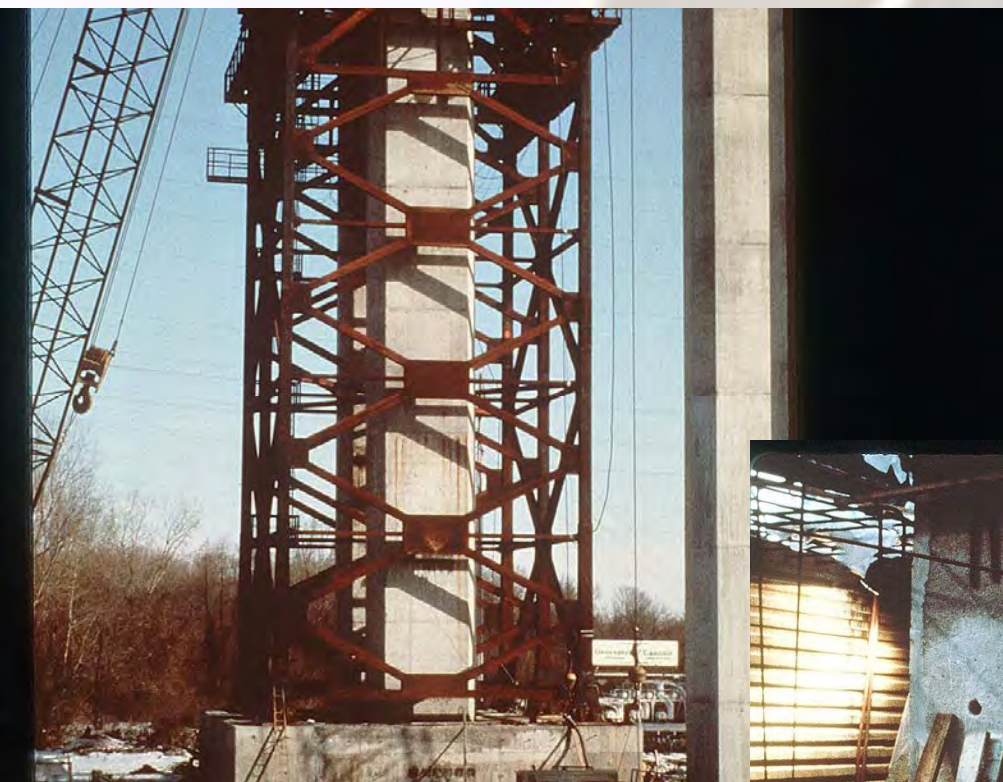
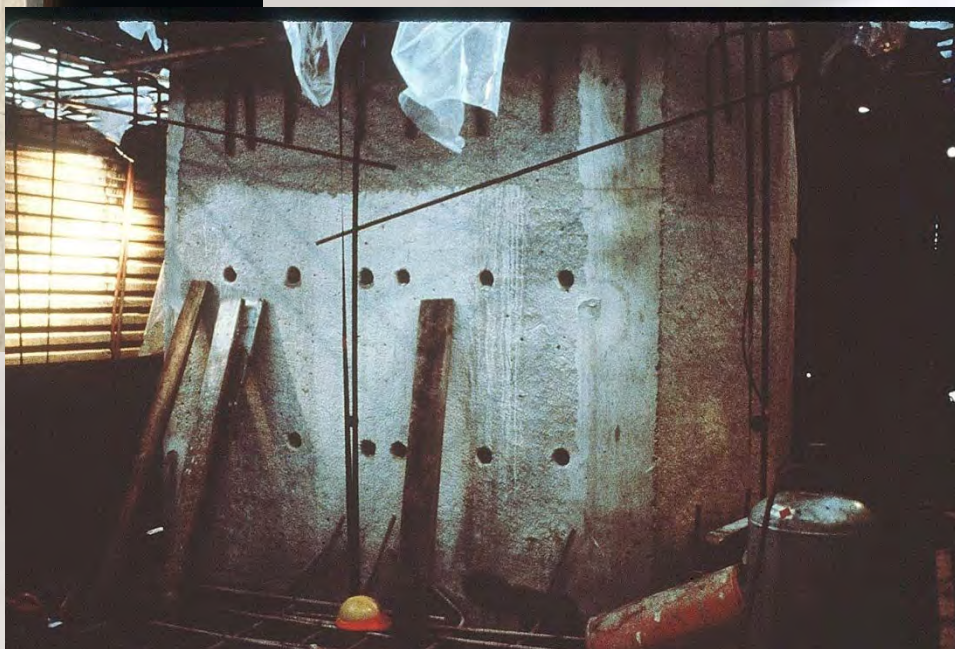
- Pier 11N columns were largely undamaged, footing was unsalvageable
- Pier 11N bearings over rotated and needed to be replaced
- Expansion hinges and span 12 segments could be salvaged
- A very complex repair scheme was prepared, that had to be completed in steps:
 - Stabilize Pier 11N, construct new footing
 - Building jacking structure to unload Pier 11N bearings
 - Construct large concrete counter weight below joint
 - Utilize jacking procedure to rebalance cantilever 11
 - Repair joint 12, remove and replace ungrouted tendons

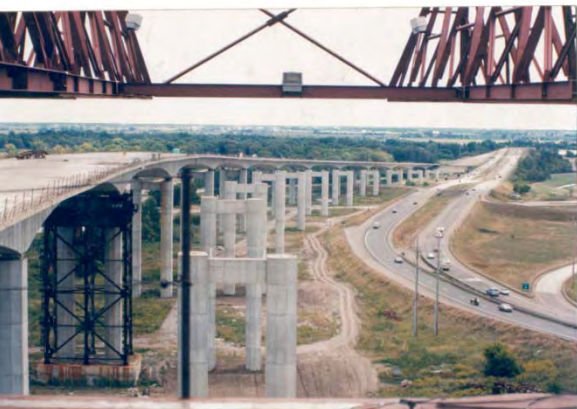
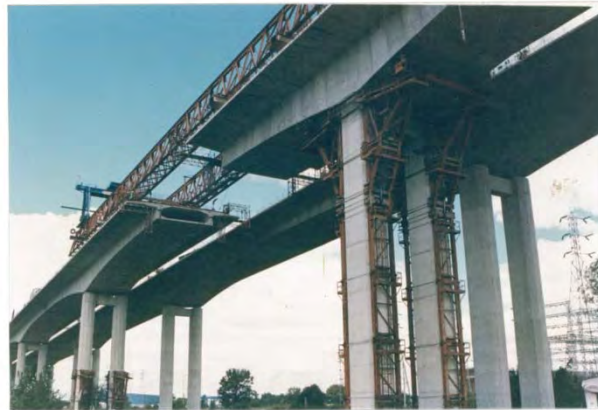
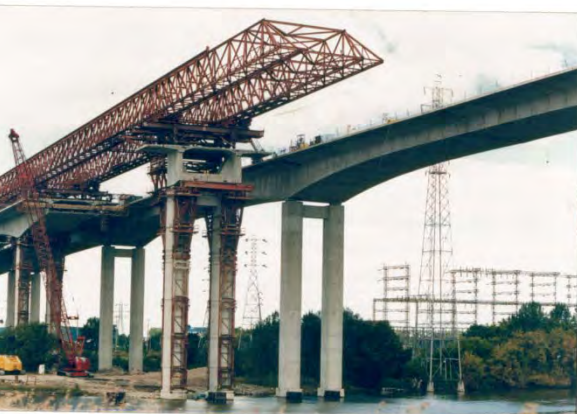
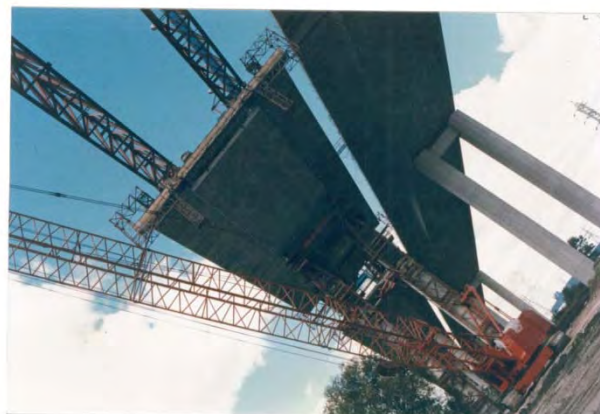
- Segments 20SNO and 20SNP bottom slabs were cast 6" too thick at one face, creating a downward thrust at the joint. This truss is vertically post tensioned into the joint to pull the slabs, counter acting the thrust

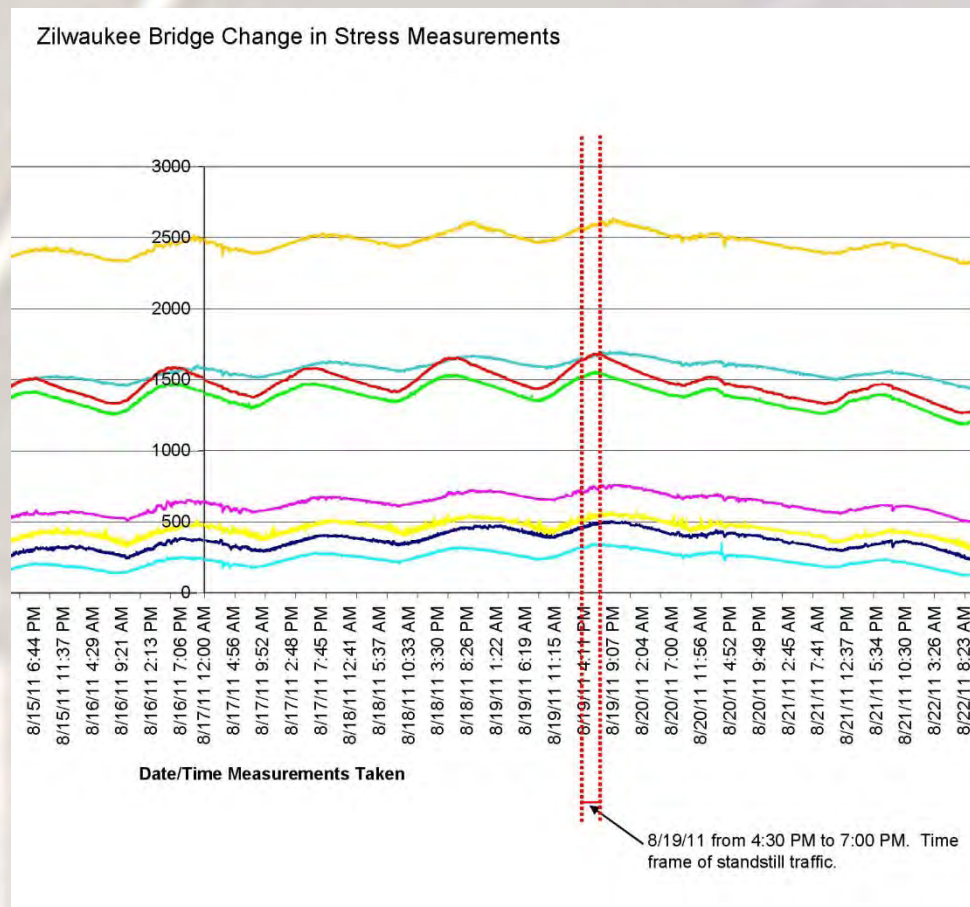
truck hauling prestressed
beam stopped over repaired
expansion joint 9N where
strain gages were installed
after 2008 retrofit

discernible increase in
stresses

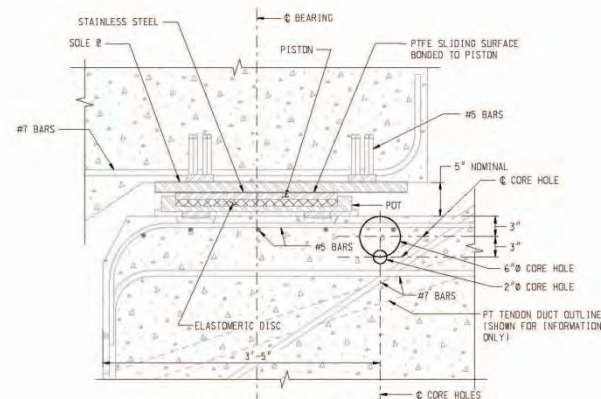
DETAIL A - EXISTING BEARING

- Maintenance facilities established in the early 1990's
- Pier 17N strut was externally post tensioned in 1995
- Expansion joints were replaced in 2001
- Engineering inspections have been conducted every 4 years since 1989, next engineering inspection scheduled for 2013 after current bearing replacement project is complete
 - Bearing replacements were recommended as early as 1993
 - Bearings extruding elastomer as early as 1989

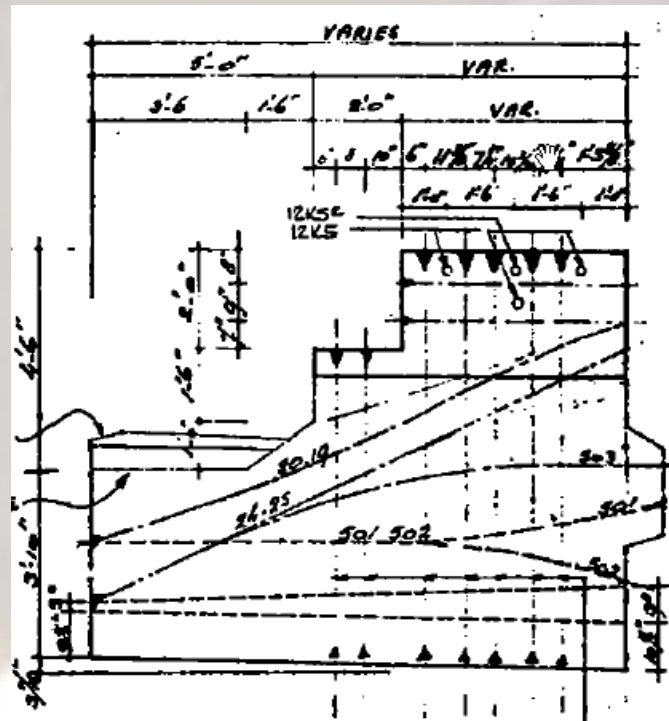
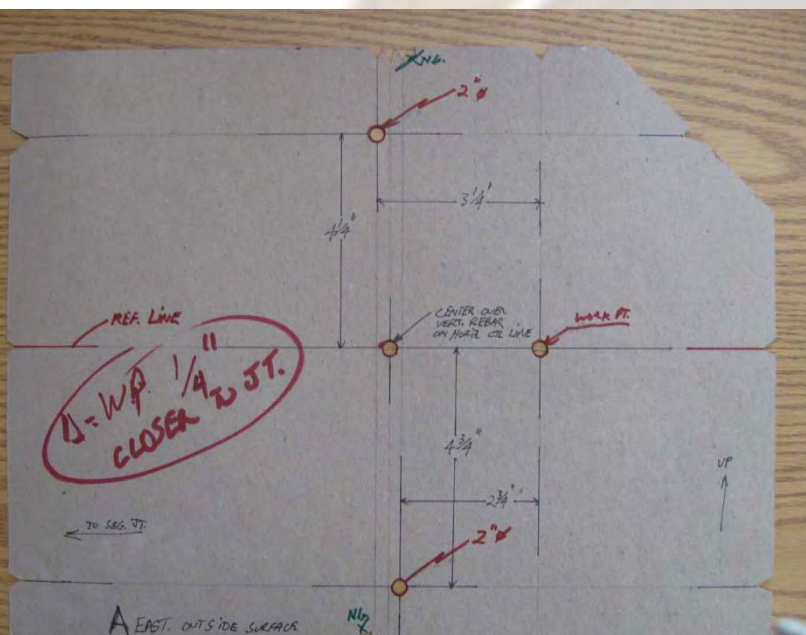
Using the existing shop drawings, the steel rebar and tendons were carefully laid out, and drilling points determined

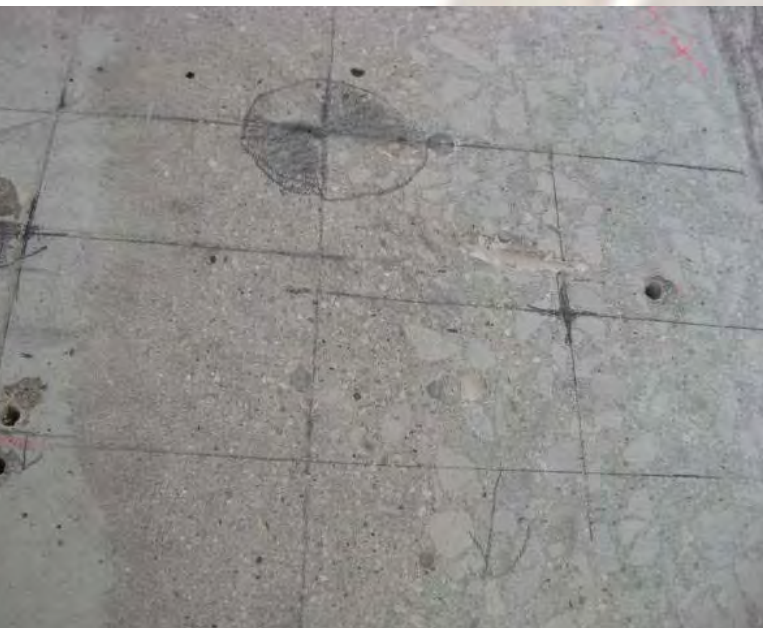
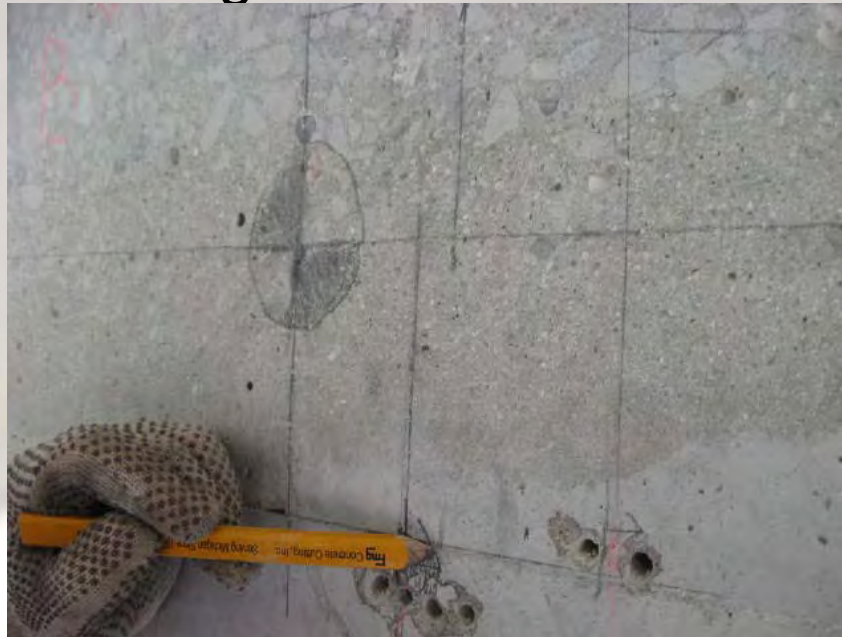
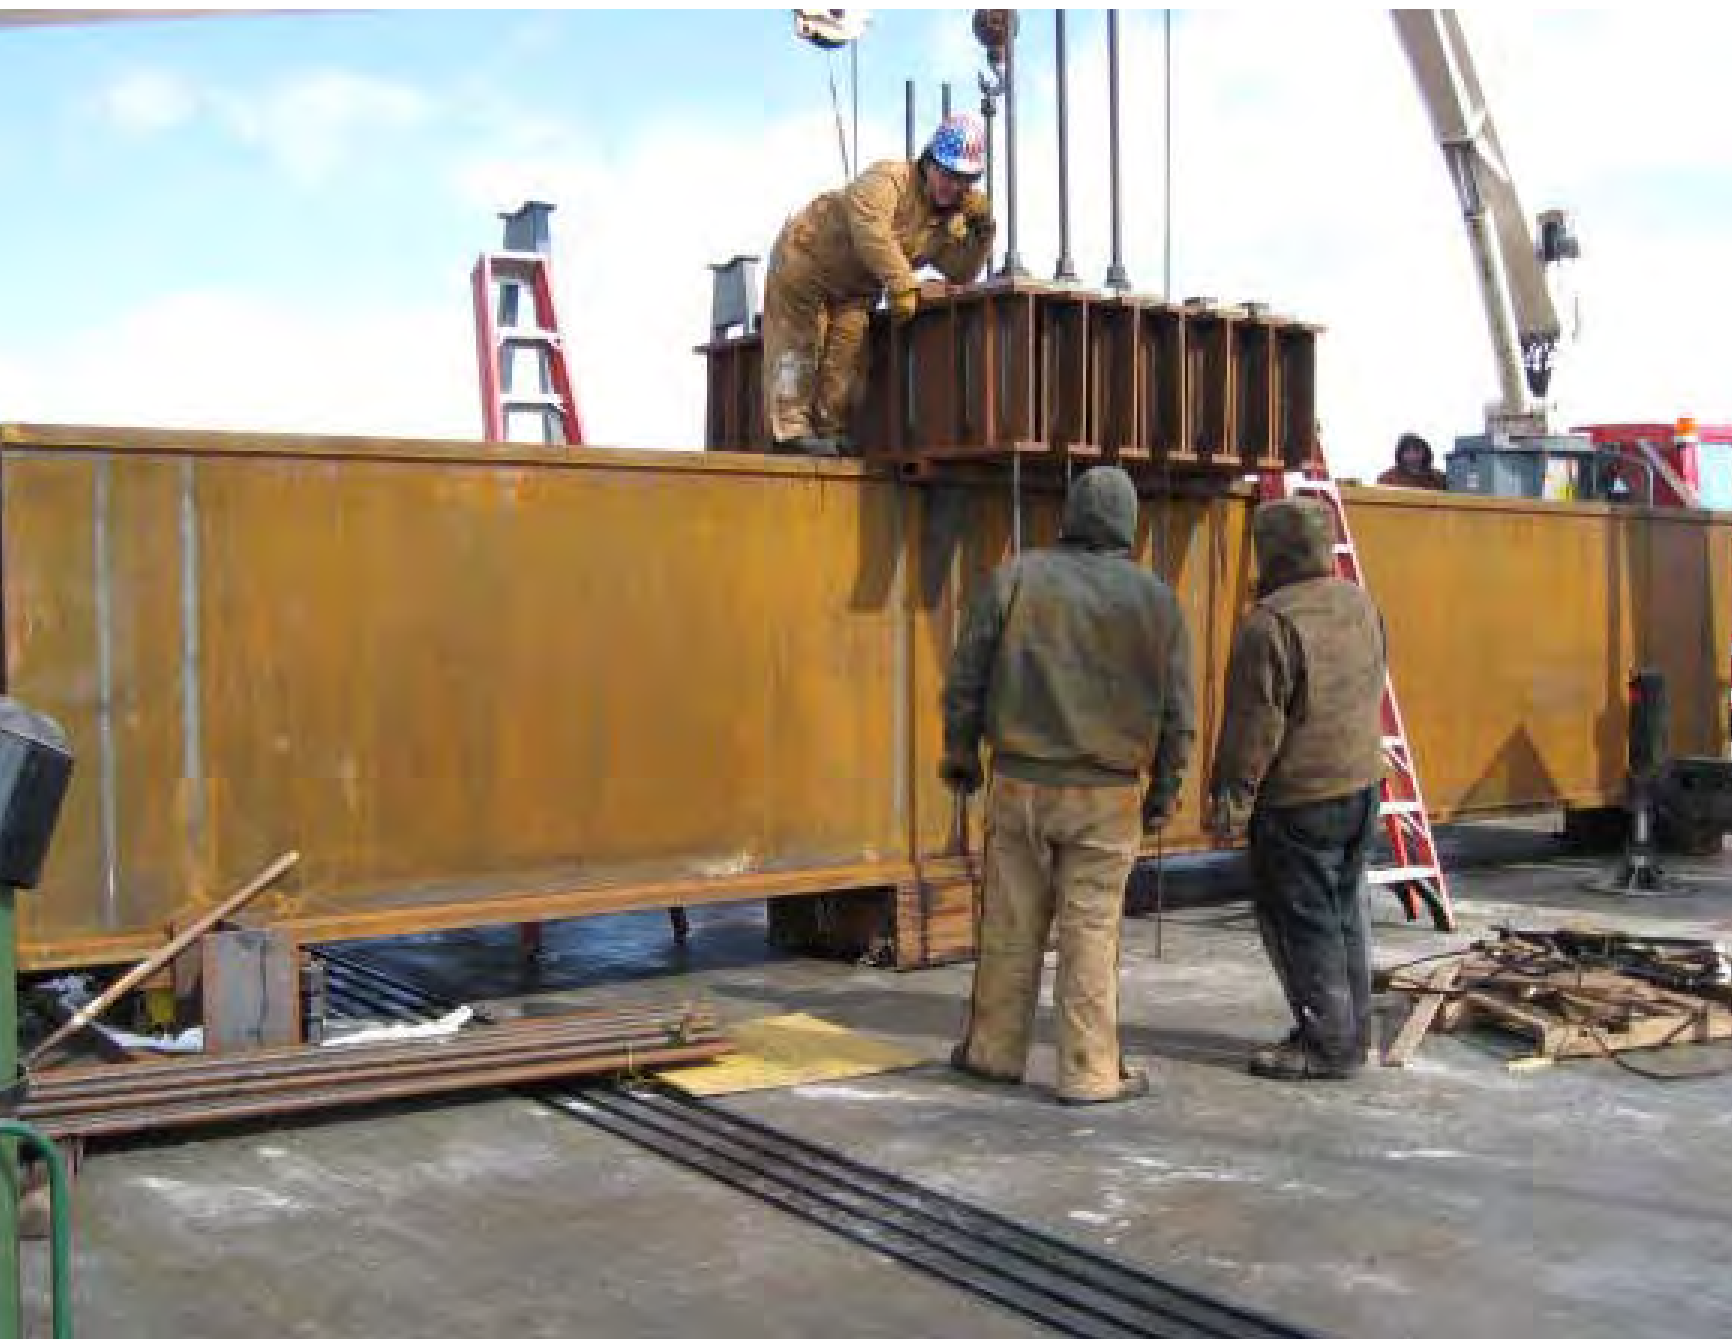
Drilling commenced in May 2008 for the
strong back placement and the bearing
plate removals

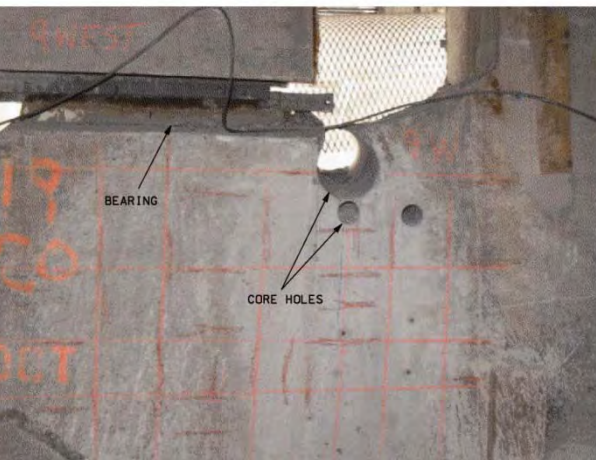
When coring commenced, primary cantilever reinforcement bars, and steel tendons used to post tension the individual segments together were unexpectedly cut

LOCATION OF CORE HOLE
IN PREPARATION FOR BEARING REMOVAL

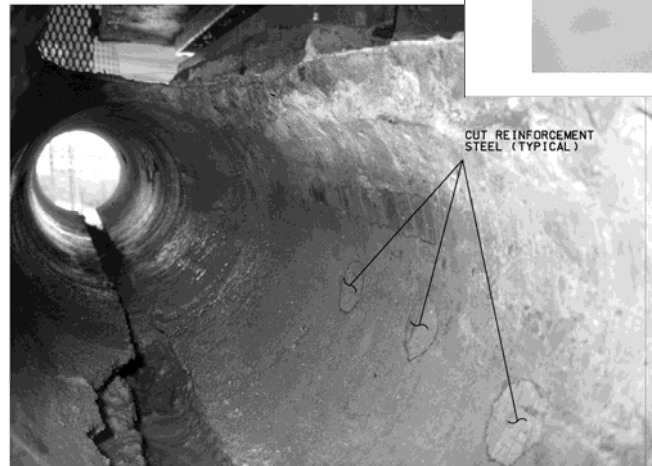
LOCATION OF CUT REINFORCEMENT STEEL
