The Zilwaukee Bridge: from the beginning to the present

Matthew J. Chynoweth, P.E.

Michigan Bridge Conference Presentation

March 21, 2012

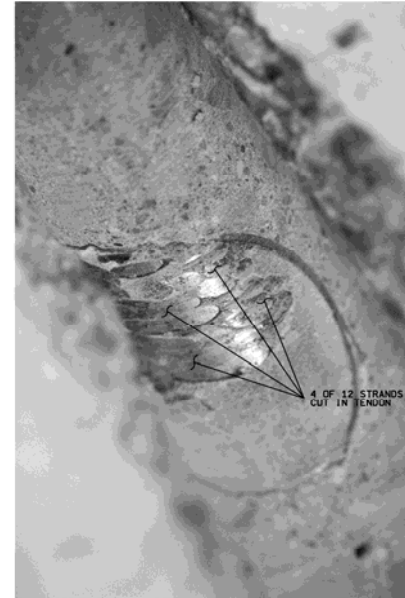
When coring commenced, primary cantilever reinforcement bars, and steel tendons used to post tension the individual segments together were unexpectedly cut

CUT STRANDS IN TENDON

- Original Design had an option for thicker bearings
- Reinforcing Steel & Post-Tensioned strands not shown in this area
- Shop drawings are not as built, and do not accurately reflect changes made during fabrication

- The project turned from bearing replacement to emergency repairs
- Parsons (designer) developed external post tensioning retrofit
- Janssen & Spaans Engineering reviewed retrofit design, and provided technical expertise during fabrication & installation

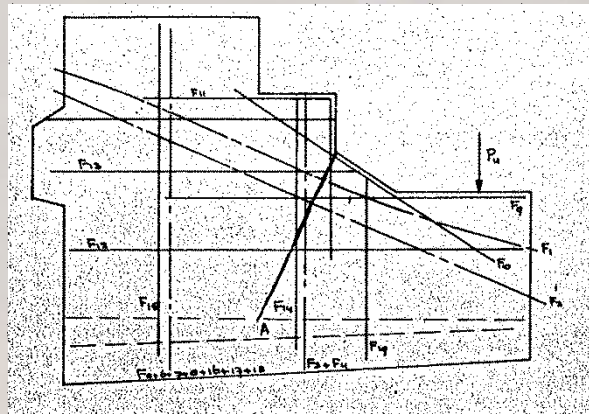
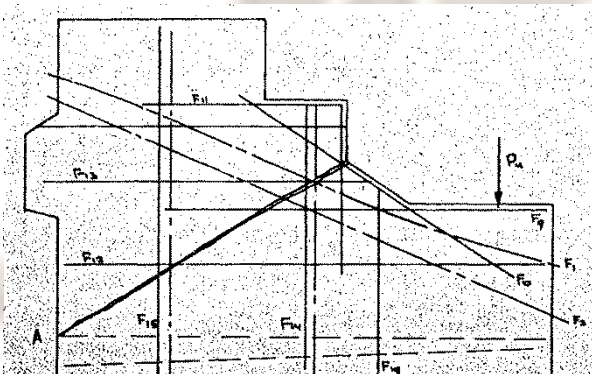
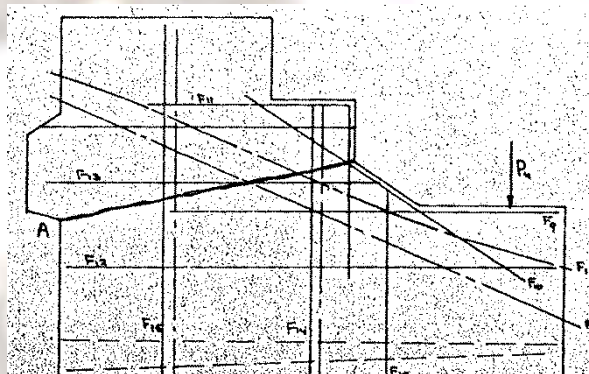
rough total of 423k of resistance was lost

external post tensioning retrofit required to compensate for these losses

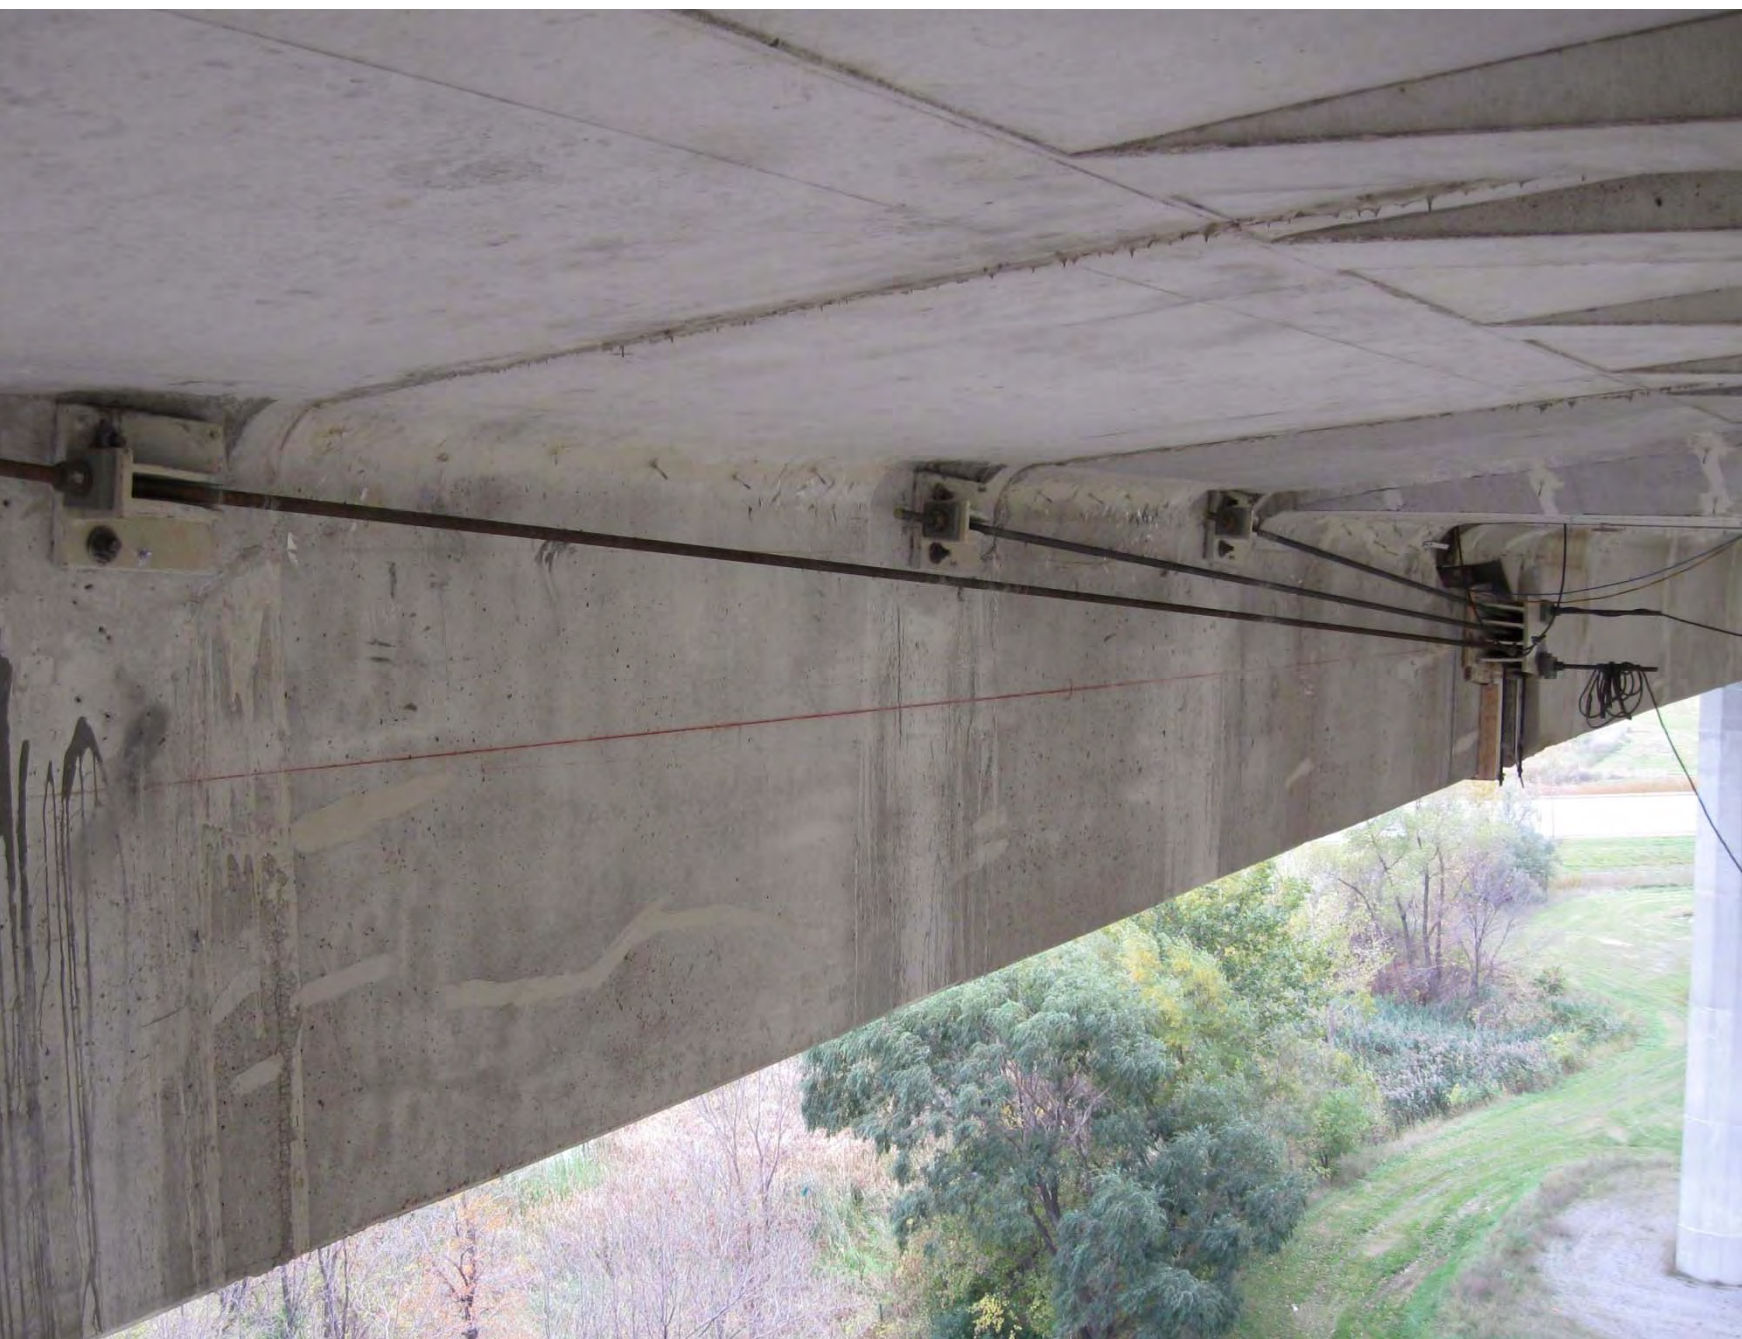
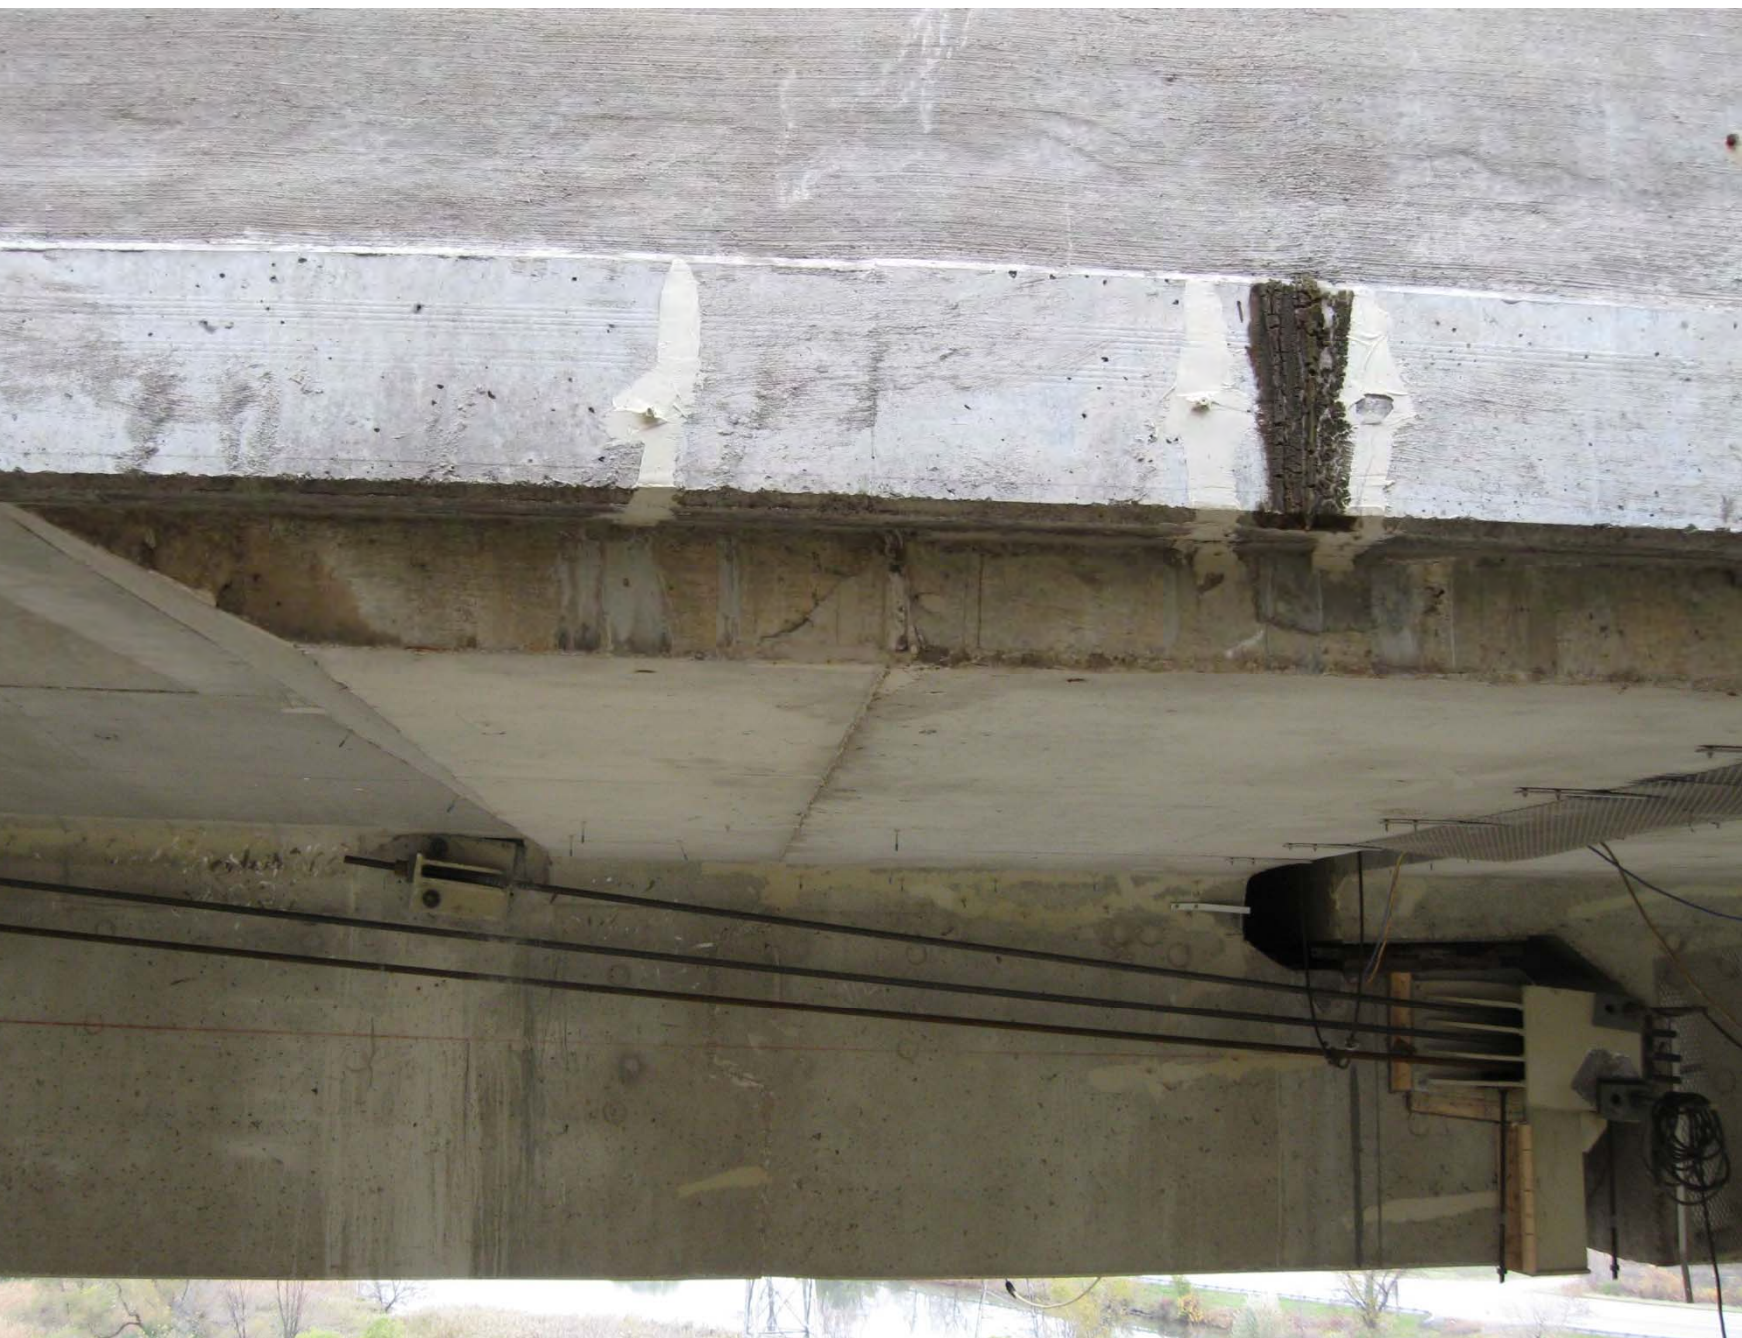
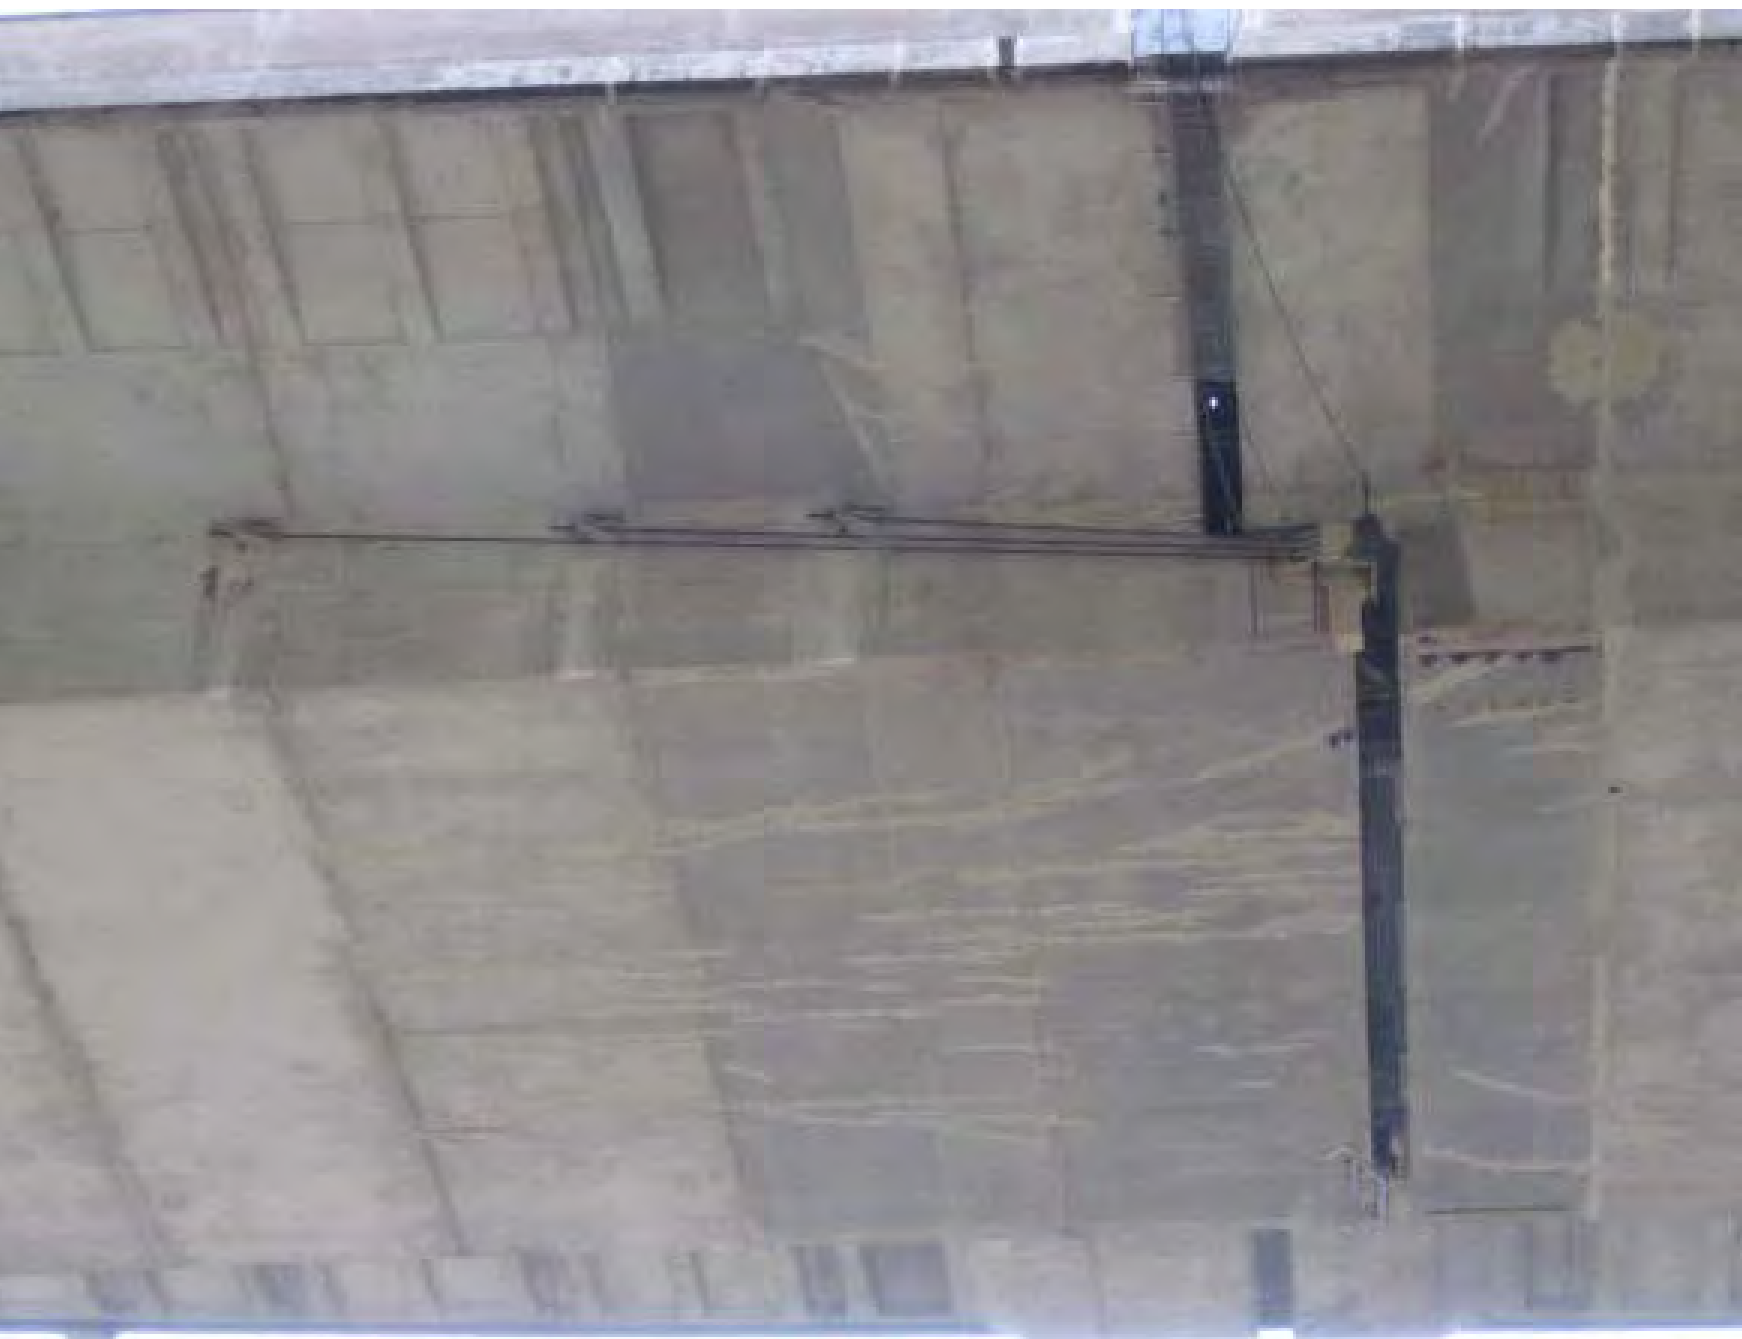
on completion of
tallation, all elements
re coated

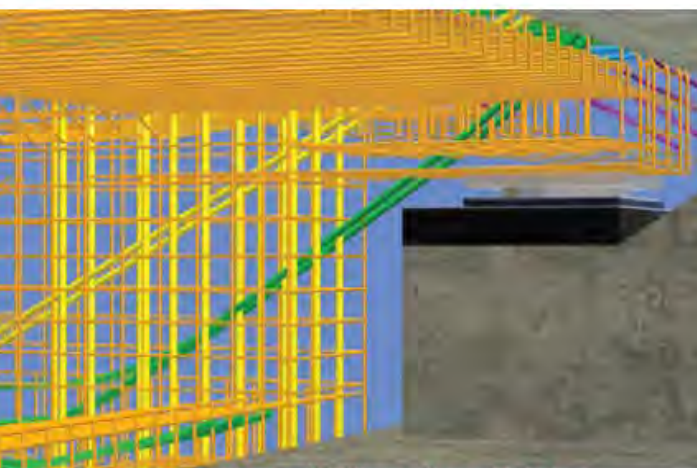
BIM 3D Model of Zilwaukee Bridge

BIM 3D Modeling of the post-tensioning tendons and reinforcing steel in the critical areas around hinge, pier and abutment bearings allowing avoidance of critical members when installing necessary shoring and strongbacks.
