2012 Michigan Bridge Conference

Infrared Deck and Substructure Case Studies

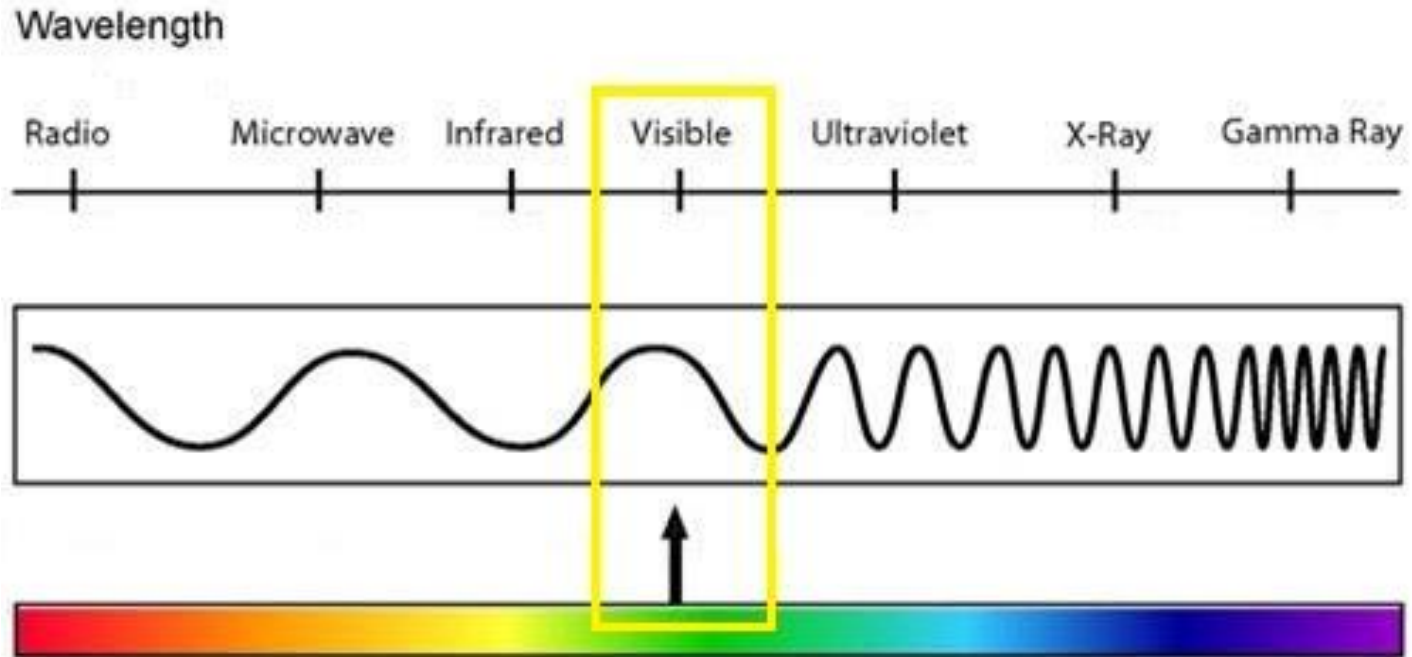
What is infrared energy?

Visible is reflected light
Infrared is emitted energy

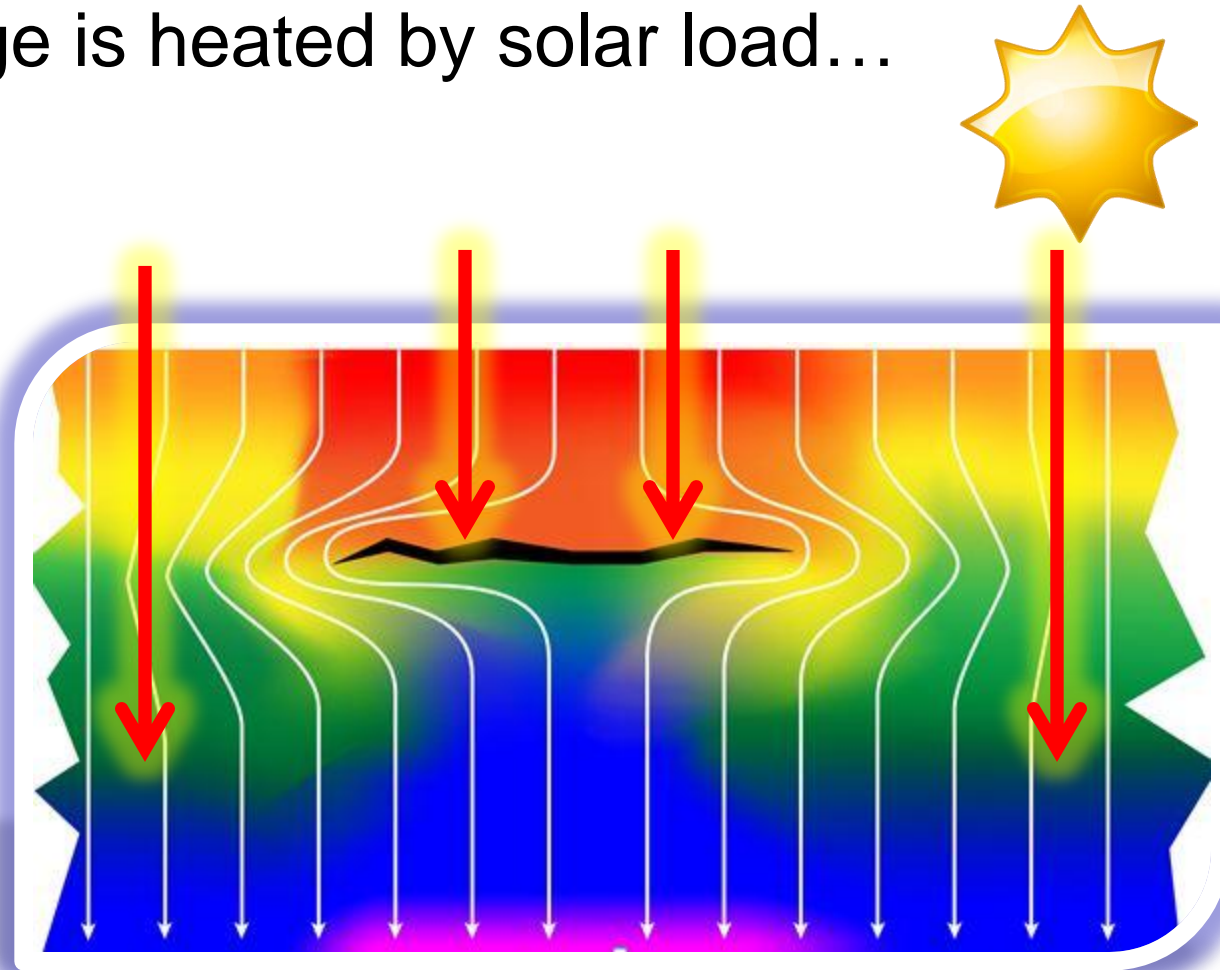
Thermal Principle

Delamination interrupts conduction path as the bridge is heated by solar load...

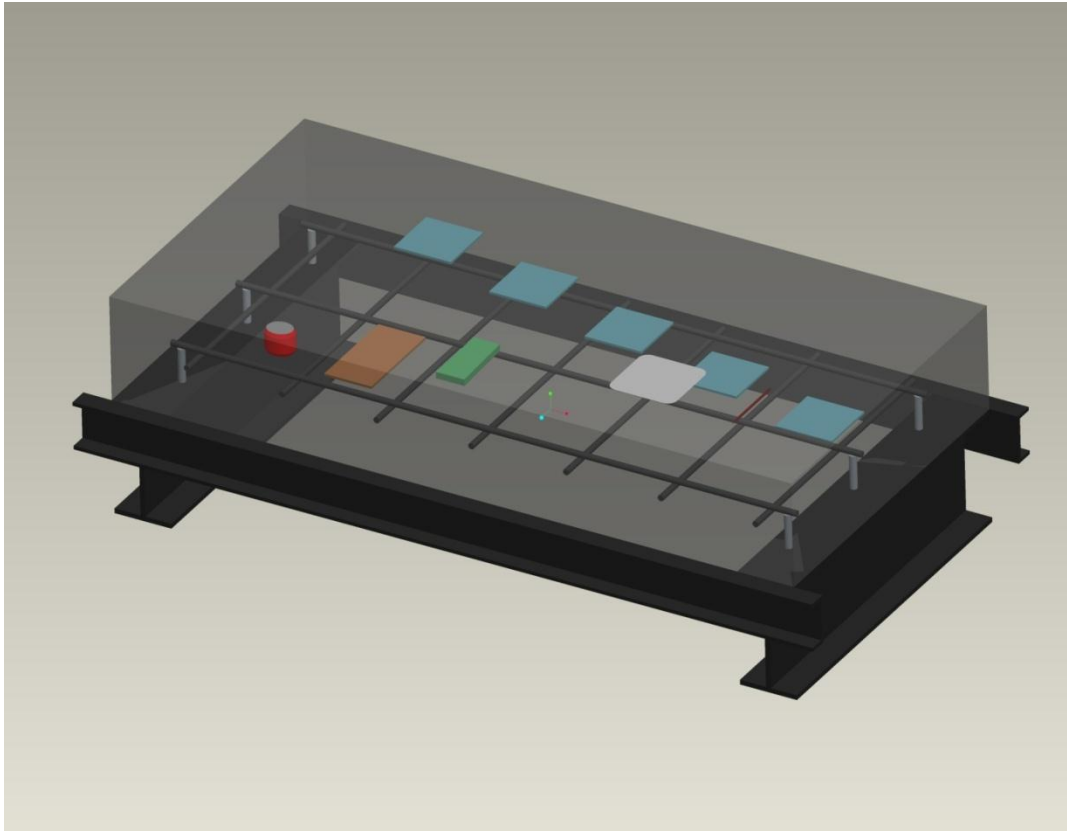
MDOT Test Slab

- Delaminations:
 - Styrofoam
 - Plywood
 - Cardboard
 - .7 ml plastic
 - Surface crack
 - Pencil
 - Soda can

6' x 3' x 11" Concrete on 6" channel & 12" I Beams

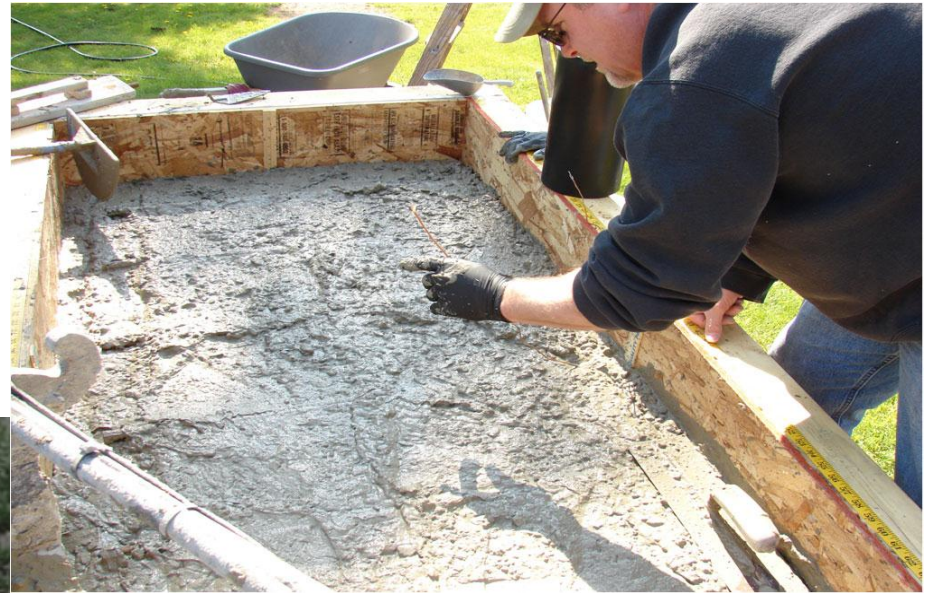
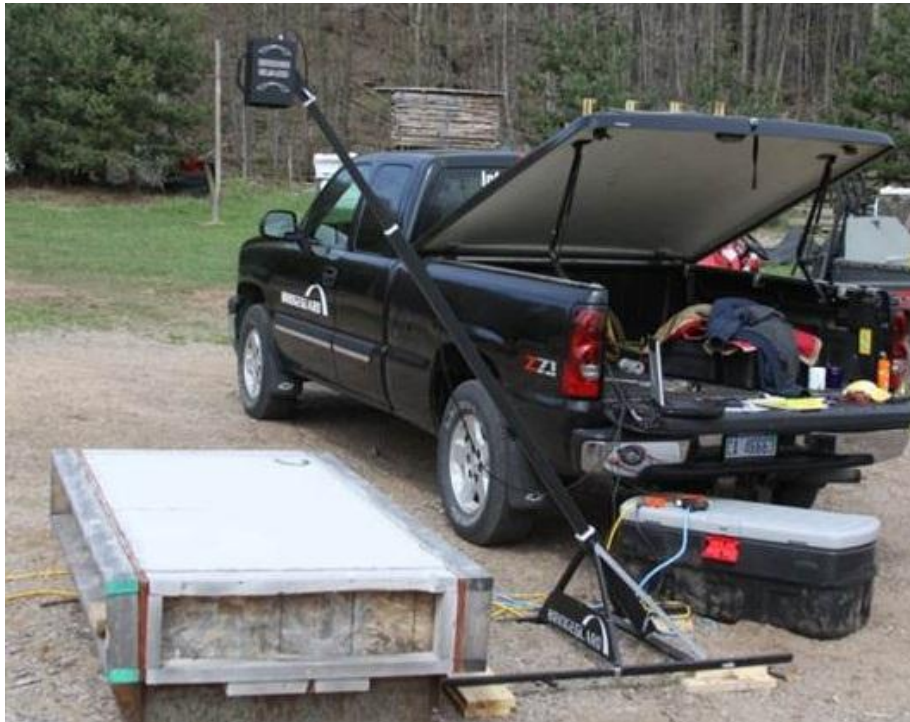
Test Slab

- MDOT Bridge Specs
 - Rebar size
 - Placement
 - Mixture – test cylinders
- 5 Thermocouples

- 24 Hour Diurnal Study

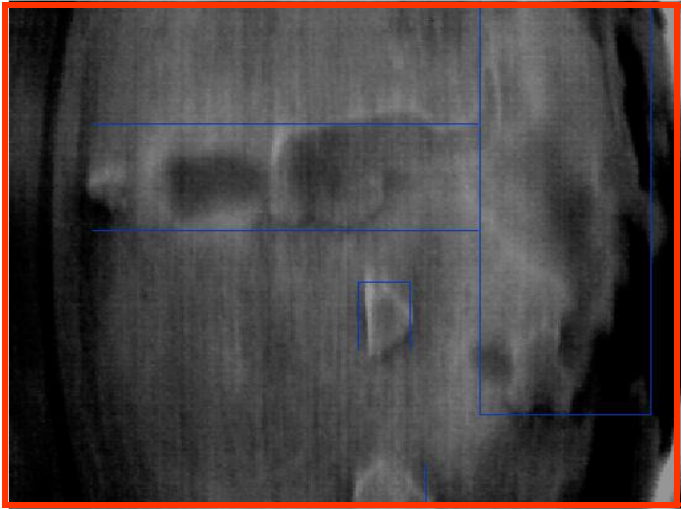
Delaminations

Bridge: NSEW 123

Lane: 1

Image Name: 1_4525000_41561_408.tif

Defect #	3	4	5	6
Feet from Start	66.90	69.70	71.50	72.00
Feet from Right	4.94	5.00	2.01	6.63
Defect Square Feet	0.95	0.99	19.34	11.36

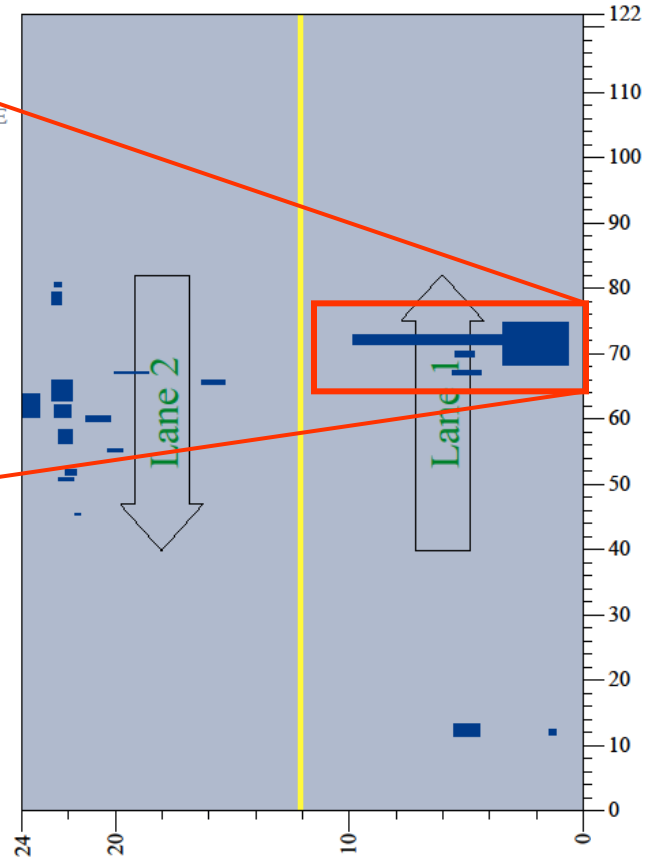
Pattern Overview

Total Bridge Area (sq ft): 2928.00
 Delamination Area (sq ft): 49.67

of Delaminations: 19
 % Delamination: 1.70

*Not to scale
 Units are in feet.

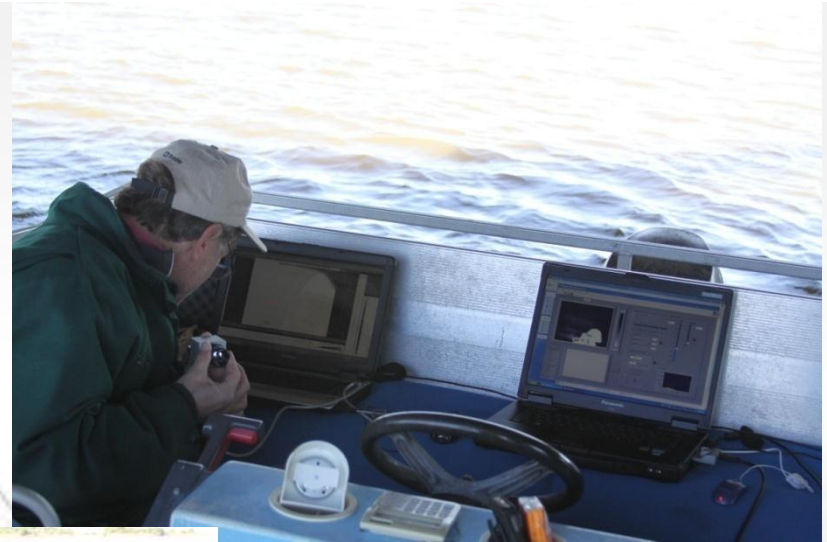
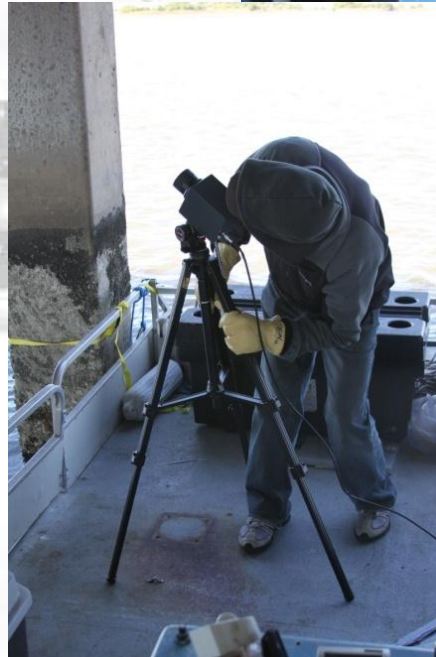
Sounding

Sensor testing
