GeoSpray™ GeoPolymer Mortar System and Concrete Cloth for Structural Rehabilitation/Repair of Sewer and Storm Infrastructure

Presented by David Keaffaber, P.E.
Midwest Region Manager

Milliken Infrastructure
Solutions, LLC

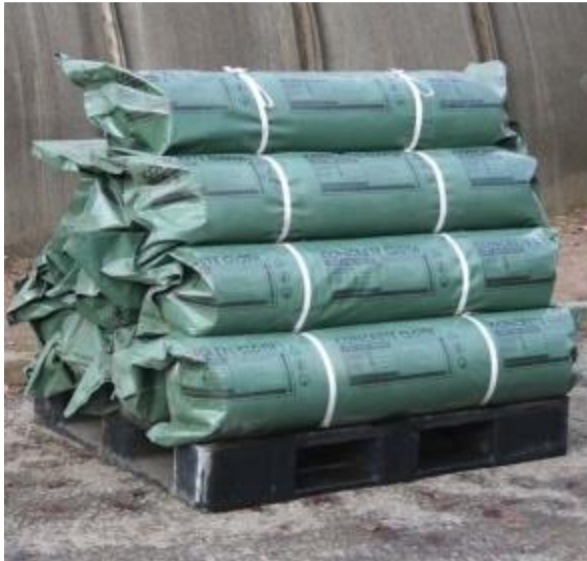
Portable Batched Rolls

Concrete Cloth™ comes in two roll varieties:

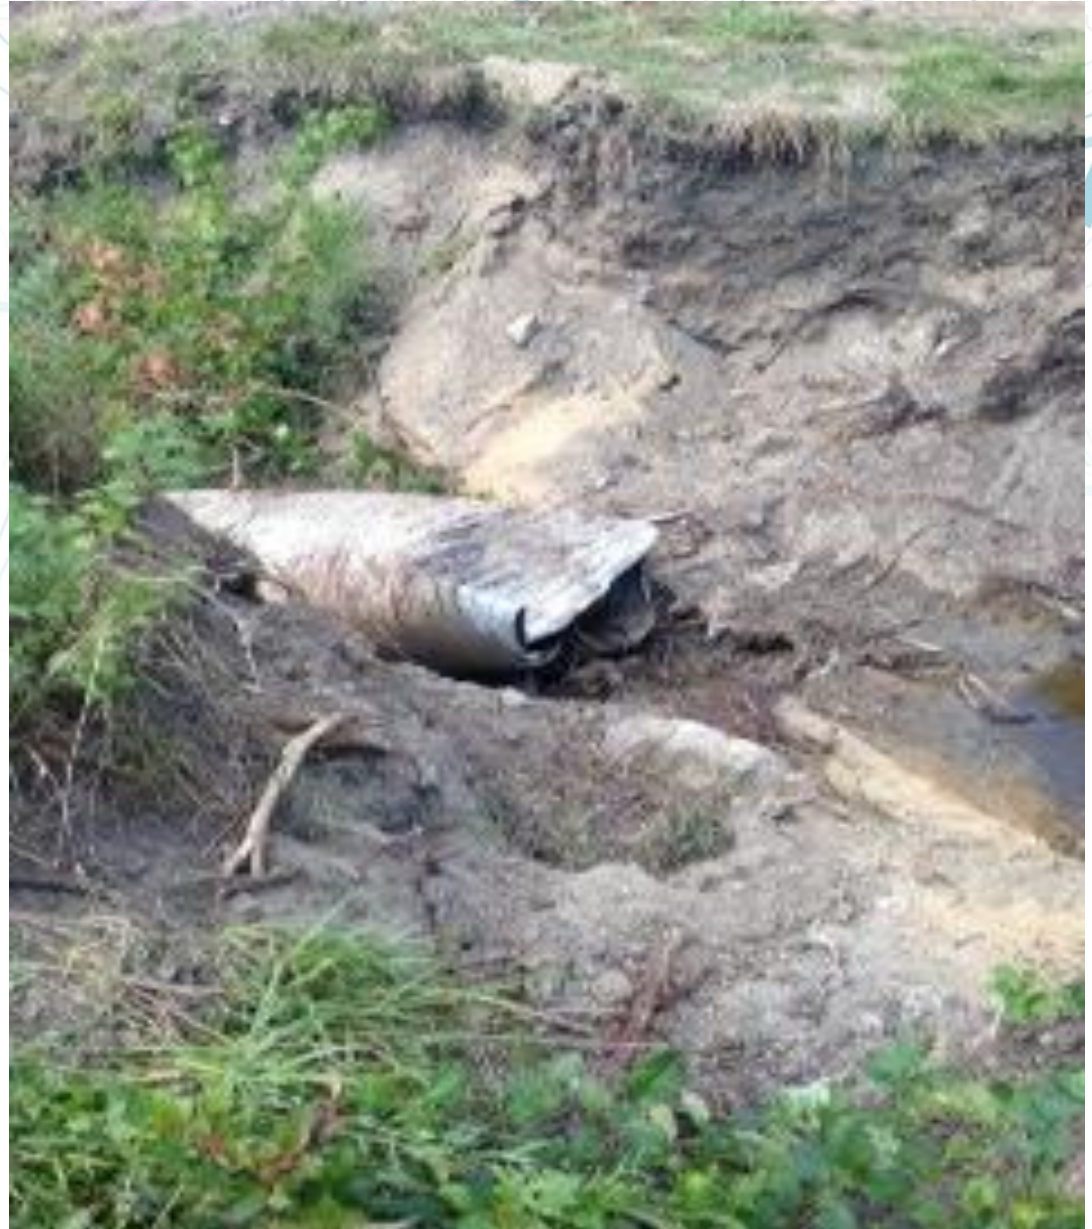
Collapsed 36" CMP Culvert with Outlet Scour

Water blew out a 36 inch diameter culvert. Repair included a Concrete Cloth outlet/channel lining/spillway lining down to the nearby stream

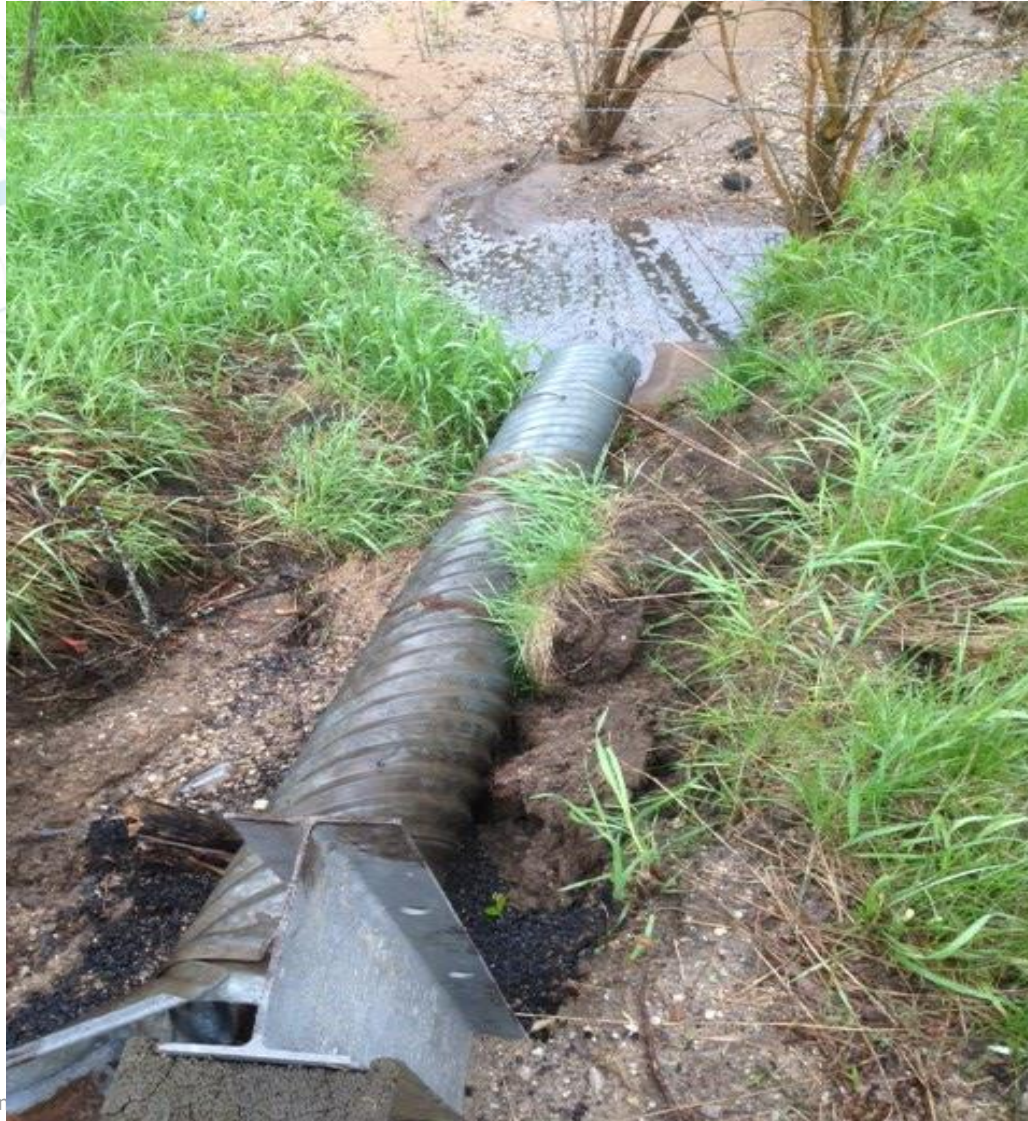
Eroding Drain Inlet and Outlet

Bridge approach drain was eroding exposing the pipe and the downstream outlet to scour. Repair included a Concrete Cloth outlet/channel lining lining down to the nearby stream

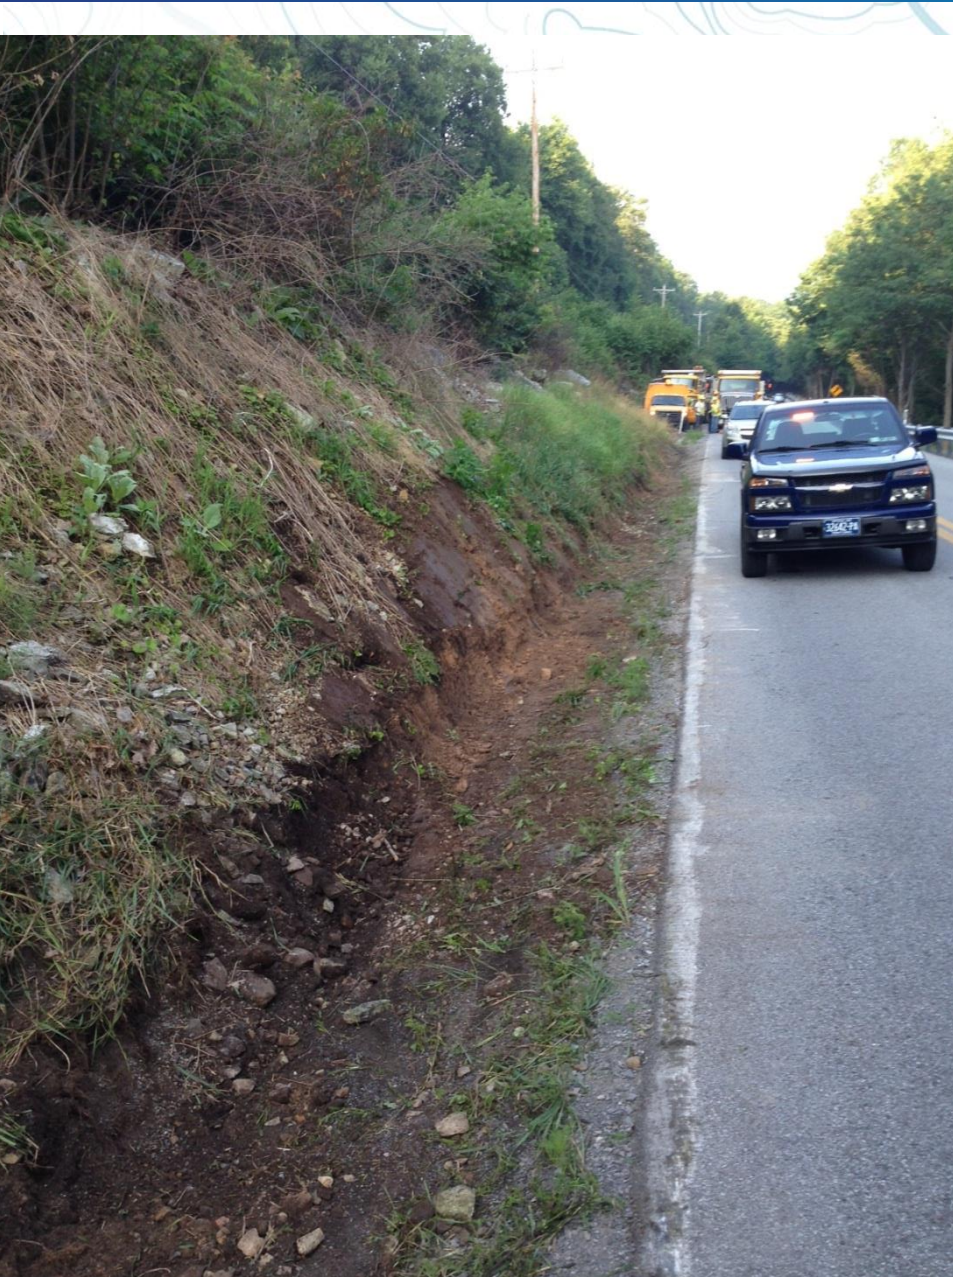
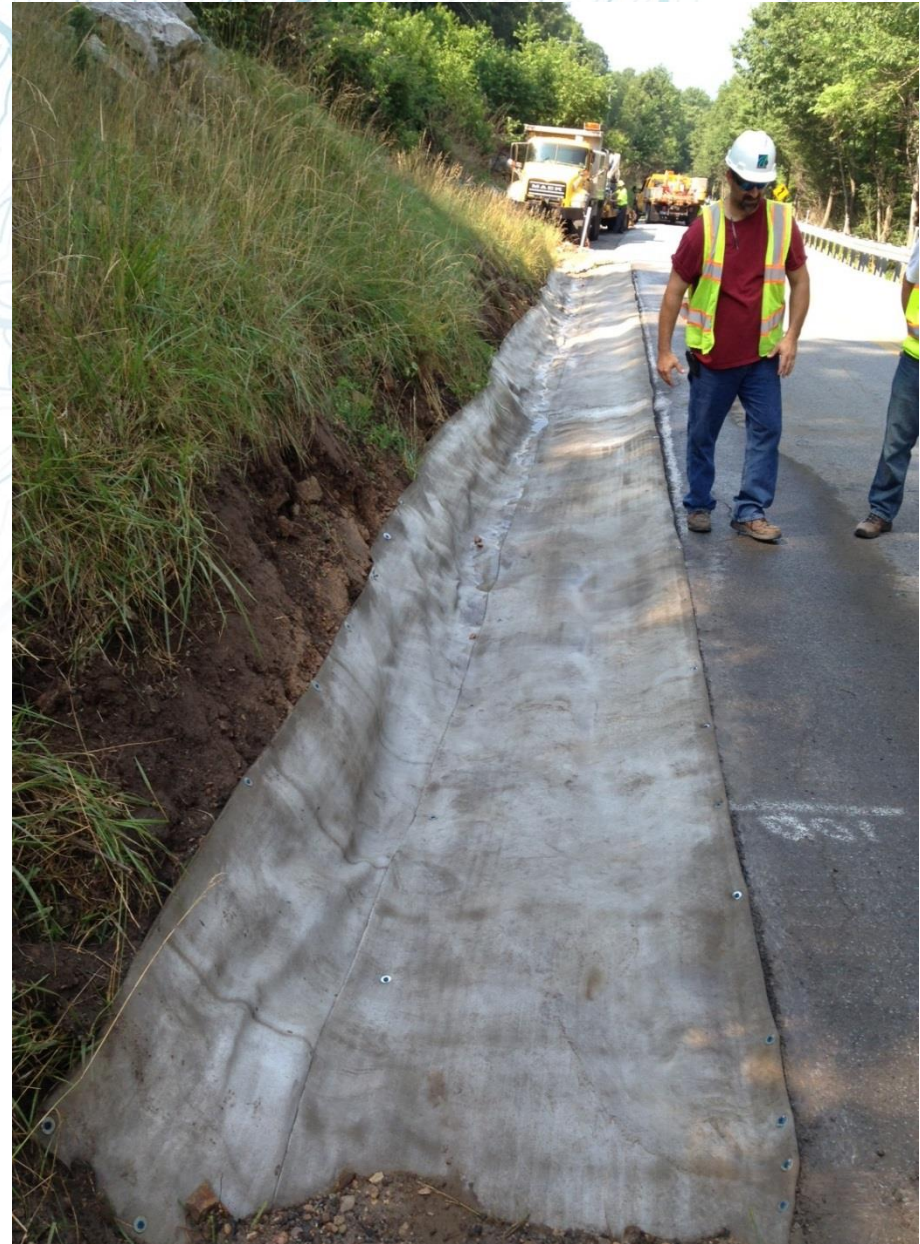
Roadside Ditch Protection

- Date: July 18, 2013
 - Location: Blair County, Pennsylvania
 - Application: Roadside Drainage Ditch
- Due to steep grades, the Pennsylvania DOT installed a number of cross culverts years ago in order to capture storm water runoff and outlet it on the downslope side of the roadway. On one stretch, the DOT wanted to improve erosion protection.

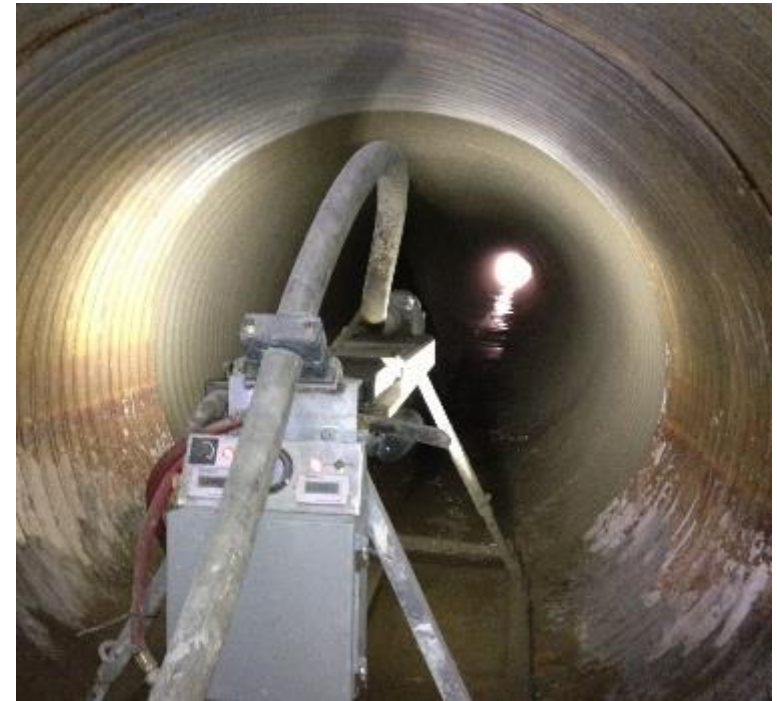
Centrifugal Casting Concrete Pipe (CCCP) / Spin Casting of Geopolymer (SCGP) using GeoSpray

- Rapidly distributes material within the pipe's internal circumference
- Forms a strong, low permeability, cement lining
- Depending upon design & thickness, creates a “pipe within a pipe” and does not rely on the integrity of the host structure
- While not generally required, it is compatible with most common reinforcement technologies

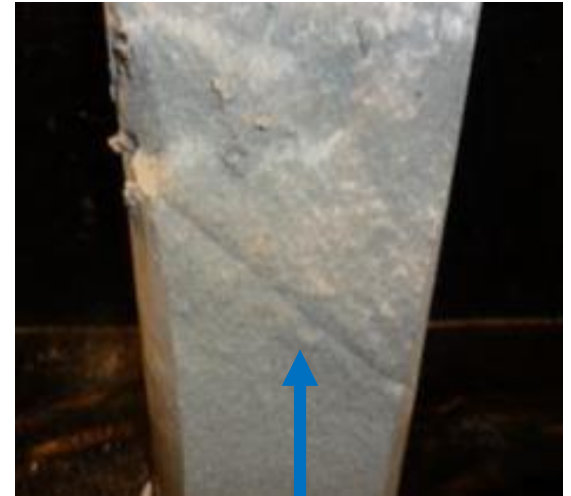
Joint in Tested Sample

- On the first day a series of 2" by 4" cylinders were cast half full and cured with on an approximately 45 angle.
- On subsequent days (1, 7, 14 and 28) the top half of the cylinders were cast and filled creating a 45 angled joint in the center of the cylinders
- Compressive strength tests were conducted 28 days after the top half of the cylinders were cast.

- Samples cast of GeoSpray (both halves) when tested under compression did not break at the joint.
- The chemical nature of GeoSpray allows for chemical bonding across the interface even with pours 28 days apart resulting in a monolithic structure.
- Samples cast of competitive cement mortars always broke along the angled joint essentially creating 2 separate layers.

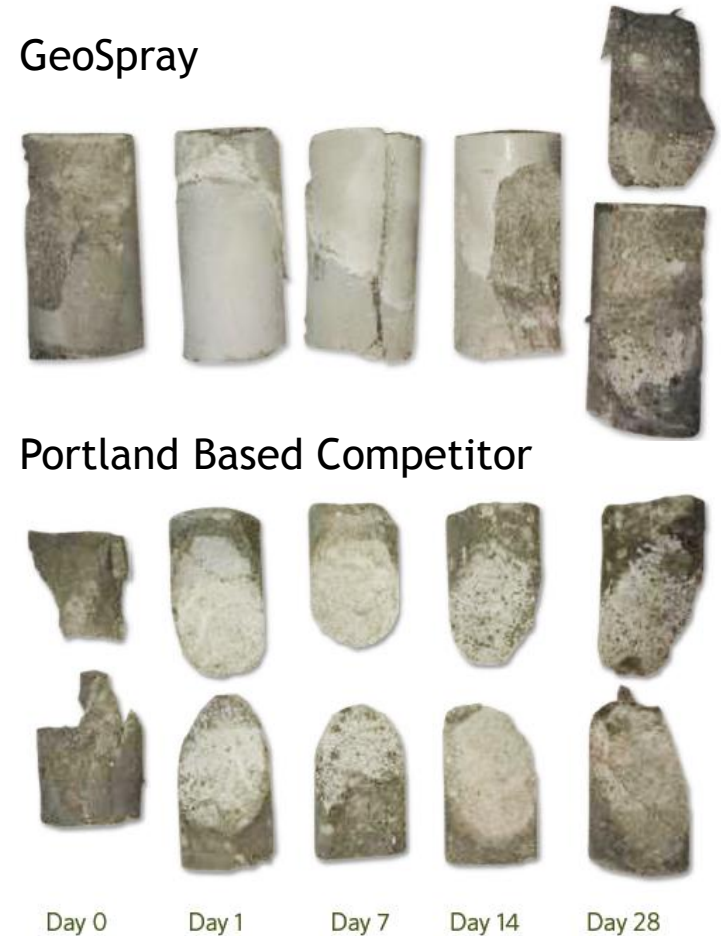
This unique property of geopolymers allows project flexibility in variable weather conditions as the covalent bonds prevent cold joint shear failure

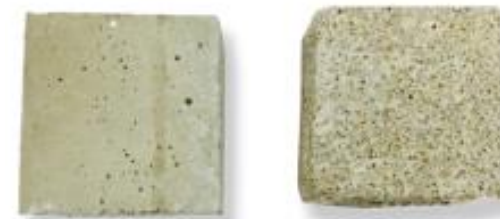
Day 0

Day 84

- When samples were further exposed to higher levels of sulfuric acid (7% H_2SO_4) GeoSpray AMS samples showed some signs of surface level corrosion after 84 days.
- GeoSpray AMS samples performed significantly better than standard portland cement samples which lost greater than 50% of their original weight.

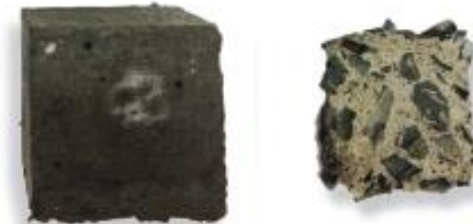
Portland

Day 0

Day 84

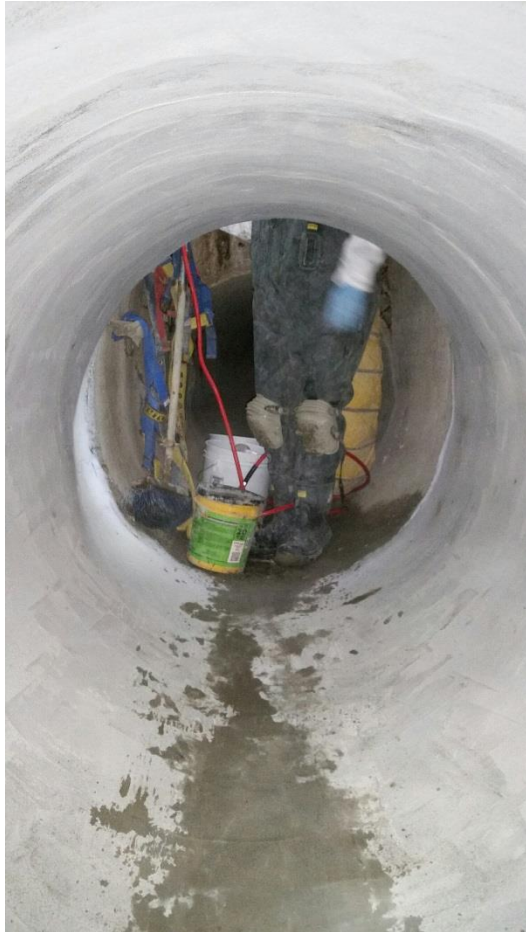
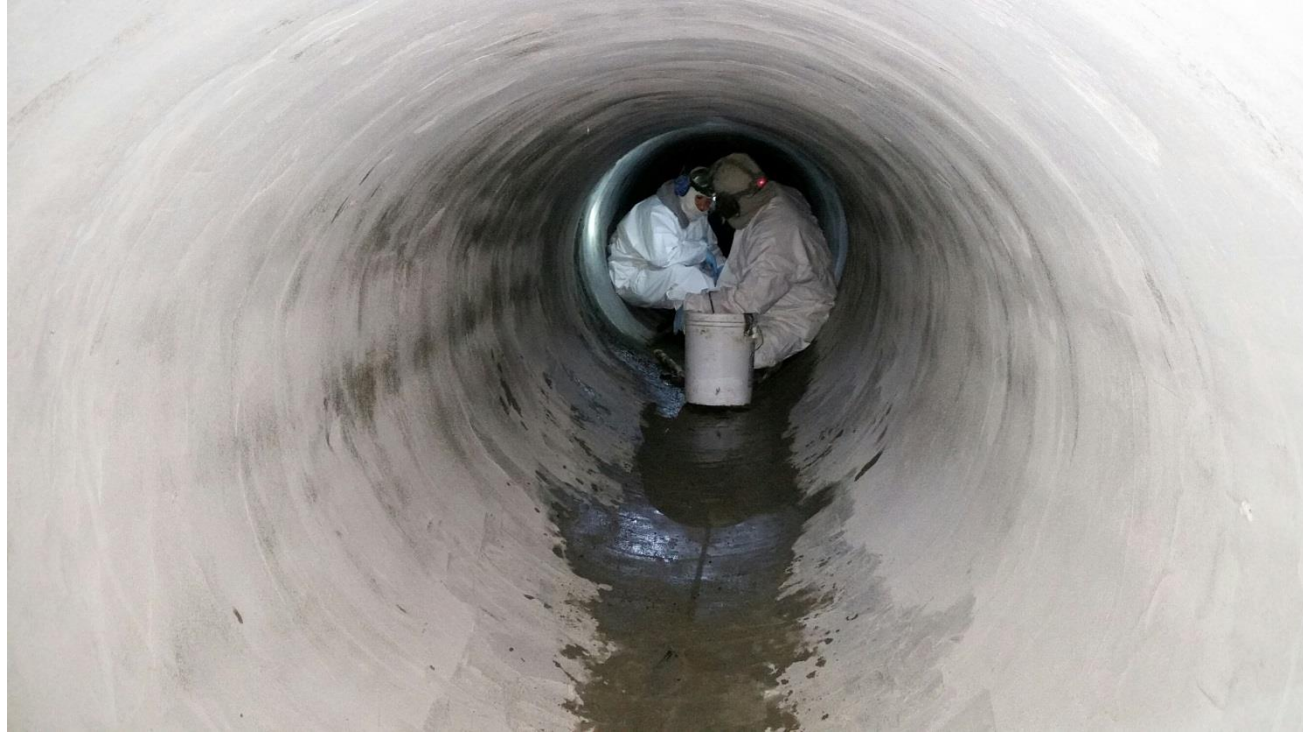
- When lining corrugated metal pipe Manning's n values will likely be reduced to a range of 0.016 to 0.018 as the lining fills in some of the corrugation.
- Option to adjust the desired roughness of the surface by hand finishing techniques

Hand trowelled finish reduces roughness to the finish of smooth concrete pipe.

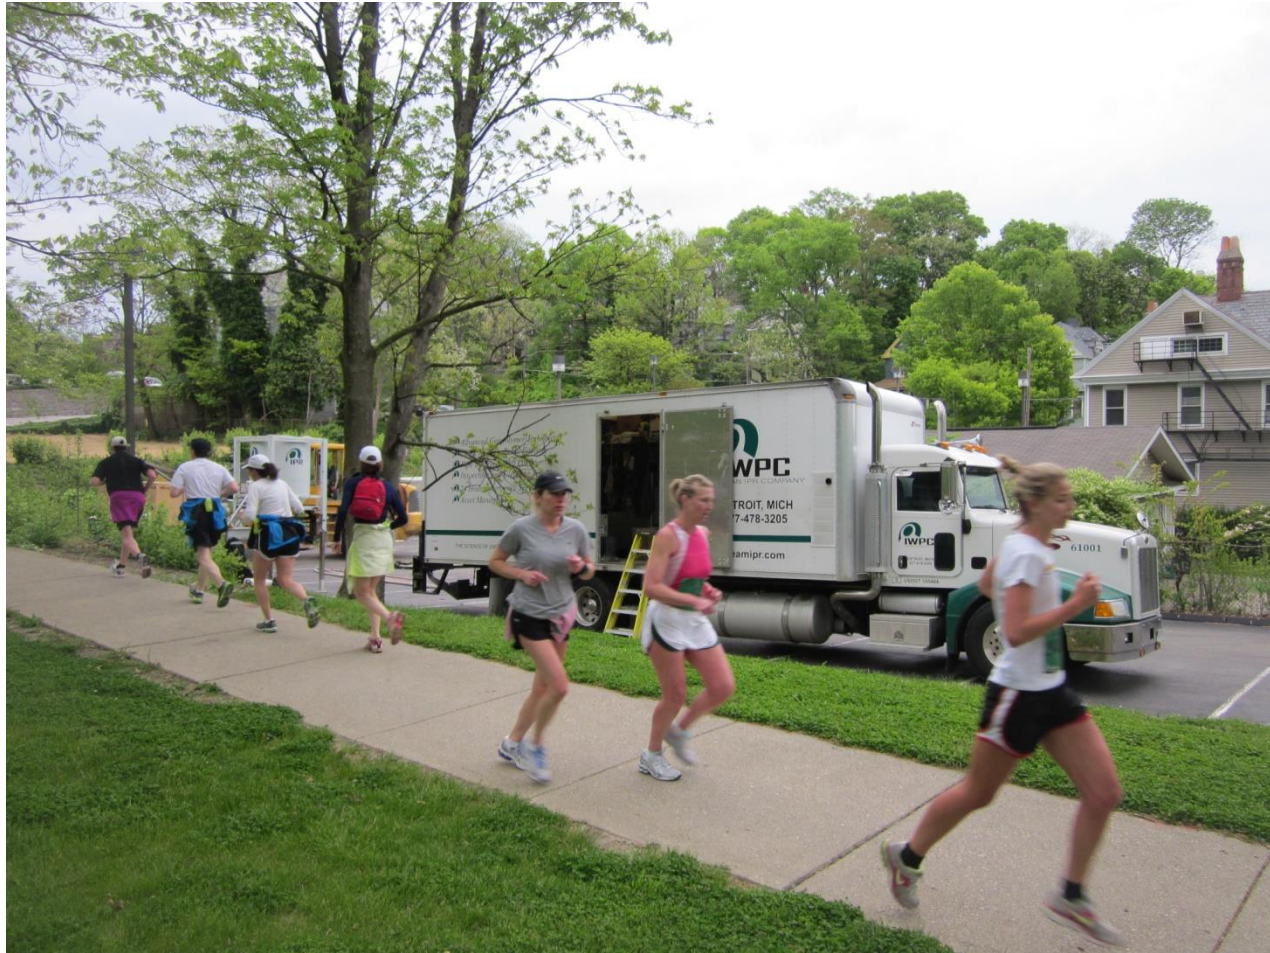
Equipment Footprint

All required equipment is housed in a single 24 ft box truck, with a hopper and materials storage. All repair equipment fits down a standard 24 inch diameter manhole.

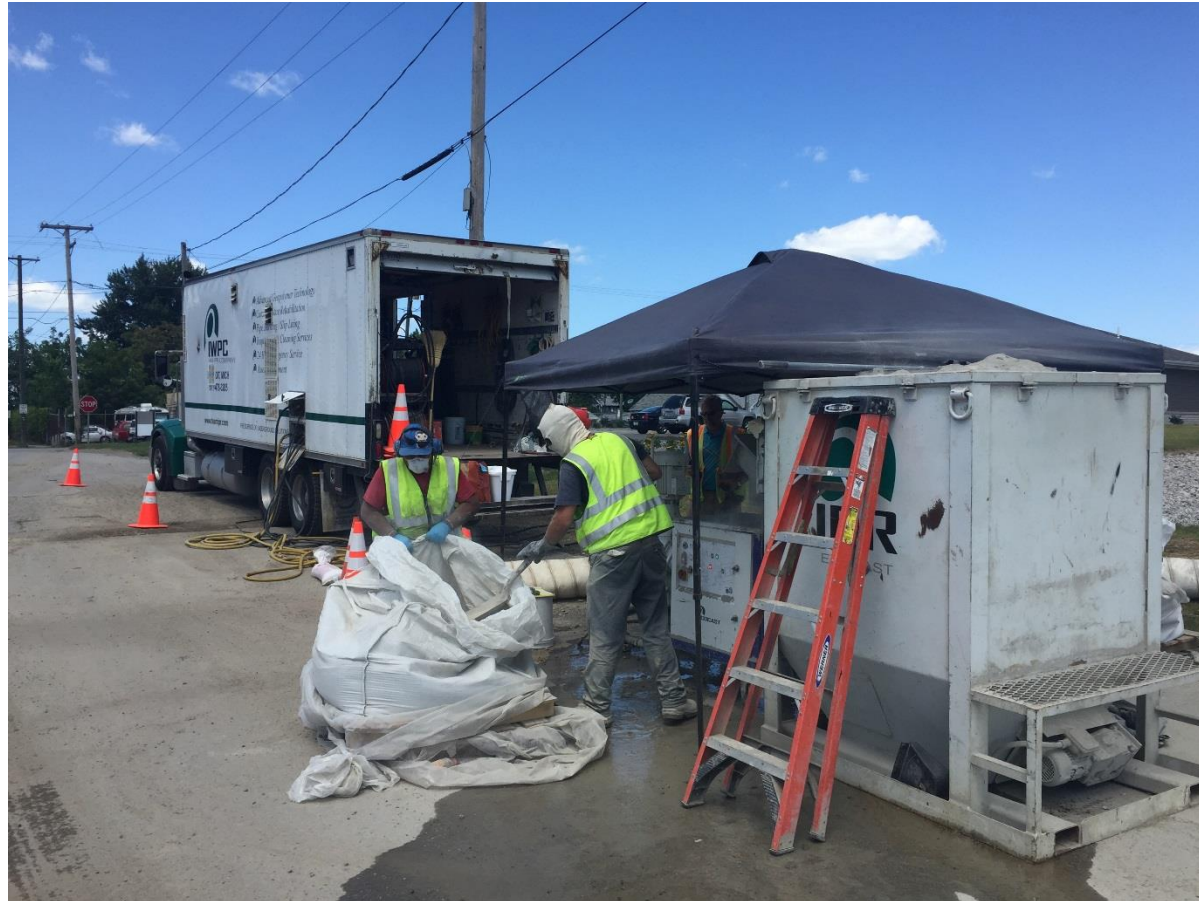
All required equipment is housed in a single 24 ft box truck, with a hopper and materials storage. All repair equipment fits down a standard 24 inch diameter manhole.

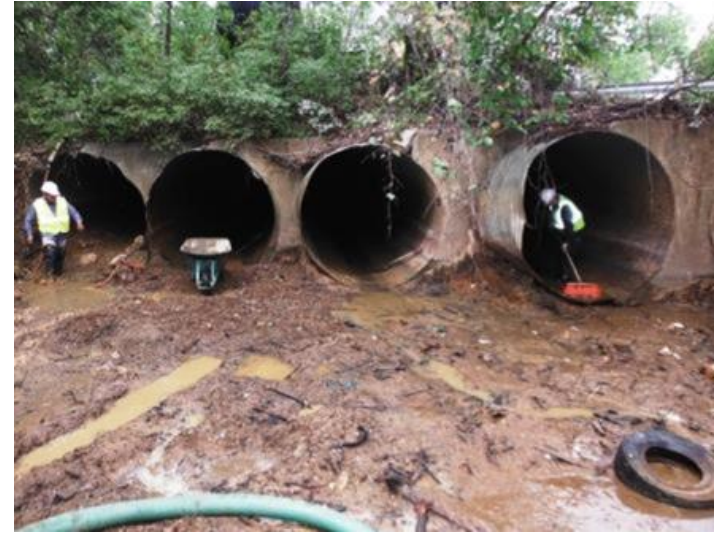
The active creek bed was dewater and flow through the culverts were diverted. The pipes were then cleaned and pressure washed in preparation for lining.

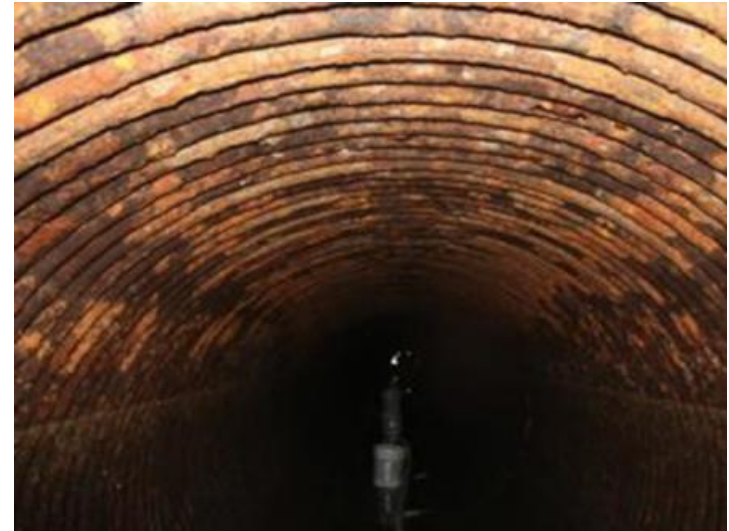
The deteriorated condition of the pipes caused significant safety concerns due the heavy industrial traffic that is common on this road. Flooding of the road was also a common occurrence.

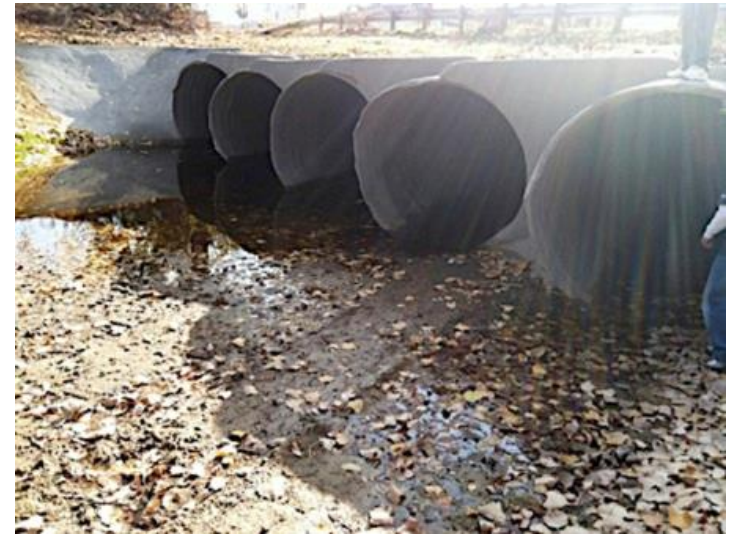
GeoSpray was used not only to rehabilitate the pipes, but also to rehab the head wall.

Carefully calculated and monitored application of the material provided improved flow characteristics and stopped flooding that had been common place.

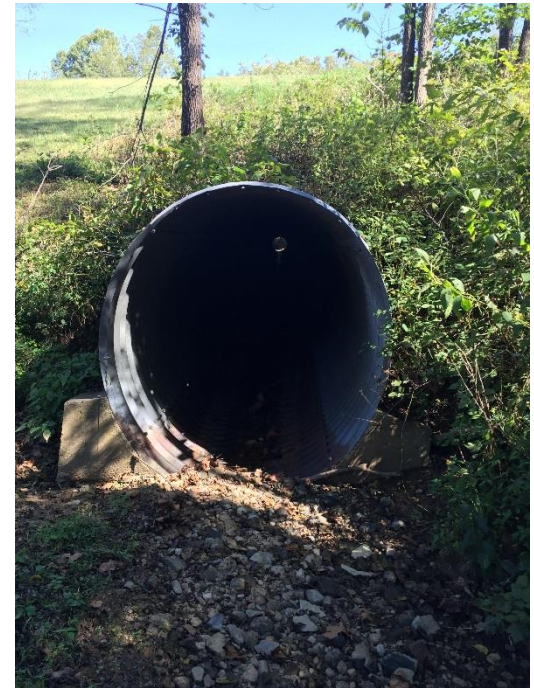
- The Indiana DOT was looking for a site to demonstrate the lining capability of a geopolymer cement mortar. SR 446 provided a pipe that allowed for good access and viewing.
- Corroded & deteriorating CMP Culvert
 - 275 linear feet of 84 inch diameter
 - Bolted multiplate corrugated metal pipe
- Contractor - Temple and Temple

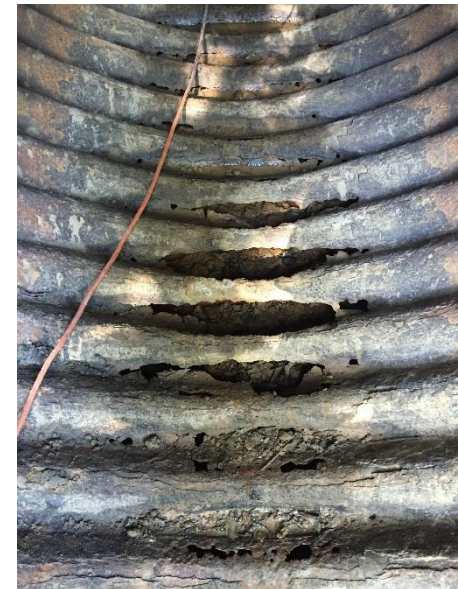
- The culvert was originally specified to be rehabilitated with cured in place pipe (CIPP).
- SR 446 culvert under 30+ of fill.
- Sections of invert have corroded completely through with significant sections of ground water infiltration.

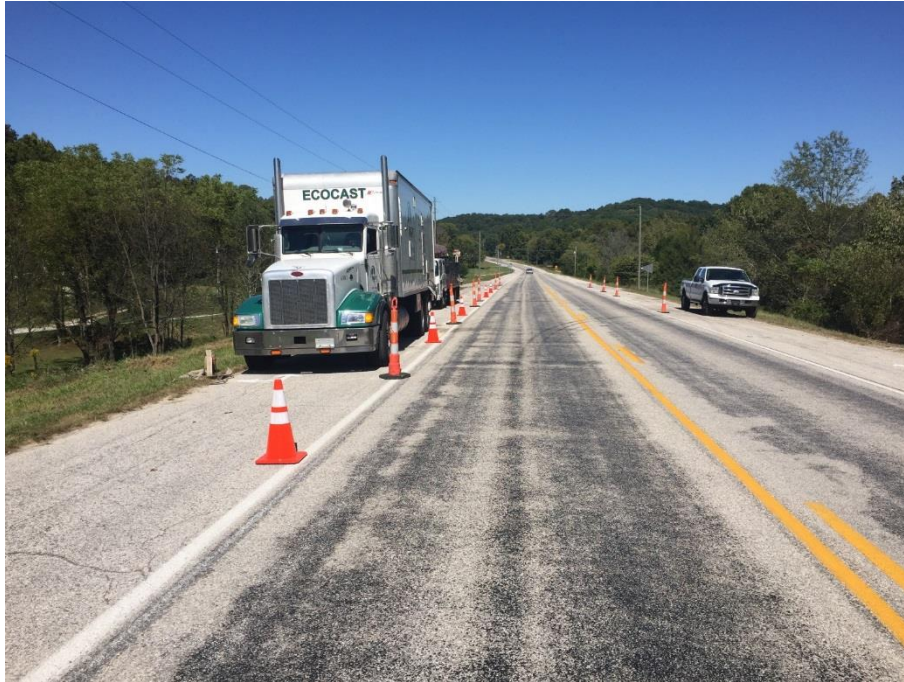
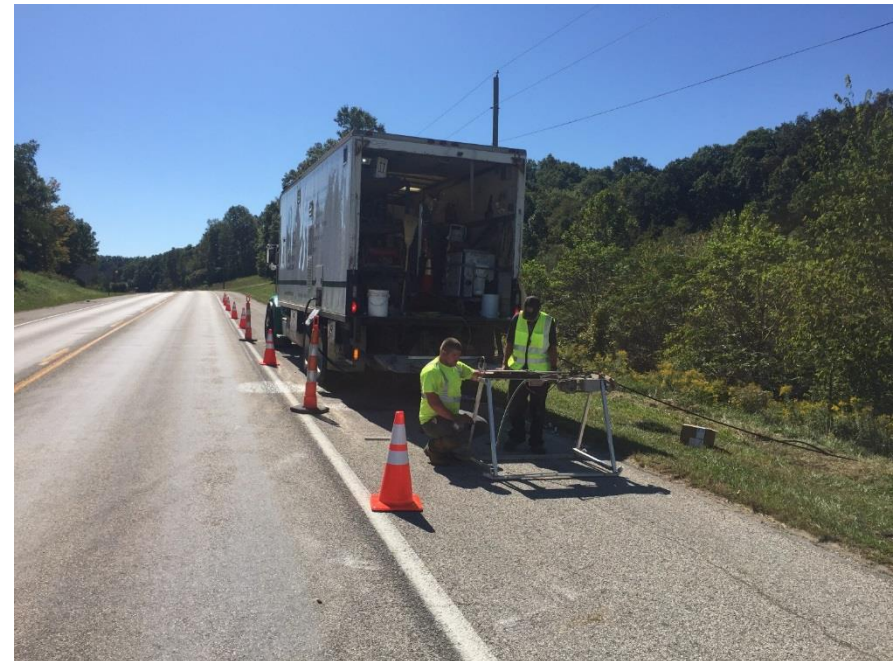
Small working footprint allowed for very limited disruption to traffic with no lane closures.

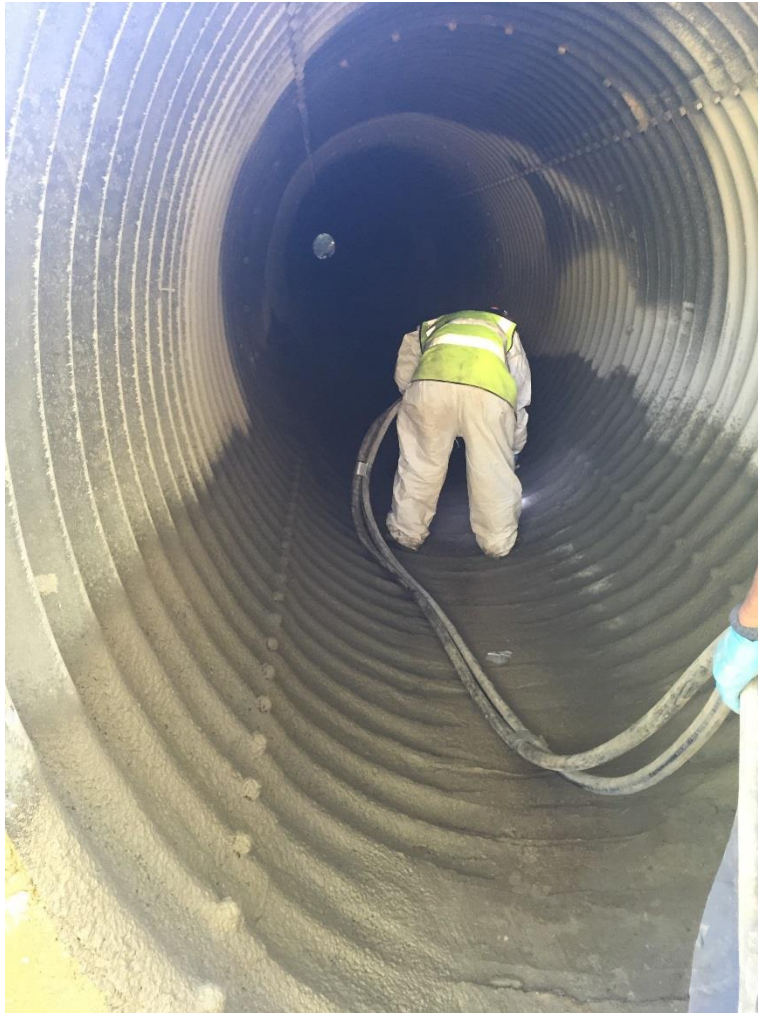
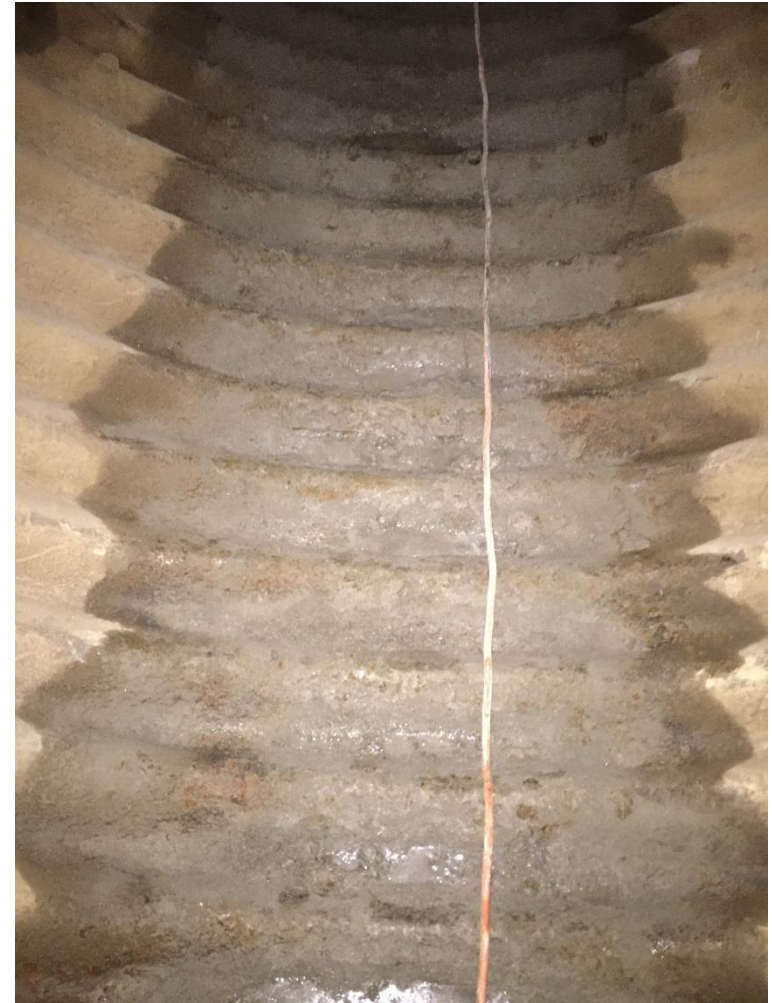
SR 446 - Bloomington, Indiana

Invert was repaired by hand spraying GeoSpray mortar into the invert voids.

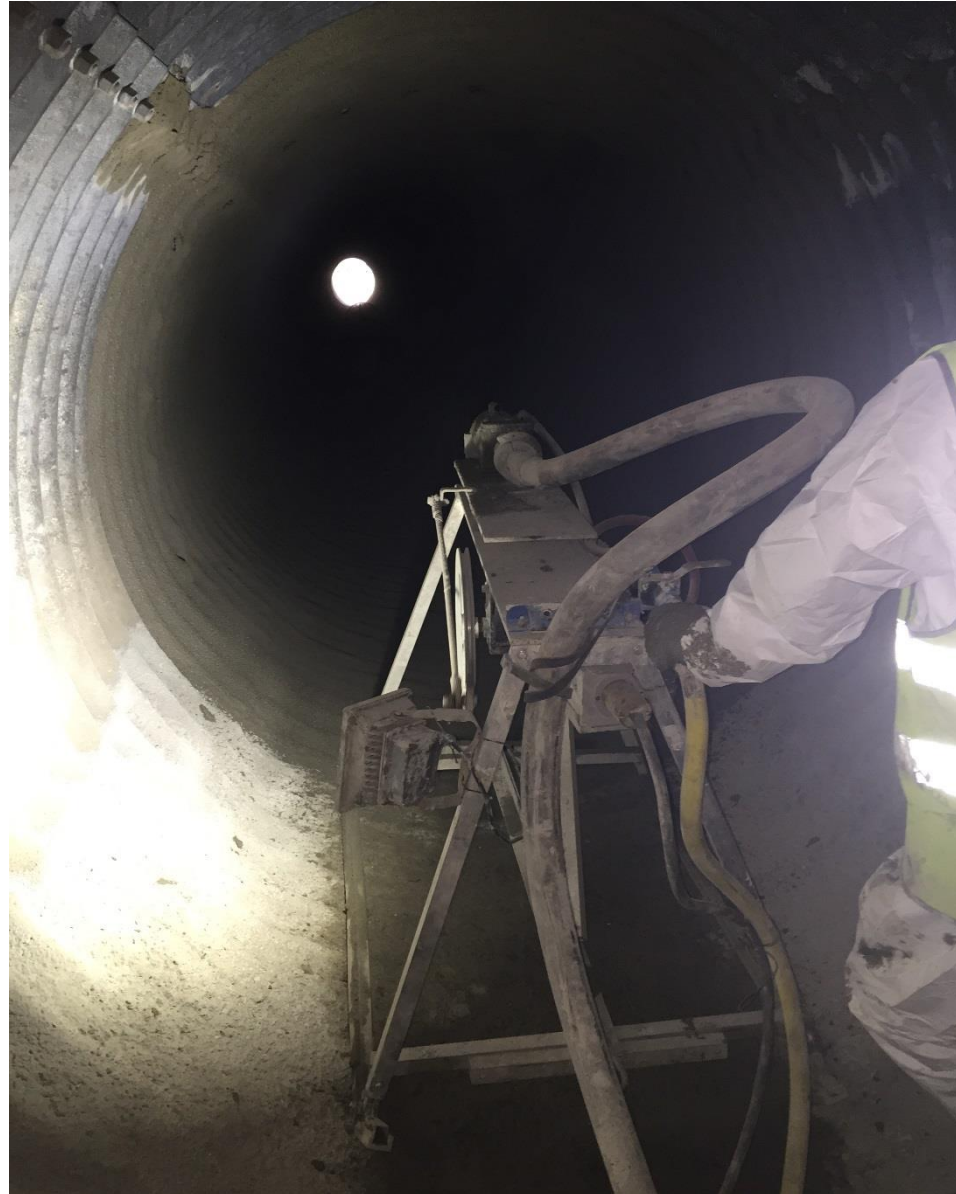
SR 446 - Bloomington, Indiana

A 1.5 inch structural
GeoSpray liner was
applied in 2 passes.

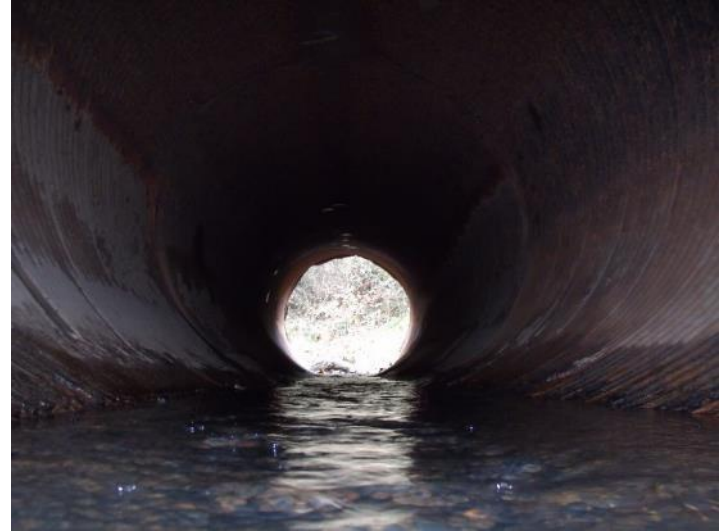
The 108 inch CMP culvert was missing significant material in the invert and was in need of repairs.

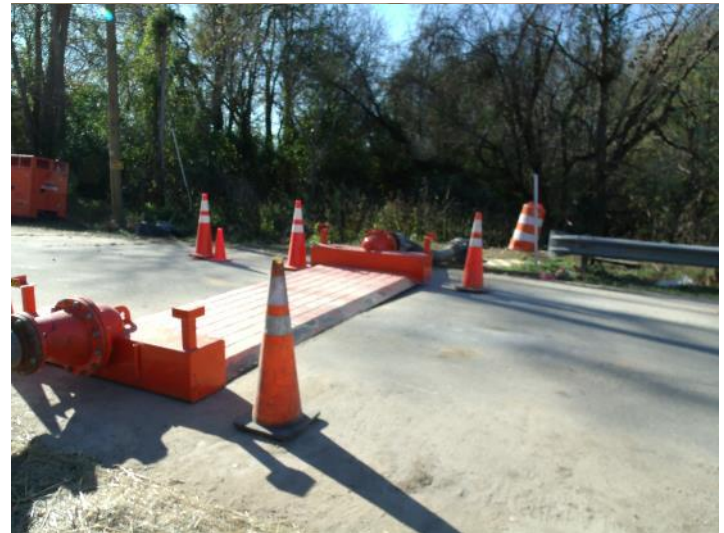
An 8 inch hydraulic by-pass was used to divert flow and allow traffic over the single lane road during the entire rehabilitation.

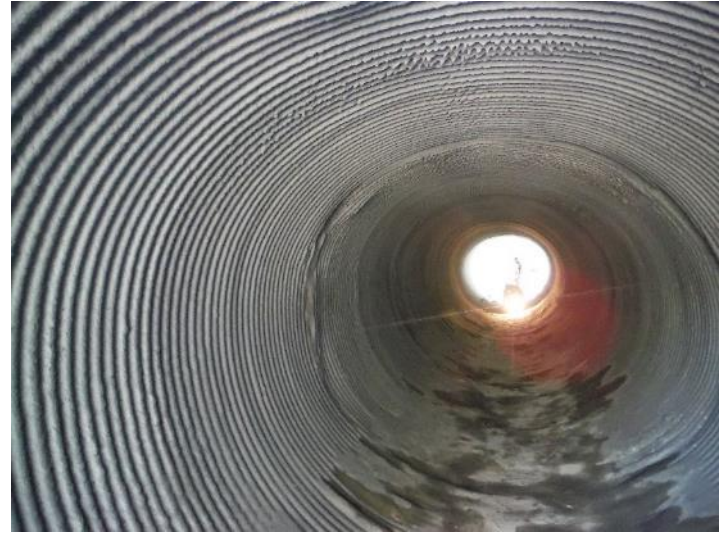
A 2.5 inch structural GeoSpray liner was applied in 4 passes.

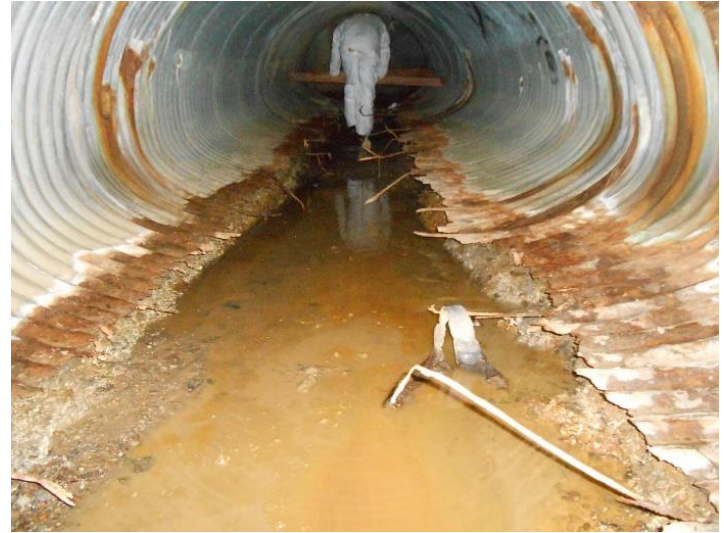
The initial culvert was in very poor shape with most of the invert corroded and lost with soil voids as deep as 2 ft below the pipe

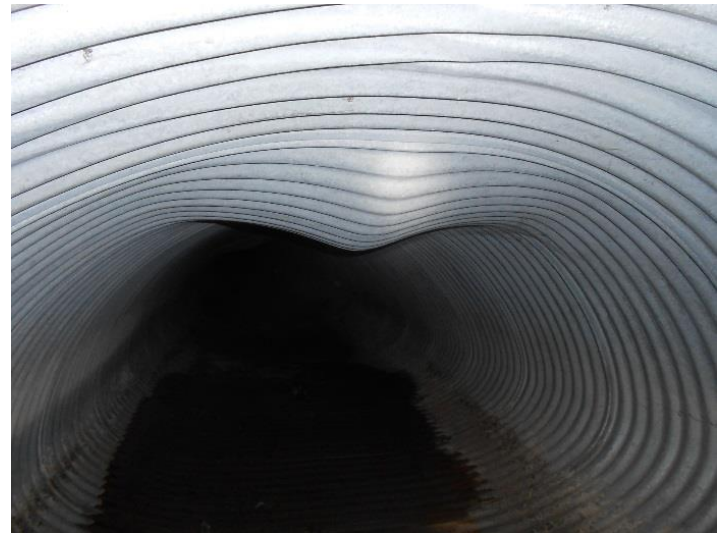
Significant damage also existed in the crown with some sections caved in.

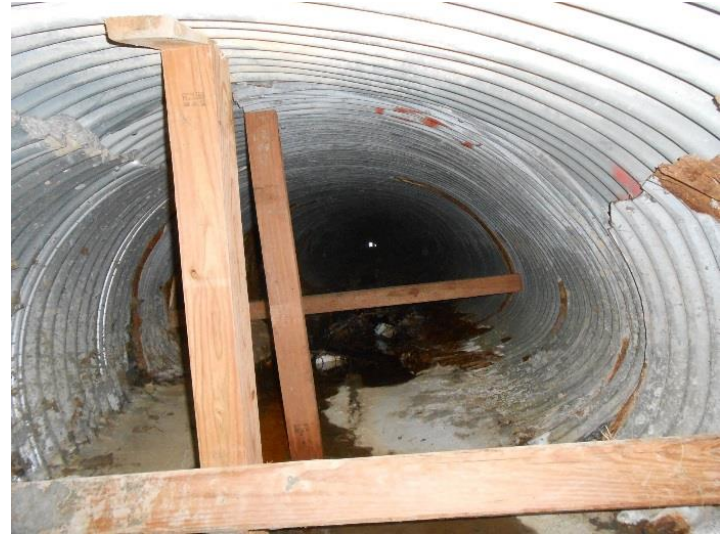
Prior to repair the pipes required bracing for safe operation.

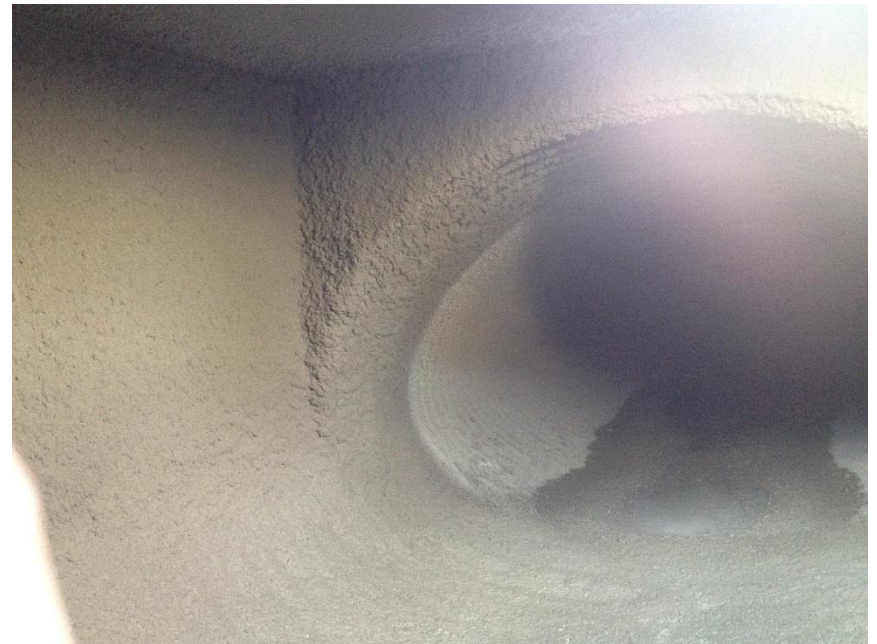
The finished culvert created a new structural system, integrated with the junction boxes

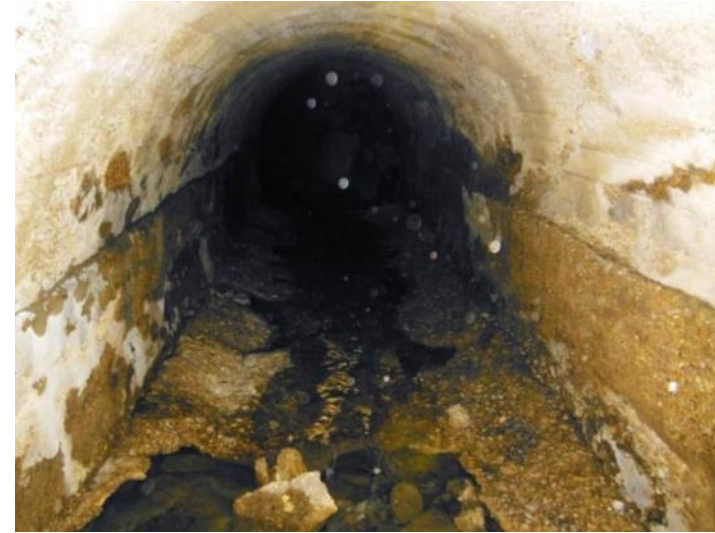
Original arched storm water pipe
with severely damaged invert.

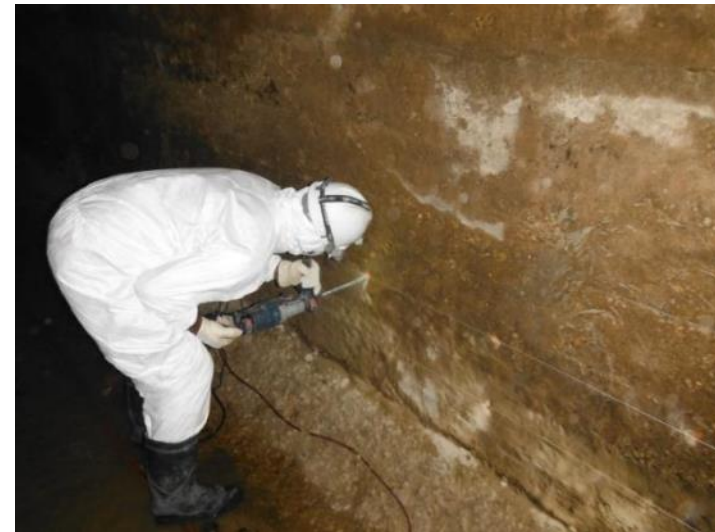
The first step was to install a rebar
cage along the bottom corners of the
pipe to support a rounded bottom.

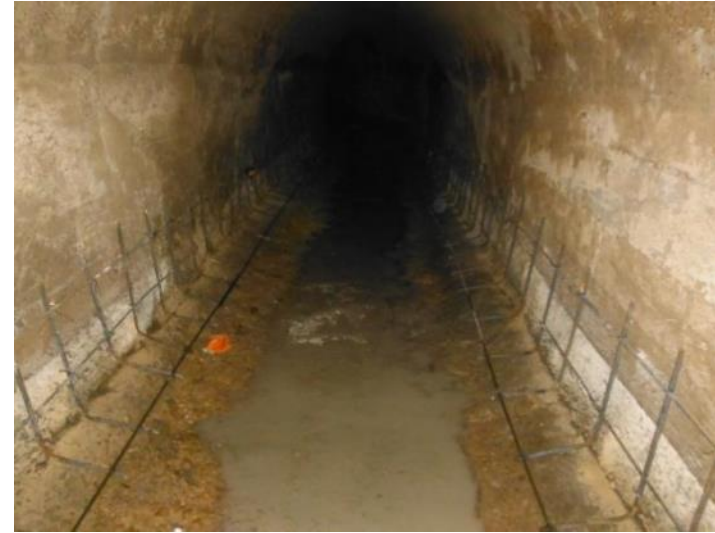
The completed rebar support system with initial repairs completed to the invert.

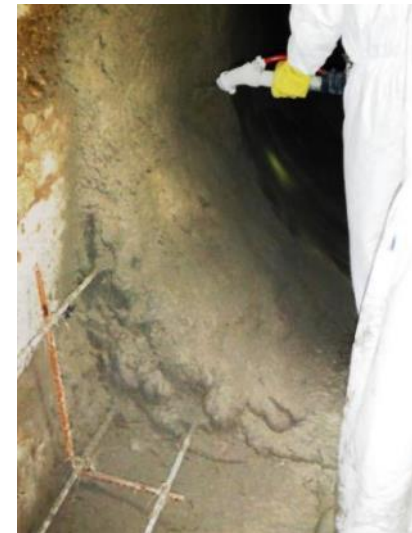
The lower corners of the pipe were then rounded with a hand sprayed application of GeoSpray.

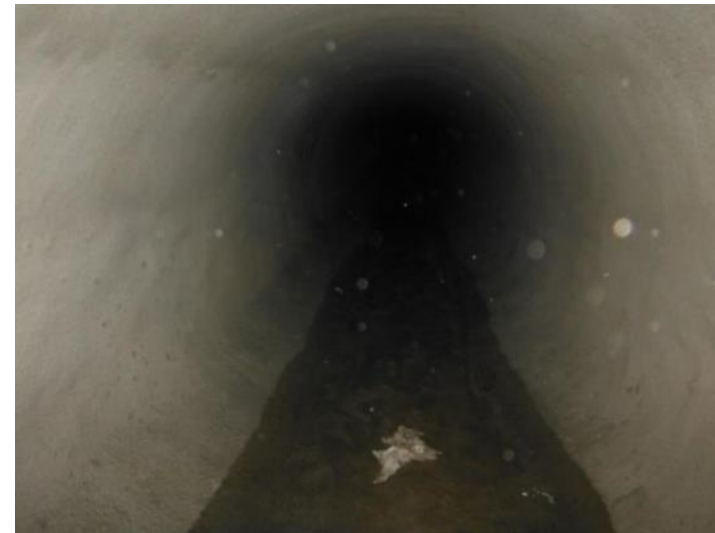
A final pass of GeoSpray was applied finishing the application process.

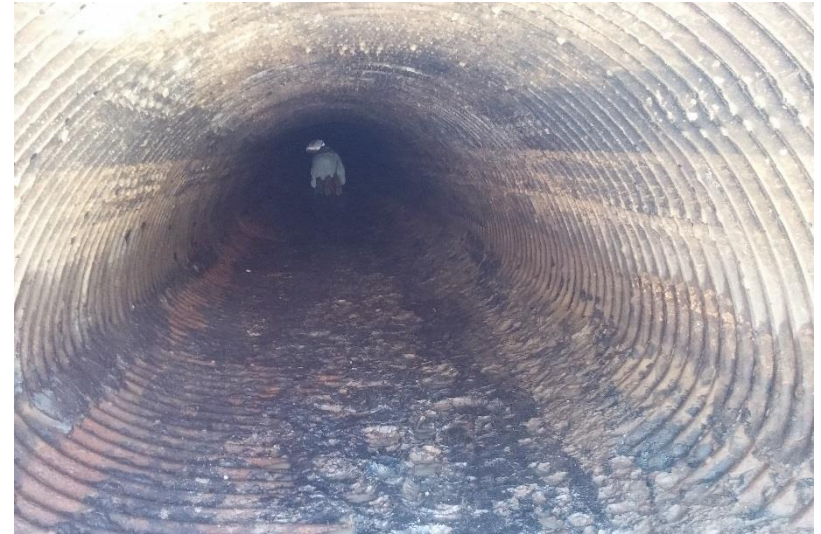
Most of the culverts were at least 40% filled with silt, so the pipes were thoroughly cleaned of the material and then pressure washed and inspected.
