GeoSpray™ GeoPolymer Mortar System and Concrete Cloth for Structural Rehabilitation/Repair of Sewer and Storm Infrastructure

Presented by David Keaffaber, P.E.
Midwest Region Manager

Milliken Infrastructure
Solutions, LLC

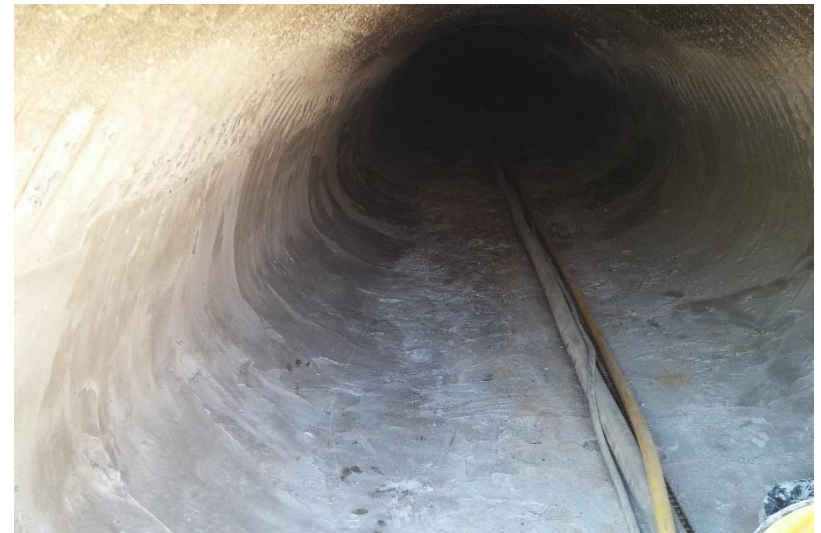
Because the inverts of the pipes were severely corroded, they were rebuilt and then prepared for GeoSpray material application.

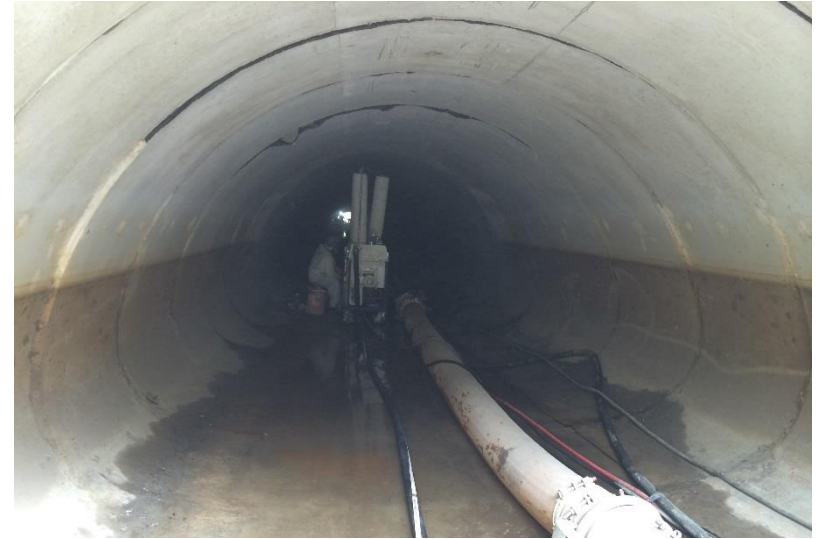
Once cleaned, a first pass of material was applied by shotcrete methods to the corners of the pipe to insure that enough material was placed in those area as required by the engineering design.

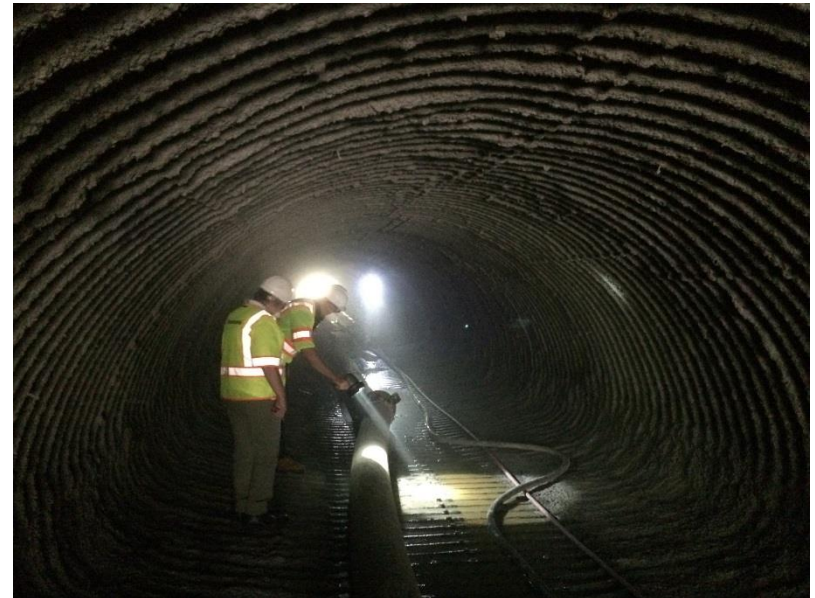
Then the material was applied by spin casting the entire pipe to cover the crown and invert. The by-pass pipe was run through the pipe to avoid disruption of the highway and it was adjusted from side to side as the pipe was rehabbed.

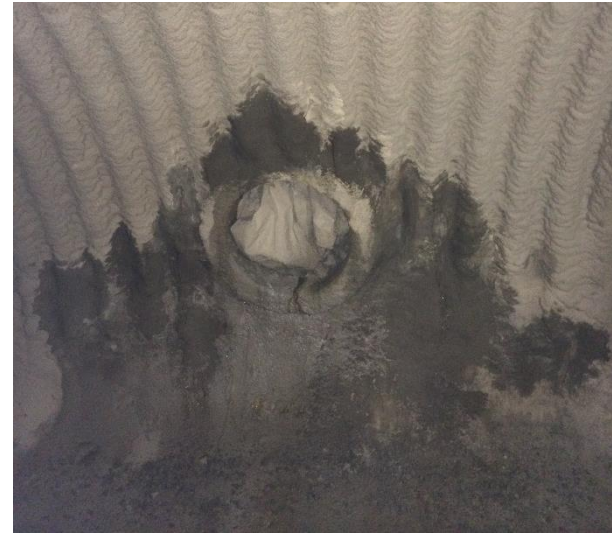
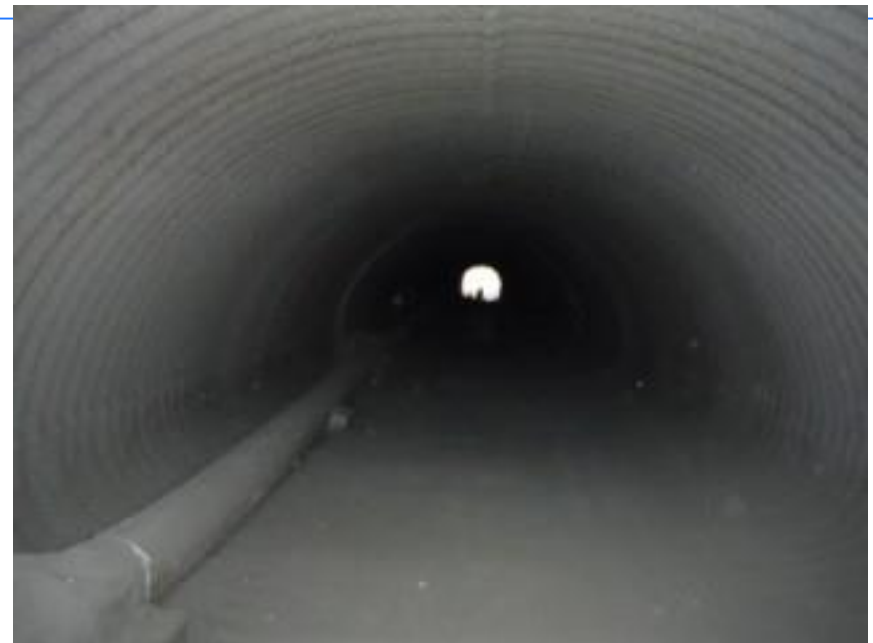
No post cutting of laterals was necessary, saving time and expense.

Each of the smaller pipes had 1.5 inches of thickness applied, while 2.1 inches was required for the largest pipe based on independent engineering. The invert was smoothed around the by-pass pipe to insure a complete structural repair.

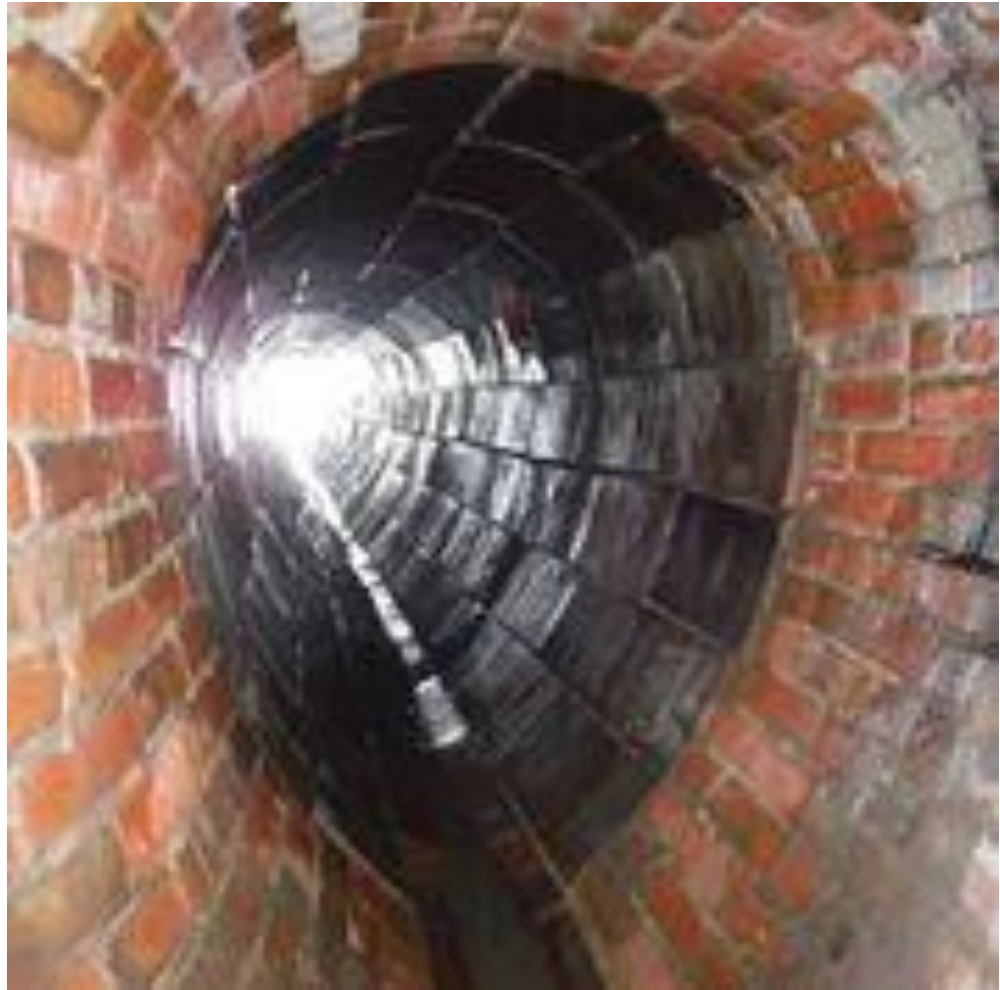
Existing 60" x 40" brick sewer.

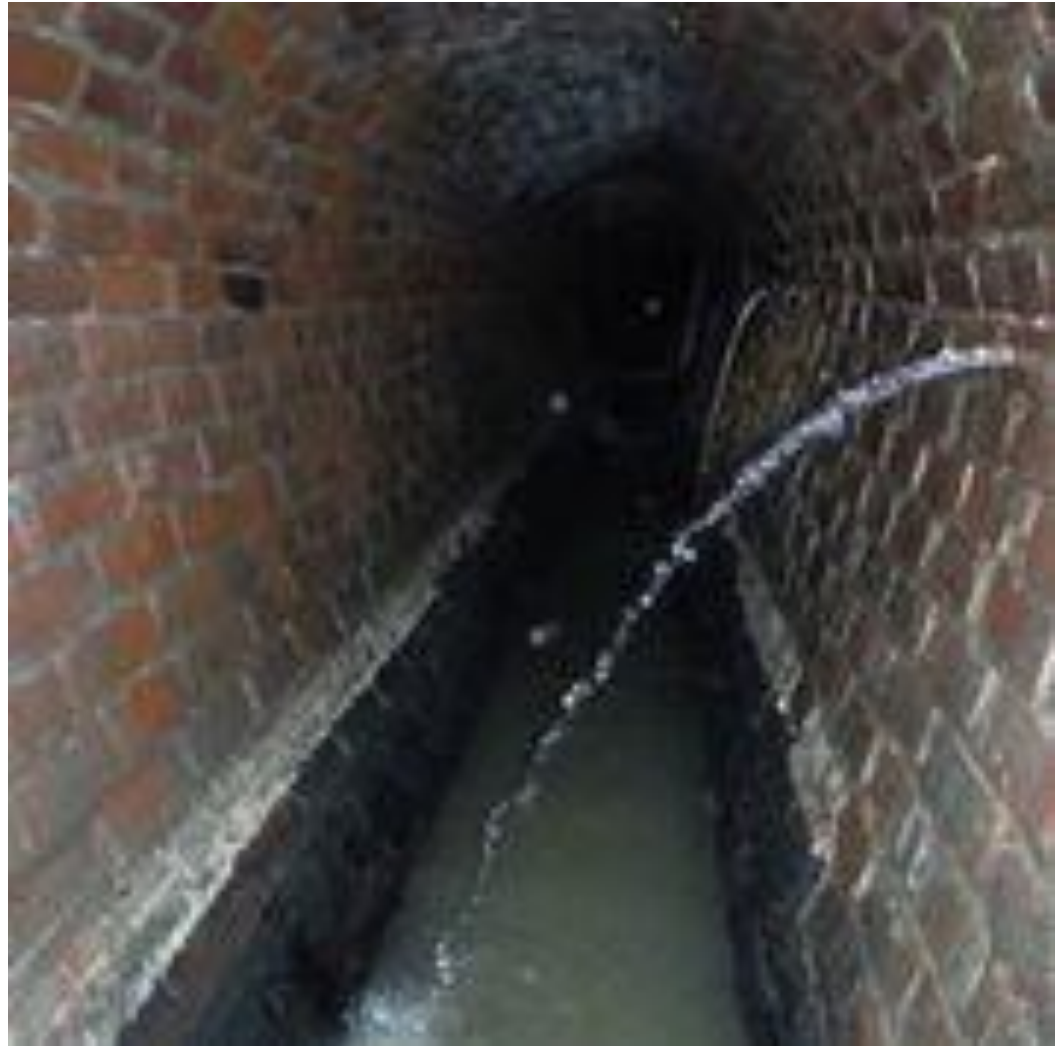
Existing 60" x 40" brick sewer.

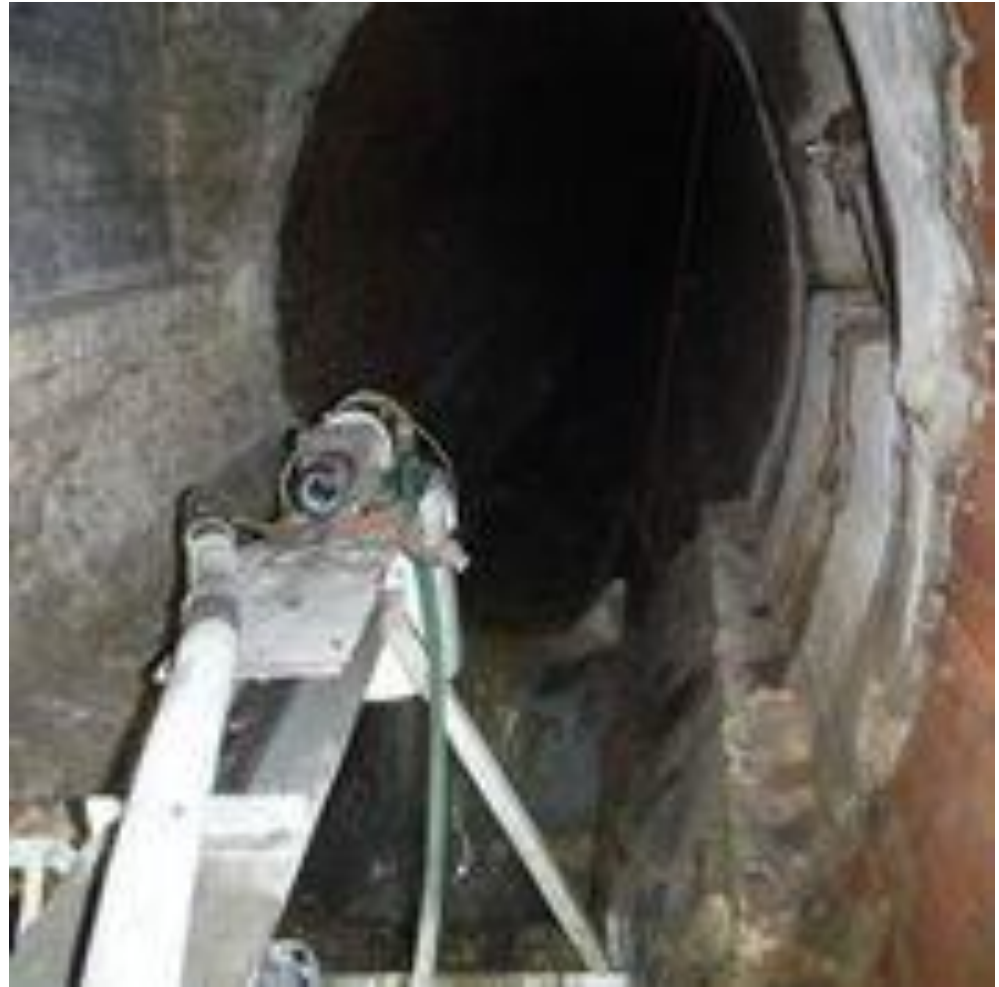
A 1.5 inch structural GeoSpray liner was applied in 2 passes.

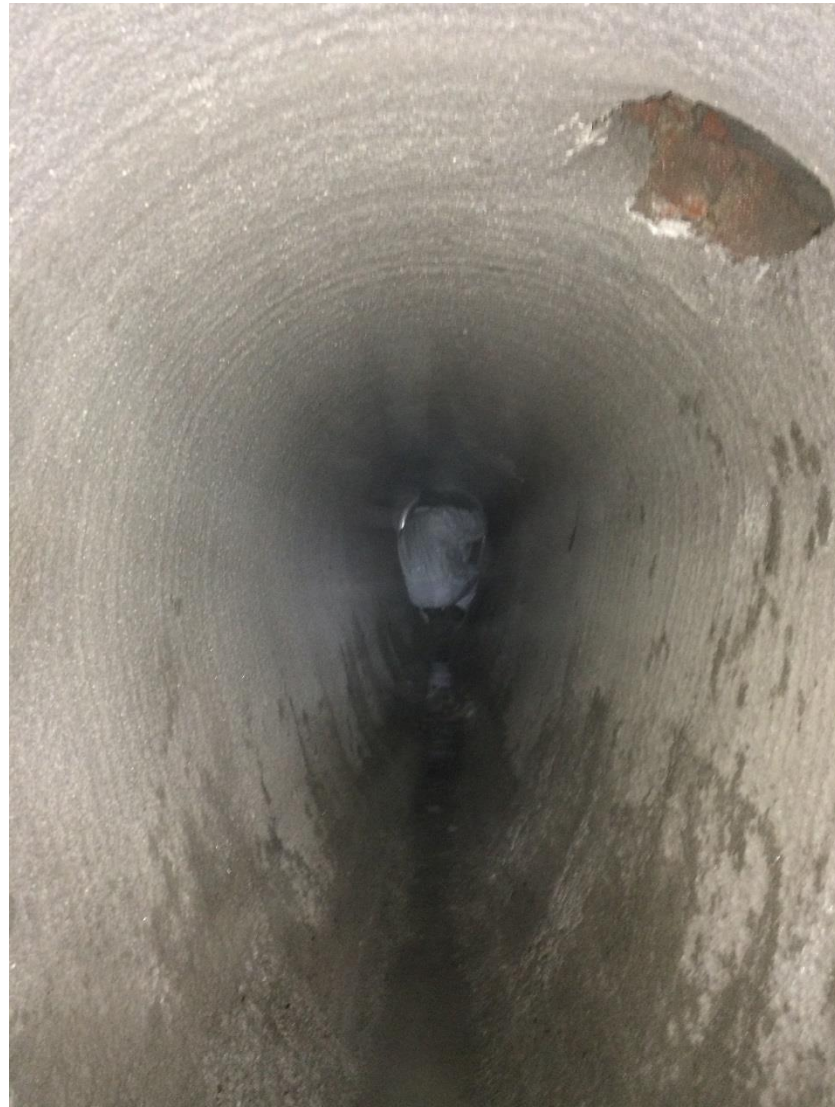
Structural rehabilitation with a 1.5
inch GeoSpray mortar lining.

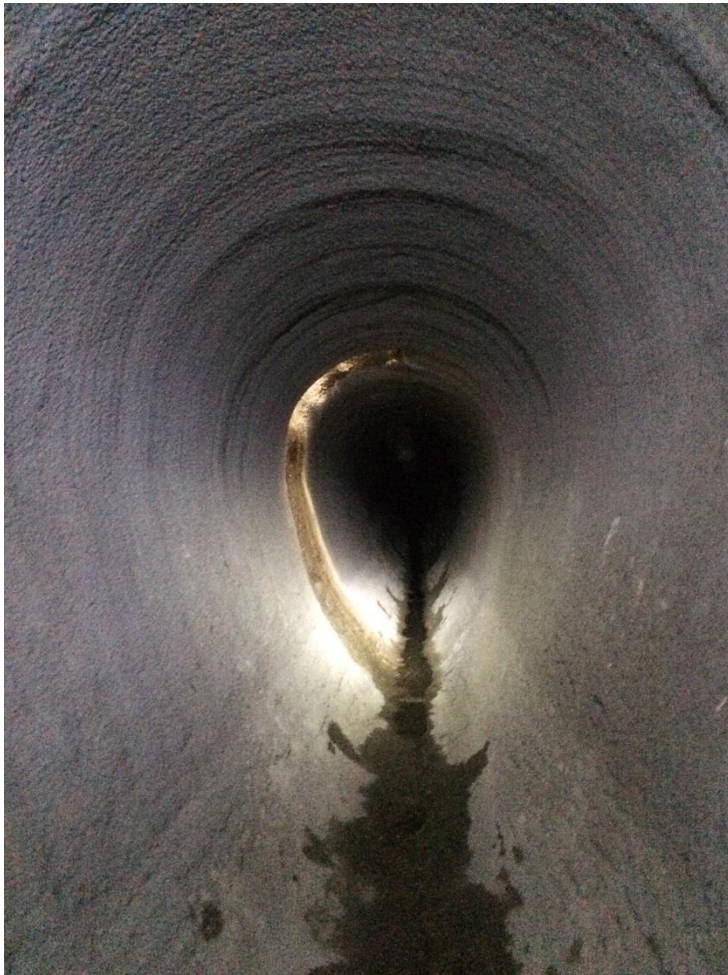
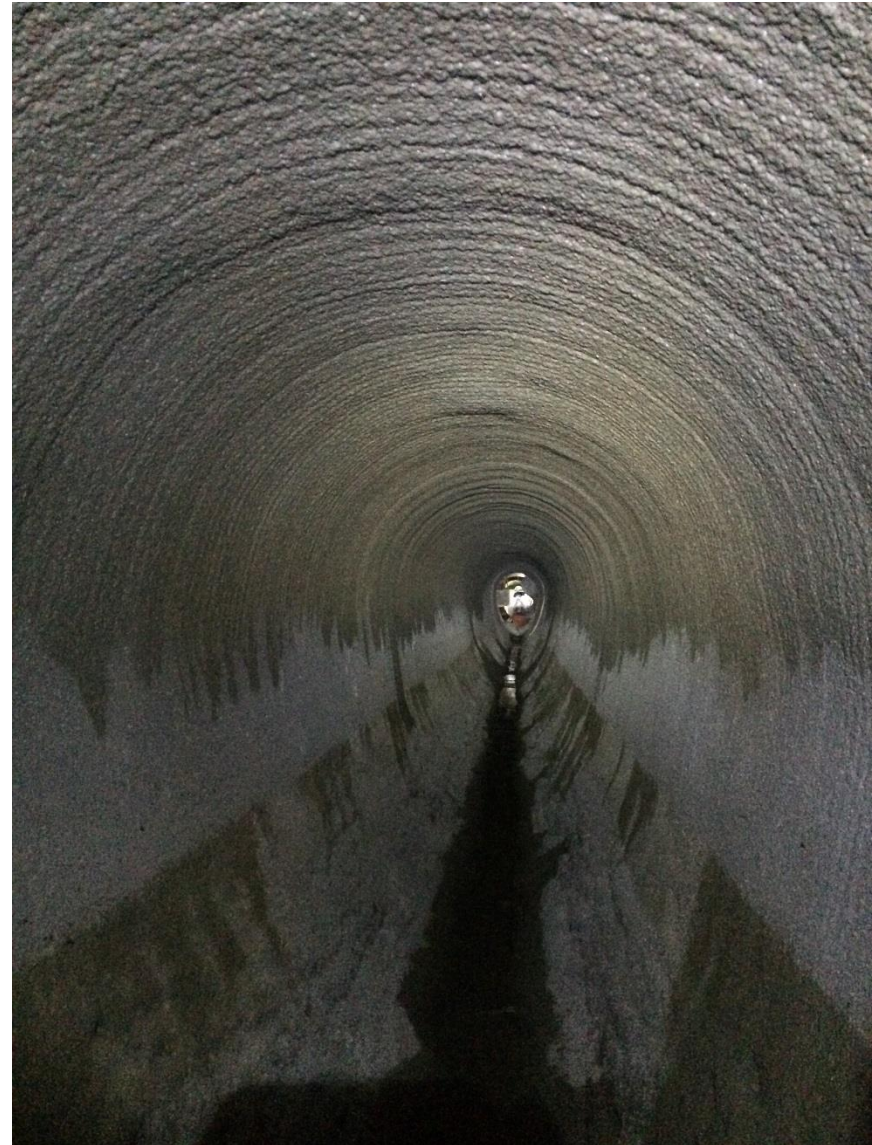
KY 9 - Newport, Kentucky - USA

Structural rehabilitation with a 1.5 inch GeoSpray mortar lining.

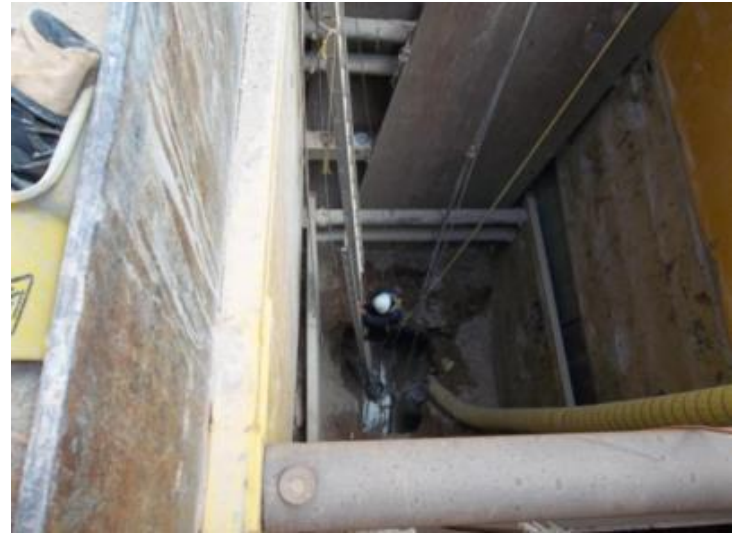
Sever corrosion had occurred within the pipe and at the joints. The pipe was pressure washed and loose material was removed. Water infiltration was stopped at the joints with a hand application of GeoPlug material.

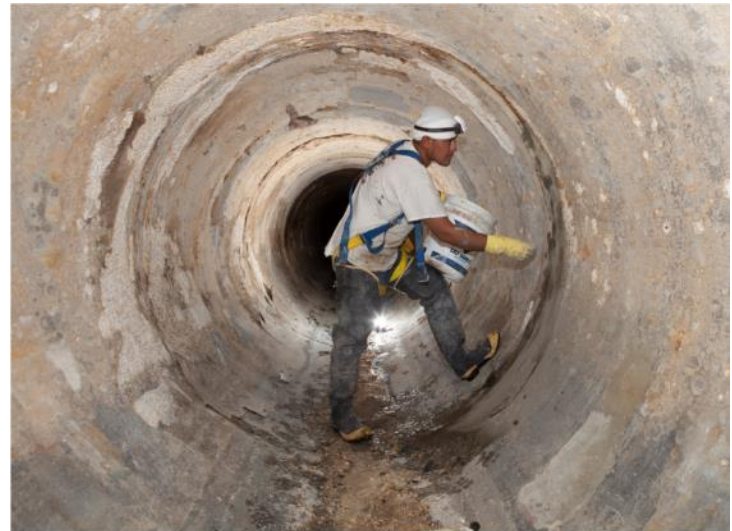
Once the pipe was cleaned and infiltration stopped, the application sled was positioned within the pipe.

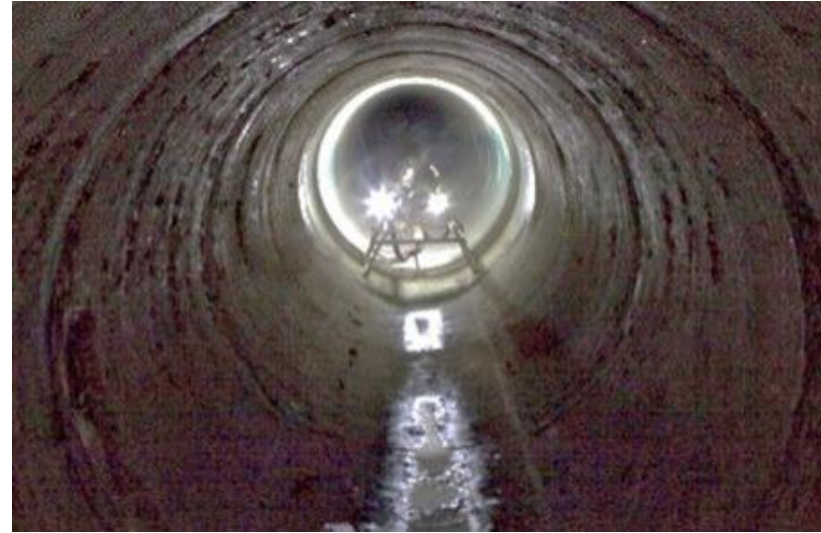
The GeoSpray mortar was centrifugally cast from the spray nozzle onto the existing pipe wall to create a whole new pipe structure.

After the GeoSpray was applied, a finish coat of AMS Post Treatment was applied to impart additional corrosion resistance

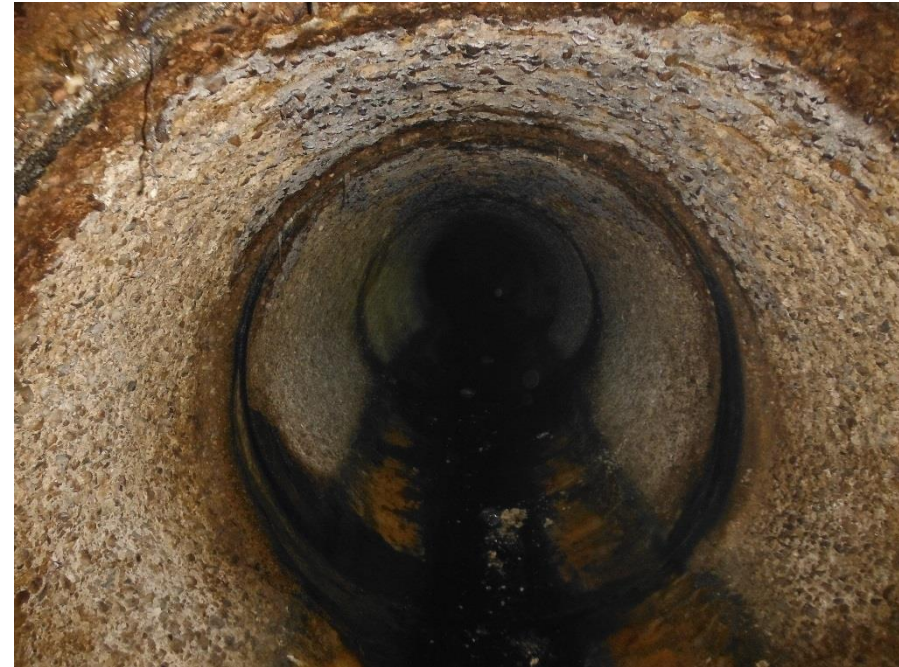
The RCP was severely deteriorated with exposed corroded rebar and several infiltration locations gushing water that needed to be repaired and controlled before lining the existing structure.

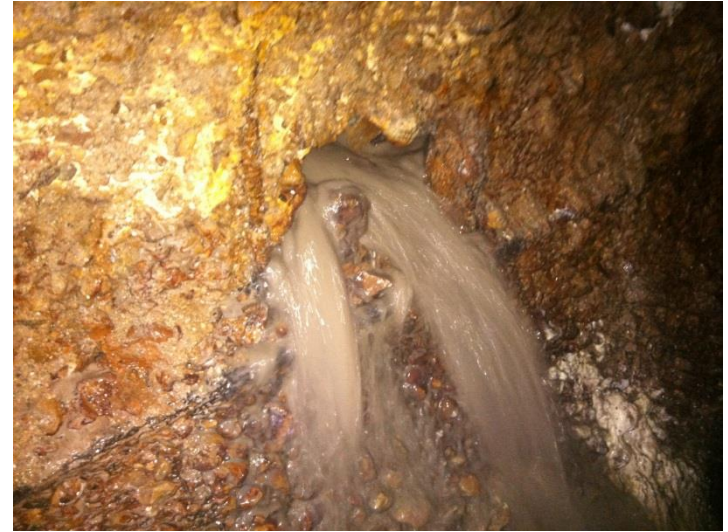
Active infiltration was a concern that had to be repaired prior to lining.

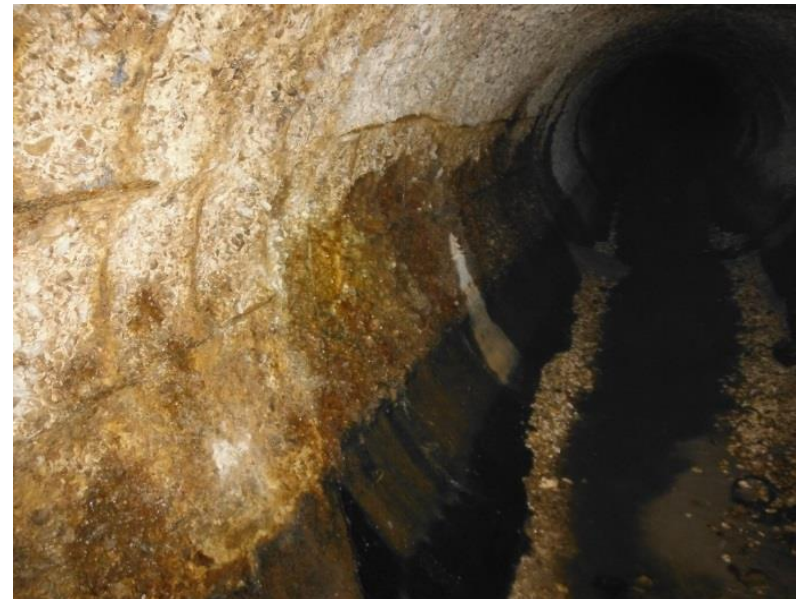
Large sections of the invert of the pipe had also been corroded.

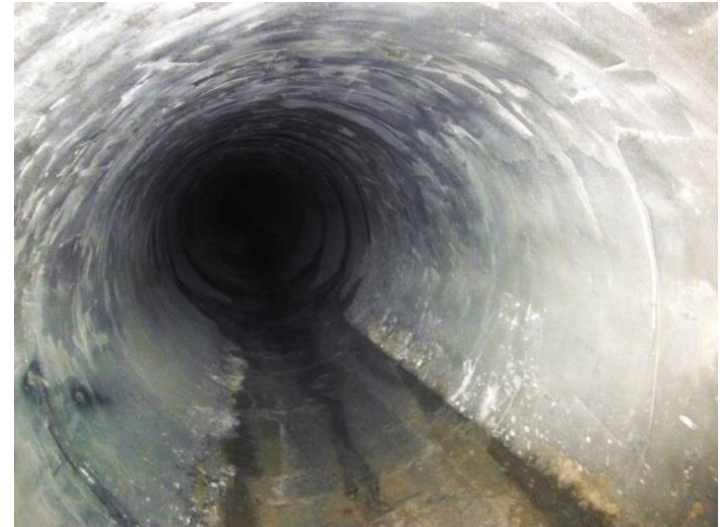
Initial repairs were made and a thin first past of GeoSpray was applied prior to the final thickness

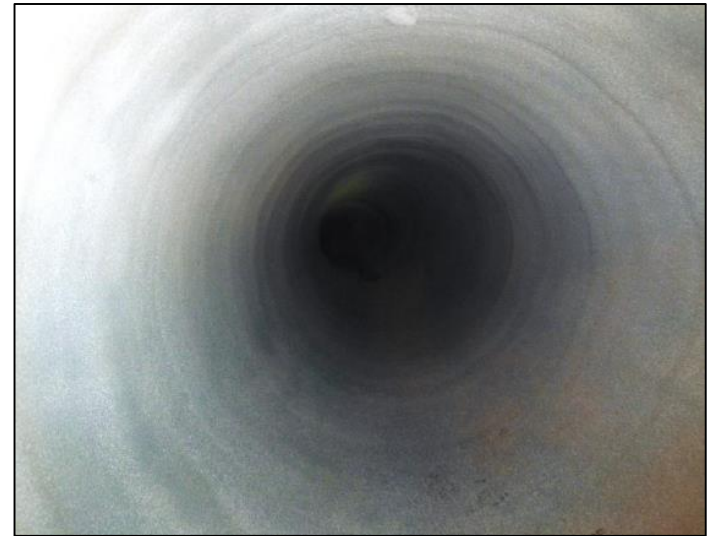
The 2.5” coating of GeoSpray was applied to the existing structure to create a new pipe inside the old. A final AMS Post Treatment was applied to provide additional corrosion resistance.
