2016 Michigan Bridge Conference Workshop

Scour Plan of Action MiSIM Chapter 6

MDOT Bridge Safety Inspection Engineer

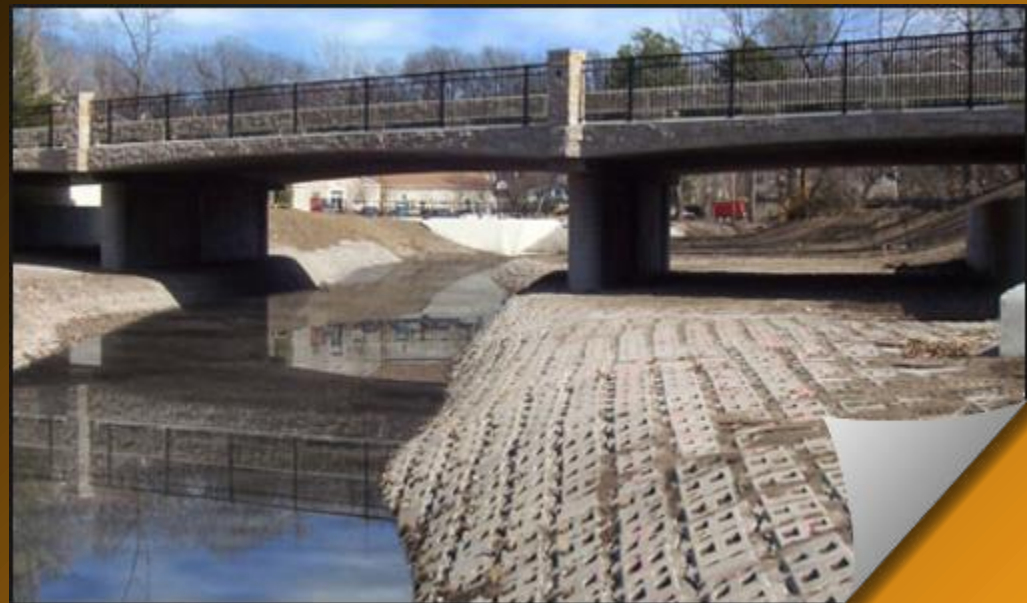
- The top of pier footings must be below the total scour depth (combined local, contraction and long term scour depth) without accounting for the benefit of scour countermeasures in order to be eligible for a coding of 8. **Piers cannot rely on countermeasures to be coded an 8.**

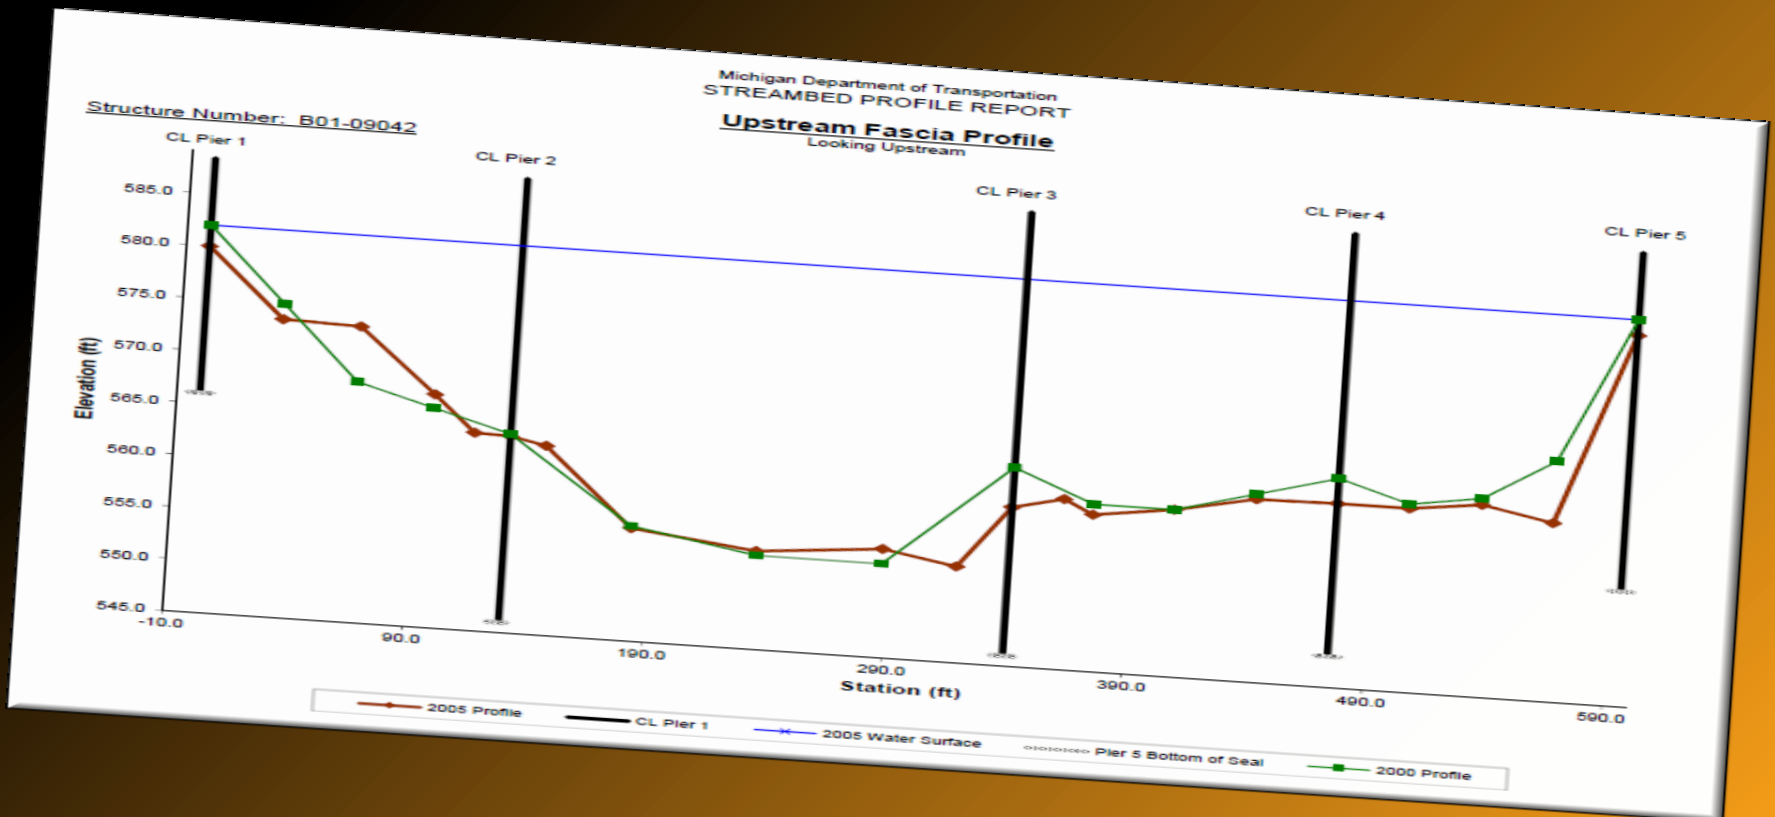
Waterway: Substructure Information

Foundation	Normally in Water	Normal Water Depth (ft)	In Water (100 Yr)	Footing Type	Depth Known	Soil Type
Abutment A	N	N/A	N	A Spread Ftg Soil	Y	Non Cohesive
Abutment B	N	N/A	N	B Footing Timber Piles	Y	Non Cohesive
Pier 1	Y	5.1	Y	C Footing Steel H Piles	Y	Cohesive
Pier 2	Y	8.2	Y	H Curtain Wall	Y	Cohesive
Pier 3	Y	18.6	Y	I Spread Footing Rock	Y	Rock
Pier 4	Y	24.3	Y	M Gravity Steel H Piles	N	Rock
Pier 5	Y	12.2	Y	Q Gravity on Rock	N	Unknown
Pier 6	Y	3.5	Y	U Unknown	N	Unknown

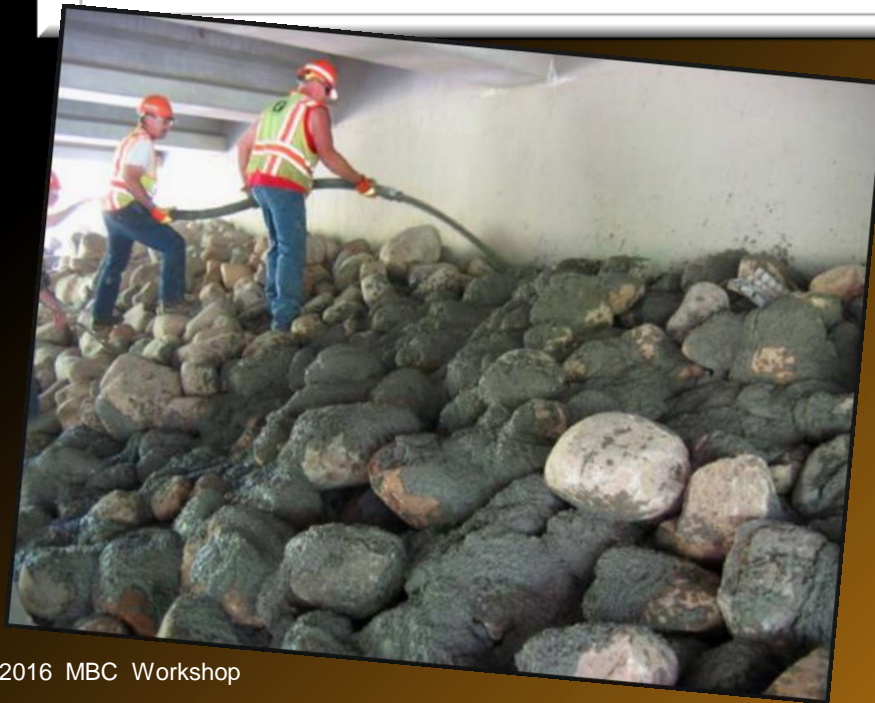
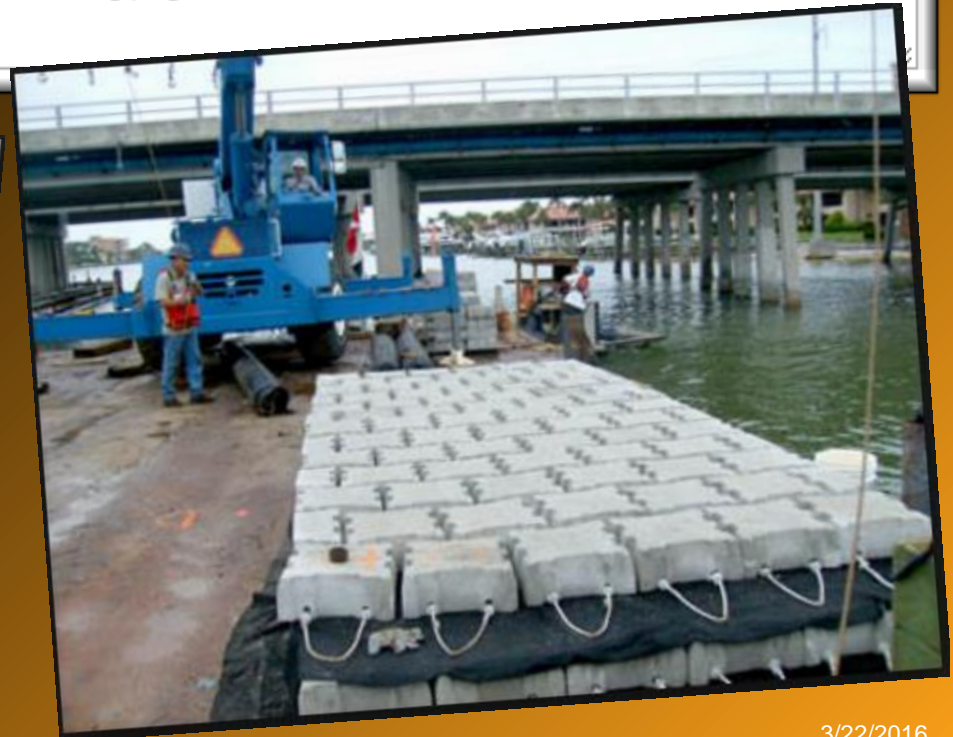
Monitoring Program

This structure has unknown foundations. Previous scour monitoring during high flow events and routine inspections indicate that this structure has remained stable. It is not feasible to install hydraulic or structural countermeasures due to the limited waterway opening. The structure is in relatively good condition and will be monitored for scour per the monitoring program described below.

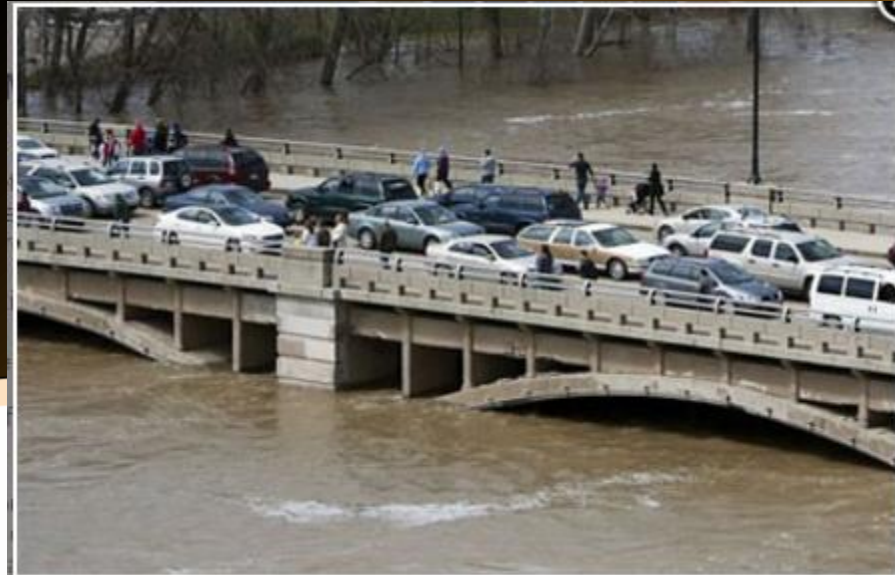
BRIDGE CLOSURE PLAN

Conditions To Consider Bridge Closure

- Water Surface Elevation ft
- Overtopping of Road or Structure
- Pressure Flow
- High Debris Accumulation
- Observed Structure Movement/Settlement
- Loss of Scour Countermeasures
