Kent County
Road Commission

2015 Bridge Conference

Pine Island Drive Bridge Restoration

LTU Beam Testing Update

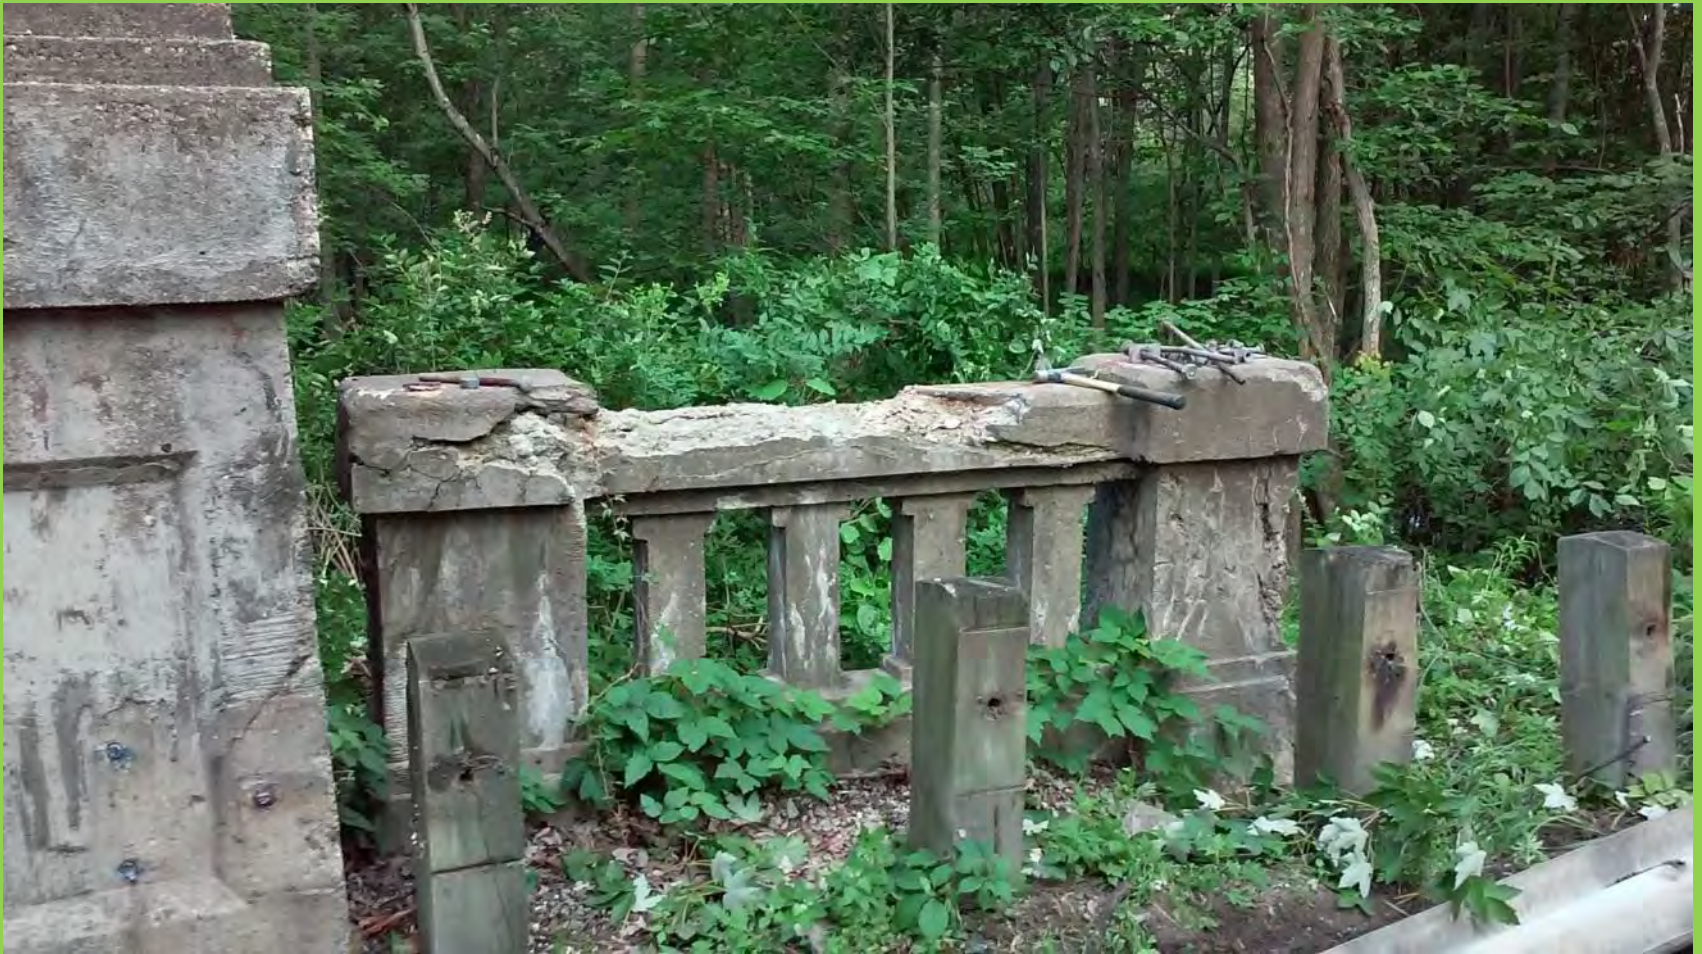
And In Some Places It Was Worse....

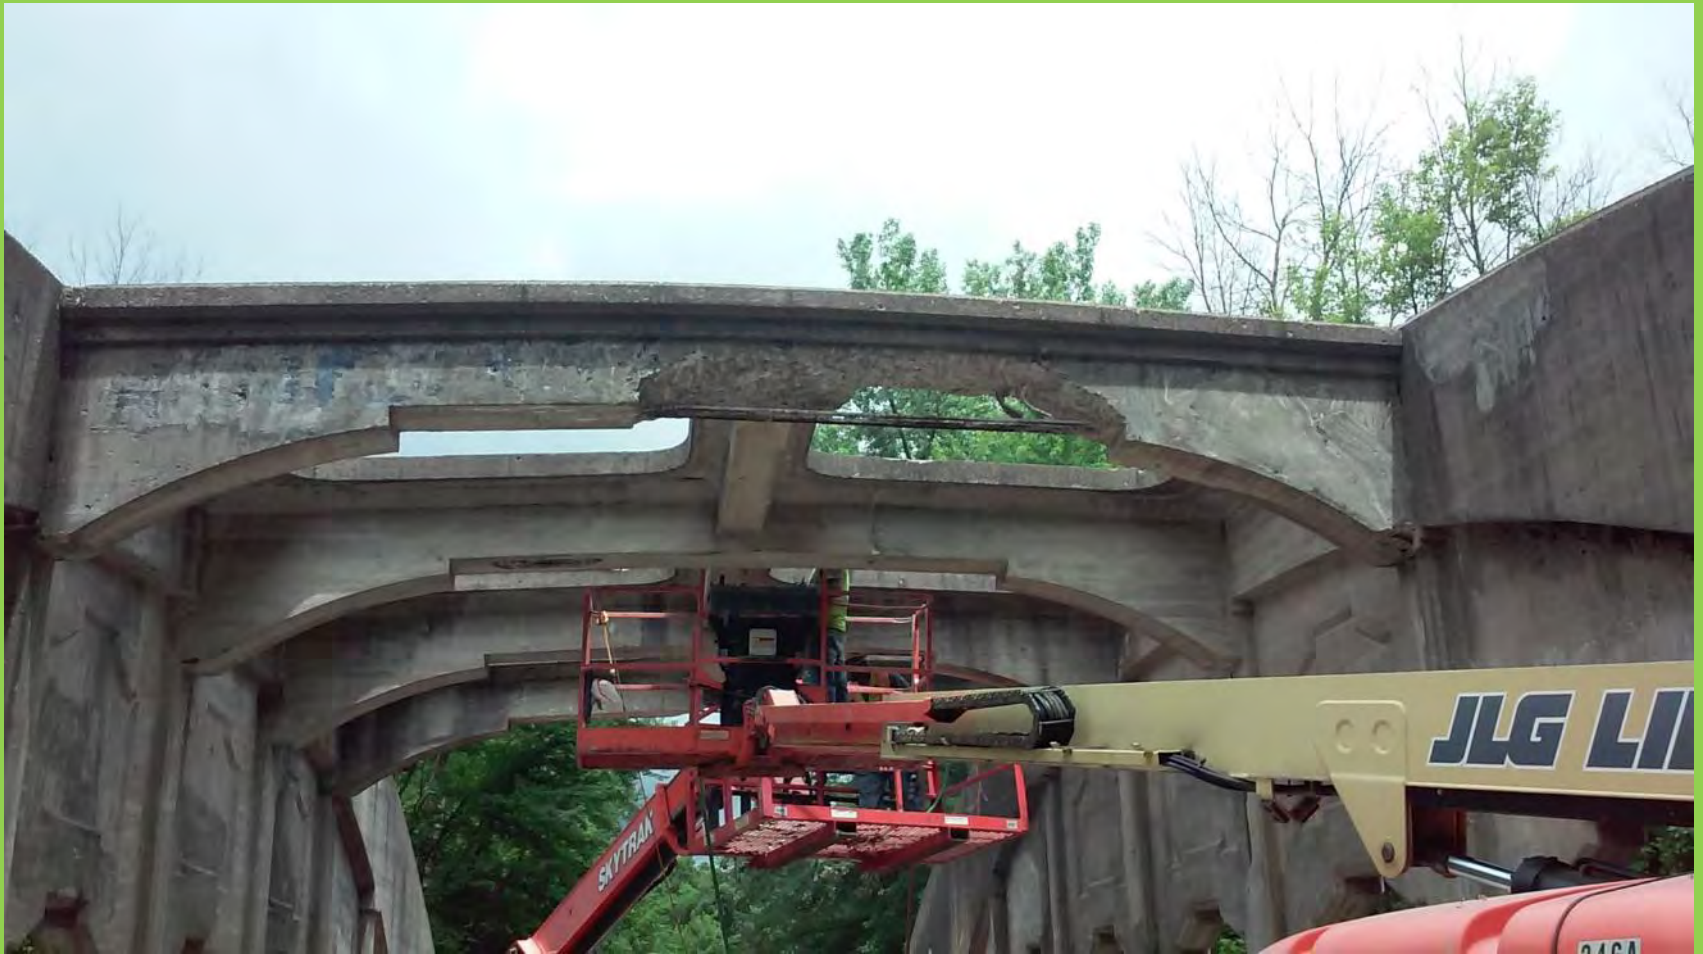
My stomach went into a knot when I saw this...

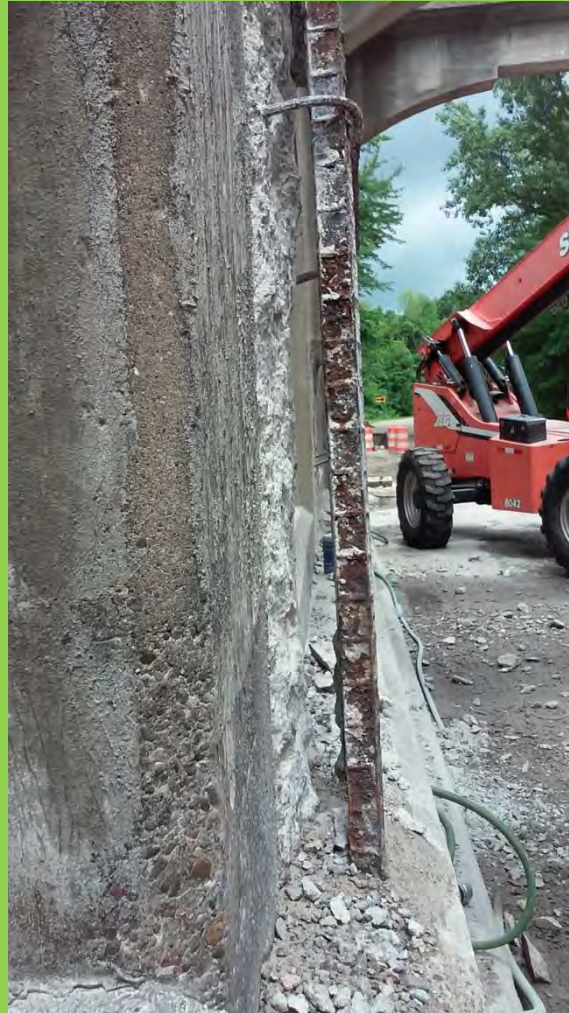
Vertical Reinforcement in “pilaster”

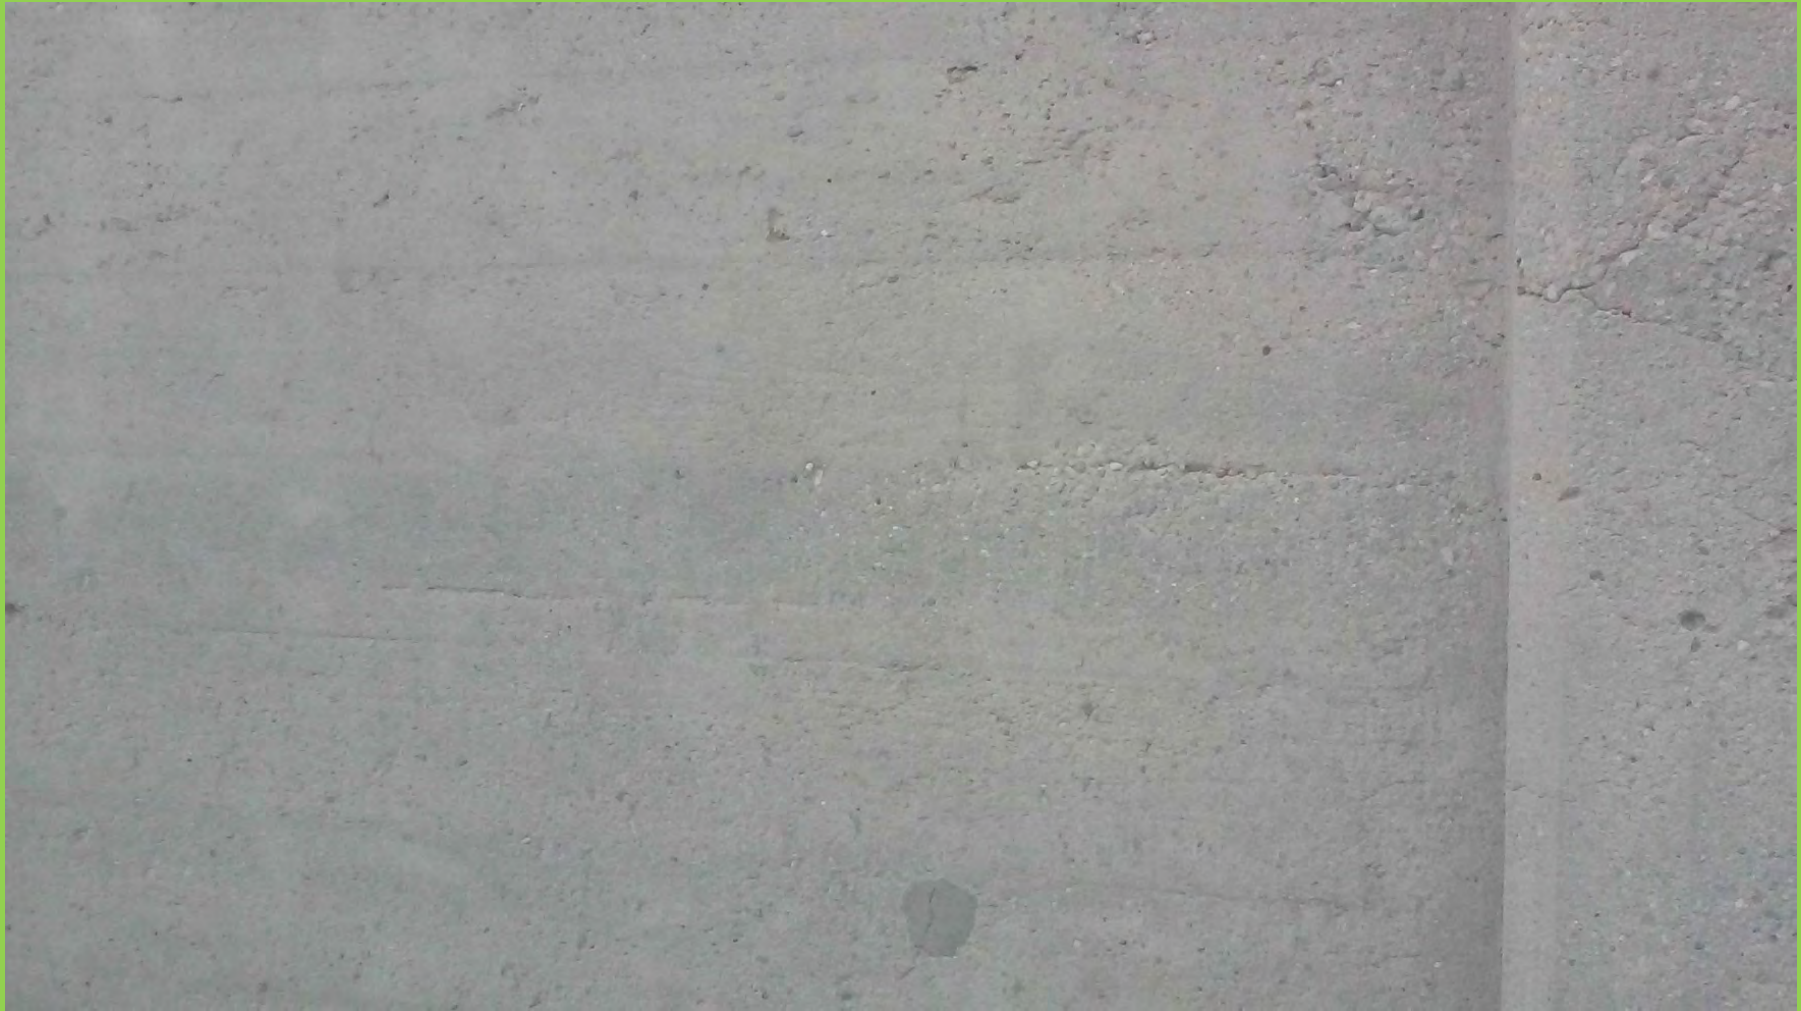
Former Epoxy Covered Area – all concrete substrate was not “perfect” – some surfaces still harbor a little epoxy

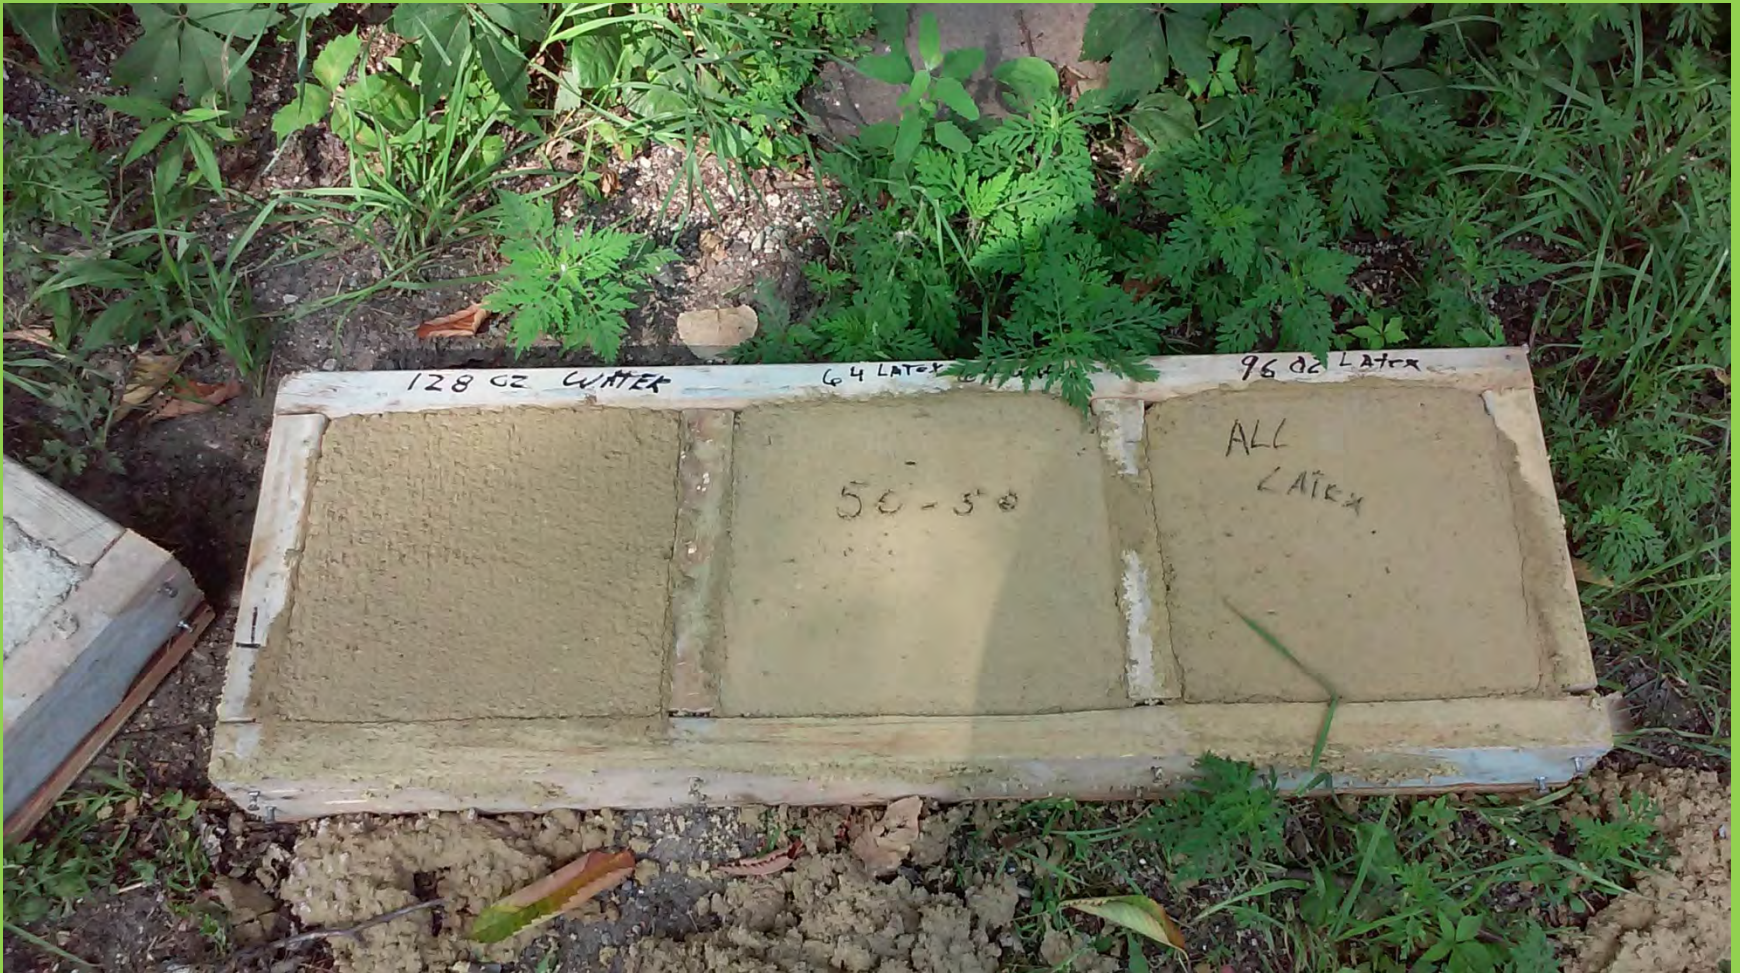
CL Mixes at 5 days – we are very concerned.....(too brown)

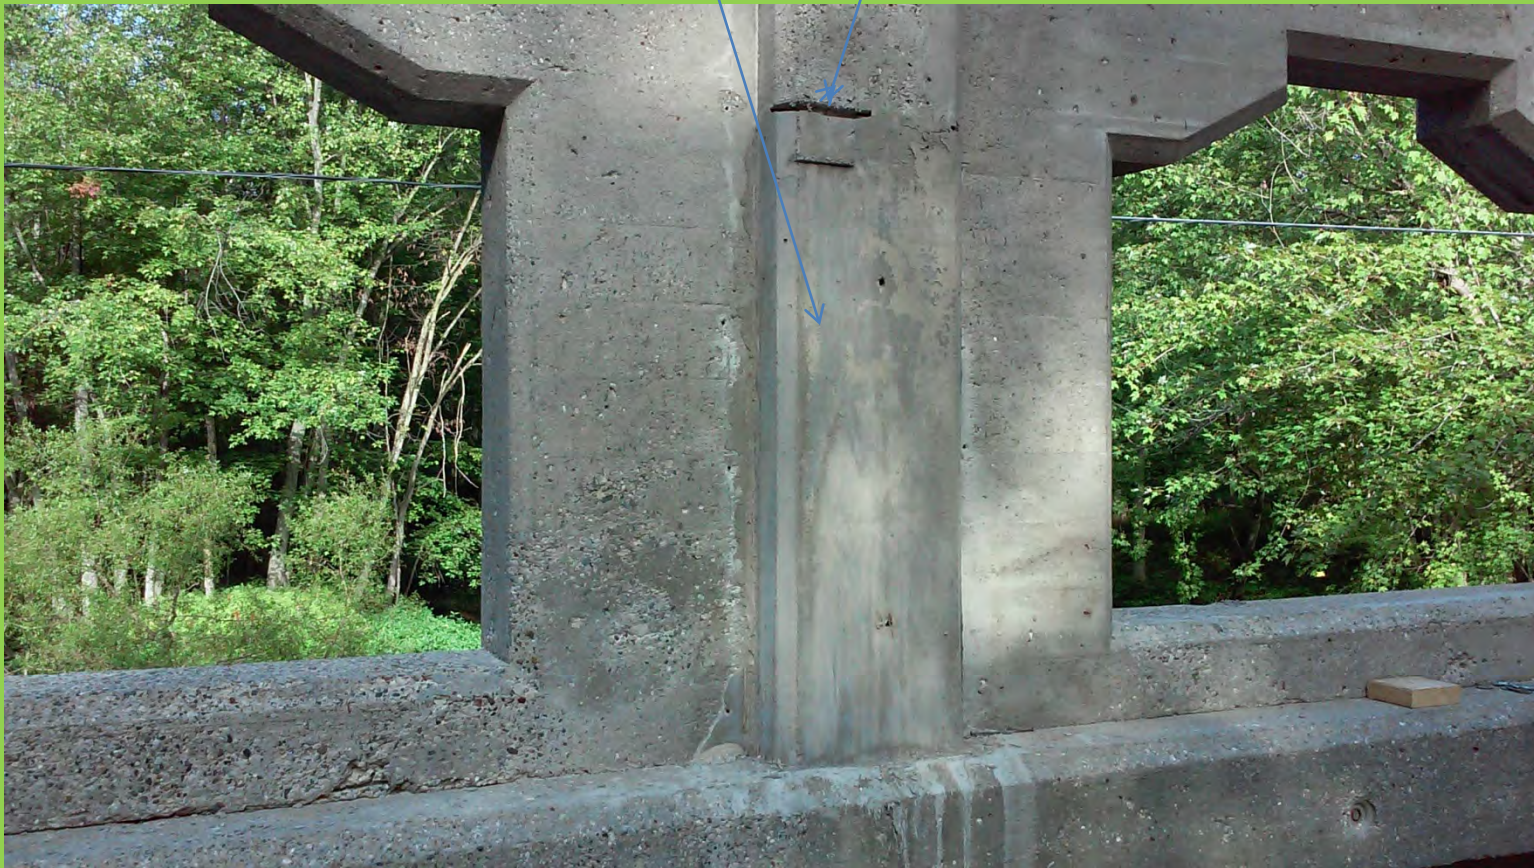
TEXTURE WILL BE
ENHANCED BY APPLICATION
OF "SAND-CEMENT"
TEXTURE

SMALL VOID –(THIS WAS
FILLED). SPRUE WAS REMOVED
TOO

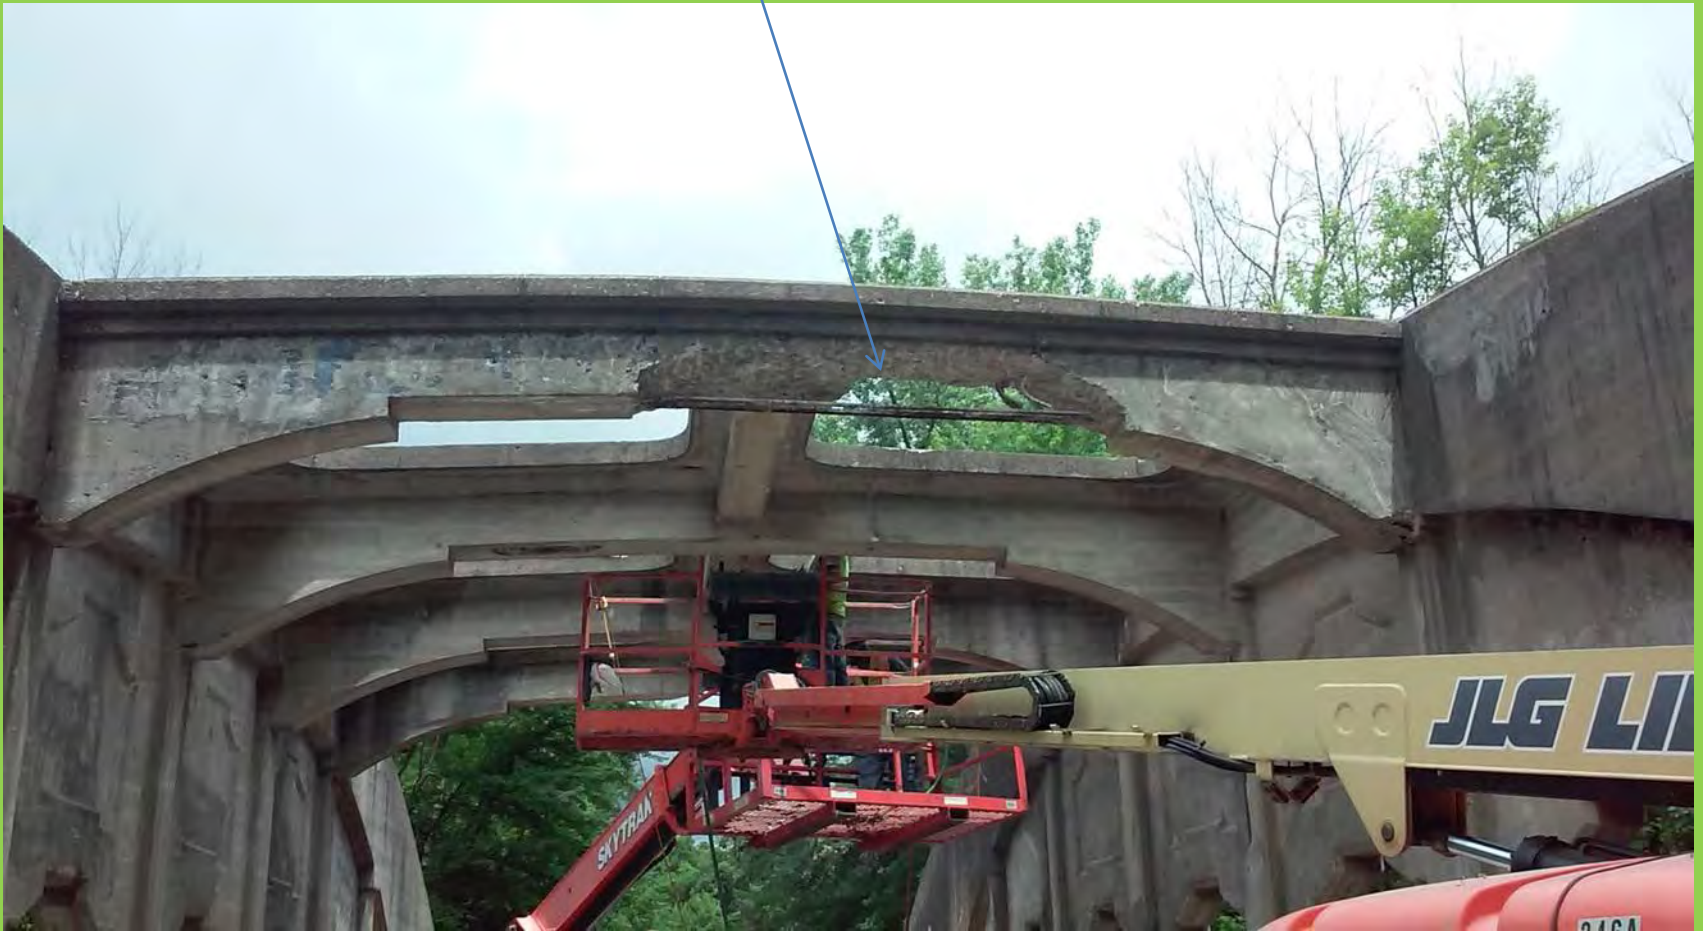
Same Patch Area, 3 Weeks Before

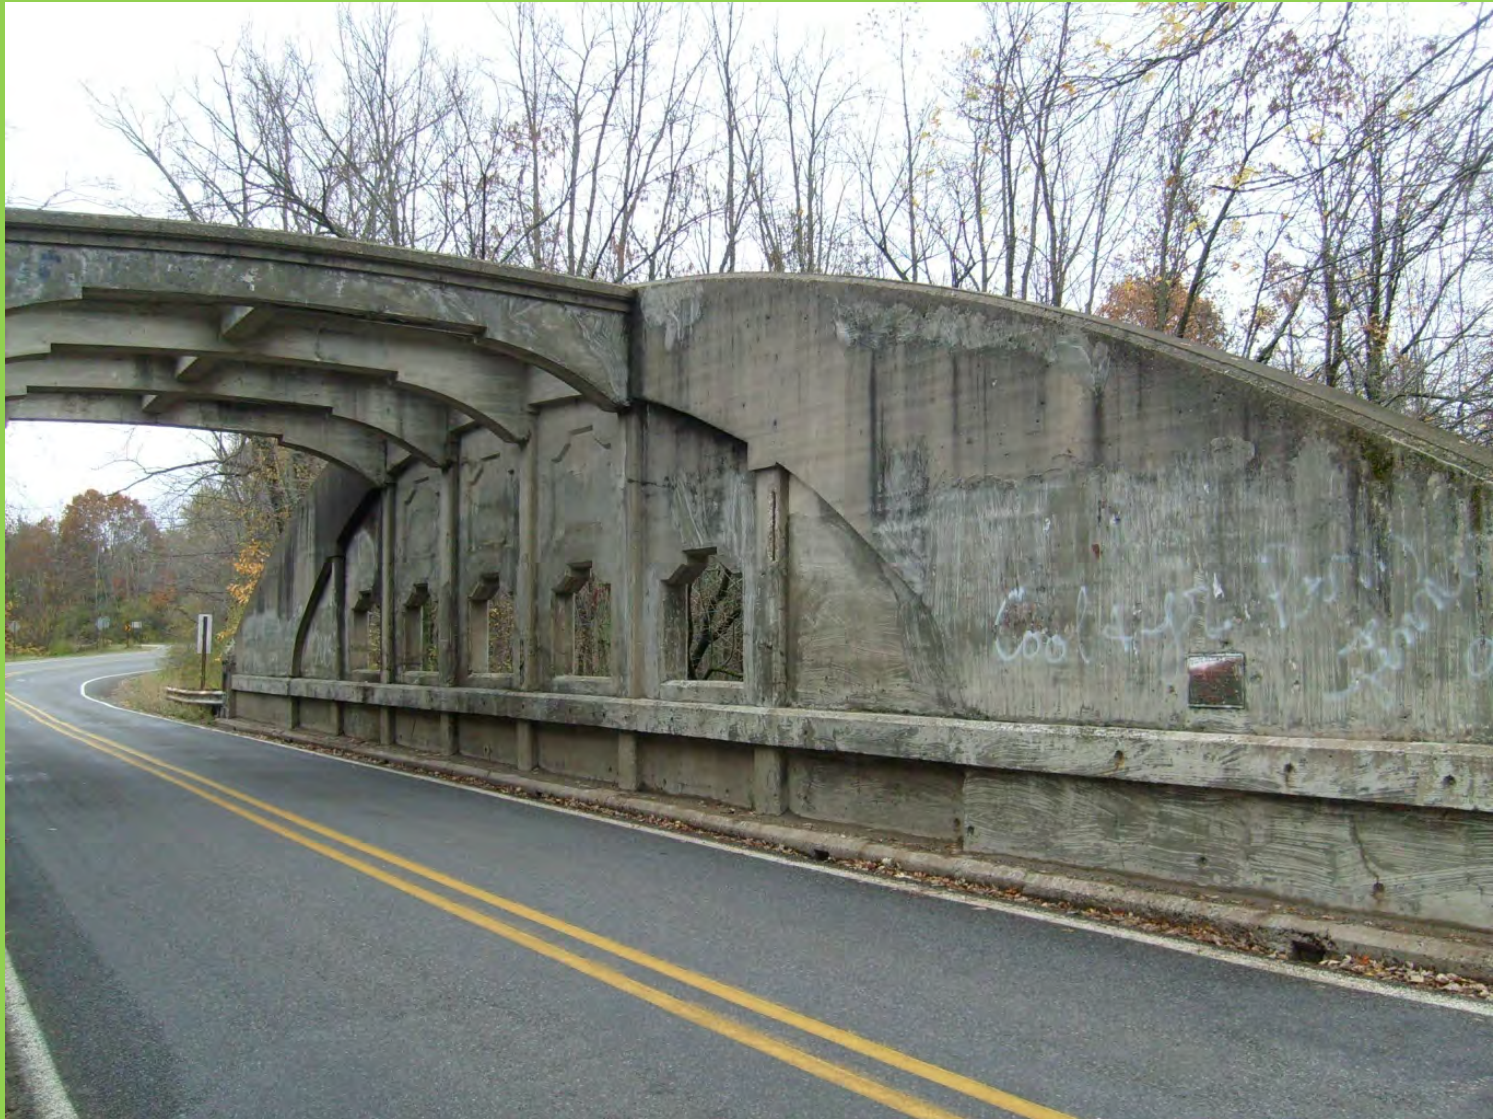
Interior, East Side, Before

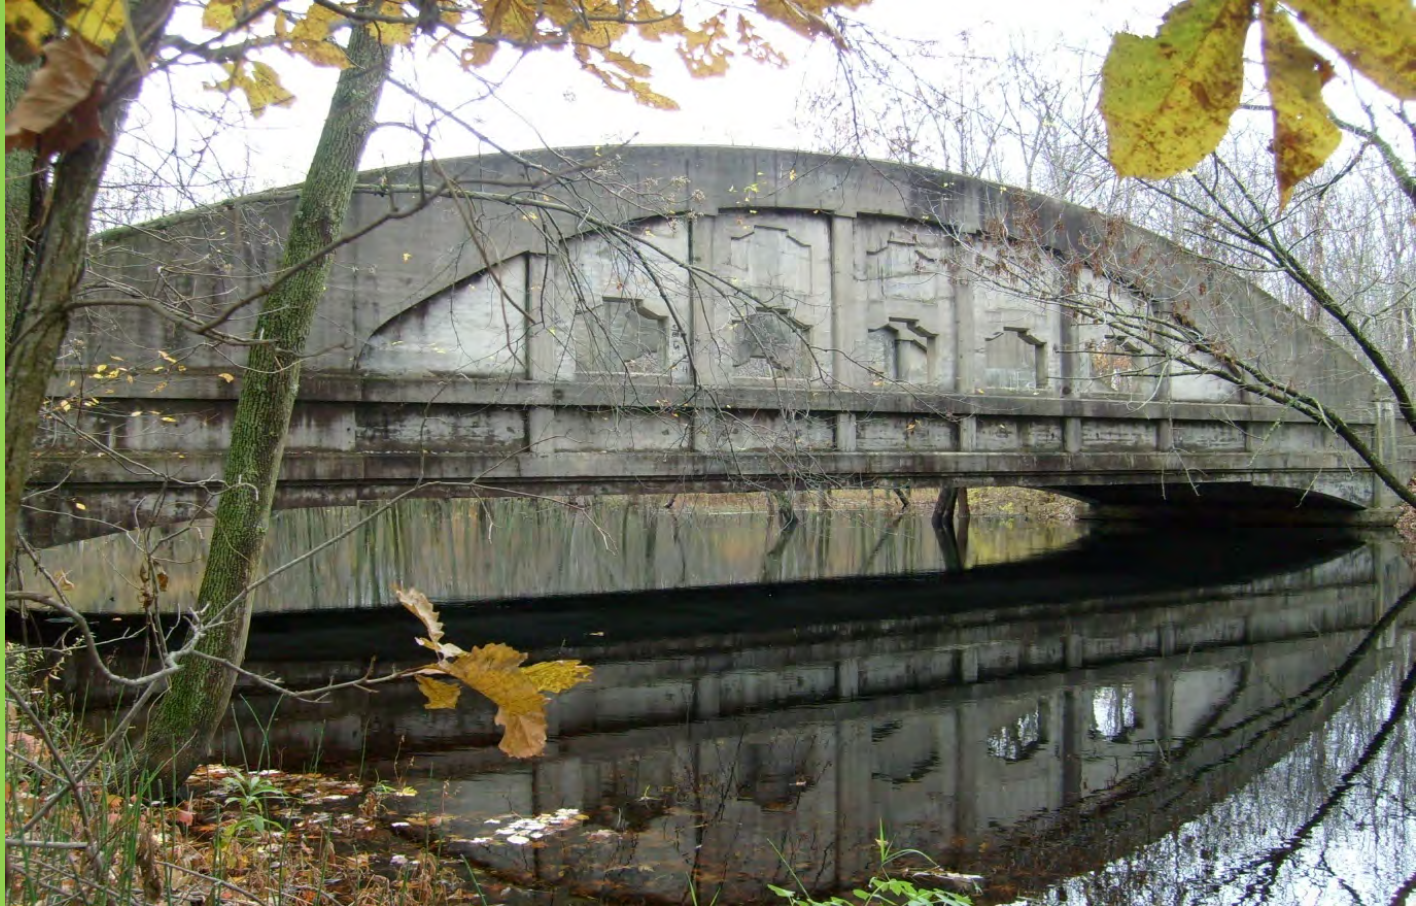
East Fascia - Before
